**DELIVERY OF RECLAMATION MATERIAL  
TO MAINLAND –  
ENVIRONMENTAL MONITORING AND AUDIT  
(CONTRACT NO.: CV/2005/01)**

## **TSEUNG KWAN O AREA 137 FILL BANK**

## **MONTHLY EM&A REPORT**

(APRIL 2009)

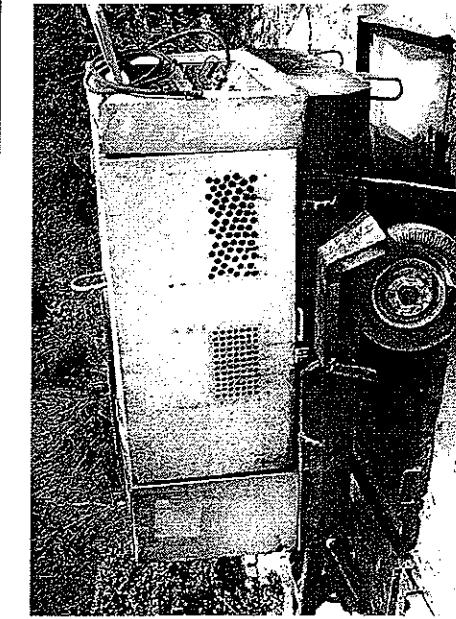
- Two 20L chemical containers were noted discarded on the ground at dumping area during the weekly site inspection on 09 April 2009. The Contractor was reminded to collect and store the chemicals properly. During the weekly site inspection on 15 April 2009, the chemical containers discarded at dumping area were collected;
