**Improvement to Tung Chung Road
between Lung Tseng Tau and Cheung Sha**

**Bi-Monthly EM&A Report for Ecological
Mitigation Audit and Landscape & Visual
Resources Audit (Version 2.0)**

November 2009

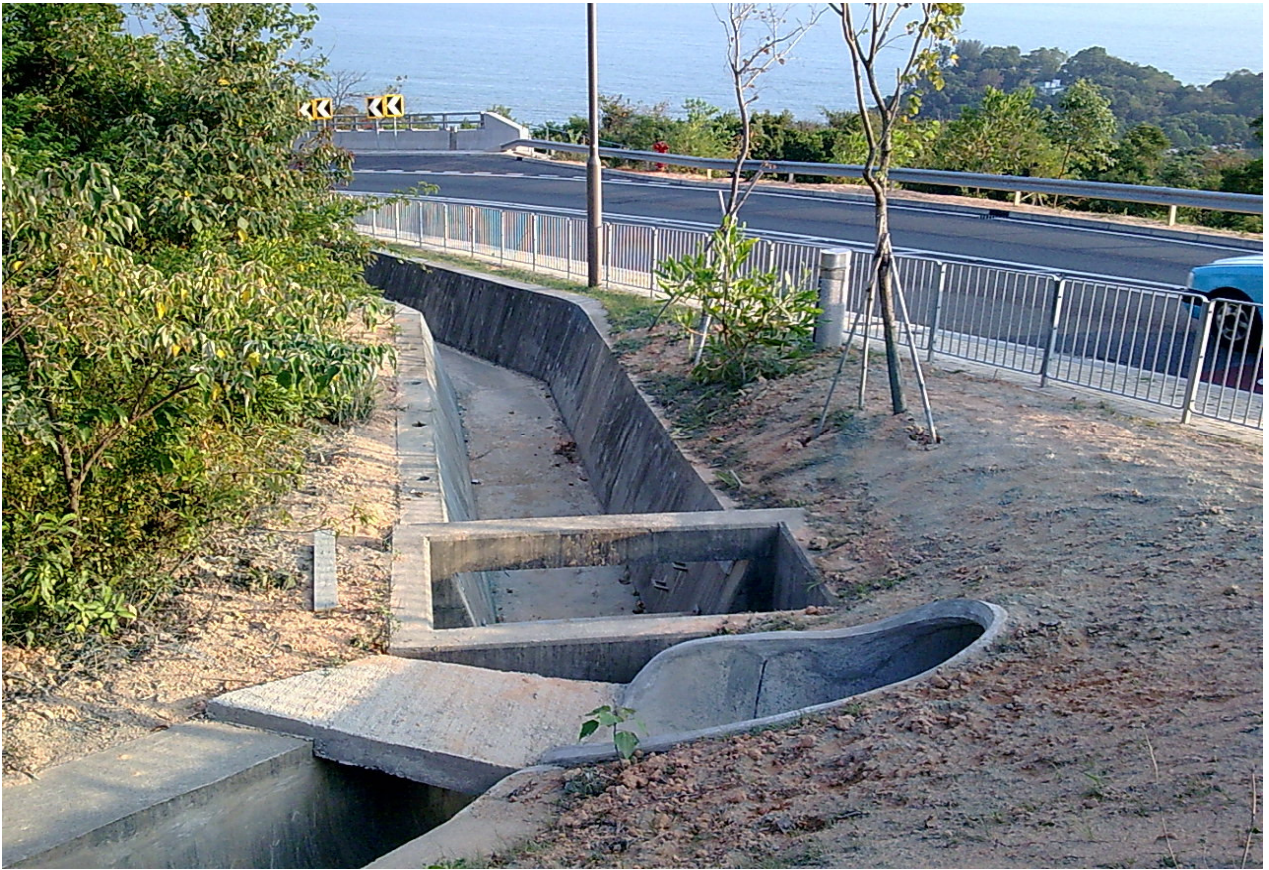
(1) Opening of Wildlife Tunnel (C)

Recommendations	Description	Reference in Appendix B	Reason
Increase the accessibility of the wildlife tunnels	(1) Decrease the slope of or the slope leading to the wildlife tunnels.	Clause 4.3	Steepness of the wildlife tunnels will cause inaccessible to organisms

(2) Installation of fencing mechanism near the wildlife tunnels.	Section 5	Fencing system can guide organisms to the mitigation measures.
	(3) Increase the area of the platform at the opening of the wildlife tunnels and ramps.	-	
Improve the substratum and surface condition of the wildlife tunnels	(1) Cover the surface of the wildlife tunnels with natural materials like soil, glass, debris, etc	Clause 4.7 & 4.8	Mitigation measures look appealing to organisms if its internal habitat resembles ambient condition. Also, small organisms will use vegetation or topography to hide themselves.

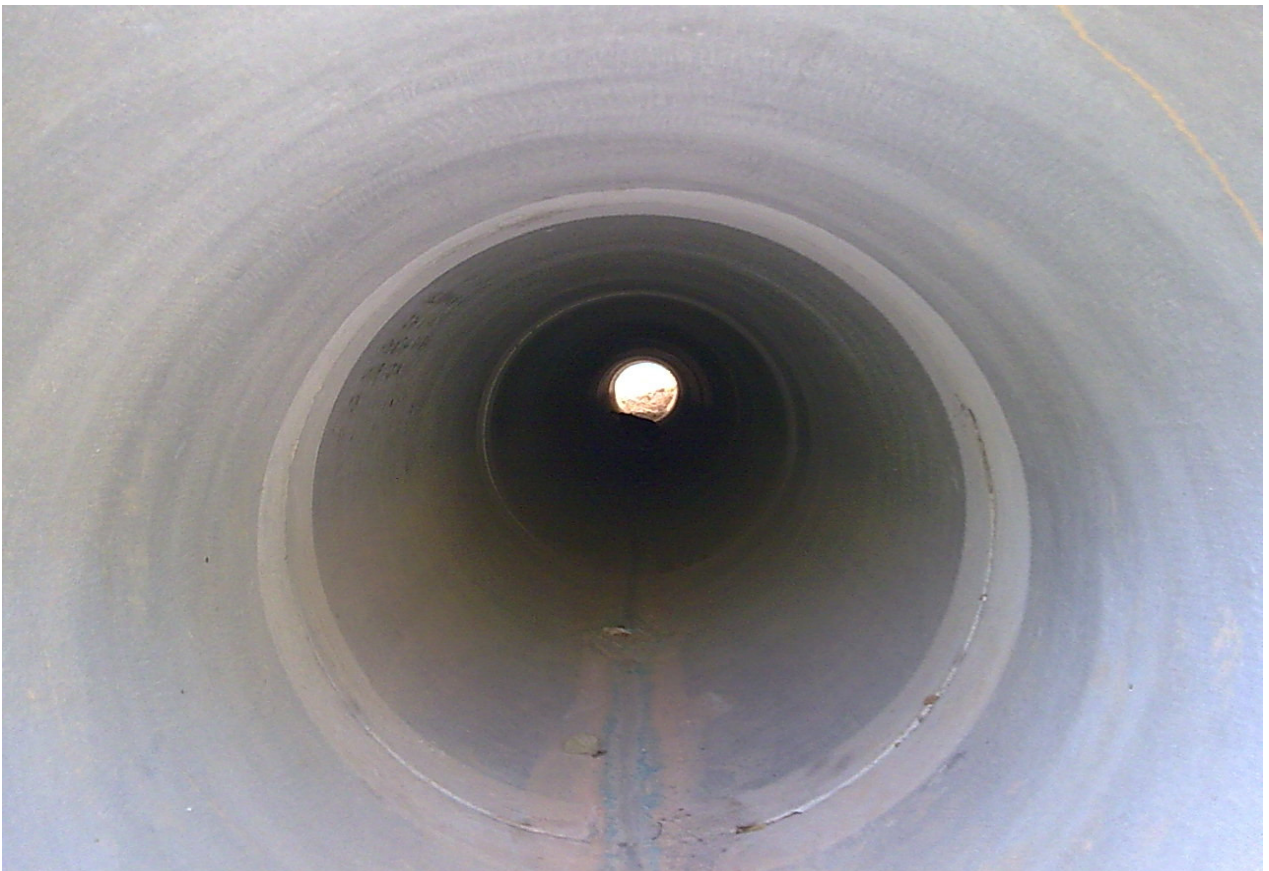
(2) Circular and smooth surface of the wildlife tunnel may cause difficulty in movement of organisms especially for mammals.	2
	(3) No shelter and/or hiding place is provided at or near the wildlife tunnels, organisms will be at risk when passing through or accessing the tunnels. Avoidance for the use of the tunnels by organisms is therefore resulted.	1, 2, 3 & 8
Location and Orientation of the wildlife tunnels	(1) The opening of wildlife tunnels cannot be seen at the natural habitats of organisms. Organisms cannot notice the presence of wildlife tunnel when they are moving along the shrub near the tunnel.	3 & 4

(2) Inside Wildlife Tunnel (C)

Recommendations	Description	Reference in Appendix B	Reason
	(3) Roughen the surface of the wildlife tunnels	-	
Reduce avoidance of organisms to the wildlife tunnels	(1) Adjusting the openness ratio of the wildlife tunnels.	Clause 4.5 & 4.6	Openness ratio of the wildlife tunnel will affect the sense of safety of organism while using the tunnel.

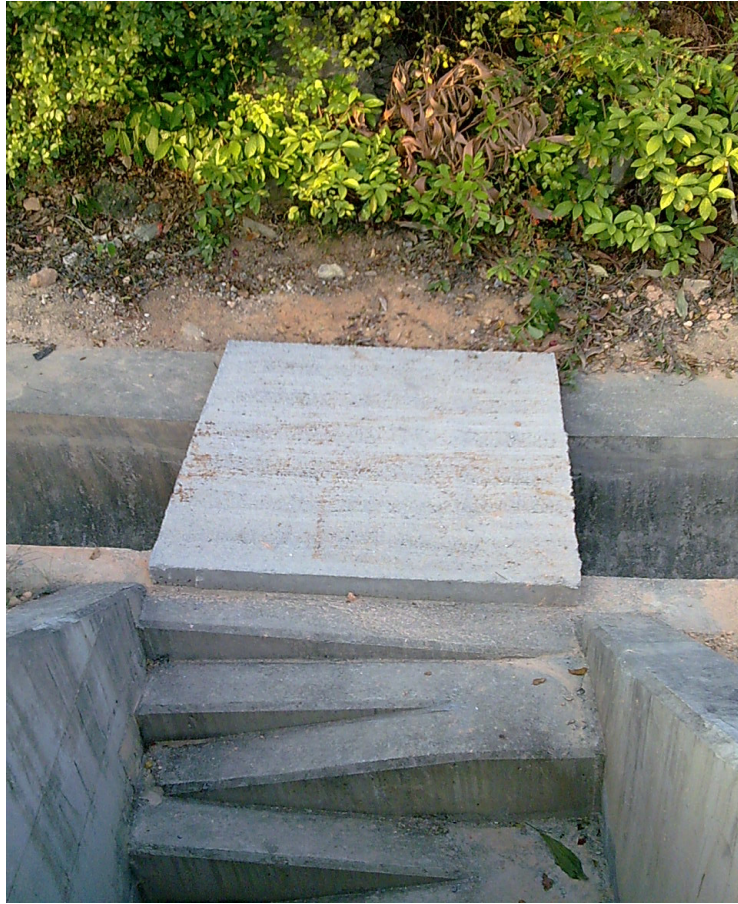
(3) Opening of Wildlife Tunnel with Wildlife Ramp (B)

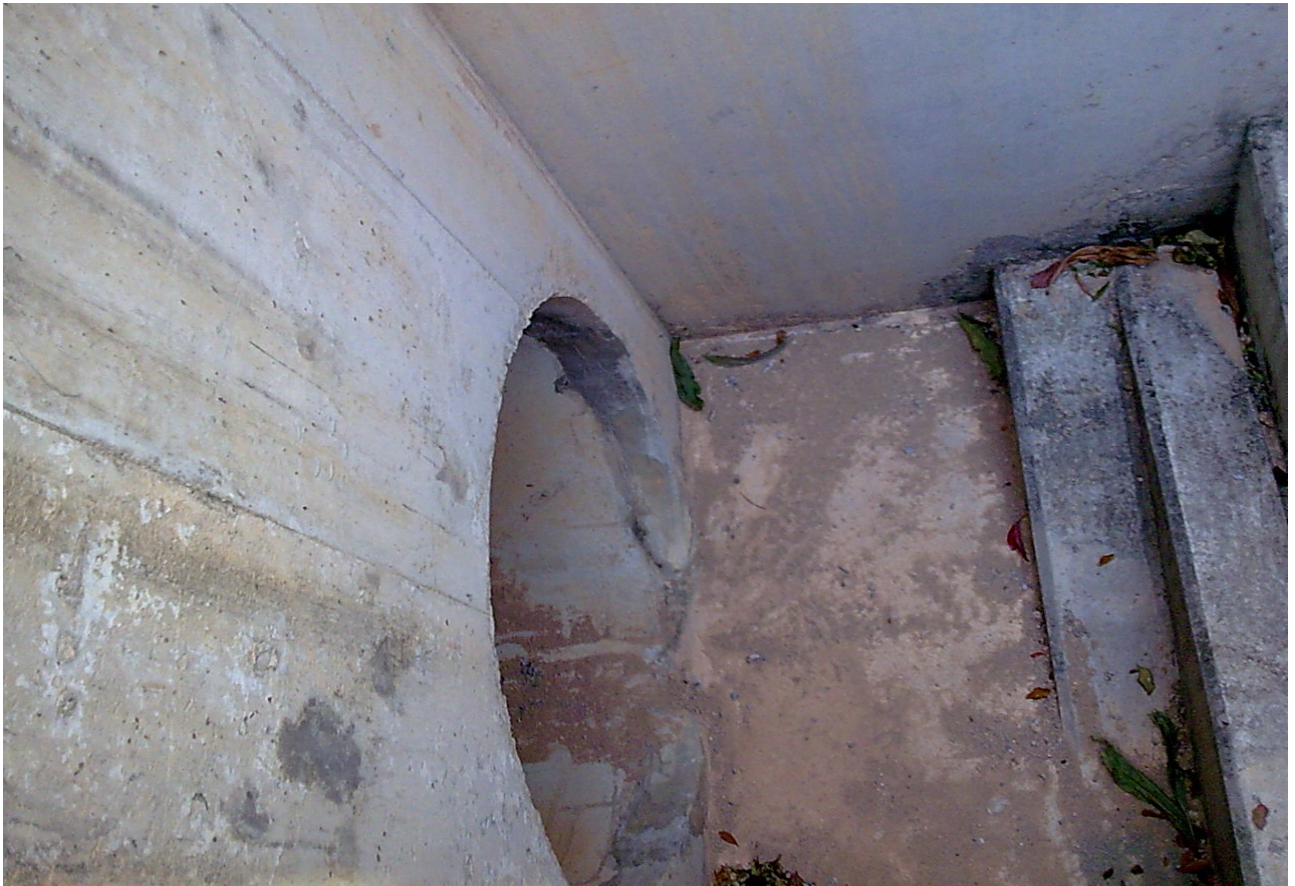
(4) Opening of Wildlife Tunnel with Wildlife Ramp (B)

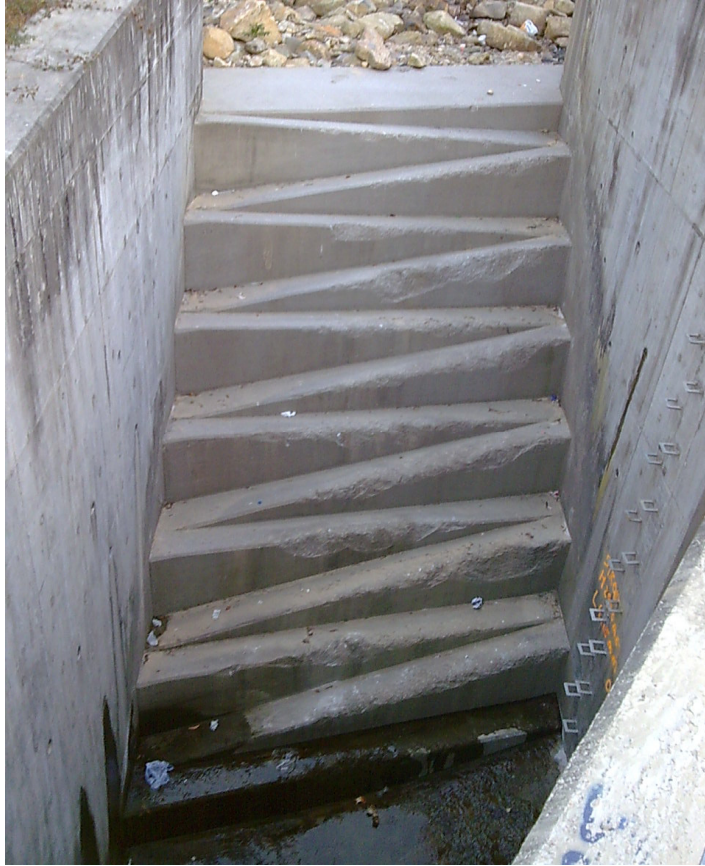
Suggested Reason	Description	Reference Photo
Difficulty to access the wildlife ramps	(1) The height of each step of wildlife ramps may cause inaccessibility to organisms and the total length of the sloped steps is too long for amphibian especially for the tiny organisms (e.g. Romer's Tree Frog).	3 & 7
Substratum and Surface of the wildlife ramps	(1) The surface and substratum of the wildlife ramps is only made up of artificial materials. This makes the tunnel less attractive to wild organisms.	3

(7) The sloped Step at Wildlife Ramp (A)

Recommendations	Description	Reference in Appendix B	Reason
Increase the accessibility of the wildlife ramps	(1) Reduce the height of each step of the wildlife ramps.	-	
	(2) Installation of fencing mechanism near the wildlife ramps.	Section 5	Fencing system can guide organisms to the mitigation measures.
	(3) Increase the area of the platform at the opening of the wildlife ramps.	-

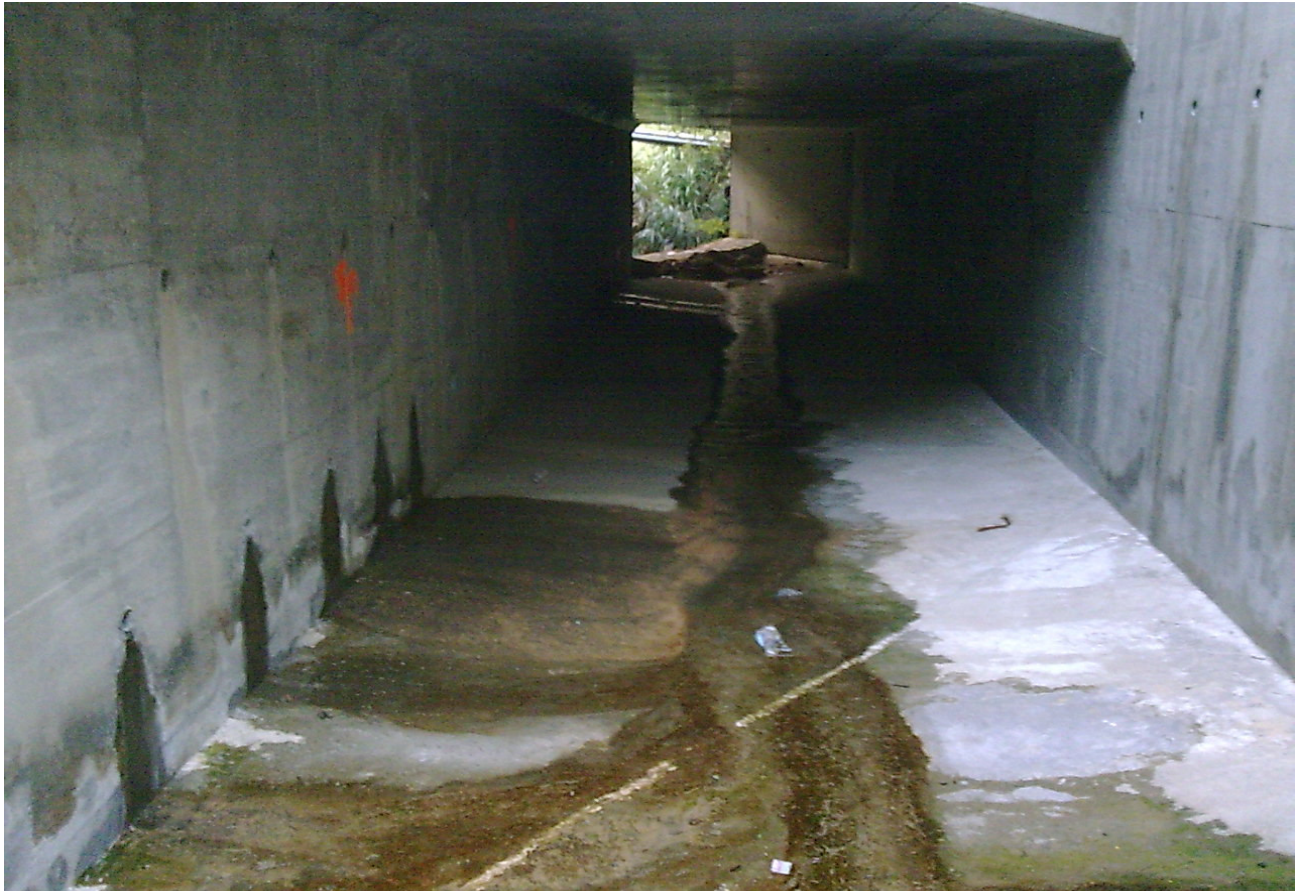
(8) Inside the Wildlife Tunnel (A)

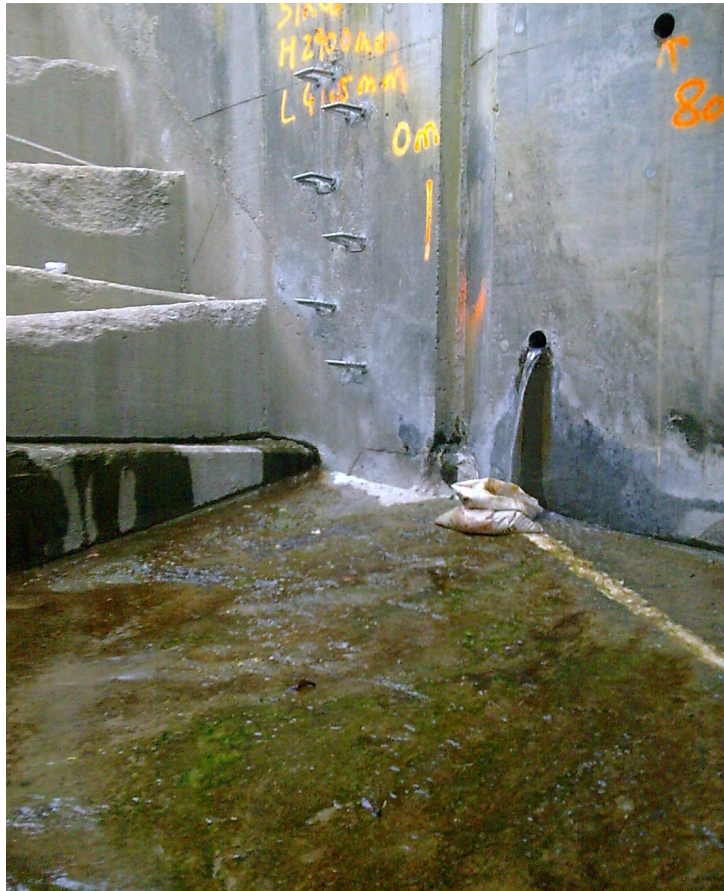
(10) The wall of the Wildlife Tunnel (A)

(3) Paint the surface of the wildlife tunnels to mimic a natural corridor	Clause 4.10	Mitigation measures look appealing to organisms if its internal habitat resembles ambient condition.
Others	(1) Add ledge into the wildlife tunnels for allowing organism to pass through the wildlife tunnel when it is filled with water.	Clause 4.9	Standing water within wildlife tunnel would deter organisms from entering the structures.

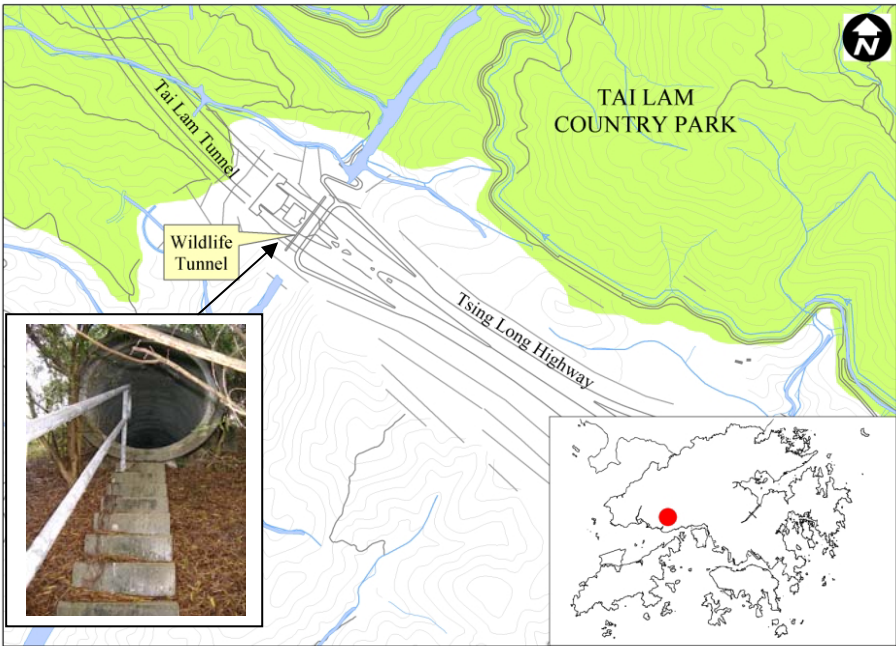
Figure 3. The first purposely constructed wildlife underpass in Hong Kong crossing beneath Route 3.

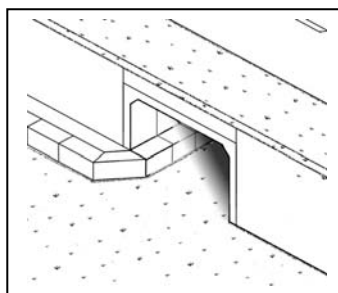
4.9 While moist substrate is important for amphibians and riparian reptiles, standing water within underpasses would deter many animals from entering the structures. As such, underpasses that accommodate amphibians and riparian reptiles should maintain moist substrate but at the same time provide a dry ledge along the entire length of one or both interior walls of the structure (Figure 4). The ledge allows other wildlife to pass through the underpass when it is filled with water. Again, the ledge should be covered with natural substrate and hiding cover consistent with the external surroundings and is wide enough to accommodate the target species.

Figure 4. Box culvert with ledge for wildlife passage

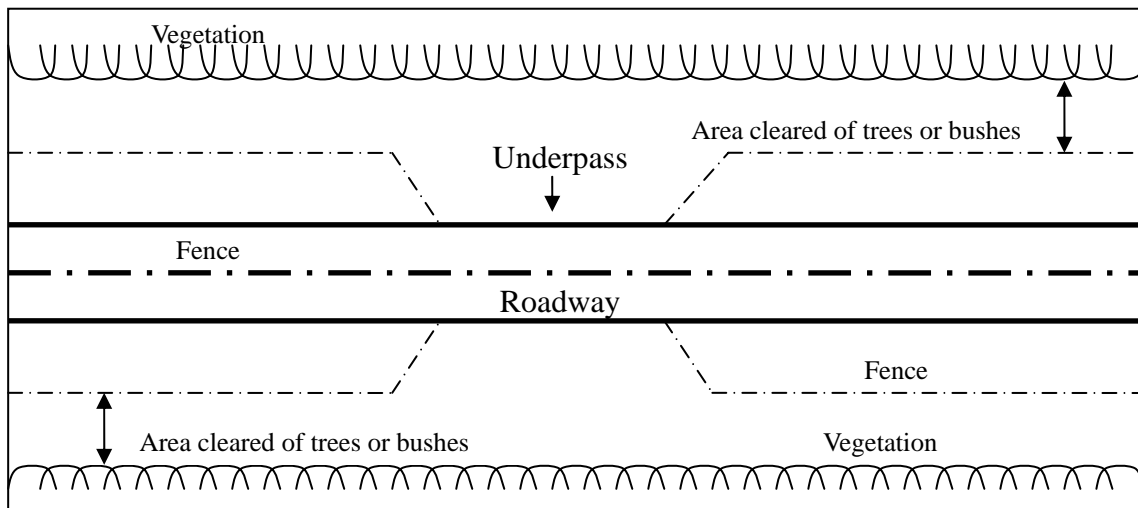
5.6 Vegetation such as trees and large bushes that are adjacent to the fence should be kept to the minimum, as they could act as “natural ladders” which facilitate animals climbing over the fence, and hence lessen the effectiveness of the fencing mechanism (Figure 12).

Figure 12. General design of fencing mechanism for a wildlife underpass (modified after USDA Forest Service, 2005).
