**Improvement to Tung Chung Road  
between Lung Tseng Tau and Cheung Sha**

**Bi-Monthly EM&A Report for Ecological  
Mitigation Audit and Landscape & Visual  
Resources Audit (Version 1.1)**

September 2010

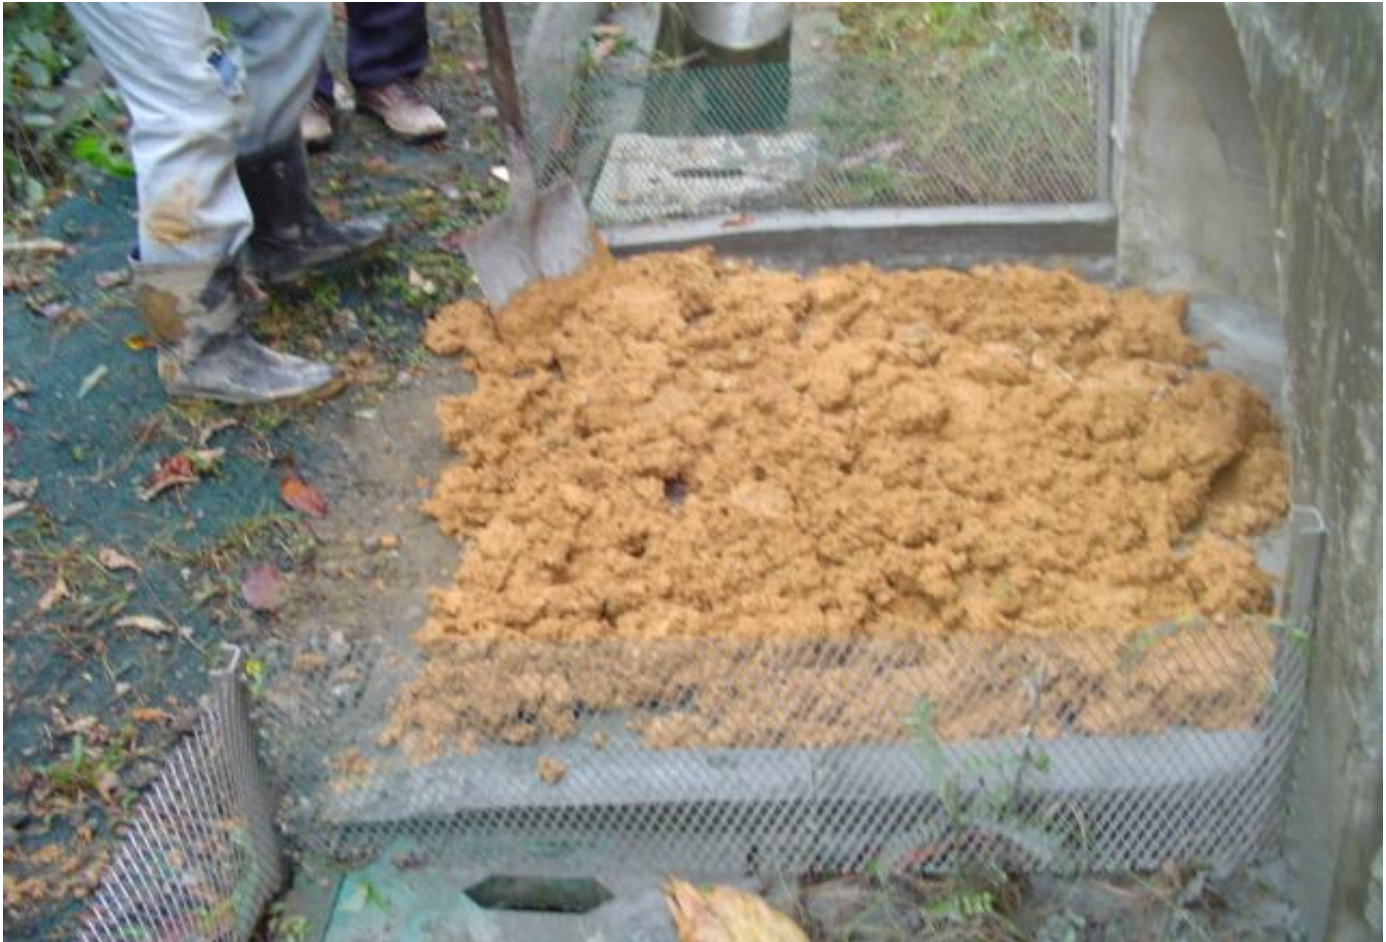
**(1) Opening of Wildlife Tunnel (C)**

<b>Recommendations</b>	<b>Description</b>	<b>Improvement Works Completed in September 2010</b>	<b>Photo Reference</b>
Increase the accessibility of the wildlife tunnels	Provide inverted net at an angle 30 to 90 degrees at the top of chain link fencing	No bending at the top of the net as the bending will cause danger to cattle when crossing the water channel.	N/A
Improve the substratum and surface condition of the wildlife tunnels	Cover the accessing platform and surface of the wildlife tunnels with natural materials like soil, glass, debris, etc	The accessing platform was covered with soil to provide an environment that match the natural habitat.	(1) ,(5) and(6)
	Flatten the base of the wildlife tunnels	The surface of the wildlife tunnels was flattened with concrete and roughens by crushed stone.	(2) and (4)
	Roughen the surface of the wildlife tunnels		
Reduce avoidance of organisms to the wildlife tunnels	Paint the surface of the wildlife tunnels to mimic a natural corridor	The bottom part of the tunnels was covered by crushed stone to mimic a natural corridor.	(2) and (4)

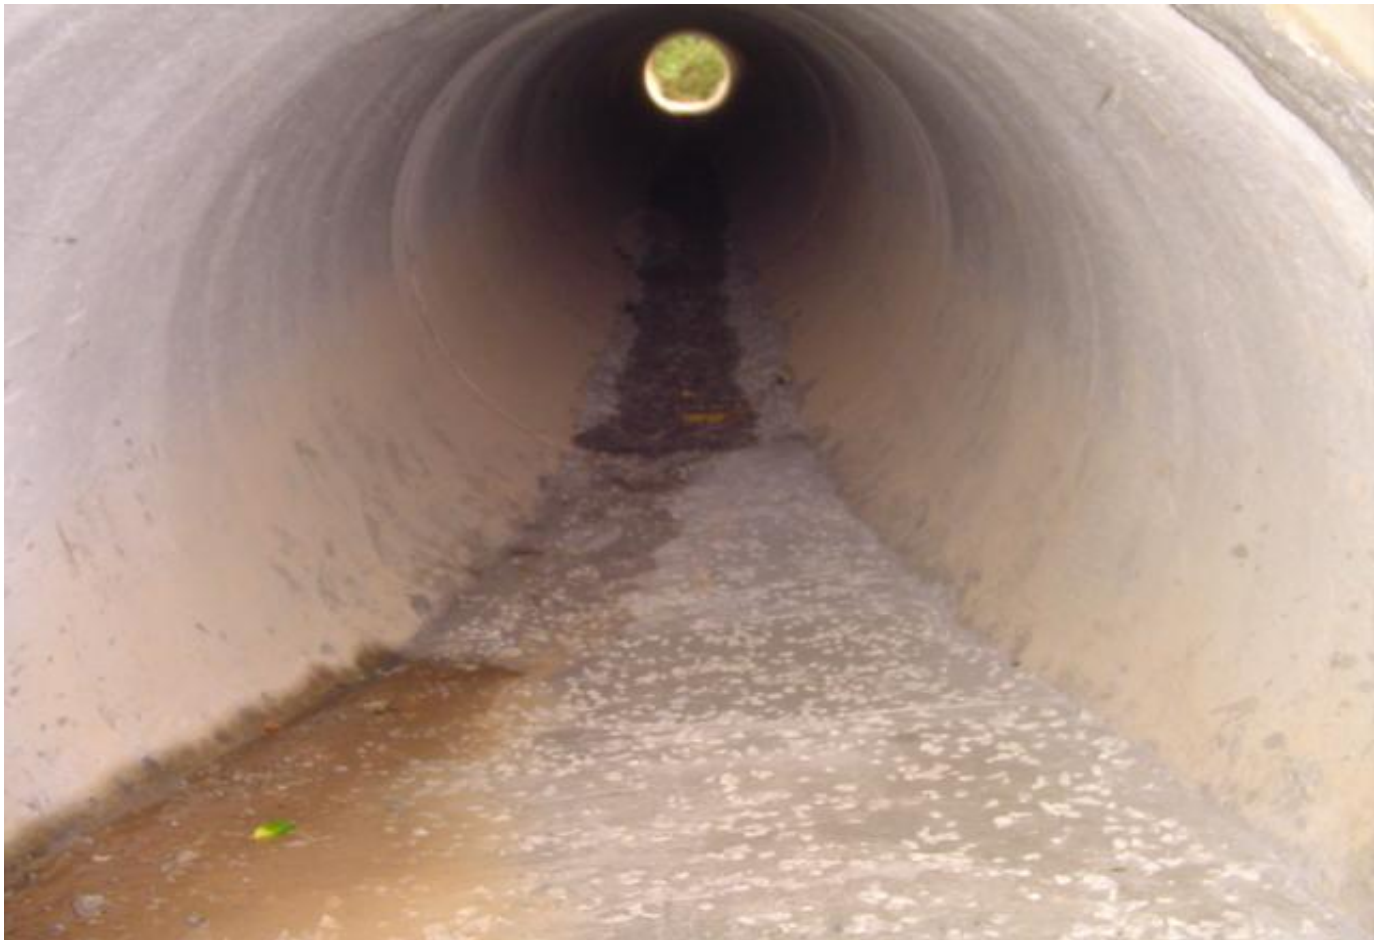
**(2) Inside Wildlife Tunnel (C)**

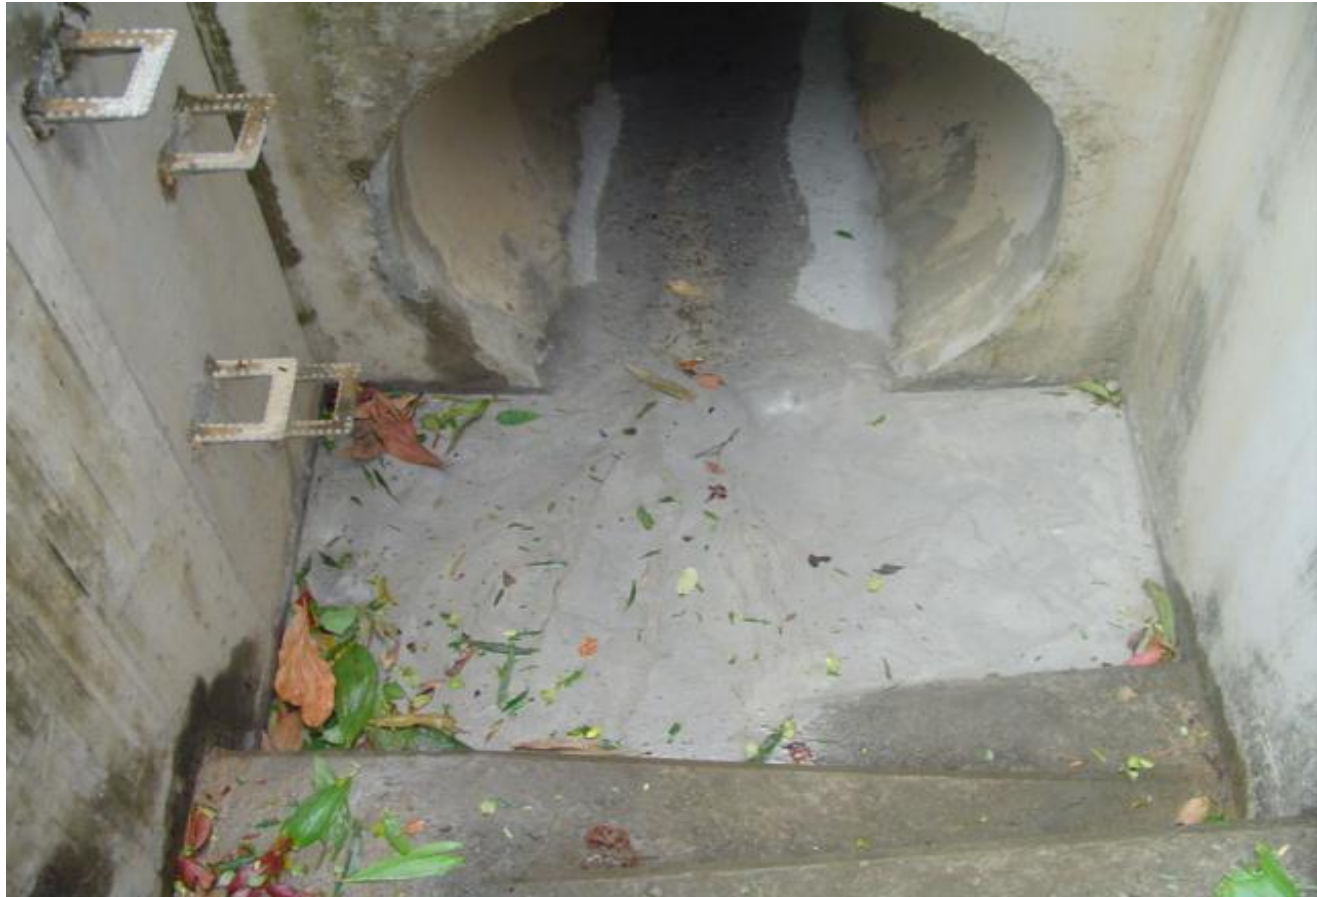
**(3) Opening of Wildlife Tunnel with Wildlife Ramp (C)**

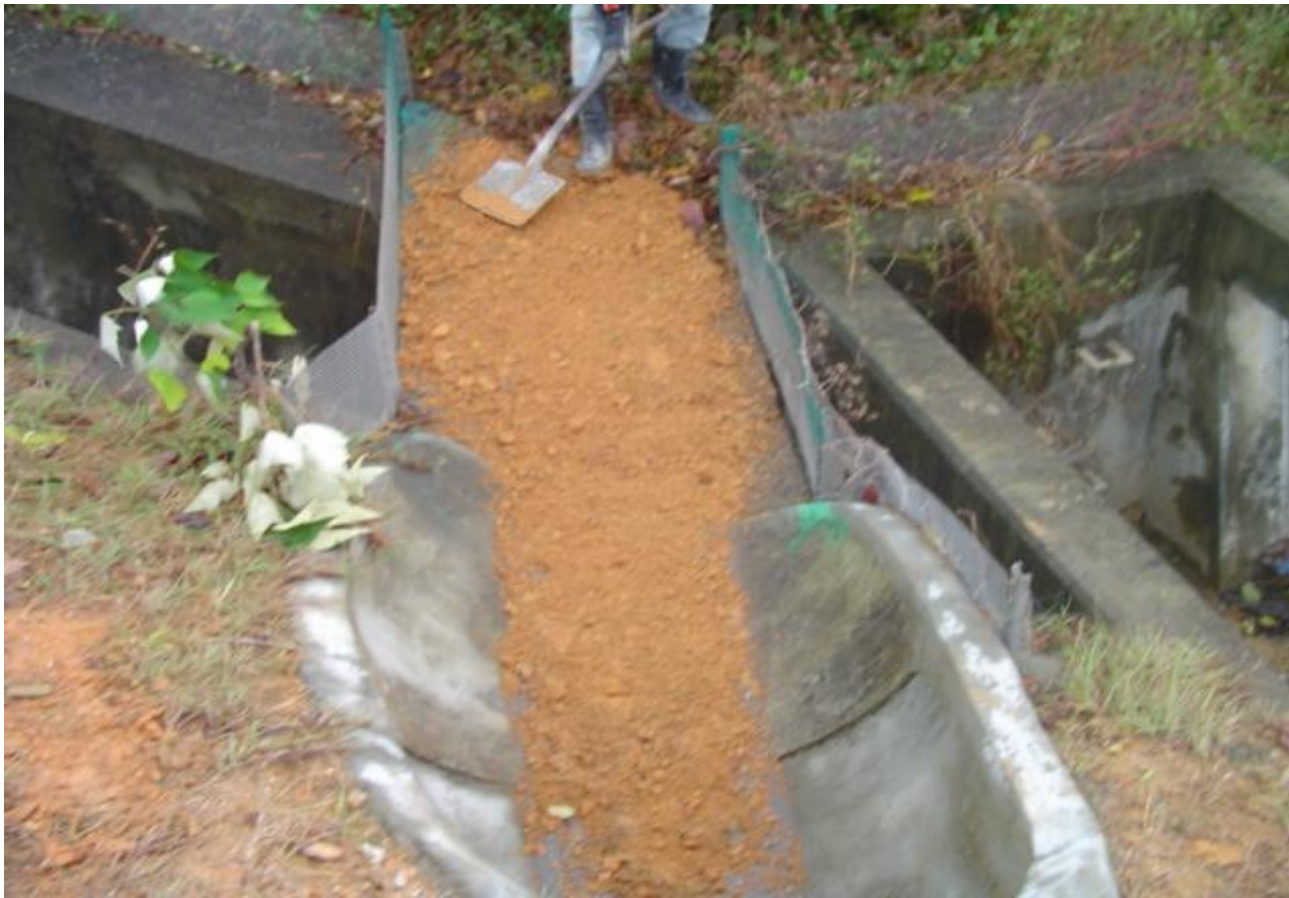
**(6) Opening of the Wildlife Tunnel (C)**

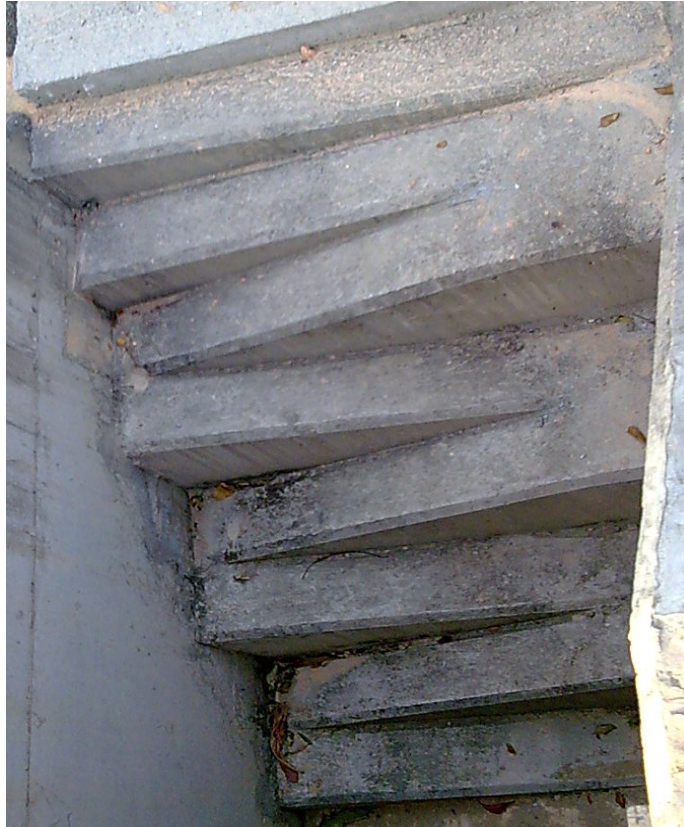
**(7) The sloped Step at Wildlife Ramp (A)**

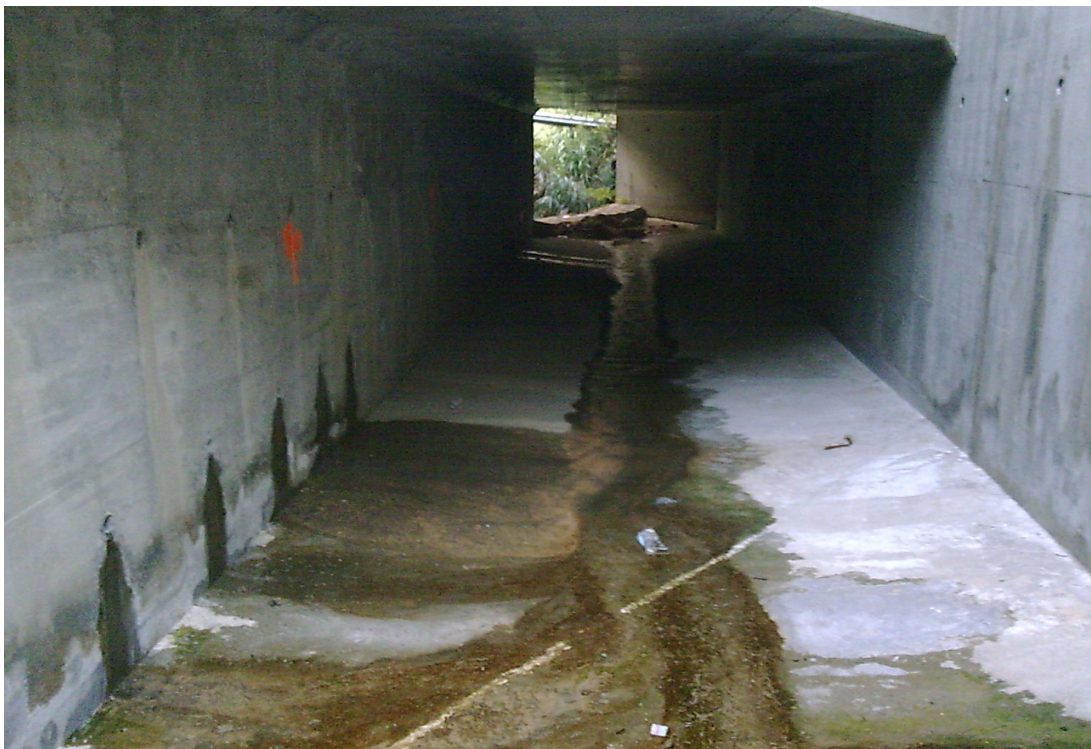
**(8) Inside the Wildlife Tunnel (A)**

<b>Recommendations</b>	<b>Description</b>	<b>Reason for Discrepancies to Recommendation</b>	<b>Photo Reference</b>
Increase the accessibility of the wildlife tunnels	Provide inverted net at an angle 30 to 90 degrees at the top of chain link fencing.	- <u>Dry Season:</u> Organism would unlikely to be encountered in such dry condition.	(7)
	Increase the area of the platform at the opening of the wildlife tunnels.	- <u>Wet season:</u> The strong water current comes from the upstream, the organisms would most likely follow the current and pass through the wild tunnels, bending at the top of the net and the widening of the platform may not increase the accessibility of the wildlife tunnels effectively.	(7)
Improve the substratum and surface condition of the wildlife ramps	Cover the surface of the wildlife ramps with natural materials like soil, glass, debris, etc.	The strong water current from the upstream will remove the soil/glass/debris in wet season.	(8)

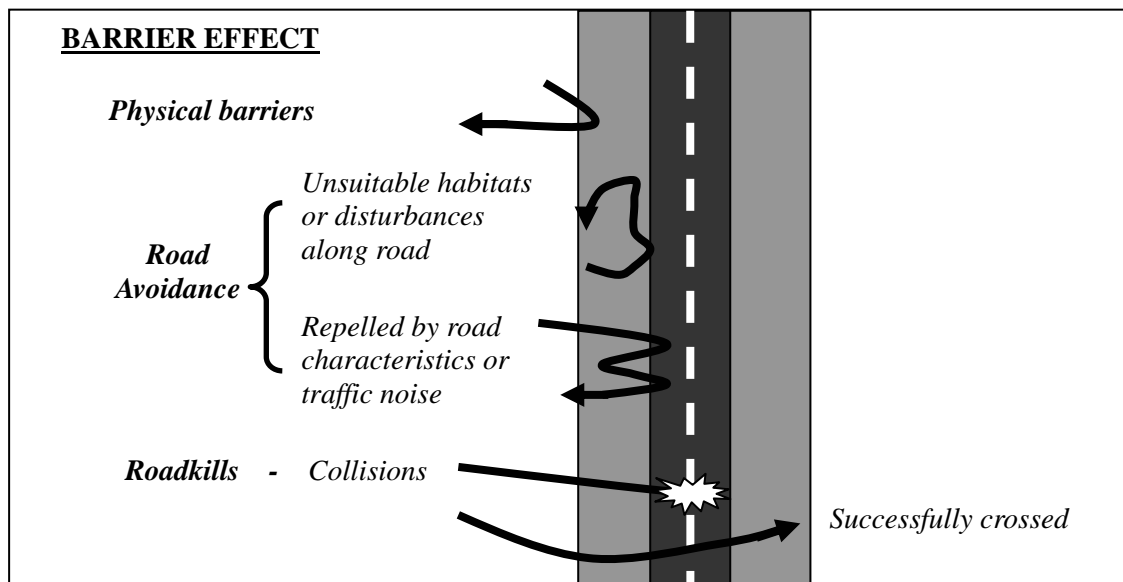
2.2 **Barrier effect** occurs when wildlife are unable to cross the road due to physical barriers (e.g. the road surface, ditches, fences and embankments), avoid the area of the roadways (**road avoidance**), or are killed on the road (**roadkills**). Barrier effect, compounds those of habitat fragmentation and isolation, cause impacts on wildlife from individual to population levels (Figure 1).

Figure 1 Barrier effect of a road results from a combination of physical hindrance, disturbance, repulsion and mortality etc. (modified after Seiler, 2001).

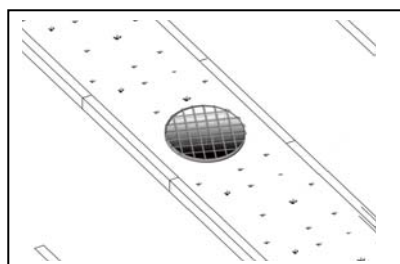
4.11 There have been evidences that artificial light deters animals from utilizing an underpass. Ambient light conditions inside an underpass could be maintained by providing an entrance of larger cross-sectional area (i.e. larger openness ratio) or by incorporating an open-top system at certain portions of the underpass (e.g. light shafts in the central divider as in Figure 5). The open-top system would also allow more air flow within the underpass which could reduce the temperature difference between inside and outside of the structure. Nonetheless, covers such as piles of rocks or vegetative debris which create a darker environment should be placed within the structures if small mammals, amphibians and reptiles are also the target groups.

Figure 5. Circular light shaft in the central divider

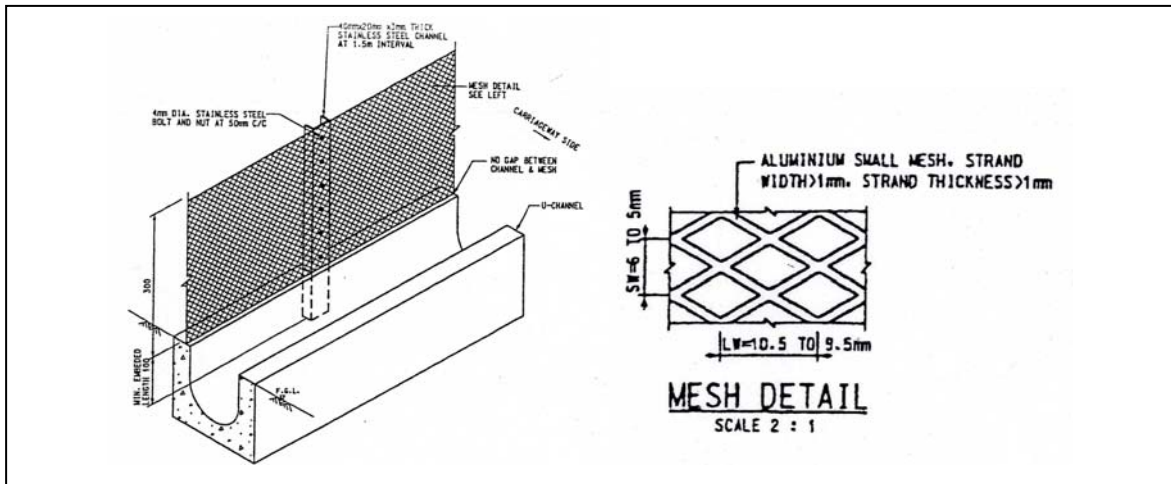
Figure 8. Fencing along the improved Tung Chung Road between Lung Tseng Tau and Cheung Sha, Lantau Island (after Mott Connell, 2003).

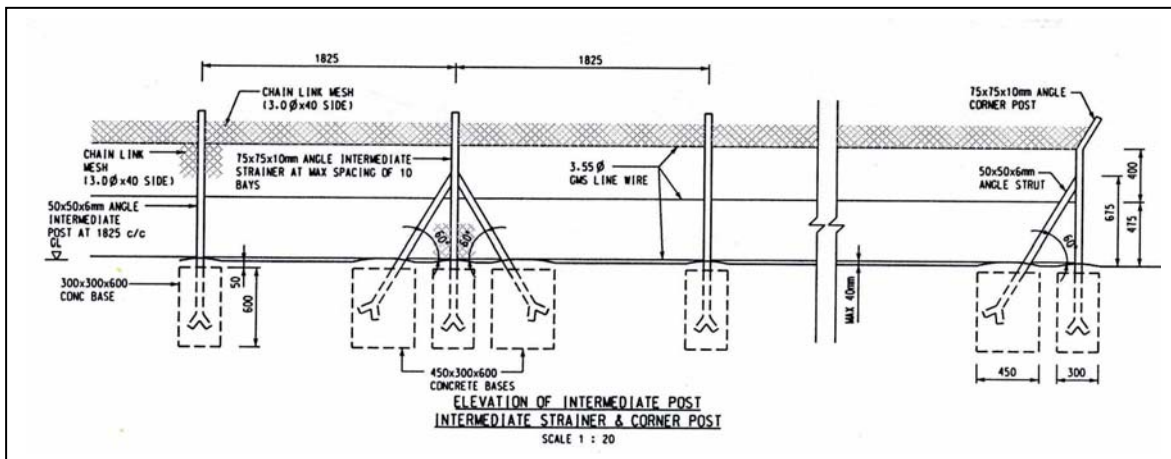
5.4 In the project of “Lok Ma Chau Terminus and Associated Works of the Kowloon-Canton Railway (KCR) East Rail Extensions”, a wildlife underpass linking the fishponds on both sides of the railway is proposed to serve as a corridor for Eurasian Otter (*Lutra lutra*) inhabiting in the area. The underpass consists of a tunnel 800mm in diameter suitable for use by Eurasian Otter or similar-sized mammals. A 300mm gently sloping grasscrete ledge connecting the tunnel with the adjacent nullah would provide a wildlife corridor suitable for Eurasian Otter which typically uses the sides of channels as movement corridors. At the center of the tunnel, a drain is provided to prevent water logging which would hinder the use of the underpass by the animals. Chain link fence of large mesh (40 x 40 mm) of 1,125 mm in height and an inclined top is adopted as the fencing mechanism (Figure 9).

Figure 9. General design of fencing connected to the wildlife underpass in Lok Ma Chau for the project of KCR Lok Ma Chau Terminus and associated works (after Mott Connell, 2004).

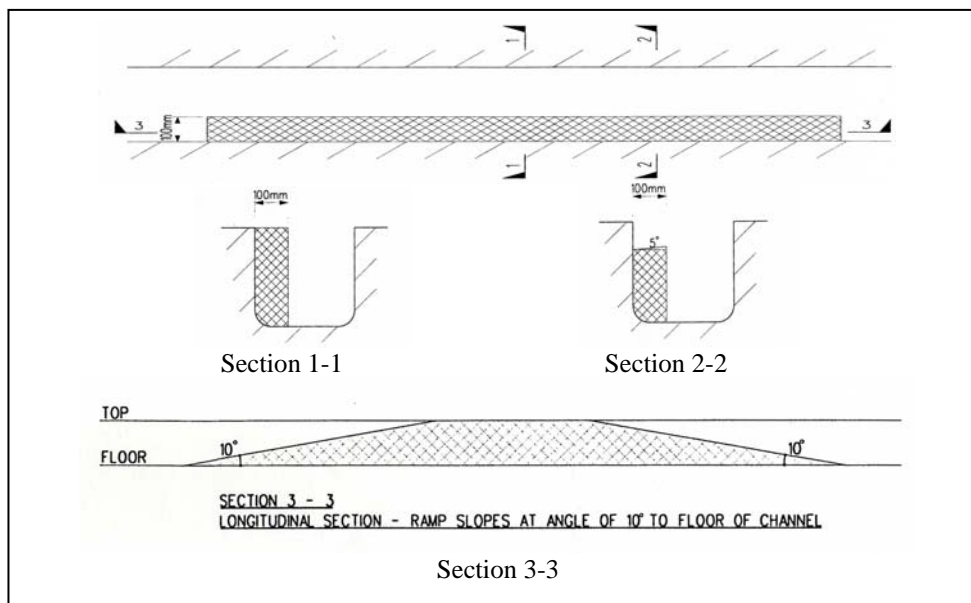
5.9 In areas where amphibians are of particular concern, ramps or breaks in kerbs and drains along the roads could prevent entrapment of these animals. In the Tung Chung Road improvement project, amphibian and reptile escape ramps are incorporated in the U-shaped channels which are 200 to 300 mm deep along the road. The ramps extend 100 mm from the channel wall and face both upstream and downstream. They have a cross-fall angle of 5° dipping into wall of channel to prevent the amphibian and reptile from falling back into the channels, and rise from floor to top of channel at a gentle slope of 10° (Figure 14).

Figure 14. Design of amphibian and reptile escape ramps in U-shaped channels along the improved Tung Chung Road between Lung Tseng Tau and Cheung Sha (after Mouchel, 2002).
