Contract No. HY/2003/19

Improvement to Tung Chung Road
between Lung Tseng Tau and Cheung Sha

Bi-Monthly EM&A Report for Ecological
Mitigation Audit and Landscape & Visual
Resources Audit (Version 1.1)

July 2010

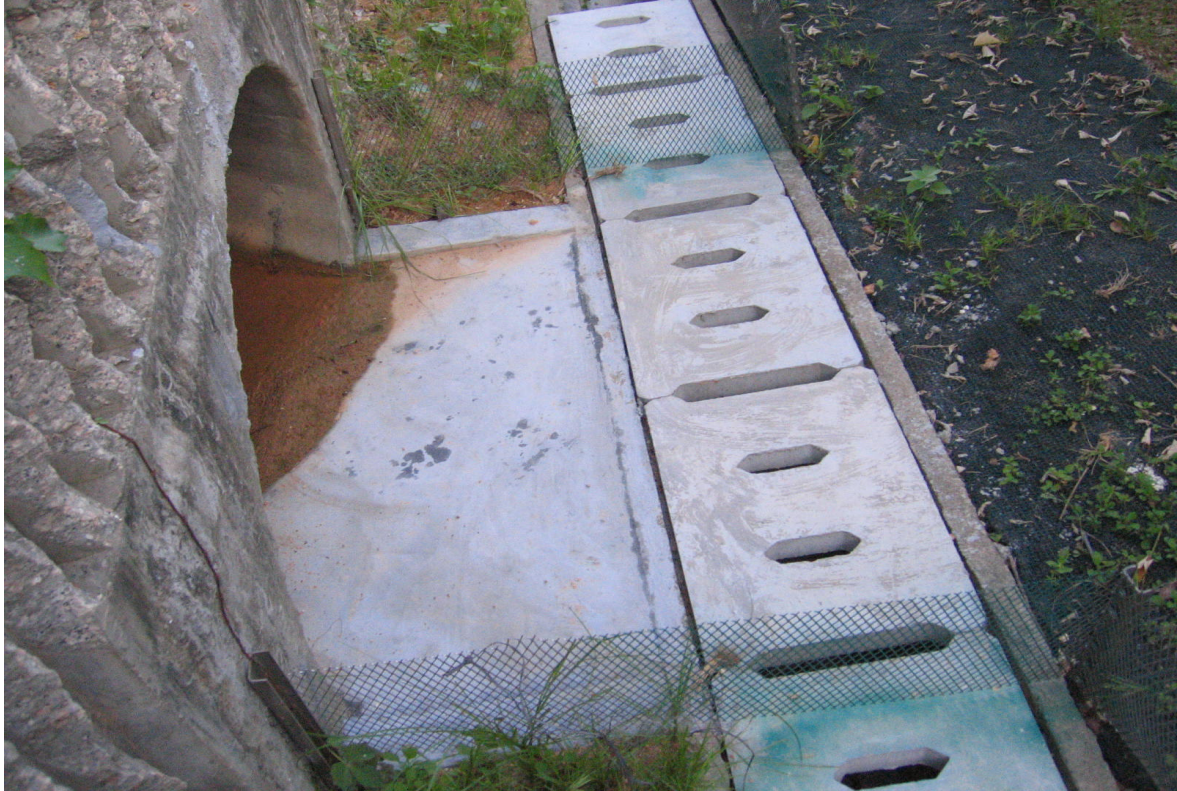
(2) Circular and smooth surface of the wildlife tunnel may cause difficulty in movement of organisms especially for mammals.	(2) & (4)
	(3) No shelter and/or hiding place is provided at or near the wildlife tunnels, organisms will be at risk when passing through or accessing the tunnels. Avoidance for the use of the tunnels by organisms is therefore resulted.	(1), (3), (5), (6) & (7)
Location and Orientation of the wildlife tunnels	(1) The opening of wildlife tunnels cannot be seen at the natural habitats of organisms. Organisms cannot notice the presence of wildlife tunnel when they are moving along the shrub near the tunnel.	(1), (3), (5) & (6)

(1) Opening of Wildlife Tunnel (C)

(3) Increase the area of the platform at the opening of the wildlife tunnels.	-	To increase accessibility of the wildlife tunnels.
Improve the substratum and surface condition of the wildlife tunnels	(1) Cover the accessing platform and surface of the wildlife tunnels with natural materials like soil, glass, debris, etc	Clause 4.7 & 4.8	Mitigation measures look appealing to organisms if its internal habitat resembles ambient condition. Also, small organisms will use vegetation or topography to hide themselves.

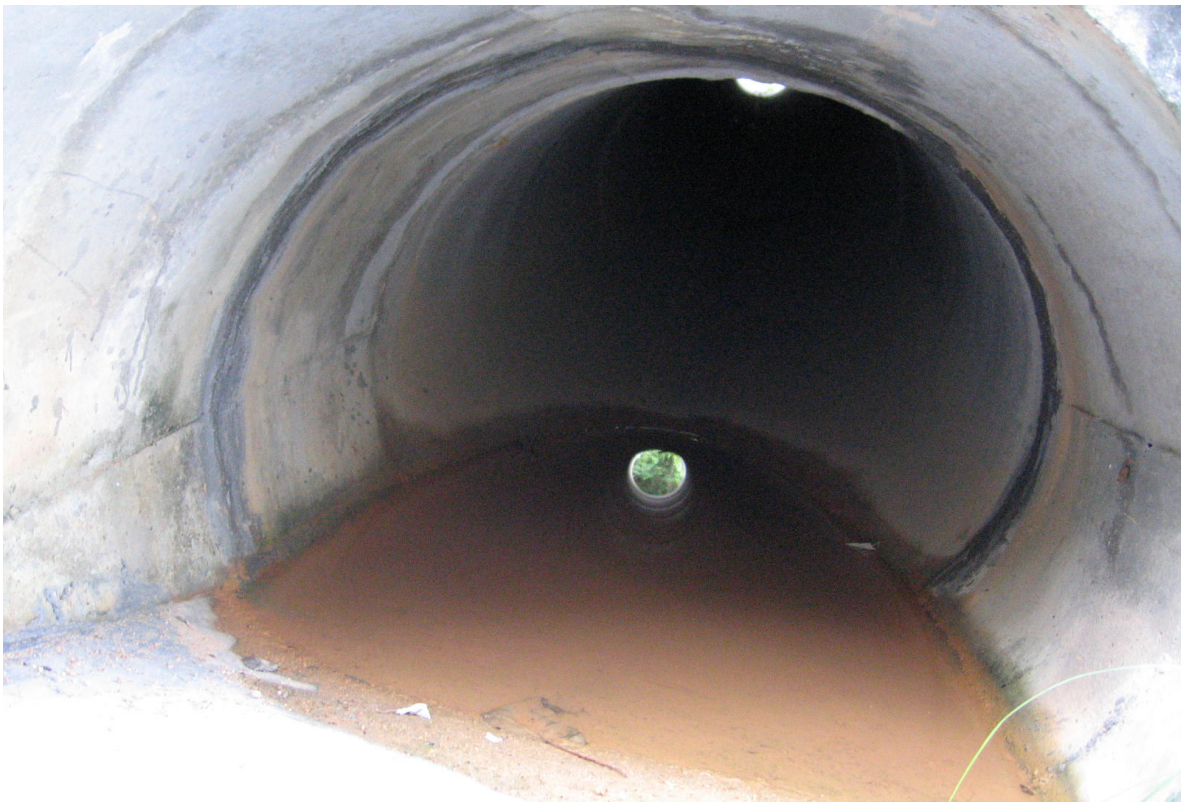
(2) Inside Wildlife Tunnel (C)

Recommendations	Description	Reference in Appendix B	Reason
	(2) Flatten the base of the wildlife tunnels	-	Mitigation measures look appealing to organisms

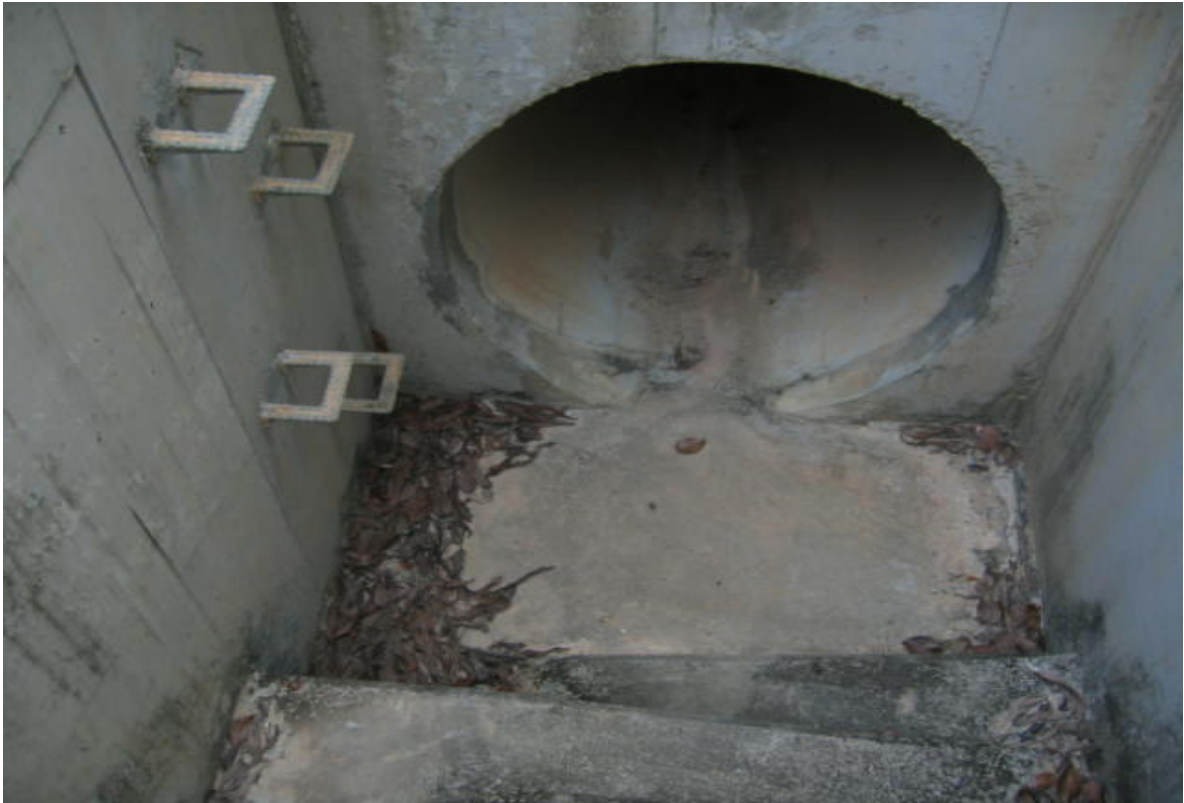
Suggested Reason	Description	Reference Photo
Difficulty to access the wildlife ramps	(1) The height of each step of wildlife ramps may cause inaccessibility to organisms and the total length of the sloped steps is too long for amphibian especially for the tiny organisms (e.g. Romer's Tree Frog).	(7)
Substratum and Surface of the wildlife ramps	(1) The surface and substratum of the wildlife ramps is only made up of artificial materials. This makes the tunnel less attractive to wild organisms.	(3) & (7)

(2) No shelter and/or hiding place is provided at or near the wildlife ramps, organisms will be at risk when passing through or accessing the tunnels. Avoidance for the use of the tunnels by organisms is therefore resulted.	(3) & (7)
Others	(1) No measure is found to help organisms to use the wildlife tunnels when the tunnels are filled with shallow water. Even amphibians can swim, a resting place along the tunnels should be provided for them.	-

(3) Opening of Wildlife Tunnel with Wildlife Ramp (C)

Recommendations	Description	Reference in Appendix B	Reason
Increase the accessibility of the wildlife ramps	(1) Reduce the height of each step of the wildlife ramps.	-	Steepness causes inaccessible to organisms
	(2) Provide inverted net at an angle 30 to 90 degrees at the top of chain link fencing	Section 5.5	To discourage animals from climbing over the fence.

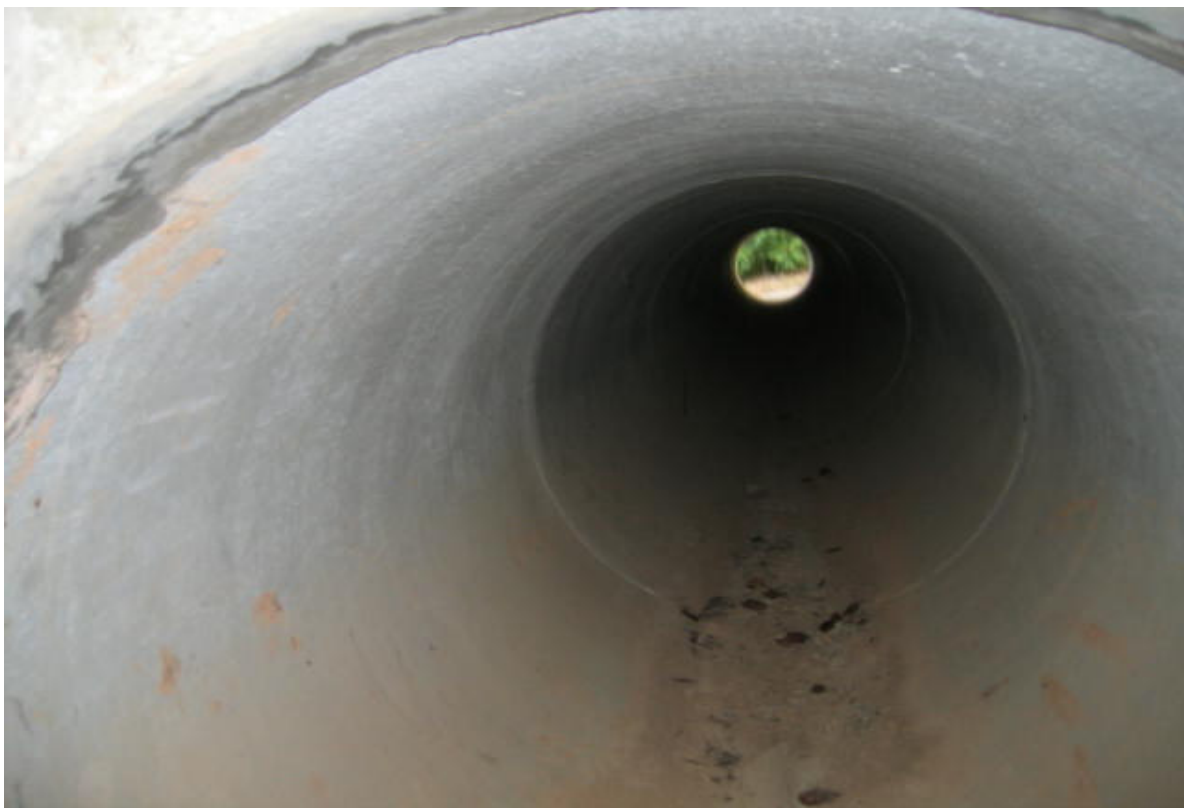
(2) The slope of or the slope leading to the wildlife tunnel is too steep. The steepness causes difficulty for organisms moving along the tunnel. Also, the steepness causes avoidance for the use of the tunnel as organisms may not be able to observe the condition of the opposite side of the tunnel.	(7)
Others	(1) No measure is found to help organisms to use the wildlife tunnels when the tunnels are filled with shallow water. Even amphibians can swim, a resting place along the tunnels should be provided for them.	-

(4) Opening of Wildlife Tunnel with Wildlife Ramp (B)

Recommendations	Description	Reference in Appendix B	Reason
Increase the accessibility of the wildlife tunnels	(1) Decrease the slope of or the slope leading to the wildlife tunnels.	Clause 4.3	Steepness of the wildlife tunnels will cause inaccessible to organisms

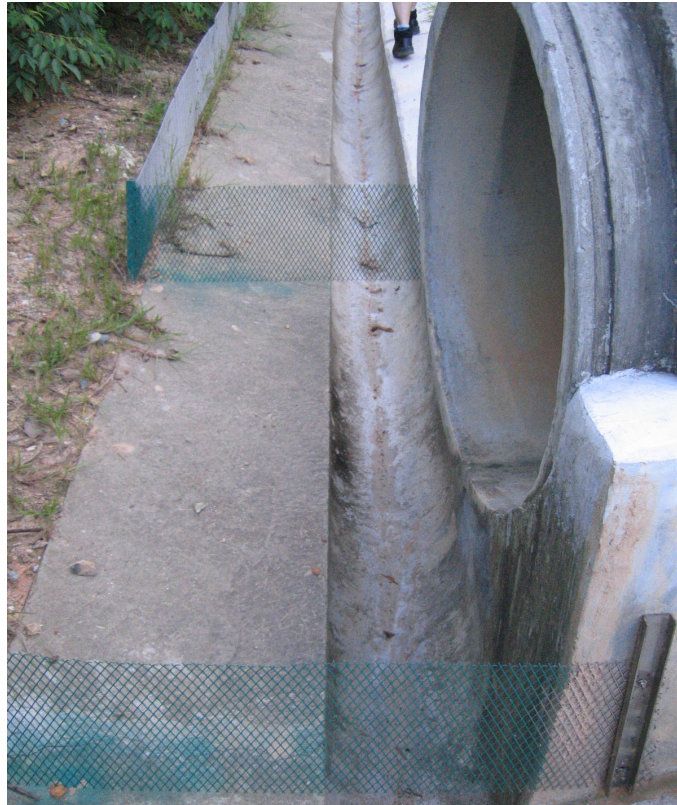
(5) Inside Wildlife Tunnel (C)

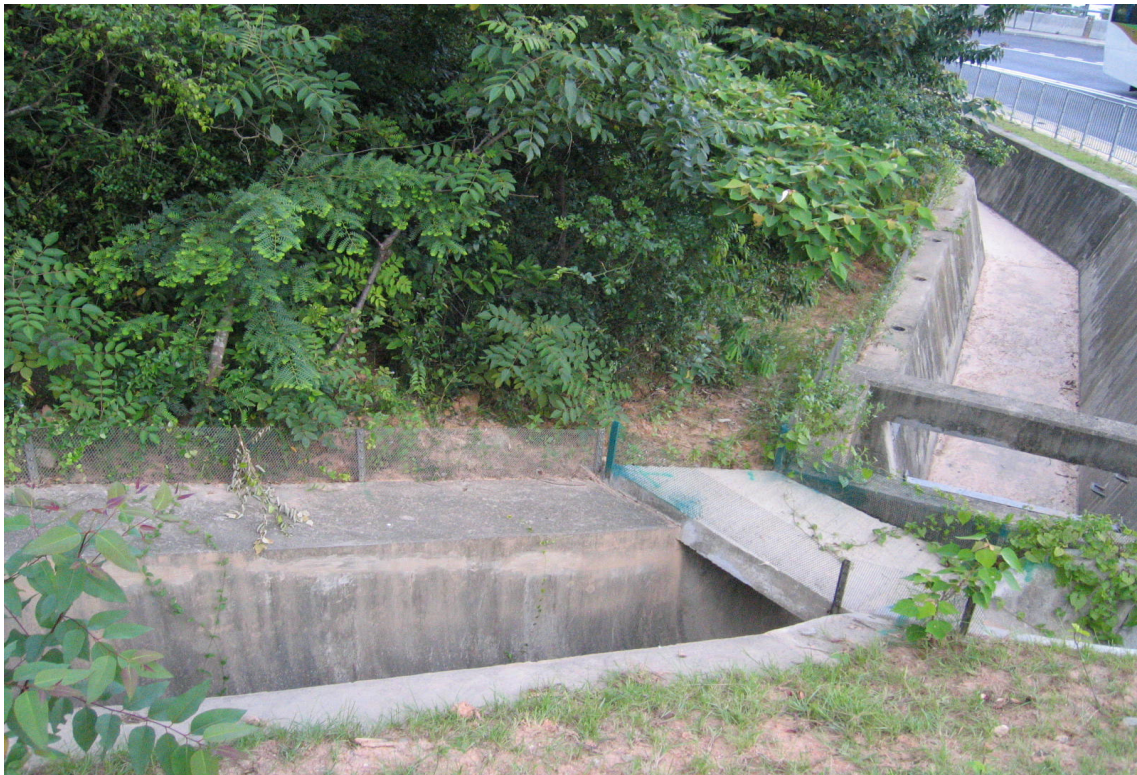
(6) Opening of the Wildlife Tunnel (C)

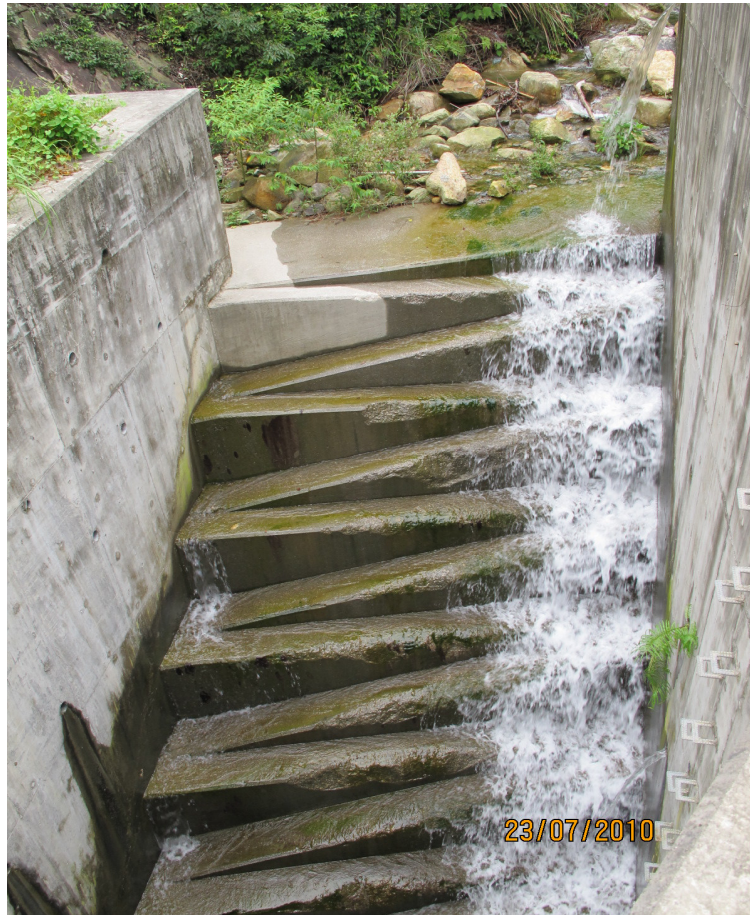
(7) The sloped Step at Wildlife Ramp (A)

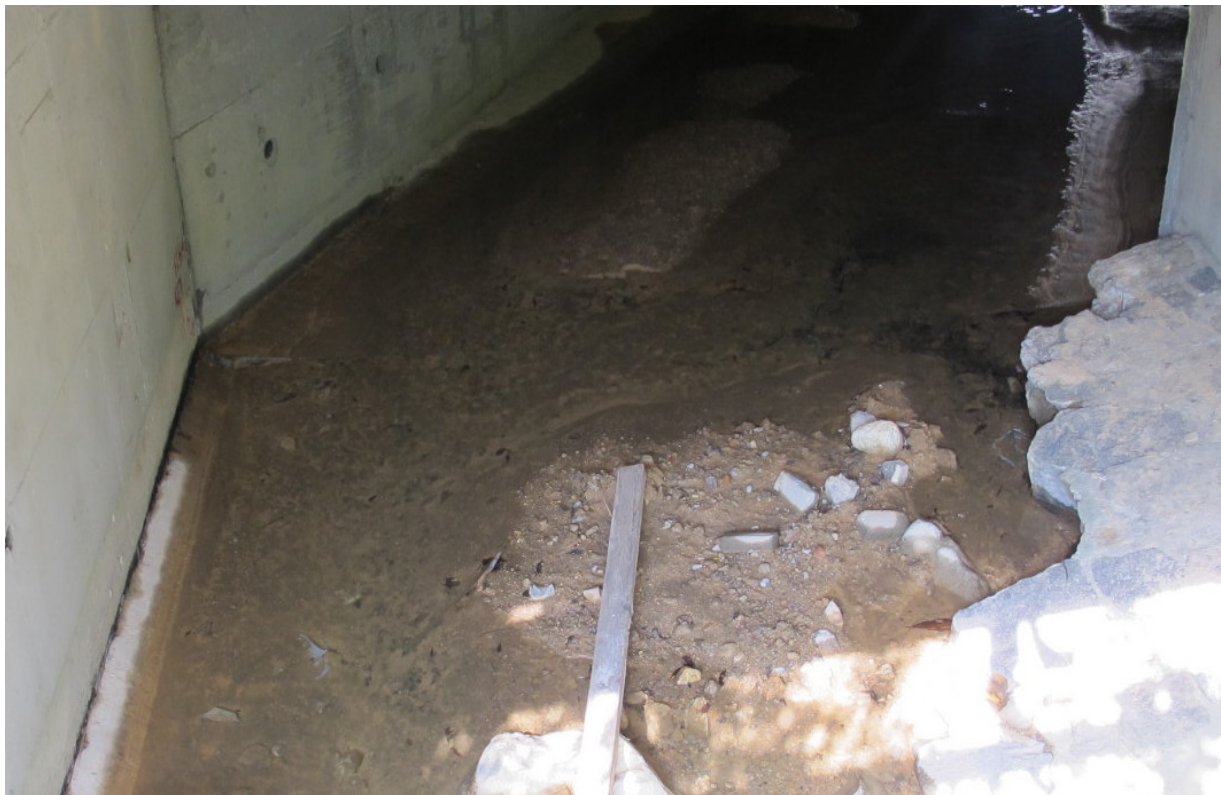
(8) Inside the Wildlife Tunnel (A)

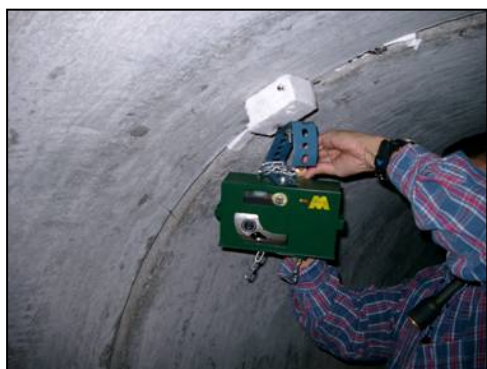
Figure 15. Automatic camera was installed inside the underpass crossing underneath the Route 3 to monitor the wildlife uses of the tunnel.

7.4 **Automatic camera and video** mounted inside underpasses are evolving technologies which make it possible to capture images or even observe the behaviour of the wildlife while utilizing the structures. They are proved effective in documenting animal use of larger underpasses such as bridges or box culverts. Automatic camera was installed inside the wildlife underpass crossing underneath Route 3, and utilization of the tunnel by Masked Palm Civets was detected (Figures 15 &16).

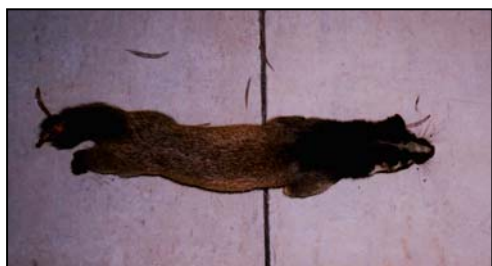
Figure 16. Picture of a Masked Palm Civet captured by automatic camera when it utilizes the wildlife underpass underneath Route 3.

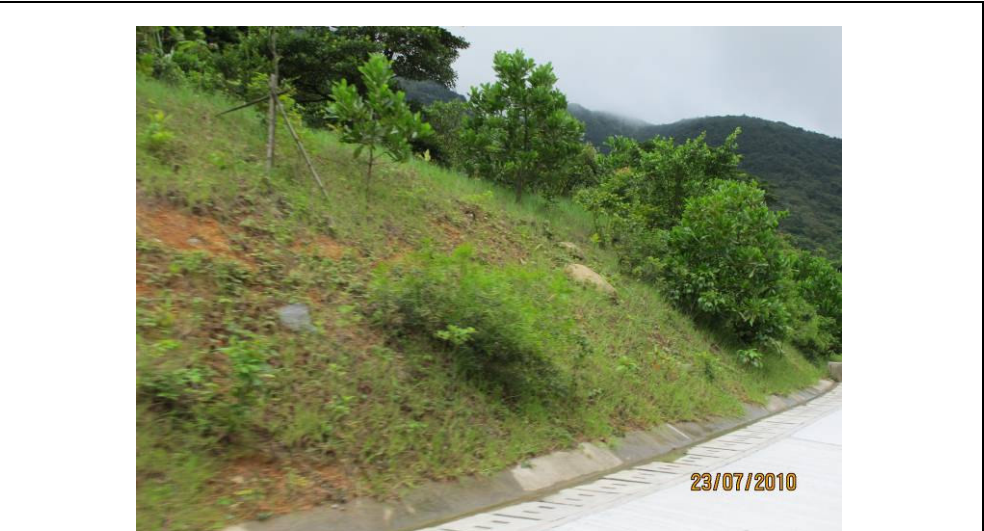
Photo 6

Type of Landscape Work	Defect	Location	Photo reference
Hydroseeding	Hydroseeding was not properly maintained on the slopes	Along Tung Chung Road	4, 6, 8, 16, 18, 23 and 26

Type of Soft Landscape Work	Recommendation
Hydroseeding	Re-apply hydroseeding to the defect areas

- 5.2 The Contractor was reminded to improve the existing mitigation measures re-applying hydroseeding to the defect areas.
- 5.3 The effectiveness of the implementation of mitigation measures will be continuously reviewed and monitored the Environmental Team through the site inspection.
