DRAINAGE SERVICES DEPARTMENT CONTRACT NO. DC/2006/02

YUEN LONG, KAM TIN, NGAU TAM MEI AND TIN SHUI WAI DRAINAGE IMPROVEMENTS, STAGE 1, PHASE 2B – CHEUNG CHUN SAN TSUEN AND KAM TSIN WAI

KT15 - MONTHLY EM&A REPORT FOR JUNE 2009 (No. 24)

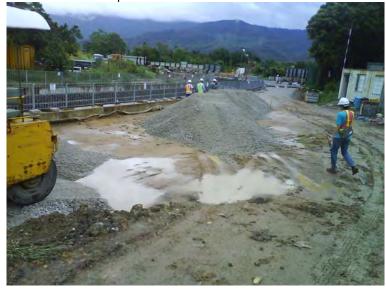
### Finding of Site Inspection on 3 June 2009:

Remark 1: The stockpiles observed at CH. 380 shall be covered with impervious sheet especially during wet season.

The stockpiles observed at CH. 380 have been removed by the Contractor.

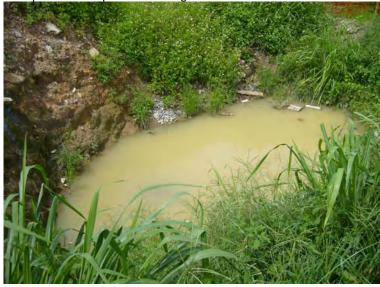
Remark 1: Stagnant water accumulation was observed at Ch. 1300, the Contractor shall drain the water away or apply larvicidal

oil to prevent mosquitoes breeding.

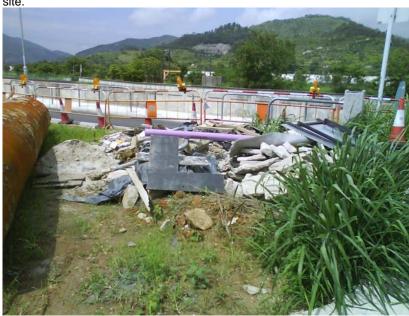
#### Finding of Site Inspection on 17 June 2009:

Remark 1: Stockpiles of C&D wastes were observed at head of KT15 (Ch. 11), the Contractor shall improve the tidiness of the site.

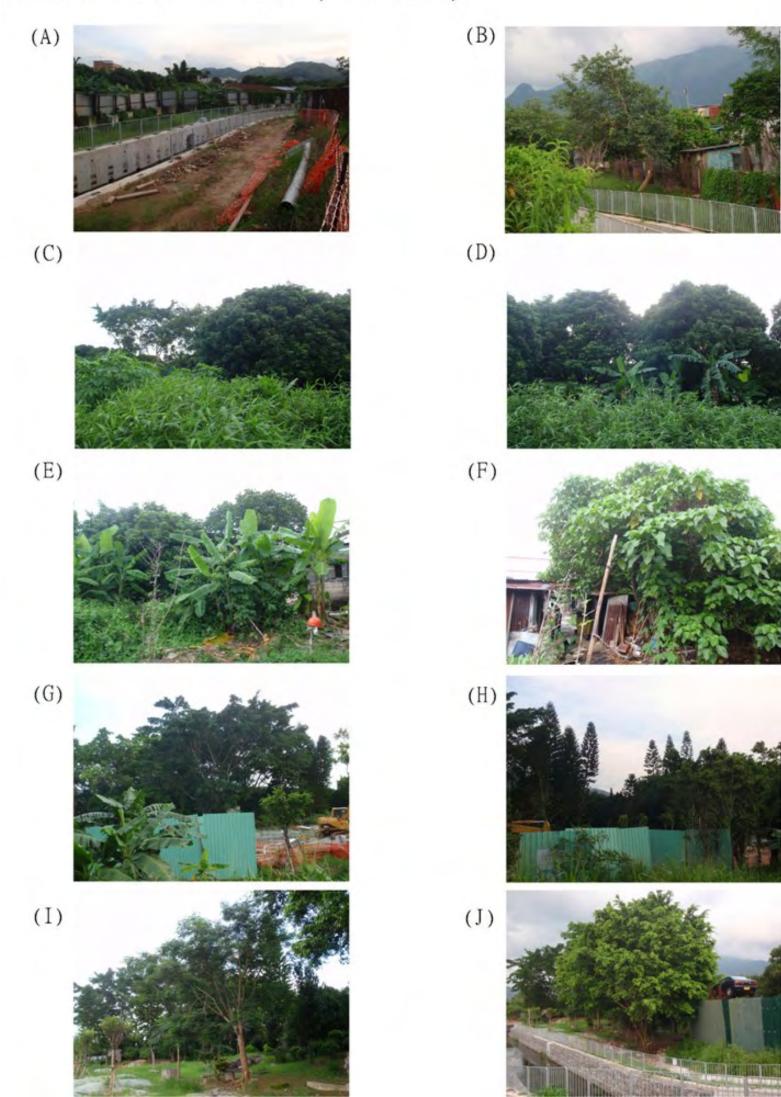
# Photo Records for KT15 (June 2009)

- 5.11 No intrusions of construction activities into the wetland areas nor adverse impact on the wetlands was found during site audit on 22 June 2009.
- 5.12 Photographic records are scheduled in six-month intervals, and thus are required in the present monthly monitoring (Jun 09). The results are presented in Appendix K. One of the trees recorded during the baseline photographic records and within the Project boundary (i.e. Tree A) was removed due to the needs of the construction works. Other recorded trees are still intact.
