DRAINAGE SERVICES DEPARTMENT CONTRACT NO. DC/2006/02

YUEN LONG, KAM TIN, NGAU TAM MEI AND TIN SHUI WAI DRAINAGE IMPROVEMENTS, STAGE 1, PHASE 2B – CHEUNG CHUN SAN TSUEN AND KAM TSIN WAI

KT15 - MONTHLY EM&A REPORT FOR JULY 2009 (No. 25)

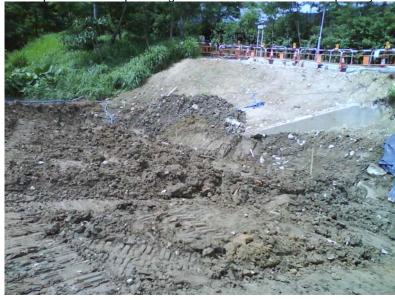
Remark 1: Exposed slope was observed after excavation at the head of KT15 (Ch. 11), the Contractor should cover the slope with tarpaulin sheet to prevent generation of surface run-off especially in wet season.

The exposed slope at the head of KT15 (Ch. 11) was found to have been covered with tarpaulin sheet.

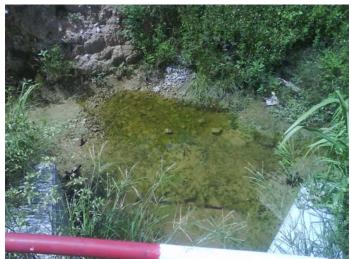
Remark 1: Scattered construction waste was observed at Ch. 300, the Contractor should improve the house keeping of the construction site.

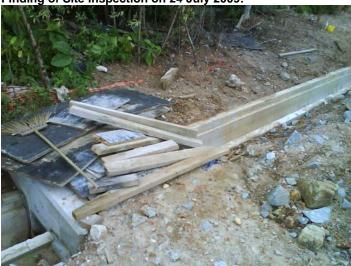
Remark 1: Used timer was observed at Ch. 200, the Contractor was reminded to improve the house keeping of the construction site.

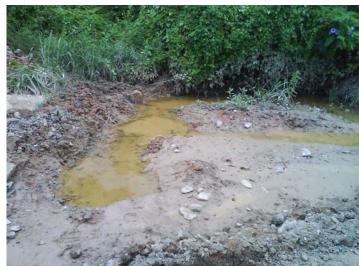
Remark 2: Stagnant water was observed at Ch. 1250, the Contractor should drain the water away to prevent mosquitoes breeding.
