Permanent Aviation Fuel Facility (EP-262/2007/B)

Marine Archaeological Watching Brief Report

6th May 2008

Permanent Aviation Fuel Facility for Hong Kong International Airport

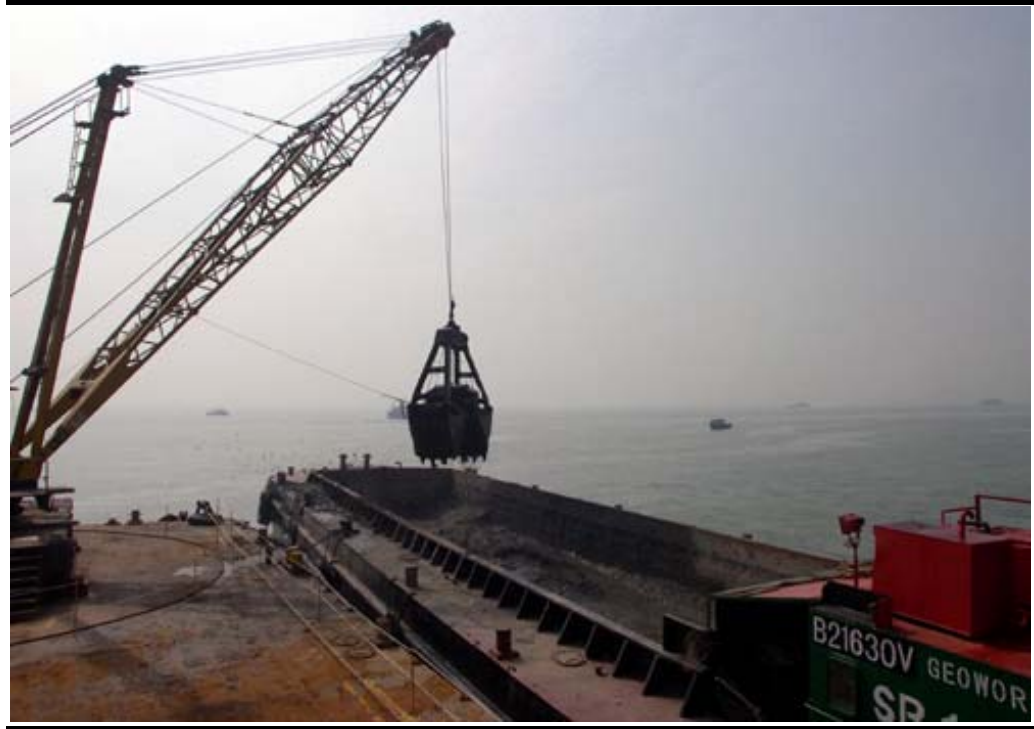
Figure 3.1 The Bucket Dredge

A bucket or grab dredge, capable of dredging a 20-metre wide trench was used to remove seabed sediments to the level of the sub-surface anomalies (see *Figure 3.1*). Located at the top of the crane used to raise and lower the bucket is a DGPS aerial which is directly above the dredge bucket; the readout is in the cabin with the dredge operator. This allows for accurate positioning of the trench (see *Figure 3.2*). The computer program displaying the DGPS

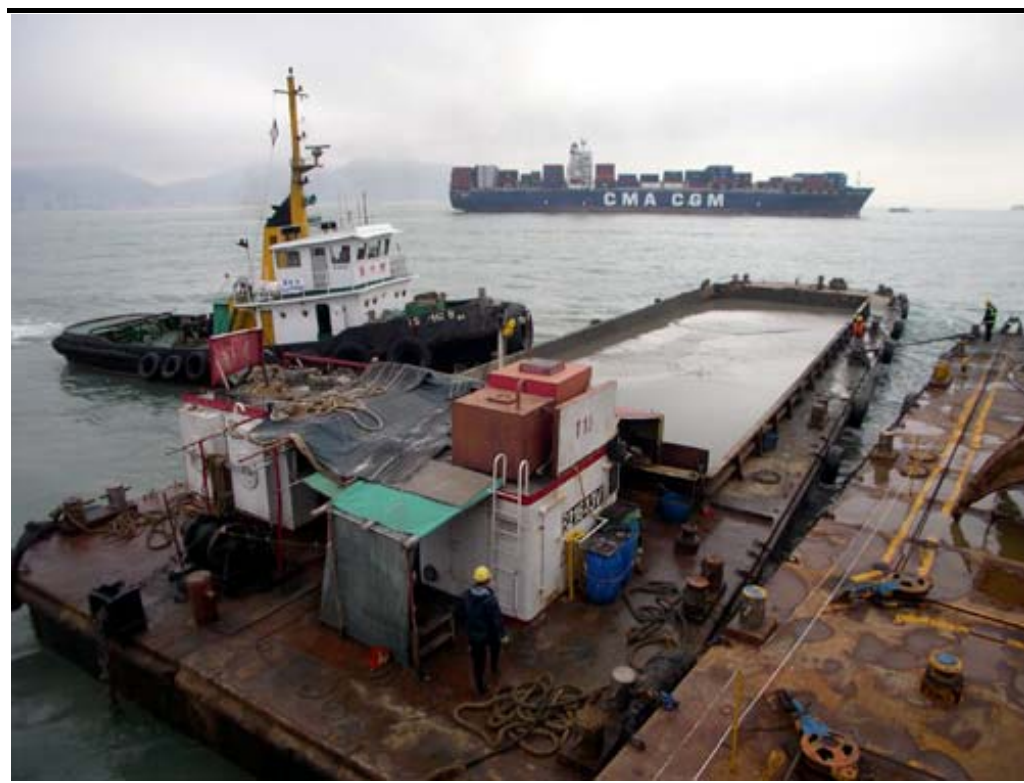
Figure 3.3 *The Split Hopper Barge and Tug Boat*

The dredging barge is fixed in position by four large anchors. It is positioned at one end of the trench to be dug and winches onboard move it forward along the anchor wires at 2-3 metre increments. The dredged sediments (the bucket used in this case had a capacity of 6.5 m³ and weighs 12 ton) are deposited in a split hopper barge positioned next to the dredging barge, of which the capacity is about 700m³. The split hopper barge is towed by a tug to the designated mud disposal areas for uncontaminated and contaminated mud (south of Cheung Chau/east of Ninepin and East Sha Chau respectively). (see *Figure 3.3*).

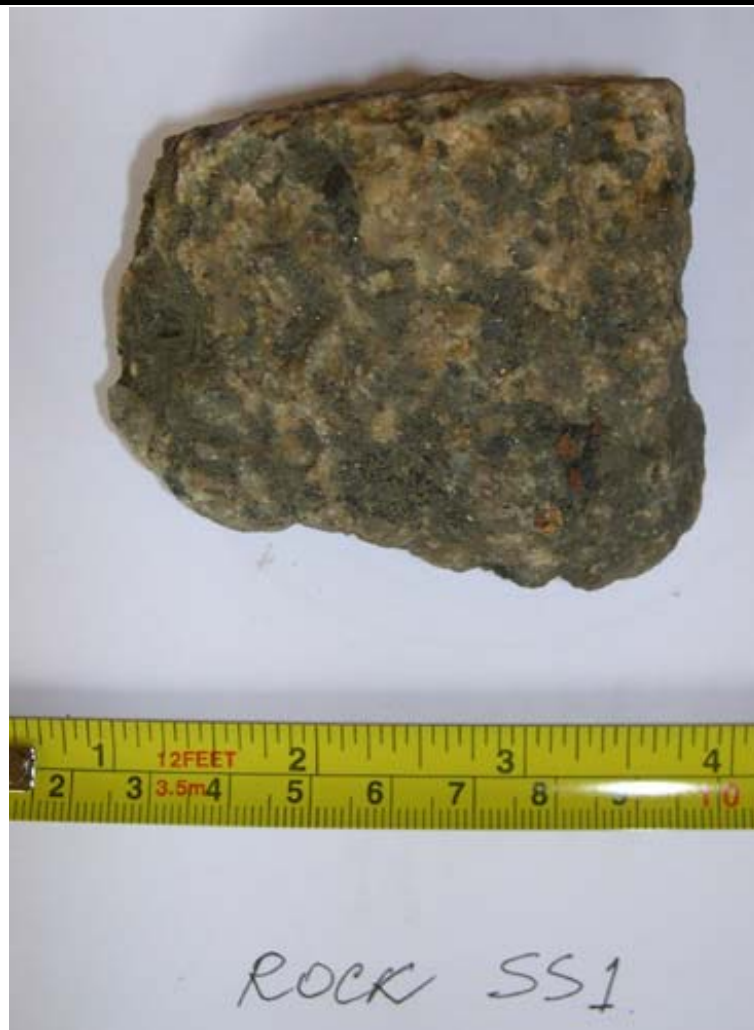
Figure 4.4 *Small Granite Rock from SS1*

A three metre scattering of small granite rocks were encountered during the first dive. During the second dive, a random scatter of small granite rocks was encountered; one was recovered for photography (see Figure 4.4). No other material was found. The divers reported nil visibility although the underwater camera with the aid of a light allowed an occasional glimpse of the seabed to be seen from about 30 cm away. No objects in addition to what the diver reported were observed on the video.

The material observed during the dredging and dive surveys in the vicinity of the SS1 and SS2 anomalies has no cultural heritage significance. No archaeological material was observed during the dredging in either area. What was observed included a small number of rocks, fishing nets and vehicle tyres. The diver surveys, conducted at the depths that exposed the anomalies, failed to locate any material other than a small number of granite and feldspar rocks. These same rocks can be found as land fill in the yard with the PAFF tanks (see *Figure 5.1*)

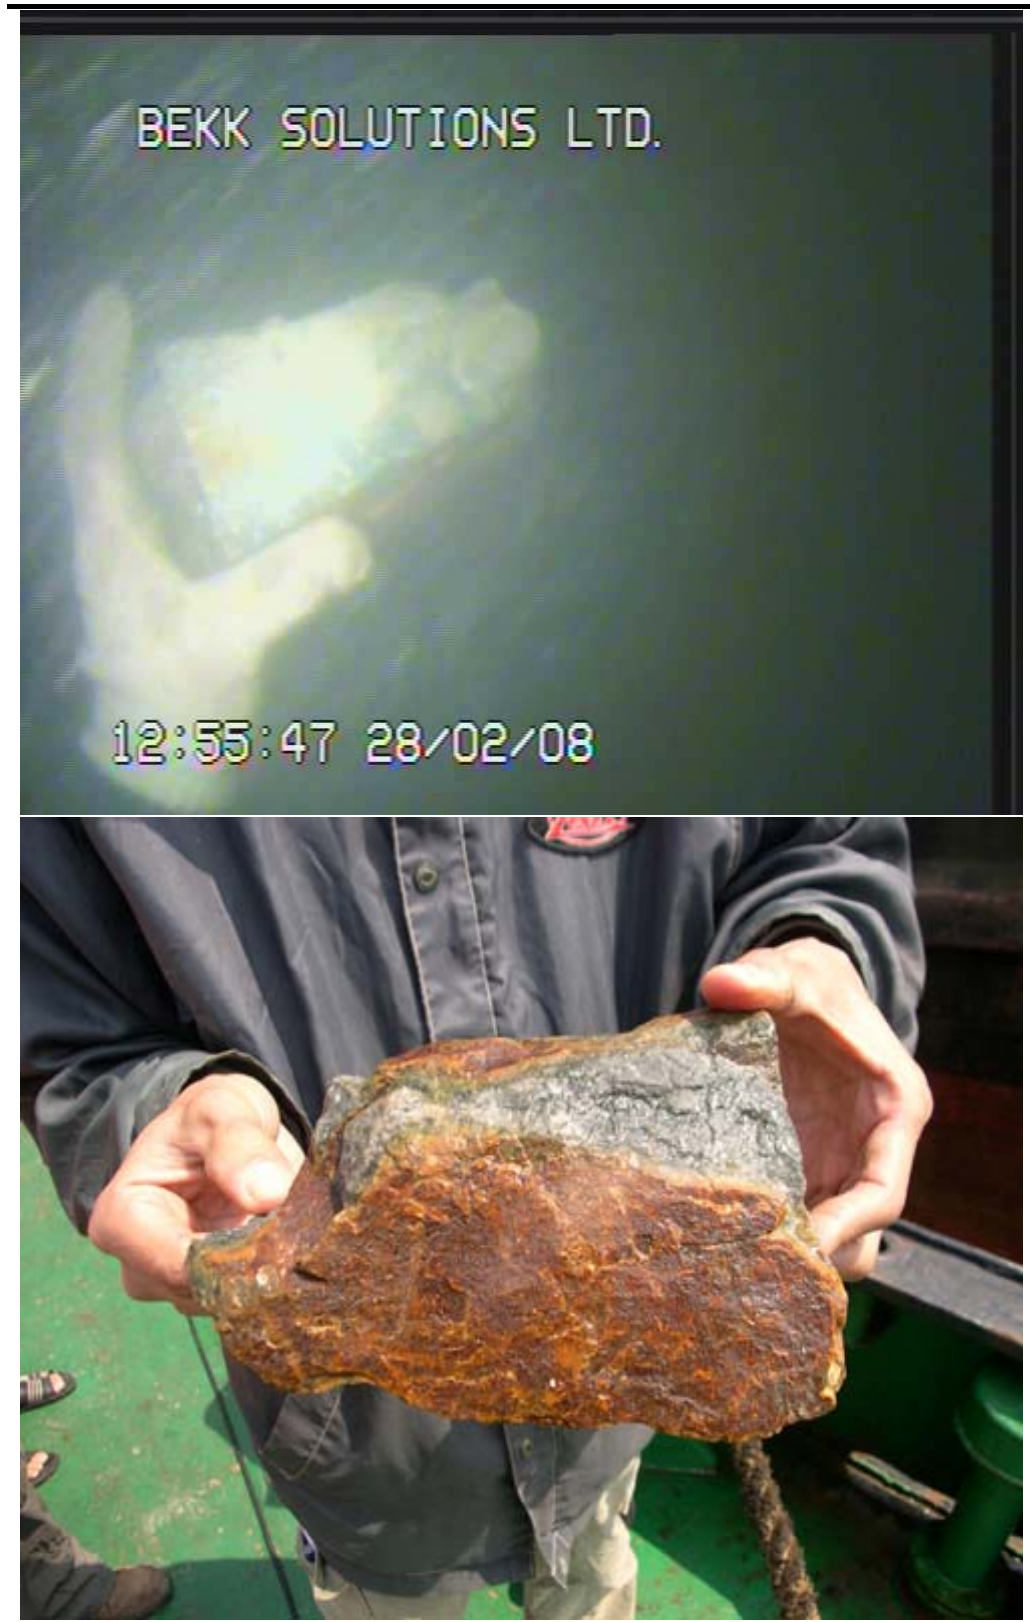
Figure 4.5 Diver Holding Feldspar Rock at SS2 and a Small Feldspar Rock from SS2

During the second dive, a swath of seabed 25 metres east x 20 north/south of the anomaly was surveyed. A few shells and 2-3 small feldspar rocks were observed through the underwater video, one was recovered for photography (see *Figures 4.5*). While the divers reported nil visibility, the camera provided for a reasonable picture of the seabed from 30cm above and clearer to that observed in SS1. No objects in addition to what the diver reported were observed on the video.
