Permanent Aviation Fuel Facility (EP-262/2007/B)

Third Landscape & Visual Bi-Monthly Audit Report – Sep 2010

1 November 2010

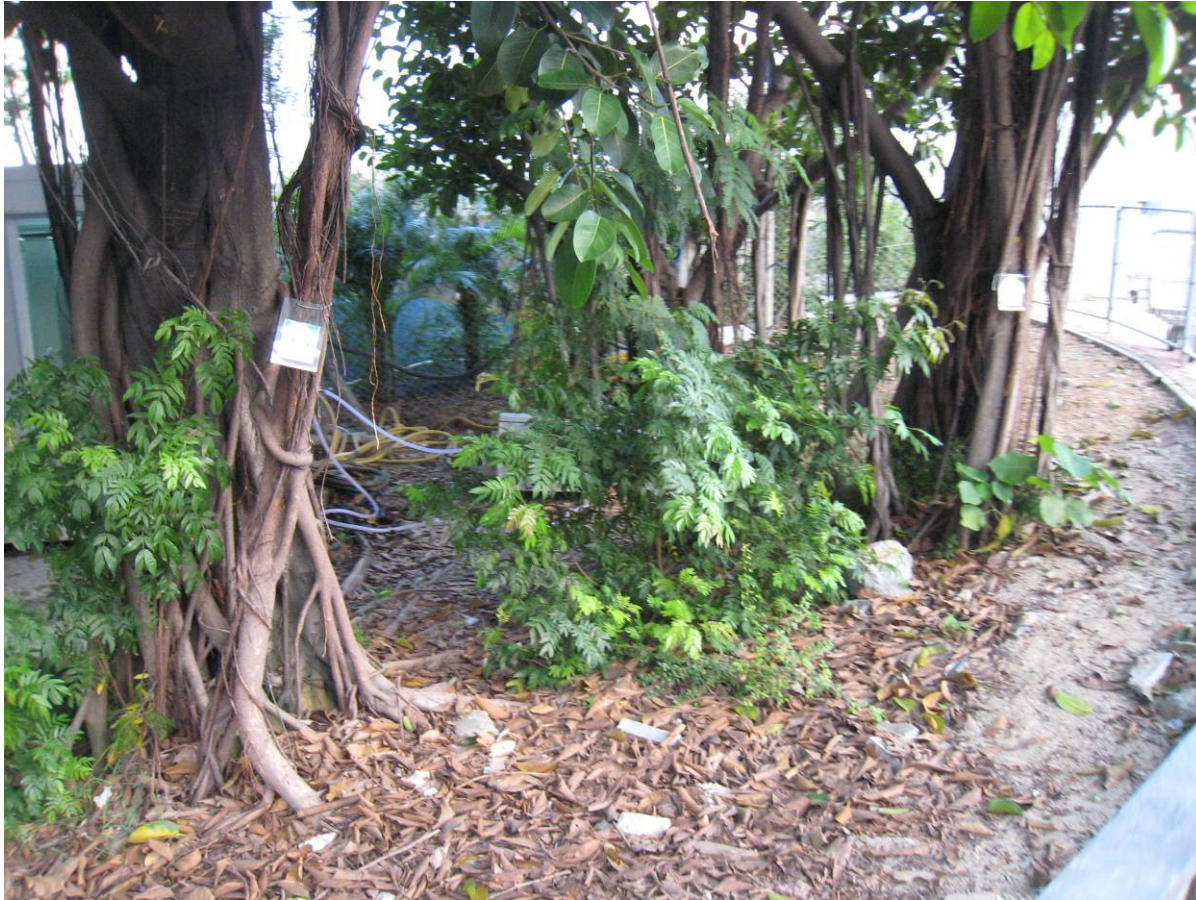
Photos 1– Stockpile of construction material and machinery observed in last inspection near Retained Trees T66-72 have been cleared.

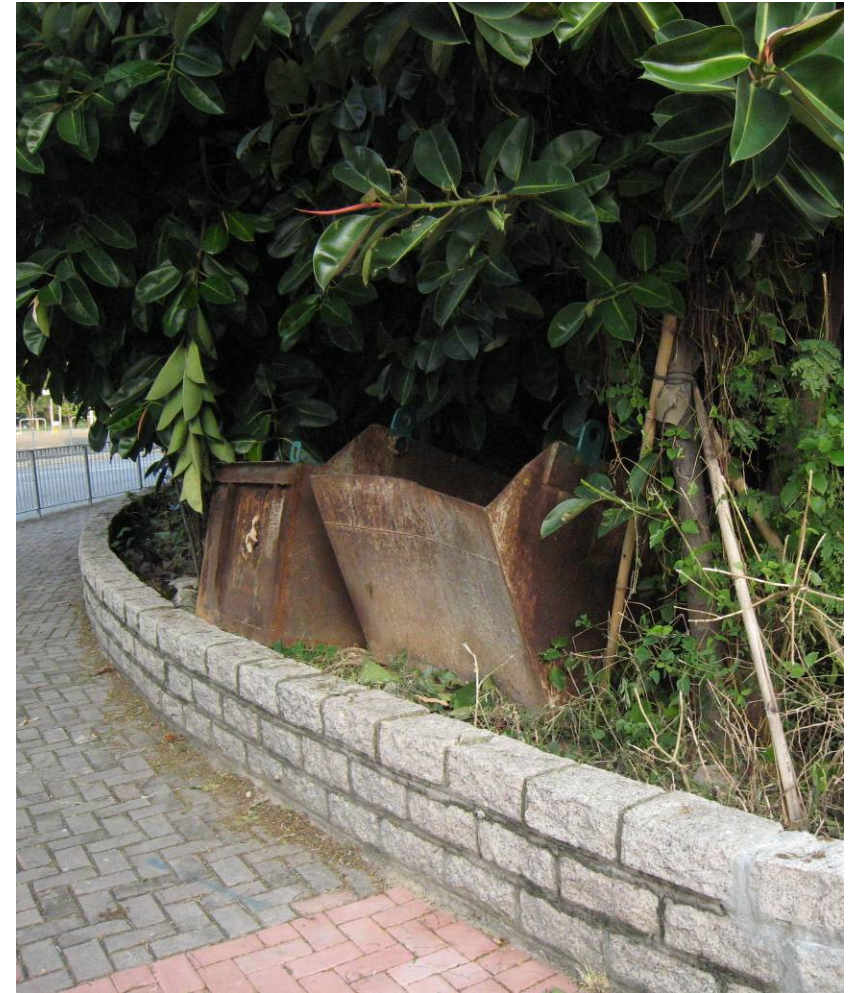
Photos 2 – Stockpile of construction material observed near Retained Tree T1

- Construction material stored near retained tree (T1) (refer to *Annex A*). The Contractor was recommended to remove any construction material stored near retained trees to keep root zones clear and prevent tree damage.
- Some Compensatory Trees were observed to be in poor health or dead. The Contractor was recommended to review health of all compensatory trees and replace any trees if confirmed dead.

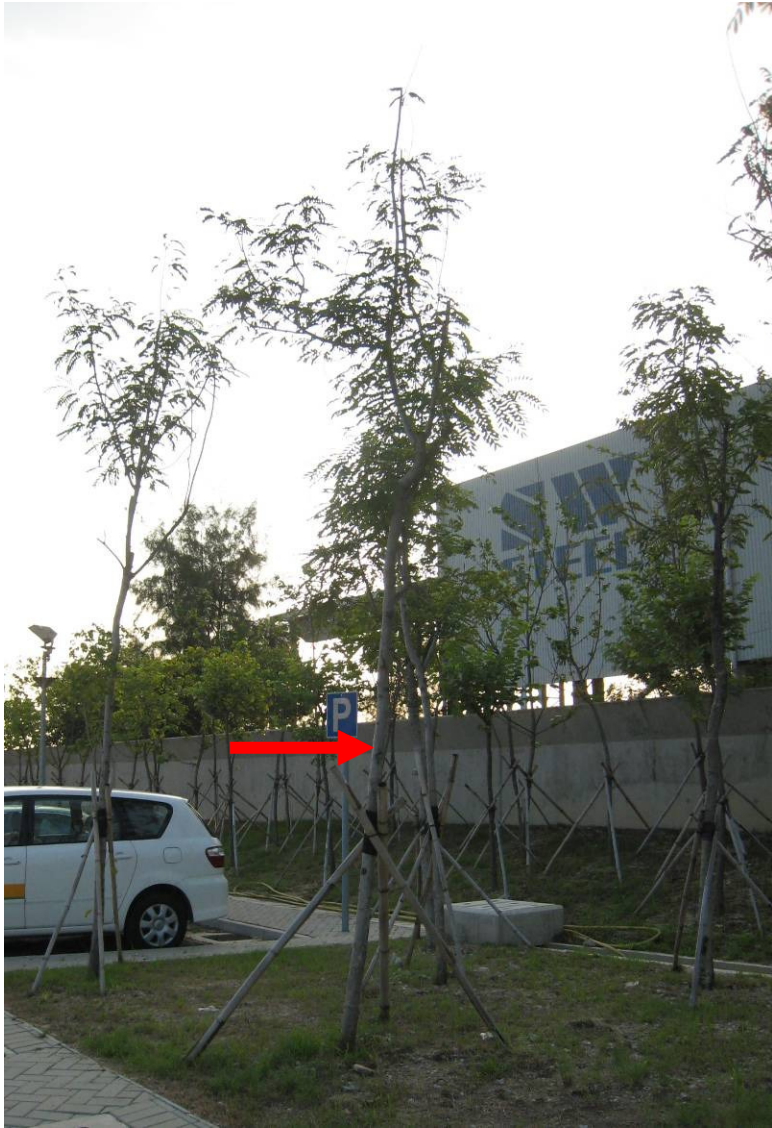
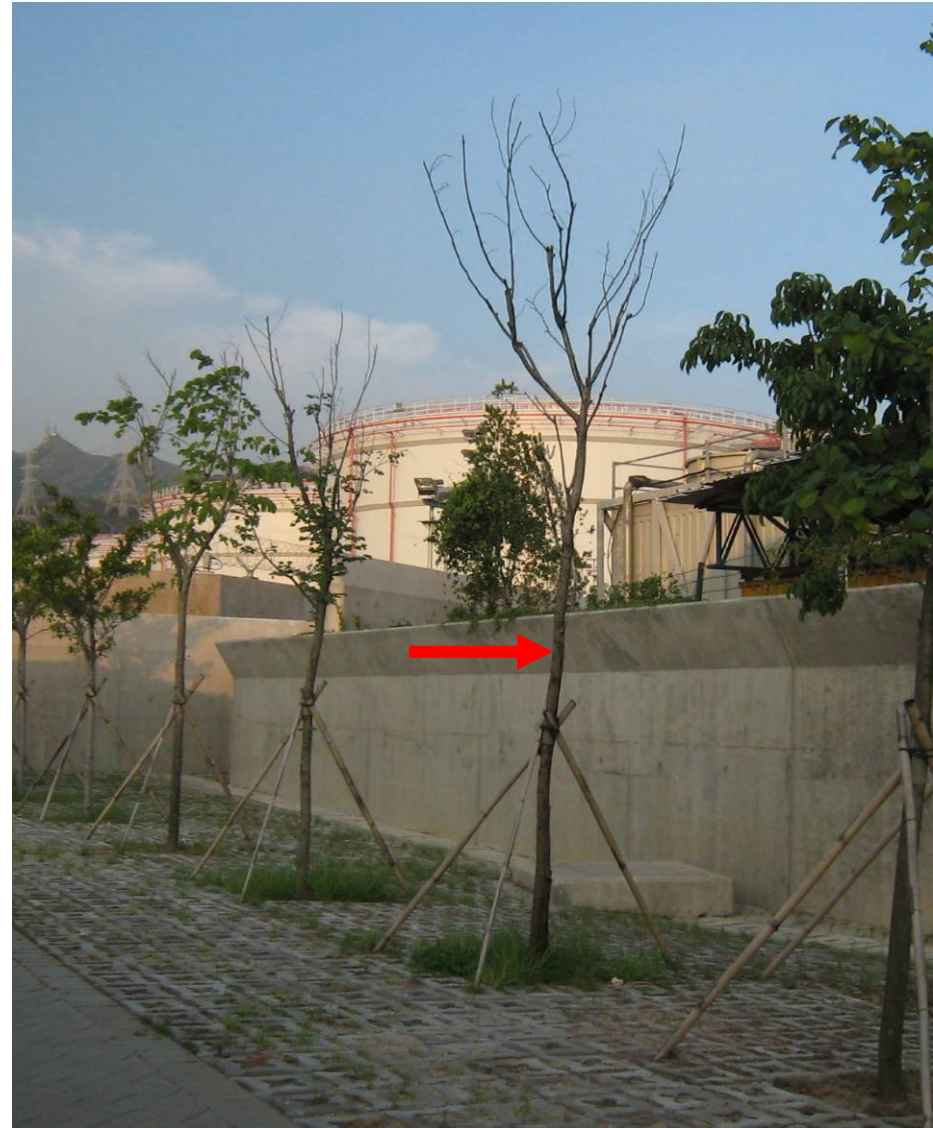
Establishment Works	Monitoring of implementation of maintenance operations during Establishment Period	Some Compensatory Trees in the Operations Building area of Phase 1a were observed to be in poor health (<i>Photos 3-4</i>).	Contractor is recommended to review health of all compensatory trees and replace any trees if confirmed dead.	Plantings have been maintained to ensure healthy establishment.	Not required.

Photos 3 & 4 – Examples of Compensatory Trees in the Operations Buildings area of Phase 1a, observed to be in poor health.
