Highways Department

**Contract No.
HY/2007/14 Widening of
Tuen Mun Road at
Tsing Tin Interchange**

Baseline Monitoring
Report

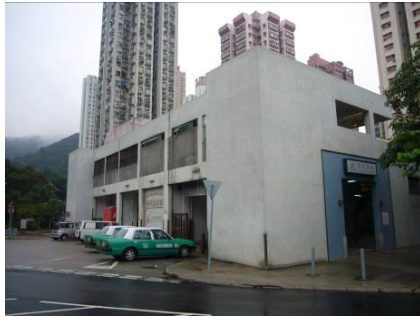
Photo 2.1: Original EM&A proposed monitoring location at Kwong Choi Market (AM1)

ID	Premise	Findings	Recommendation / Justification
AM1	Kwong Choi Market at 2 Tsing Min Path	AM1 is situated at the entrance of the market. Since it is a public place and lacking of proper electricity supply for the HVS, it is not suitable.	Relocate to the roof of the market as agreed by the market representative. New designation: AM1(a)
AM2	Lakeshore Building at 7 Tseng Choi Street	Representative of management office rejected the placement of the HVS since the building will carry out facade renovation work soon until 2009. Endeavour was made to other buildings which are in vicinity of the Lakeshore Building included Kam Fat Building, Tan Oi Building, Nam Kwong Building, Kam Men Mansion, Florence Mansion, Ka Hay Building, Fung Tei Park, Victory Building, Kam Bo Building and Rich Building, they all rejected the placement of the HVS.	Propose to delete the air quality baseline and impact monitoring at this location. In fact, due to the vicinity of the Kwong Choi Market, monitoring results obtained from the market can be referenced to the Lakeshore Building.

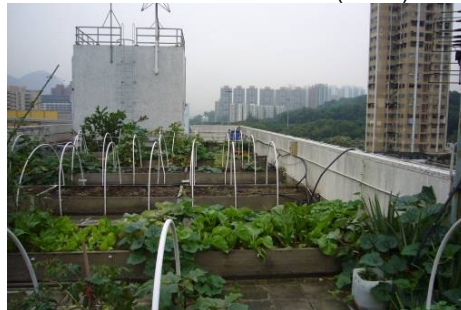
Photo 2.5: Original EM&A proposed monitoring location at The CCC Tam Lee Lai Fun Memorial School (TLLF)

ID	Premise	Findings	Recommendation / Justification
LB1	Lakeshore Building at 7 Tseng Choi Street	Representative of management office rejected the placement of the noise meter since the building will carry out facade renovation work soon until 2009. Endeavour was made to other buildings which are in vicinity of the Lakeshore Building included Kam Fat Building, Tan Oi Building, Nam Kwong Building, Kam Men Mansion, Florence Mansion, Ka Hay Building, Fung Tei Park, Victory Building, Kam Bo Building and Rich Building, they all rejected the placement of the noise meter.	Propose to delete the noise baseline and impact monitoring at this location.
TLLF	The Church of Christ in Chan Tam Lee Lai Fun Memorial School at 10 San Wo Lane	TLLF is situated at the roof top of the school academic building, but school students will always go there for academic purposes.	Relocate to the car park of the school (line of sight between the noise meter and car park area was avoided but direct line of sight between the noise meter and construction site was maintained). New designation: TLLF(a)

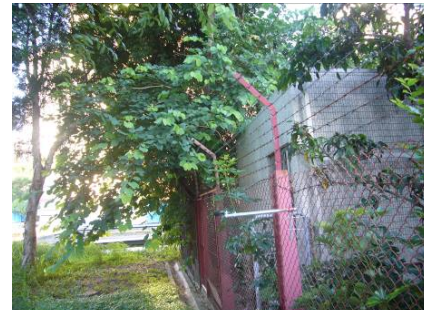
Photo 2.6: Noise meter installed at The CCC Tam Lee Lai Fun Memorial School (TLLF(a))

ID	Premise	Address	Monitoring Location Detail
TLLF(a)	The Church of Christ in China Tam Lee Lai Fun Memorial Secondary School	10 San Wo Lane	Car park of the school, facing to the construction area.

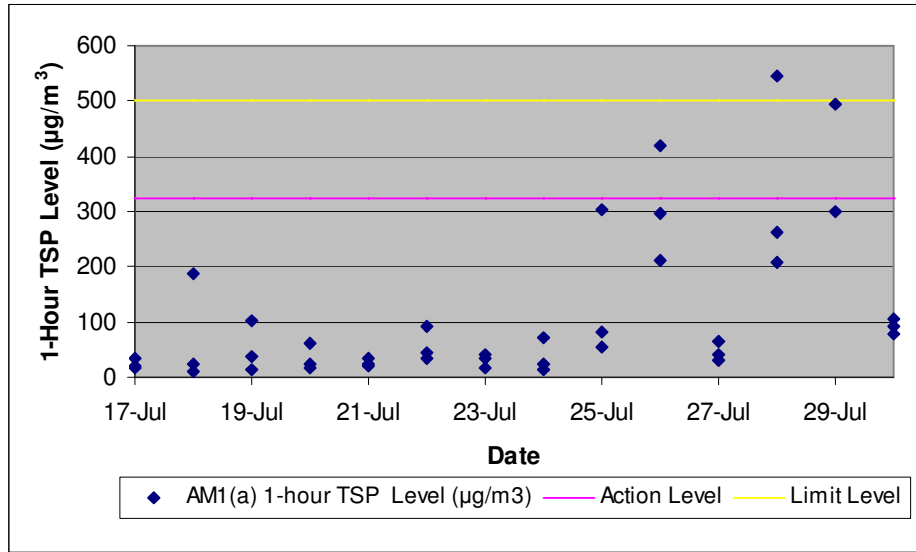
Figure 3.1: Baseline 1-hour TSP monitoring at air monitoring station AM1(a)

Air Monitoring Station	Mean ($\mu\text{g}/\text{m}^3$)	Minimum, $\mu\text{g}/\text{m}^3$ (date)	Maximum, $\mu\text{g}/\text{m}^3$ (date)
AM1(a)	47	23 (23 Jul 08)	97 (28 Jul 08)
AM3(a)	58	21 (22 Jul 08)	206 (29 Jul 08)

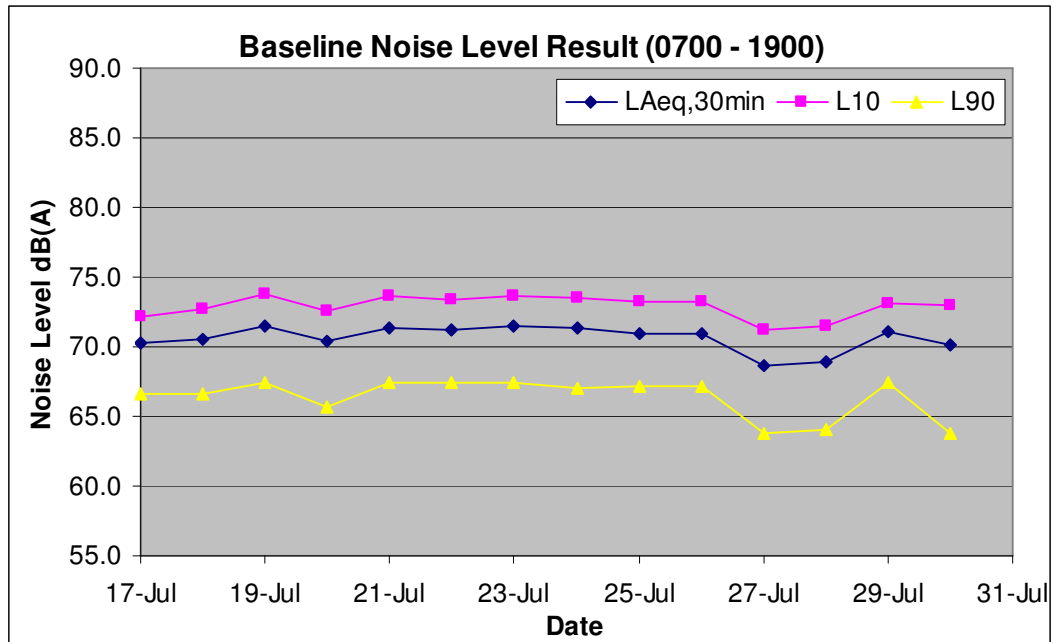
Figure 3.5: Baseline day-time average noise monitoring results (0700 – 1900 hours)

(1) $L_{eq(30min)}$ was measured at day-time while $L_{eq(5min)}$ was measured at evening- and night-time

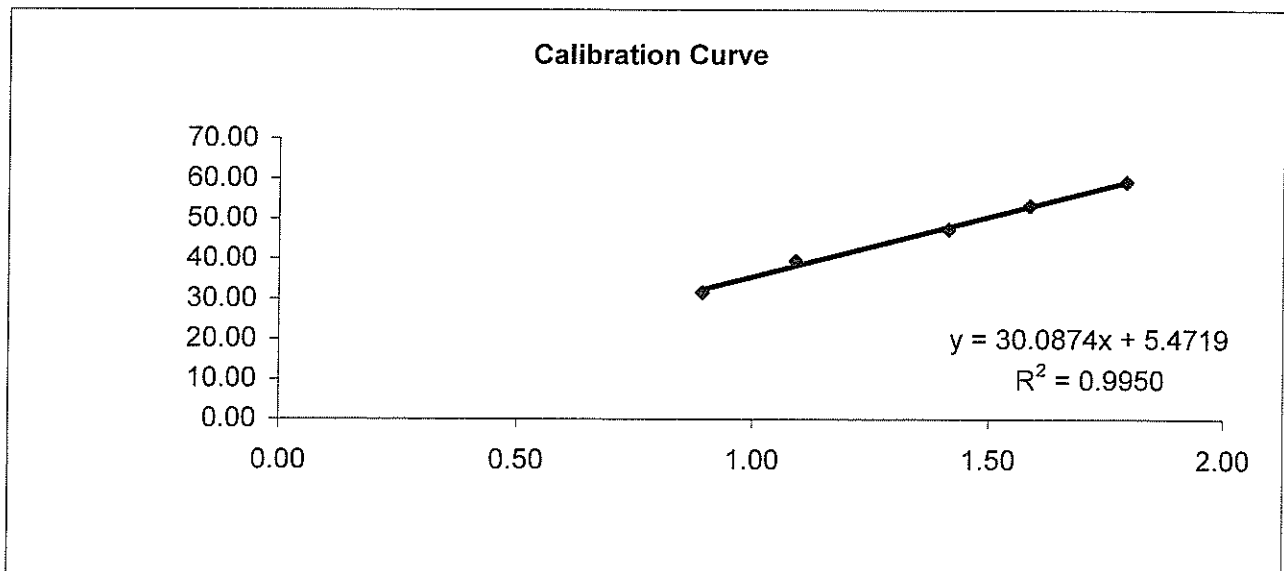
Resistance Plate No.	Manometer Reading (inch H ₂ O)	Flow Recorder Reading (CFM)	Calculated Q _{std} (m ³ /min)	Continuous Flow Recorder Reading IC (CFM)
5	3.20	32.00	0.89	31.62
7	4.80	40.00	1.09	39.52
10	8.10	48.00	1.41	47.43
13	10.20	54.00	1.59	53.36
18	13.00	60.00	1.79	59.29

Sampler slope (m) : **30.0874**
 Sampler intercept (b) : **5.4719**
 Correlation coefficient (R²) : **0.9950**

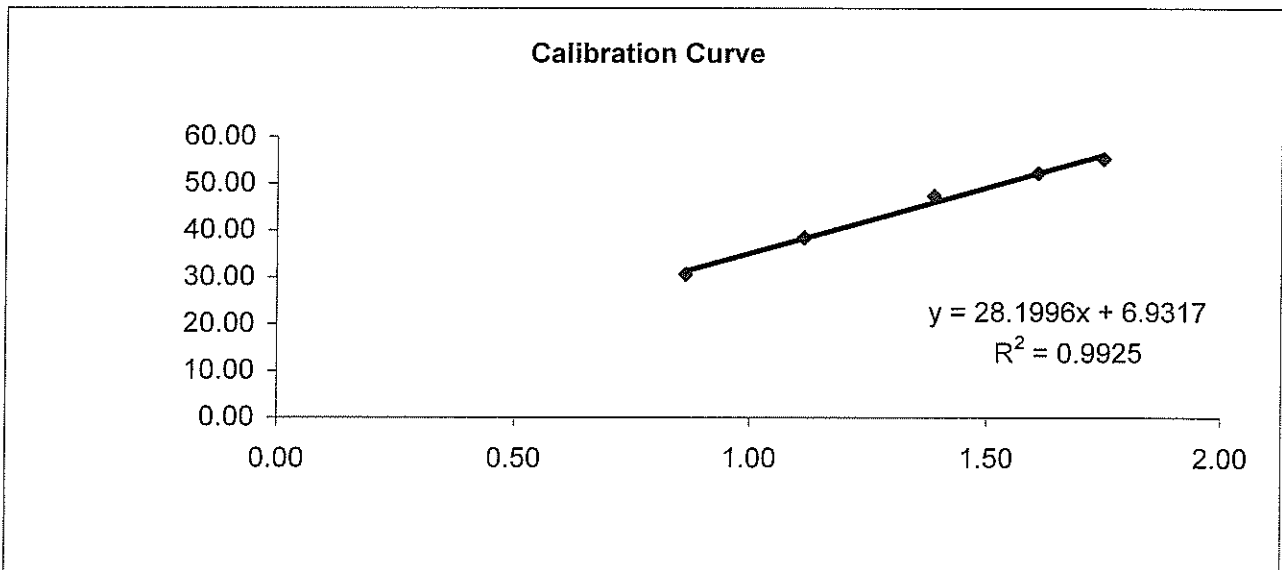
Resistance Plate No.	Manometer Reading (inch H ₂ O)	Flow Recorder Reading (CFM)	Calculated Q _{std} (m ³ /min)	Continuous Flow Recorder Reading IC (CFM)
5	3.00	31.00	0.87	30.63
7	5.00	39.00	1.11	38.54
10	7.80	48.00	1.39	47.43
13	10.50	53.00	1.61	52.37
18	12.40	56.00	1.75	55.33

Sampler slope (m) :	28.1996
Sampler intercept (b) :	6.9317
Correlation coefficient (R ²) :	0.9925

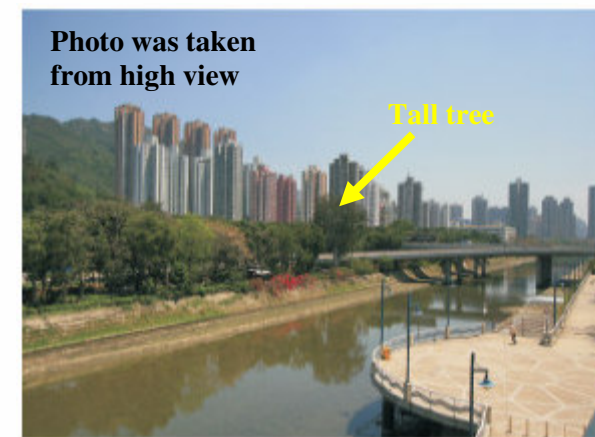
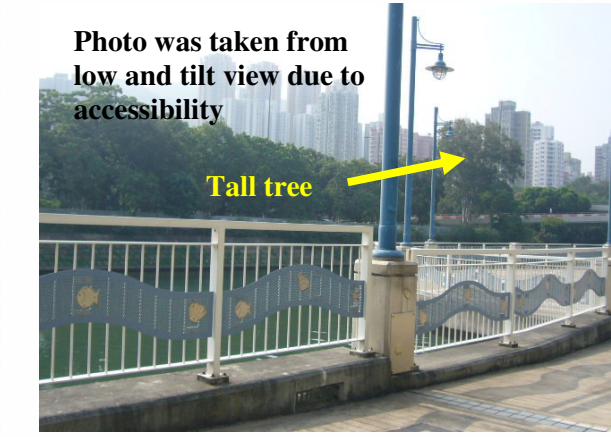
V10 View from the waterfront near Tuen Mun Hospital

Photo was taken from high view

Photo was taken from low and tilt view due to accessibility

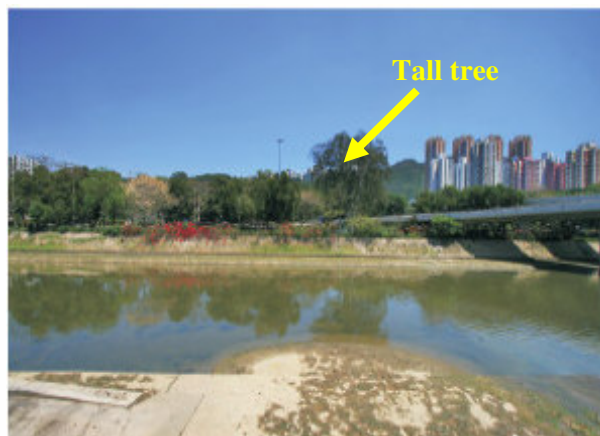
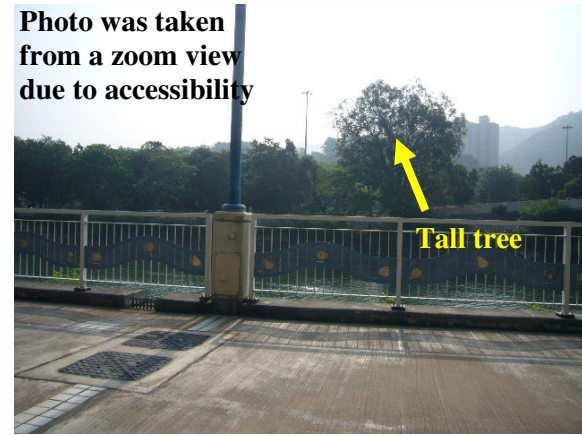
V11 View from waterfront near Tuen Mun Hospital

Photo was taken from a zoom view due to accessibility
