Contract No.
HY/2007/14 Widening of
Tuen Mun Road at
Tsing Tin Interchange

Impact Environmental
and Audit Report -
October 2008

Revision 2

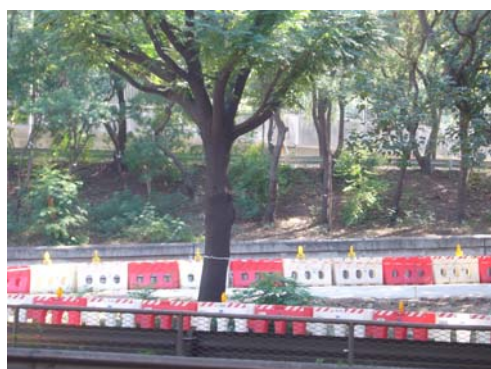
Photo 7-1 Tree Number 69 in LR1

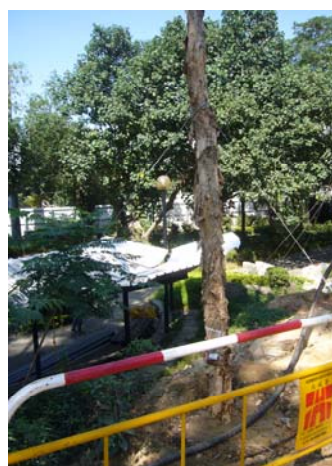
| Tree no. | Location | Botanical Name | | Status | Measures |
|---|---|---|---|--|--|
| 411 | LR2 | <i>Melaleuca quinquenervia</i> | 白千層 | Completion of interim transplant within the site | To be transplanted at designated location |

Photo 7-2 Tree Number 411 in LR2
