Highways Department

Contract No.
HY/2007/14 Widening of
Tuen Mun Road at
Tsing Tin Interchange

Monthly Environmental
Monitoring and Audit
Report - December 2008

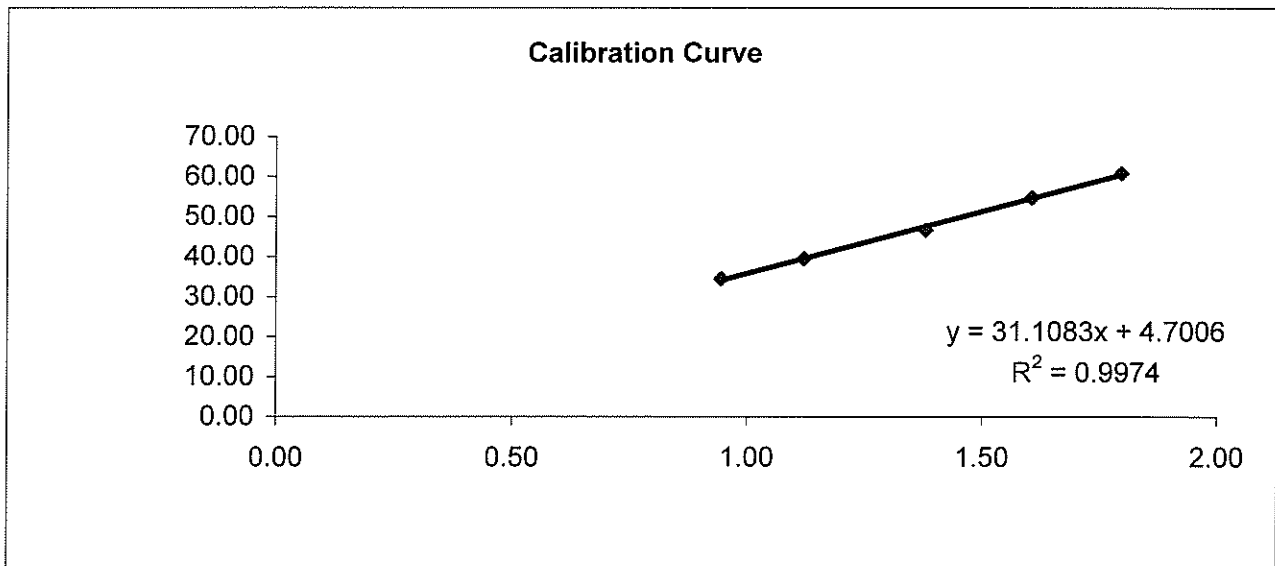
Calibration date	5-Dec-08	Barometric pressure	767 mm Hg
Calibration due date	3-Feb-09	Temperature (°C)	19 °C
Sampler location	TT2 - G/F Tam Lee Lai Fun Memorial School	Temperature (K)	292 K
Sampler model	TE-5170	P _{std}	760 mm Hg
Sampler serial number	0523	T _{std}	298 K
Calibrator model	GMW-2535		
Calibrator serial number	1378		
Slope of the standard curve, m _s	2.00216		
Intercept of the standard curve, b _s	-0.02053

Resistance Plate No.	Manometer Reading (inch H ₂ O)	Flow Recorder Reading (CFM)	Calculated Q _{std} (m ³ /min)	Continuous Flow Recorder Reading IC (CFM)
5	3.40	34.00	0.94	34.51
7	4.80	39.00	1.12	39.58
10	7.30	46.00	1.38	46.68
13	9.90	54.00	1.61	54.80
18	12.40	60.00	1.80	60.89

Linear Regression

Sampler slope (m) : **31.1083**
 Sampler intercept (b) : **4.7006**
 Correlation coefficient (R²) : **0.9974**
