Contract No.
HY/2007/14 Widening of
Tuen Mun Road at
Tsing Tin Interchange

Monthly Environmental
Monitoring and Audit
Report - April 2009

Revision 2

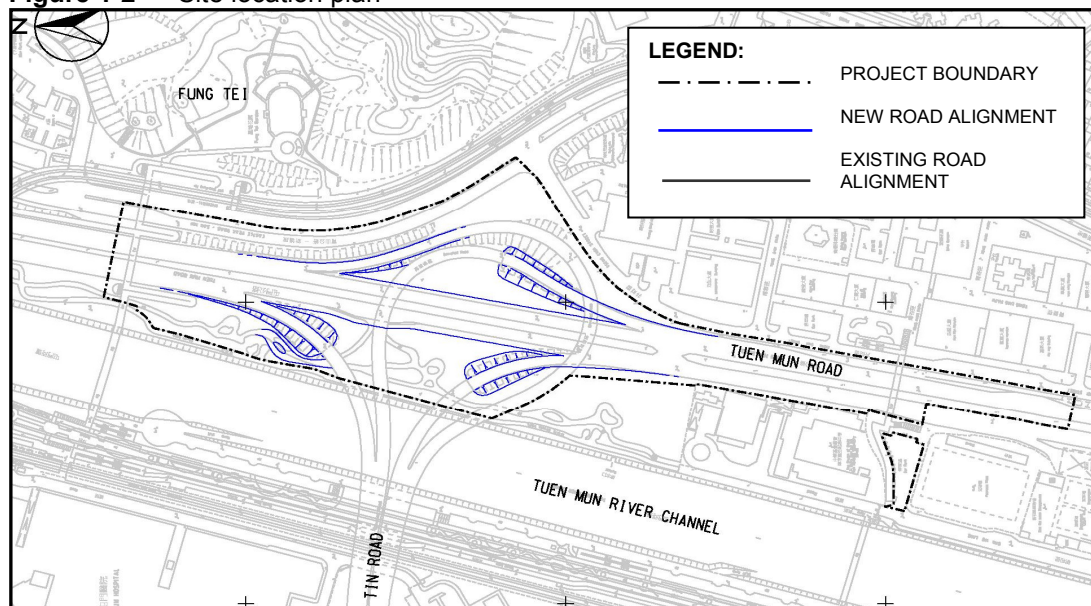
Figure 1-2 Site location plan

The project area and the location of the sensitive receivers and monitoring stations are shown in **Figures 1-2 and 1-3** respectively, while **Table 1-3** shows the detail correspondences of monitoring stations.

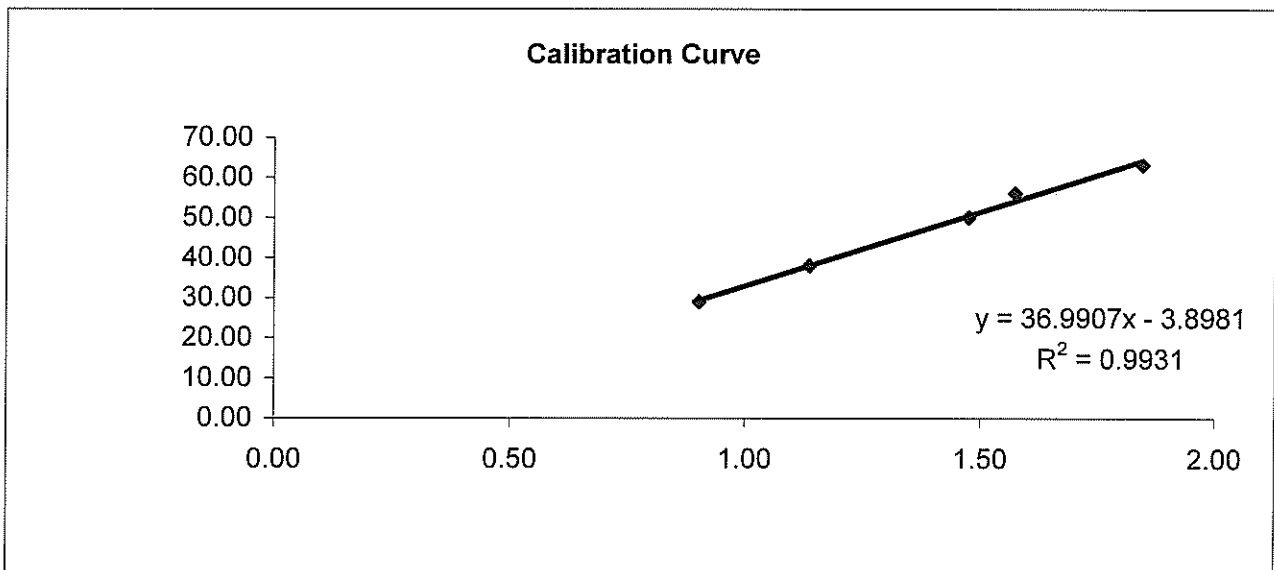
Linear Regression

Sampler slope (m) : **36.9907**
 Sampler intercept (b) : **-3.8981**
 Correlation coefficient (R²) : **0.9931**

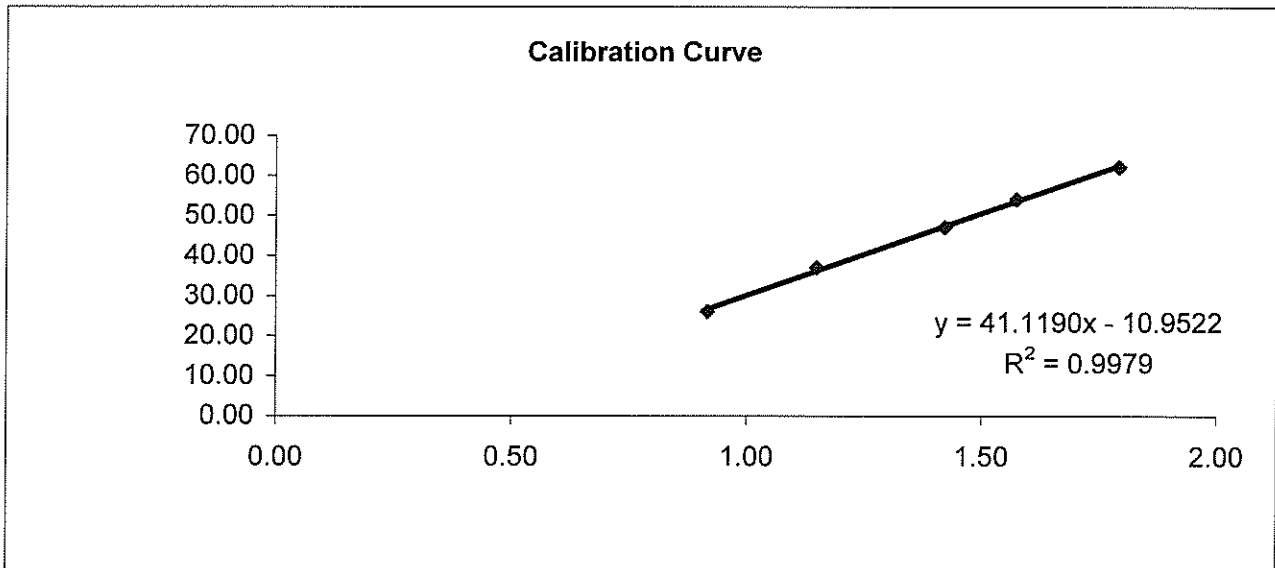
Linear Regression

Sampler slope (m) : **41.1190**
 Sampler intercept (b) : **-10.9522**
 Correlation coefficient (R²) : **0.9979**

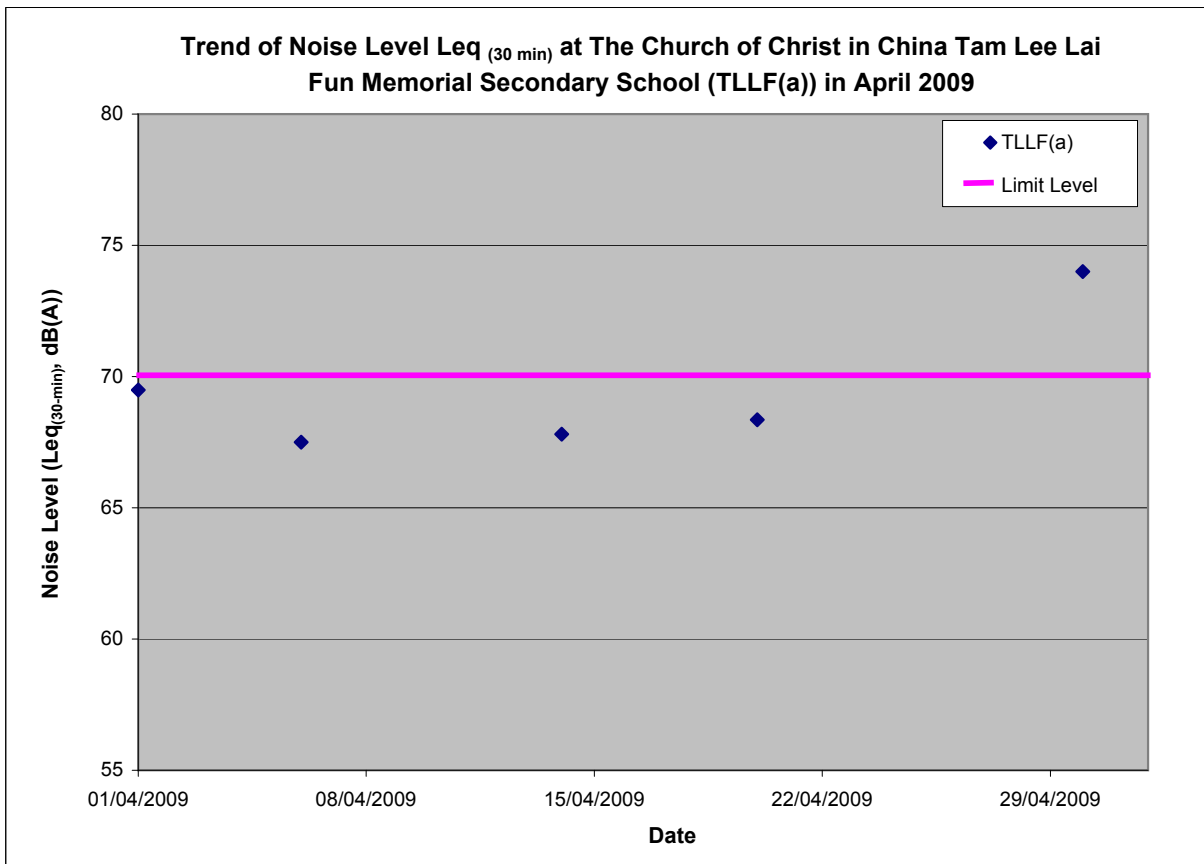
One (1) limit level exceedance for noise measurement during non-restricted hours was recorded on 30 April 2009. On-site observations during the noise monitoring revealed that the noise source was mainly the traffic noise along Tuen Mun Road although it was also observed that the Contractor was undertaking the noise barriers construction works.

Together with the on-site observations and interpretation from the monitoring results, construction noise was considered insignificant and below the noise limit level. It was therefore concluded that the noise exceedance was not related to the construction activities. No further actions were applicable. It was however recommended that the Contractor shall maintain the existing practices stipulated in the EIA report in order to minimise the potential noise impact in future.

Notes:
Noise result on 30 April 2009 is not project-related exceedance

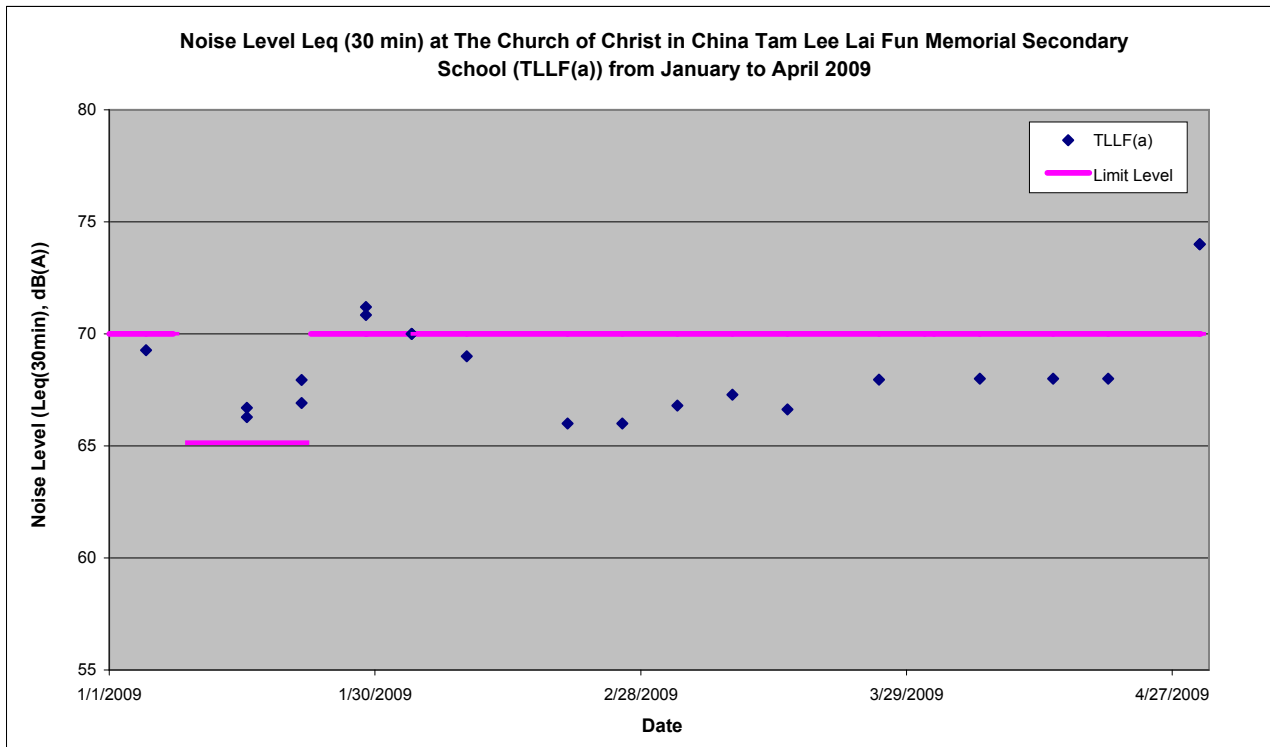
Notes:
All noise results exceeding limit level were not project-related.

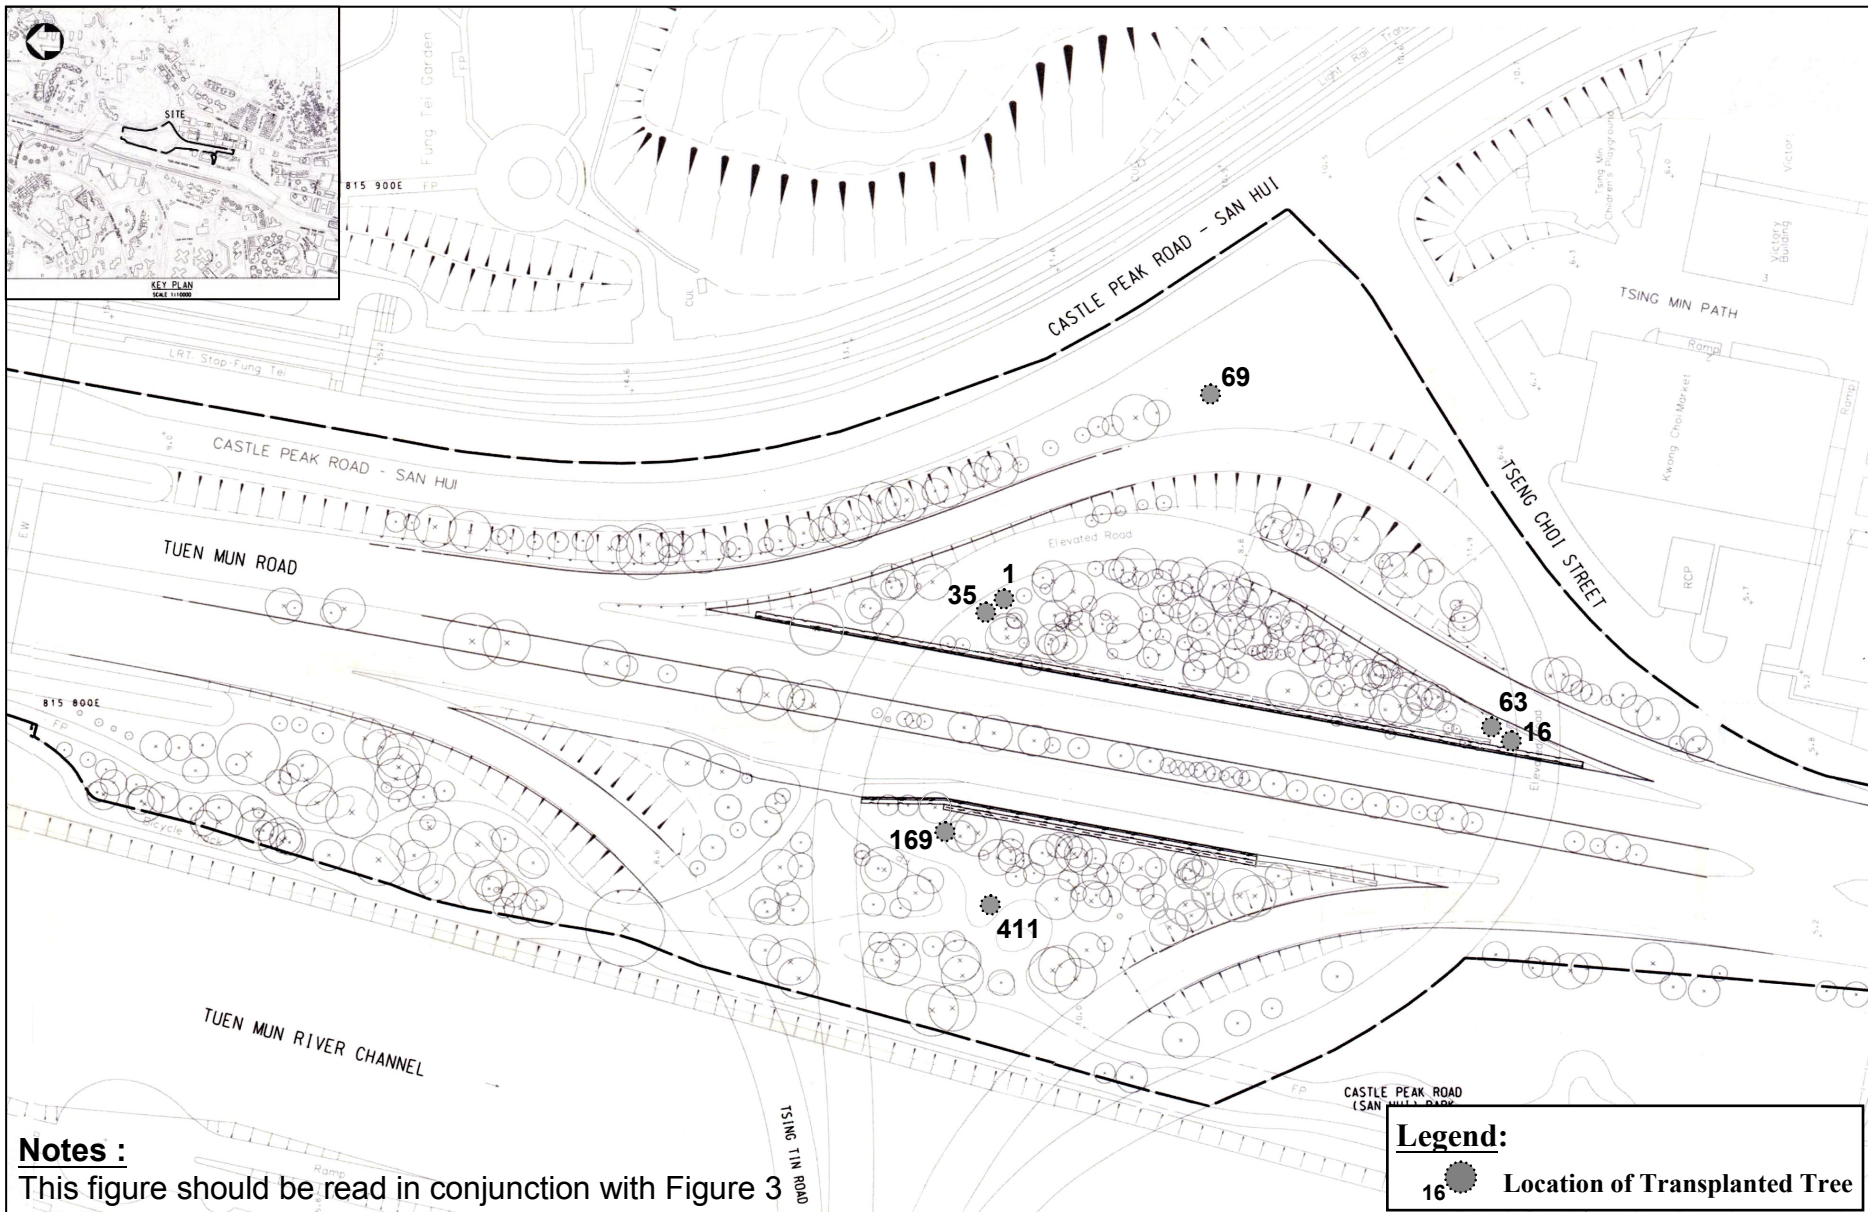
**Widening of Tuen Mun Road at Tsing Tin Interchange
- Locations of Transplanted Trees**

Based on the updated information provided by the contractor and the site inspections, no significant change on the tree status was noted during the reporting month except the tree no.69 had been relocated to new transplanting location on 29 April 2009.

- The Contractor was reminded to keep 7m protect zone and properly fenced for tree no.69;
- The Contractor was reminded to avoid trunks damage during the construction works and, takes the proper remedial measures immediately and tree protection when damage was observed; and
