Contract No. : DC/2007/06
**River Improvement Works in Upper Lam Tsuen, She
Shan River and Upper Tai Po River**

ENVIRONMENTAL MONITORING AND AUDIT

MONTHLY EM&A REPORT of

UPPER TAI PO RIVER

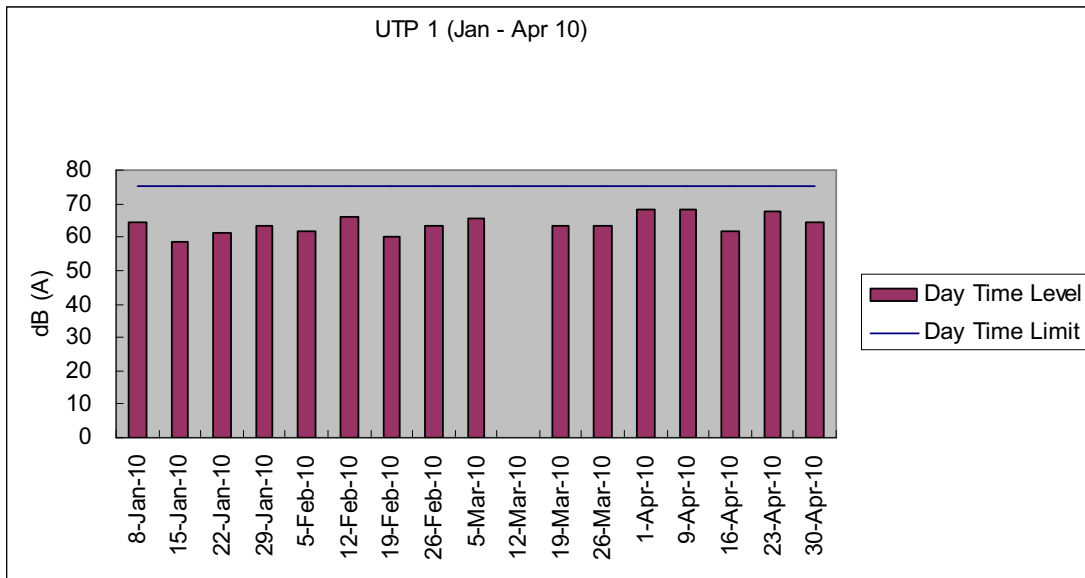
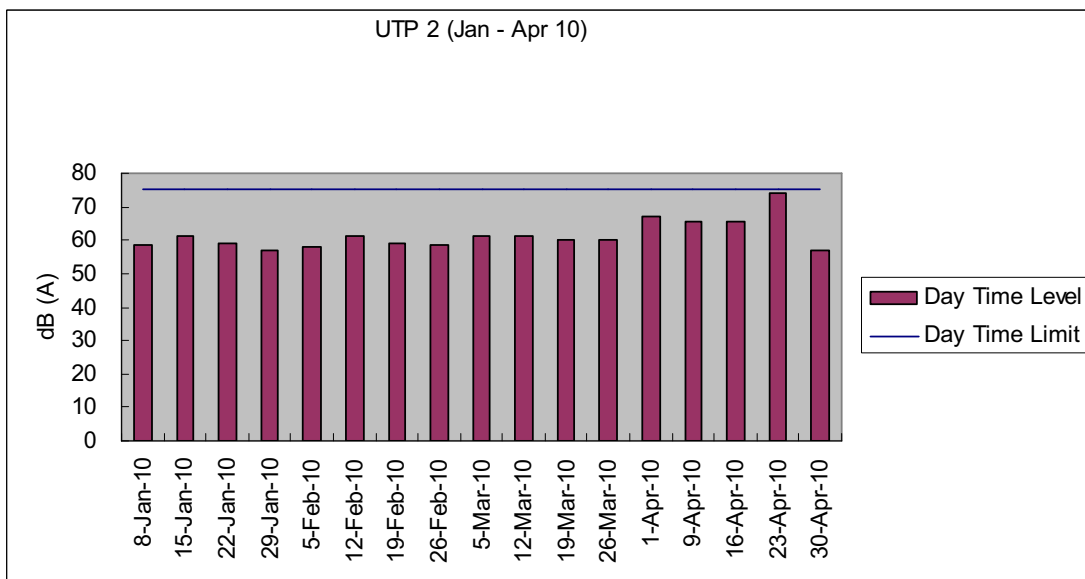
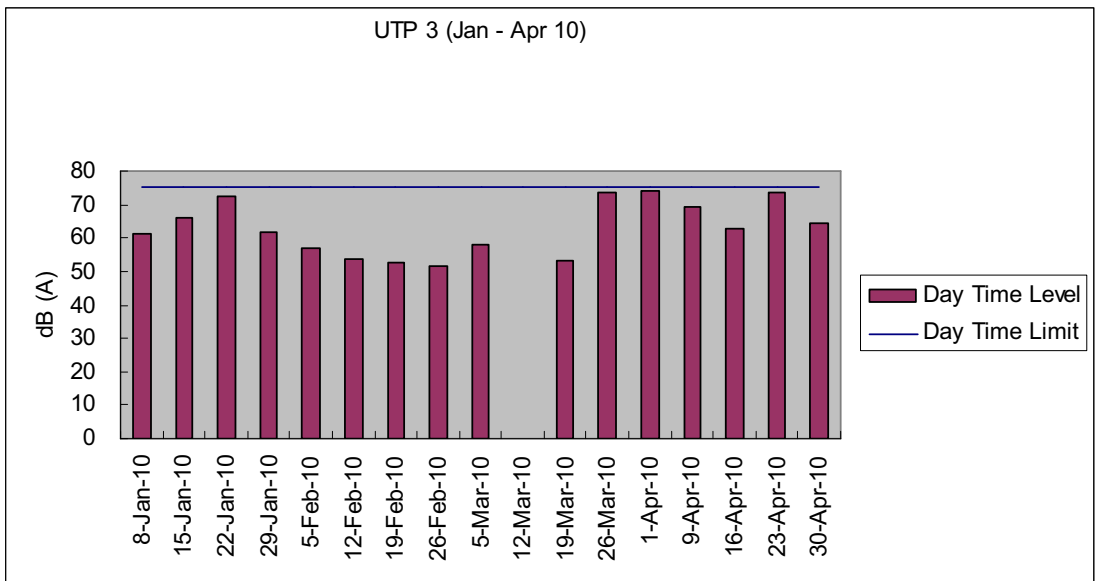
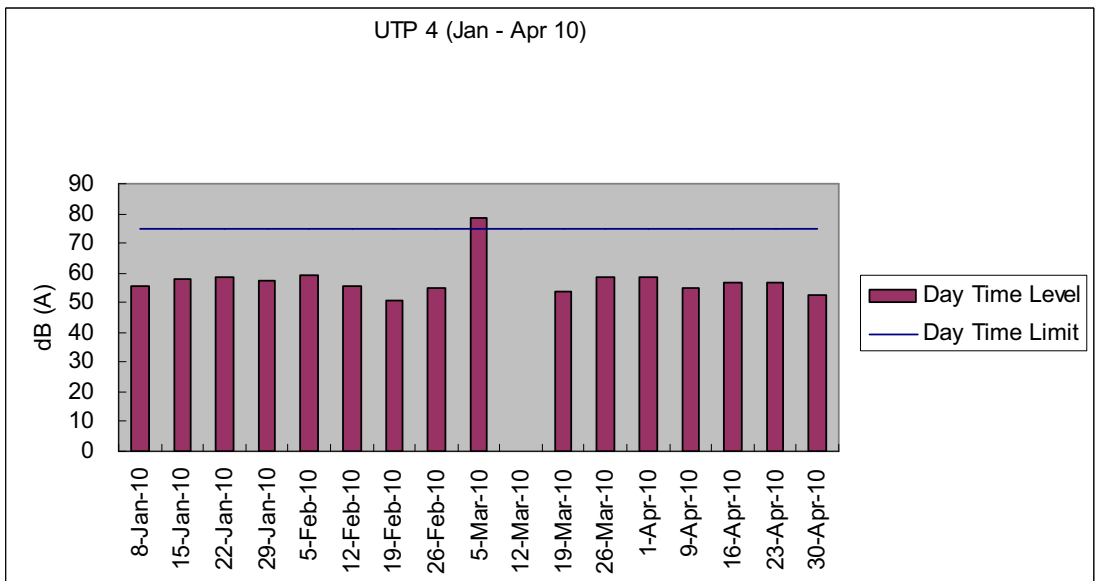
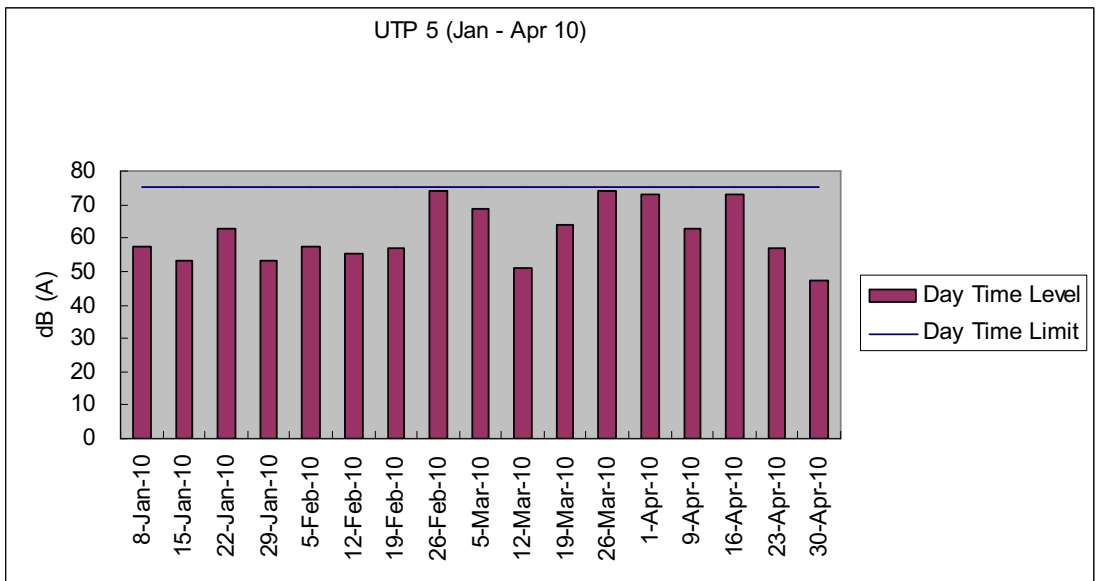
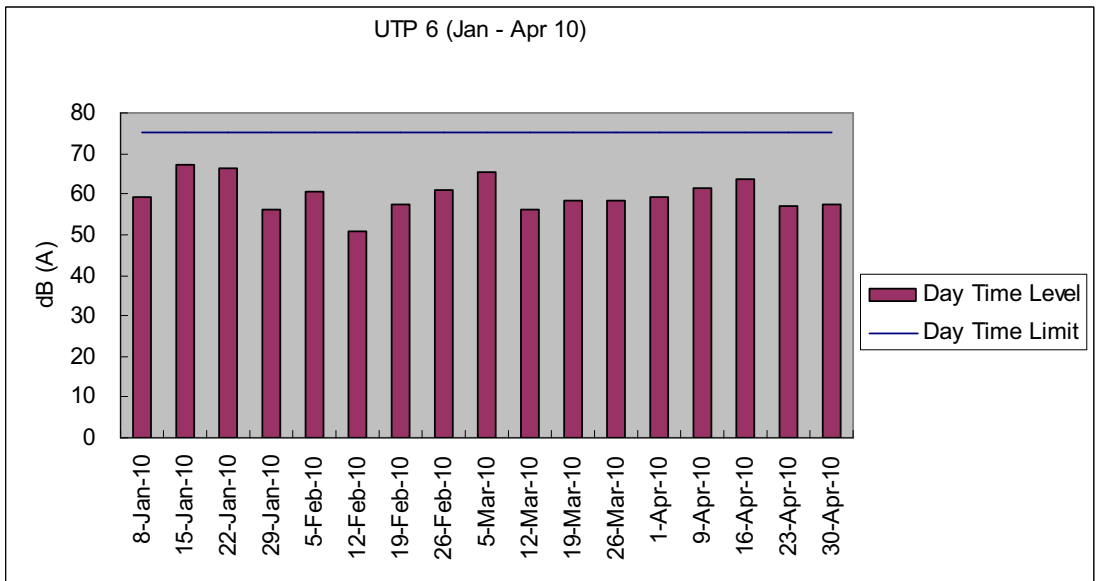
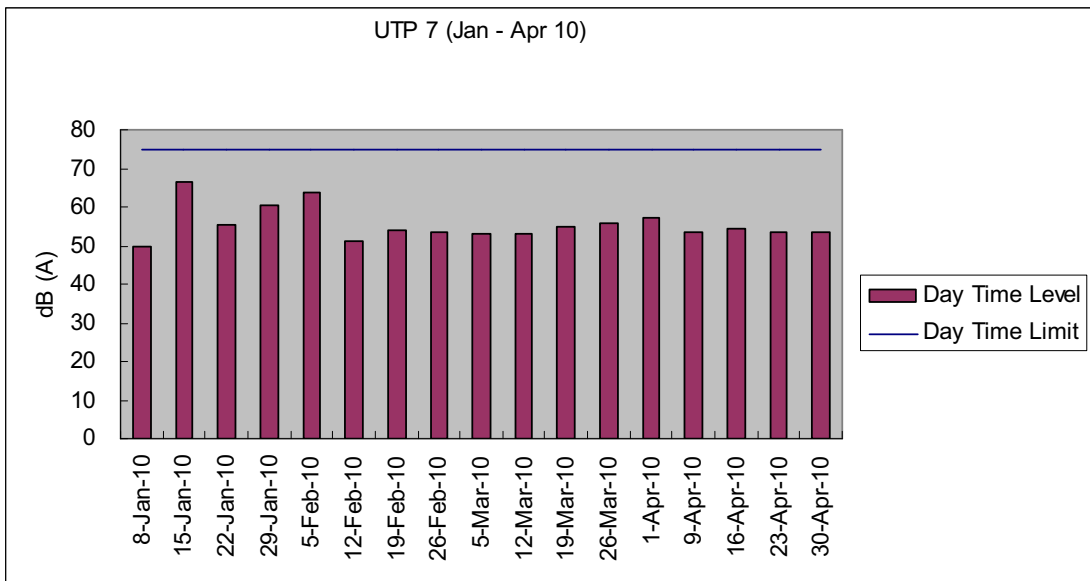
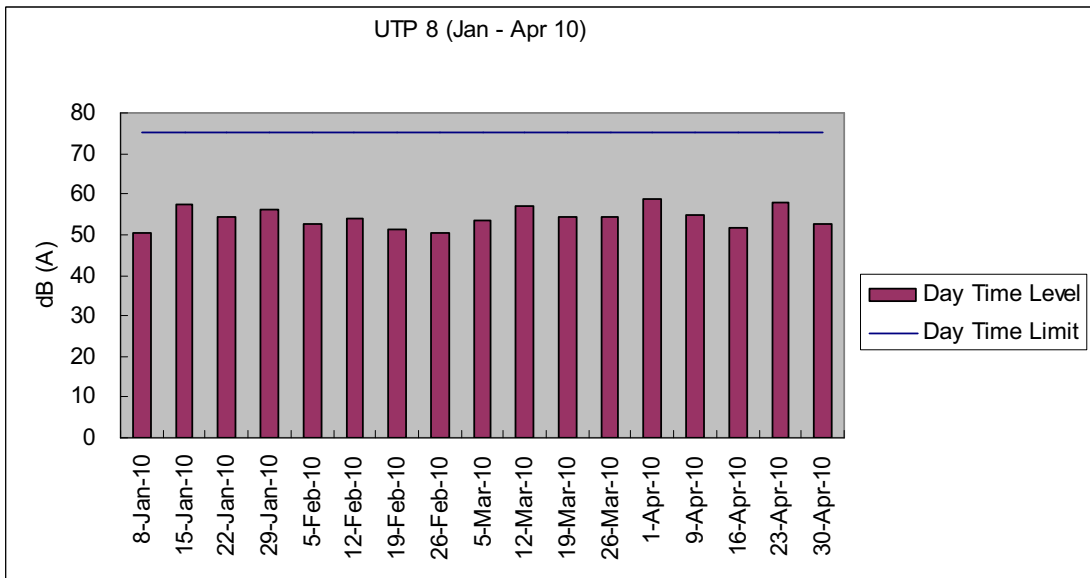
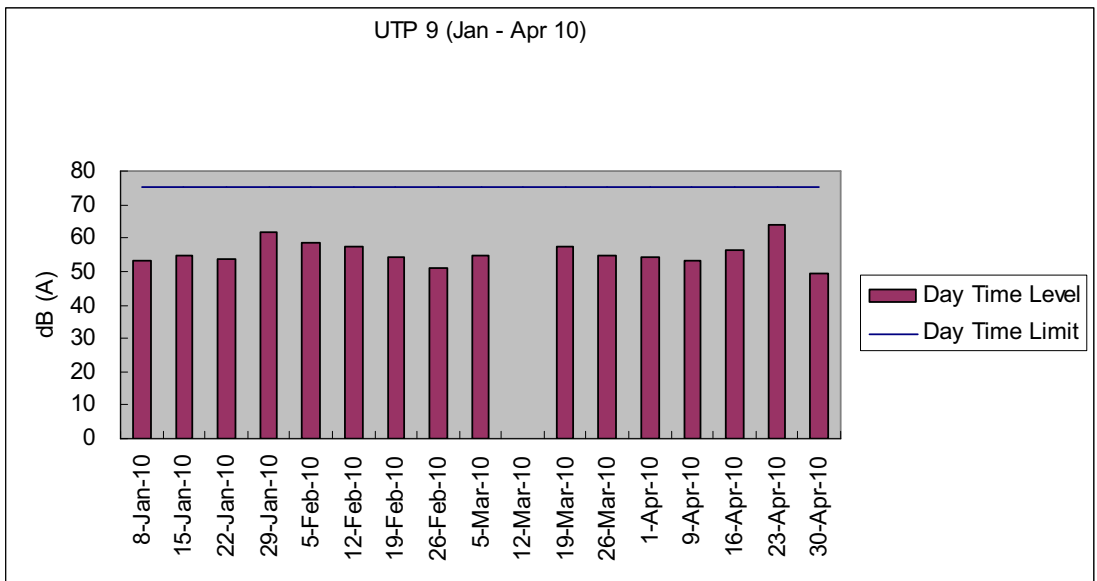
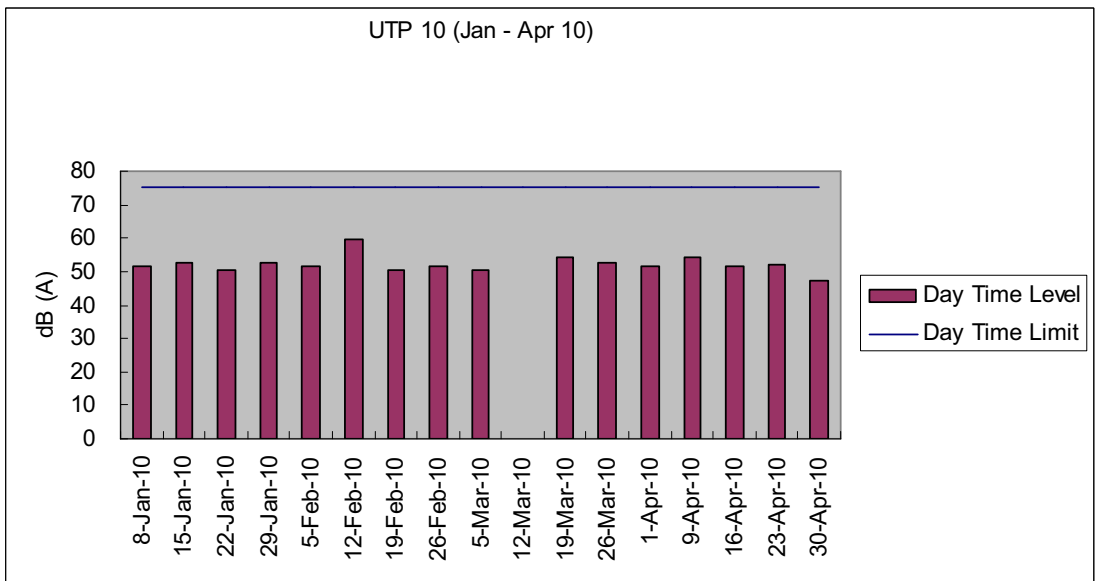
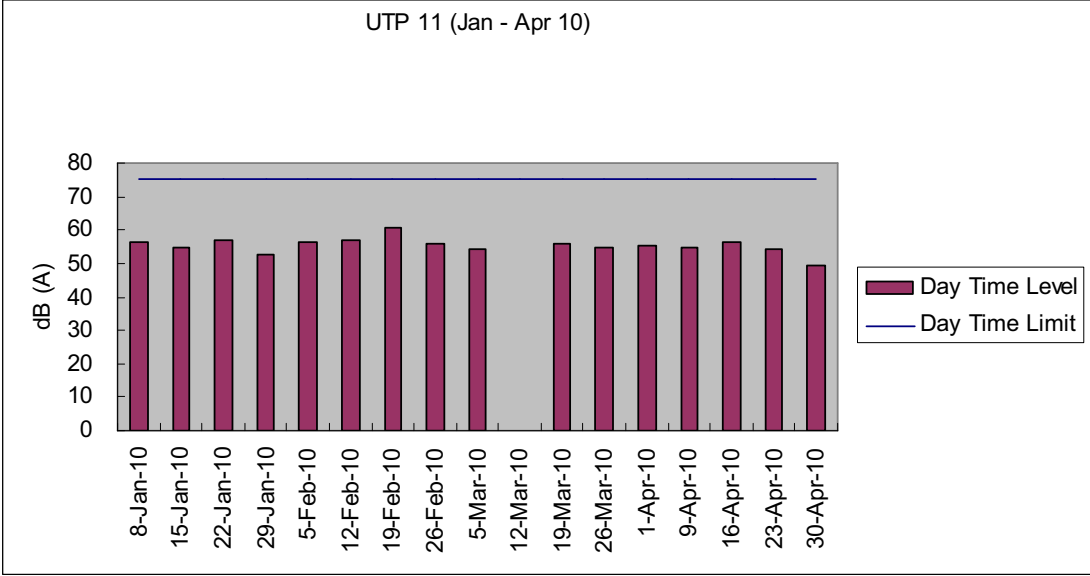
Graphical plot for noise measurements

The followings were the graphical plots for the 11 monitoring locations. Each plot showed the date of measurement taken, day time limit of 75 dB(A) as well as the measured daytime level for each location. The graphs contain the data recorded from January 2010 to April 2010.

Measured $L_{eq(30min)}$ results ranged from 47.0dB(A) to 74.0dB(A). And therefore, no exceedance was recorded within the reporting period.
