Contract No. : DC/2007/06
**River Improvement Works in Upper Lam Tsuen,
She Shan River and Upper Tai Po River**

ENVIRONMENTAL MONITORING AND AUDIT

MONTHLY EM&A REPORT of

UPPER TAI PO RIVER

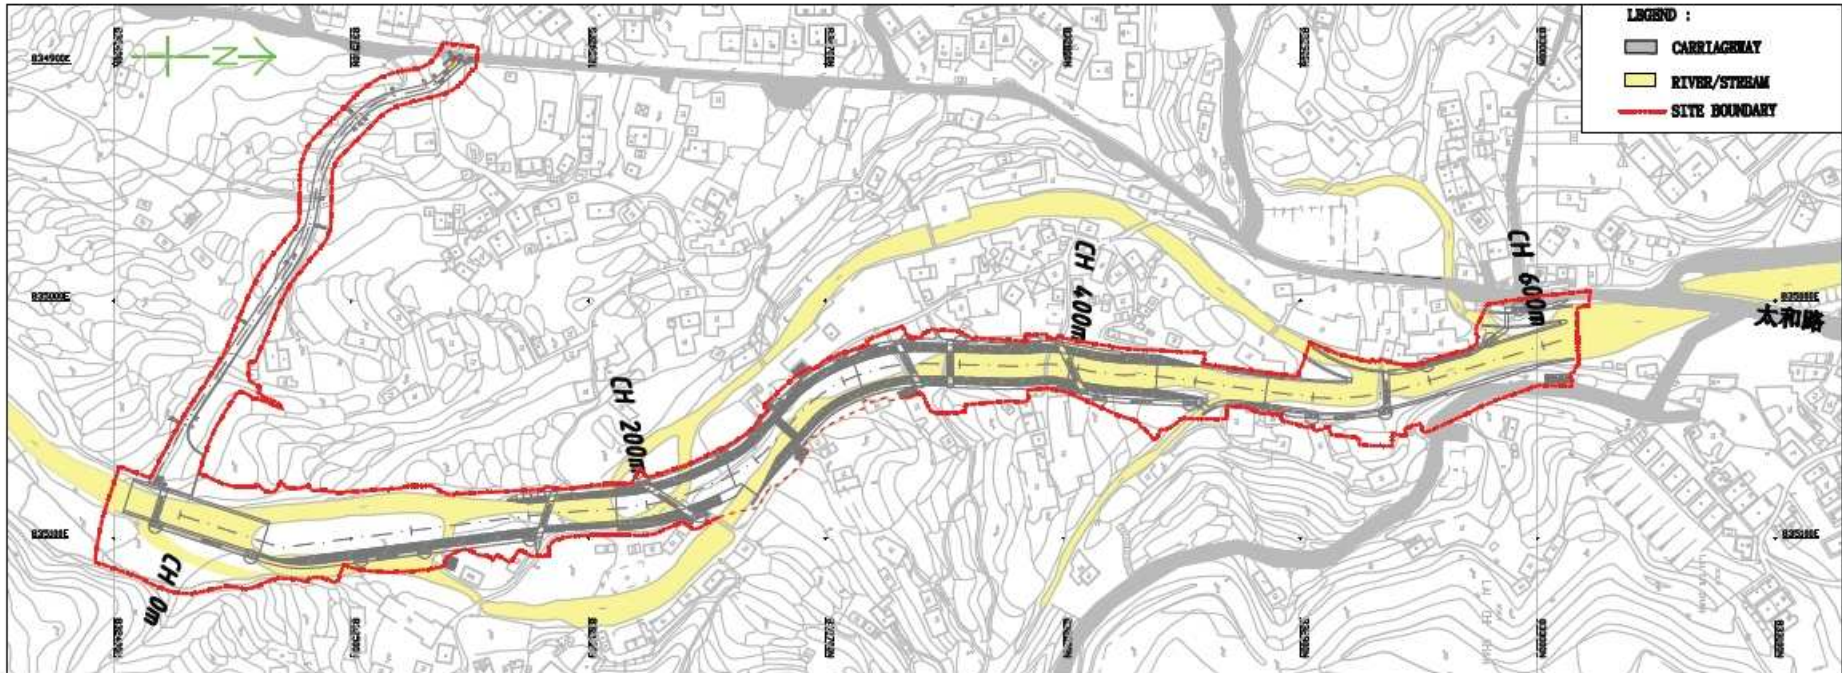
Fig 2.1 Layout of construction area

The location of the project site – Upper Tai Po River starts from Ta Tit Yan of Yai Mo Shan, flows from southeast to northeast alongside Wilson Trail, turning northward before joining the Lam Tsuen River and then runs towards Tai Po Market. For the east of the river, there are active and abandoned cultivated lands. The village settlements are mainly located on the west and northeast side of the river bank, where the San Uk Ka and Lai Chi Shan establishment also lie. The Project site is indicated in **Figure 2.1**.

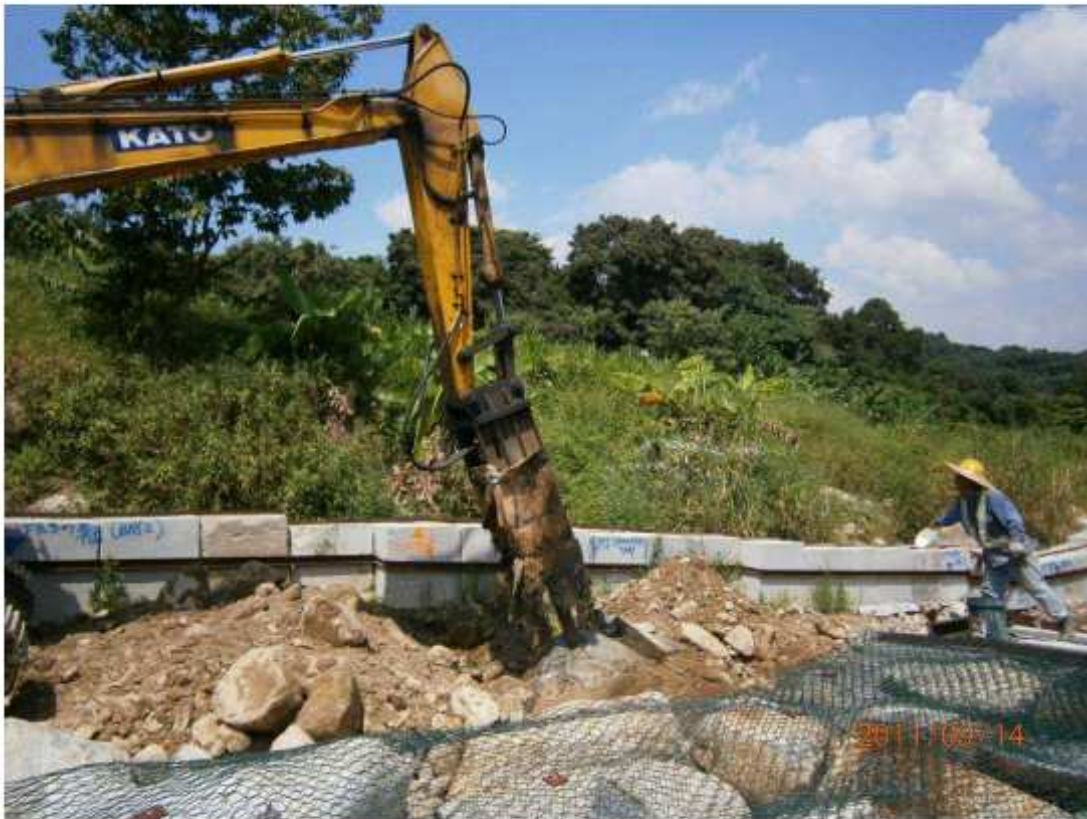
4. Site investigation was held on 14th September 2011 with the representatives of Contractor to resolve the concerns.
5. During investigation, rock breaking was being carried out by an excavator-mounted breaker at approximate ch.50. Due to size of boulders to be broken and difficulty of transportation, as reported by Contractor boulder breaking activities were confined within the abovementioned location.

7. Inefficient water spraying during rock breaking by worker as air quality mitigation measure was observed. Also,

Fig 7.1 – During site investigation, water spraying was provided and the breaker Tips of Hydraulic Breaker was warped up with noise insulation material

8. To minimize noise and dust generation from the concerned activities, The following recommendations has been given to the Contractor:
 - Existing noise barriers should be well-maintained.

9. Contractor was reminded to maintain proper practices and noise and dust mitigation measures, such as the administrative planning and public liaison, to minimize adverse impact to the vicinity sensitive receivers. Other noise minimization features by means of insulation or screening should be regularly reviewed and maintained to ensure they are in good condition and functional.

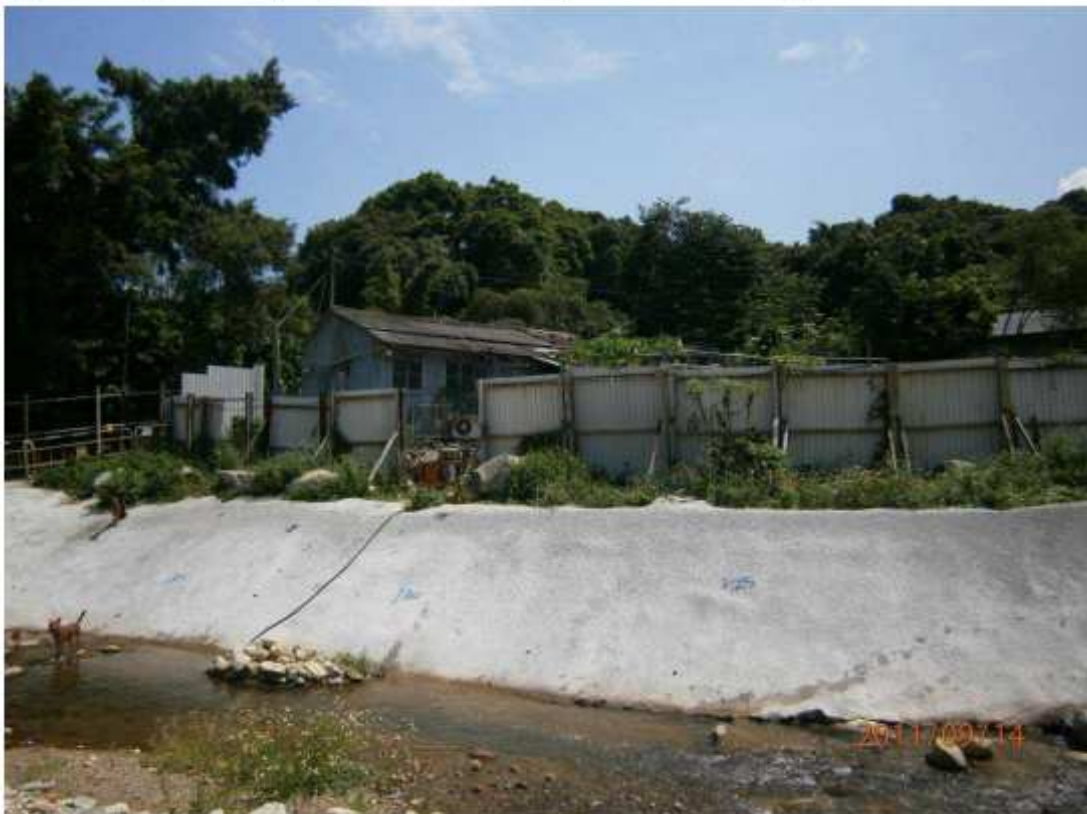
Fig 7.2 – During site investigation, noise barriers were set up near Sha Po Tsai Village

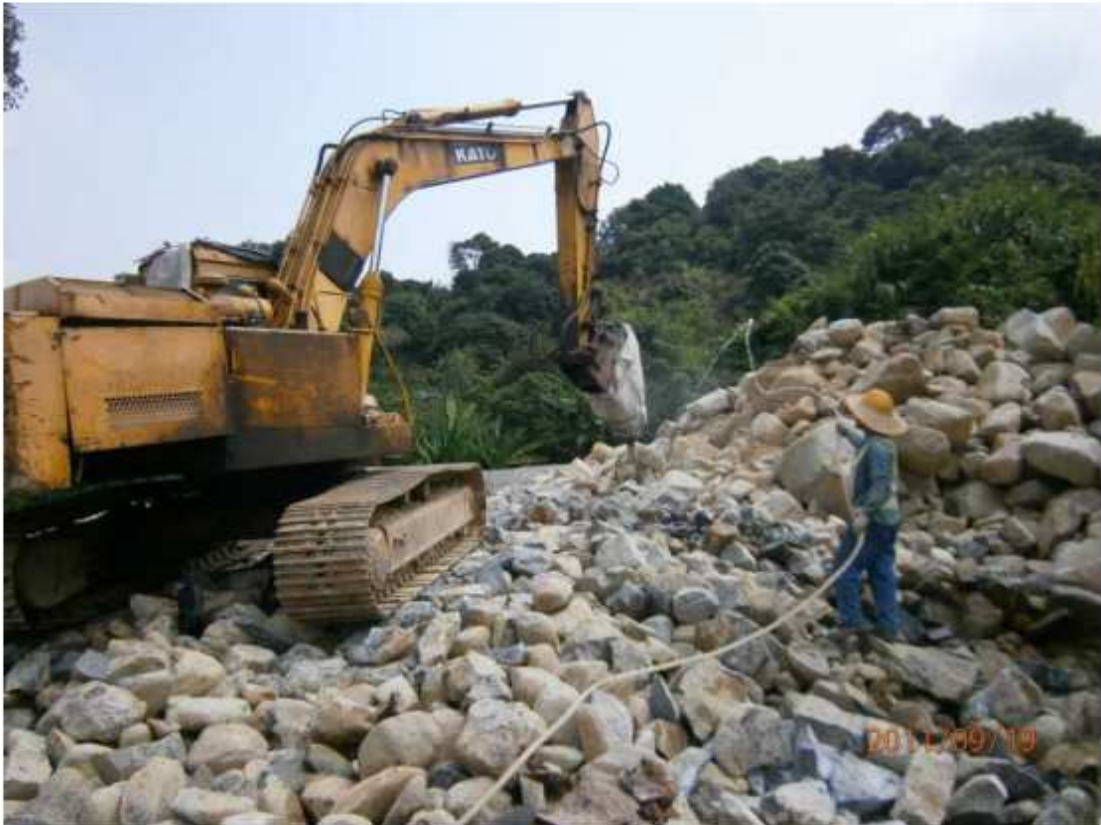
4. ET has conducted a site investigation on 19th September 2011 with representatives from Contractor to resolve the concern.
5. During the investigation, it was observed that the rock breaking activity was carried out inside the rock breaking zone and a frontline staff was assigned to provide water spraying for the public area at rock breaking zone (Fig.5.1). After the implementation of mitigation measures, dust emission was still observed during the rock breaking (Fig.5.2).

Fig.5.1 – Water spraying was provided during rock breaking.

6. To minimize dust generation from the concerned activities, The following recommendations has been given to the Contractor:
 - Water spraying funnel shall be mounted on the breaker tip or sprinkler system shall be installed for effective dust suppression

- Sufficient water spraying shall be continuously applied on the surface where any site activities such as mechanical breaking operation that caused dust emission is carried out.
 - Spray the working area with water before, during and immediately after the operation to maintain entire surface wet.
 - Monitor performance by recording frequency of application and review its effectiveness
 - Briefing to frontline staffs about prevention of dust generation, especially of issue of rock breaking.
7. Contractor was reminded to maintain proper practices and dust suppression measures to minimize dust pollution to the surrounding environment.
8. ET has reminded the contractor to pay serious attention to prevent causing possible environmental impacts in the future.

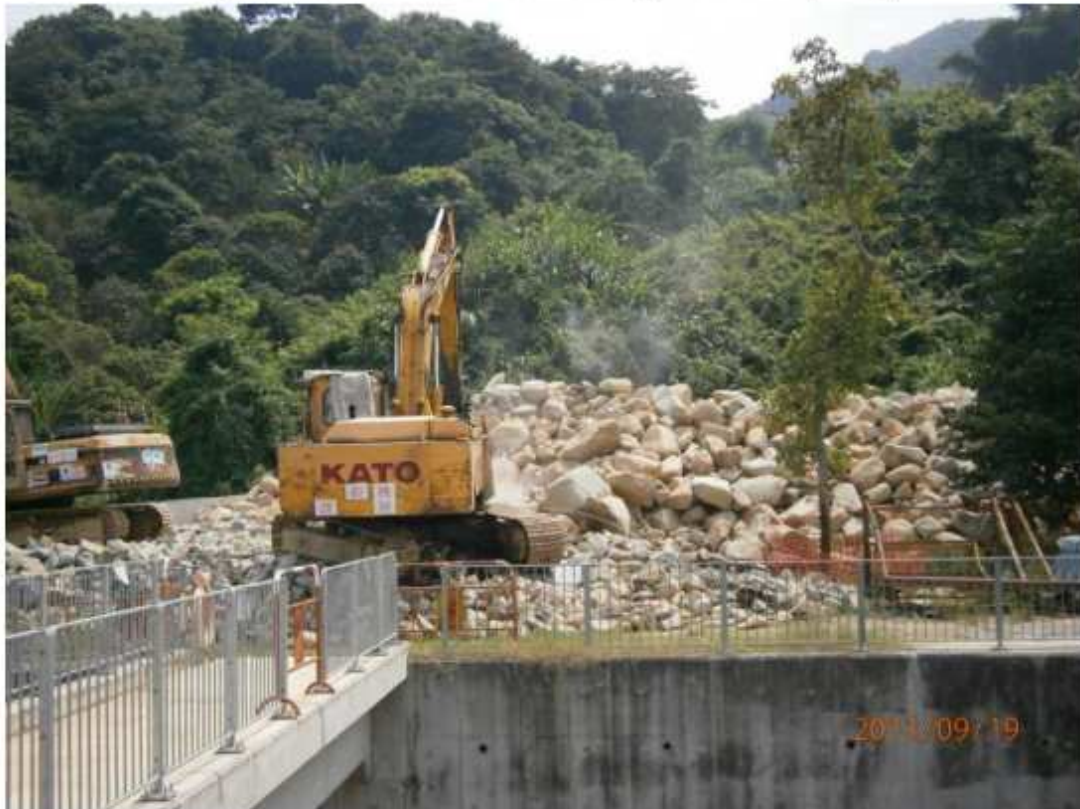
Fig.5.2 – Dust emission was still observed during the rock breaking activity.
