Contract No. : DC/2007/06
**River Improvement Works in Upper Lam Tsuen,
She Shan River and Upper Tai Po River**

ENVIRONMENTAL MONITORING AND AUDIT

MONTHLY EM&A REPORT of

for November 2011

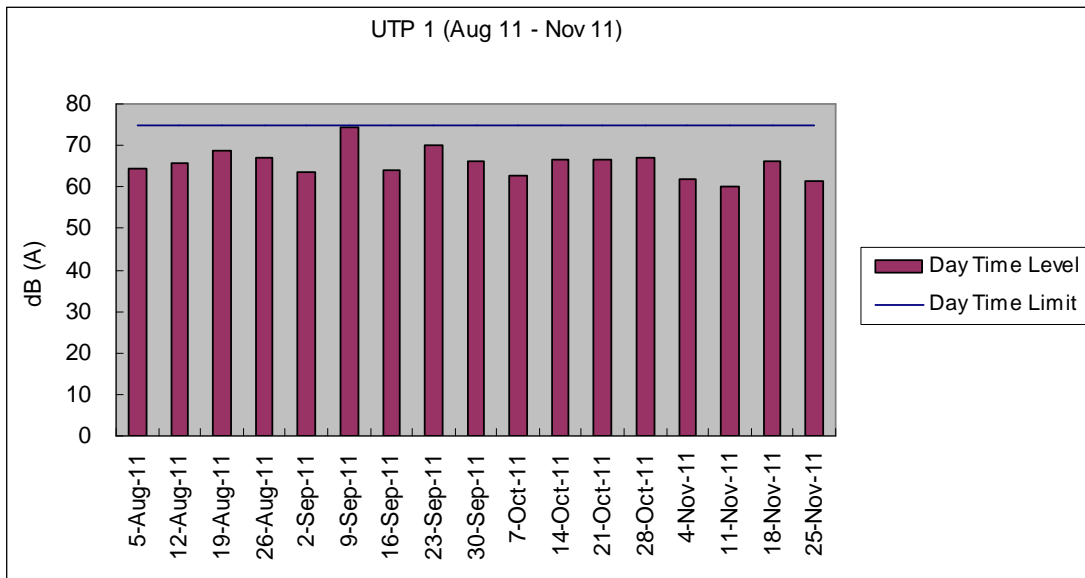
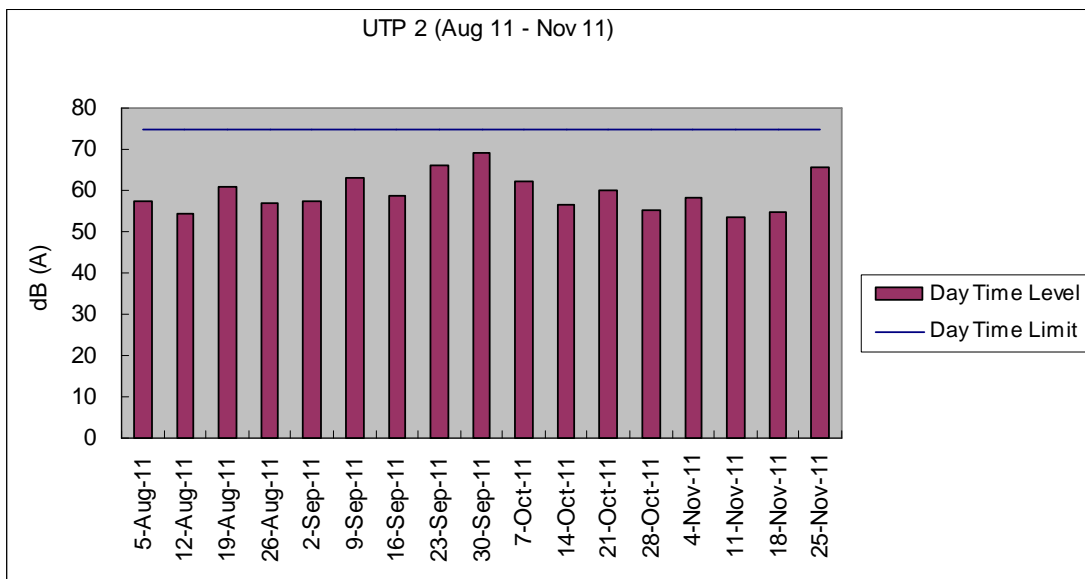
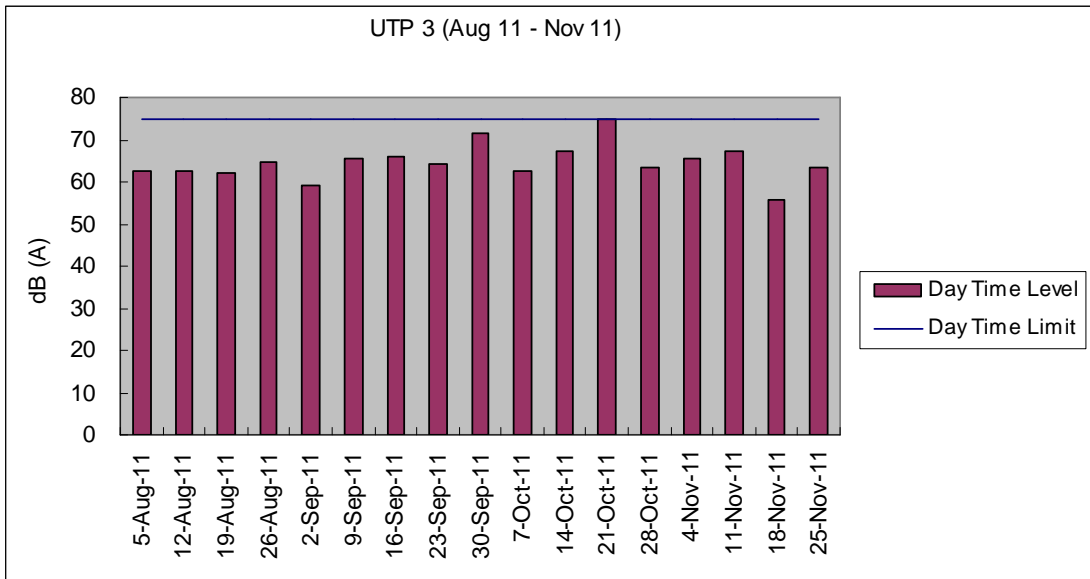
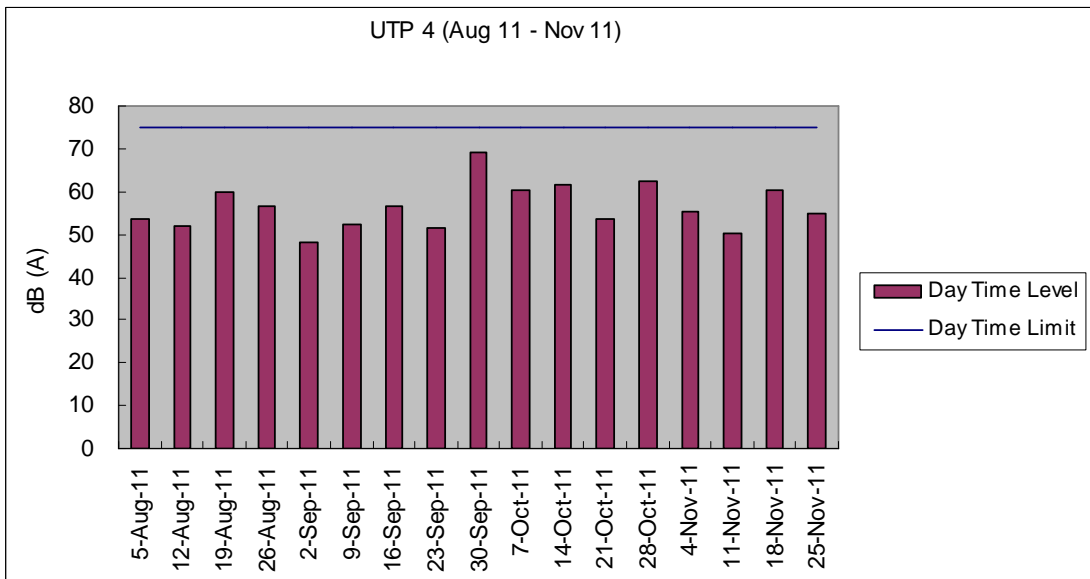
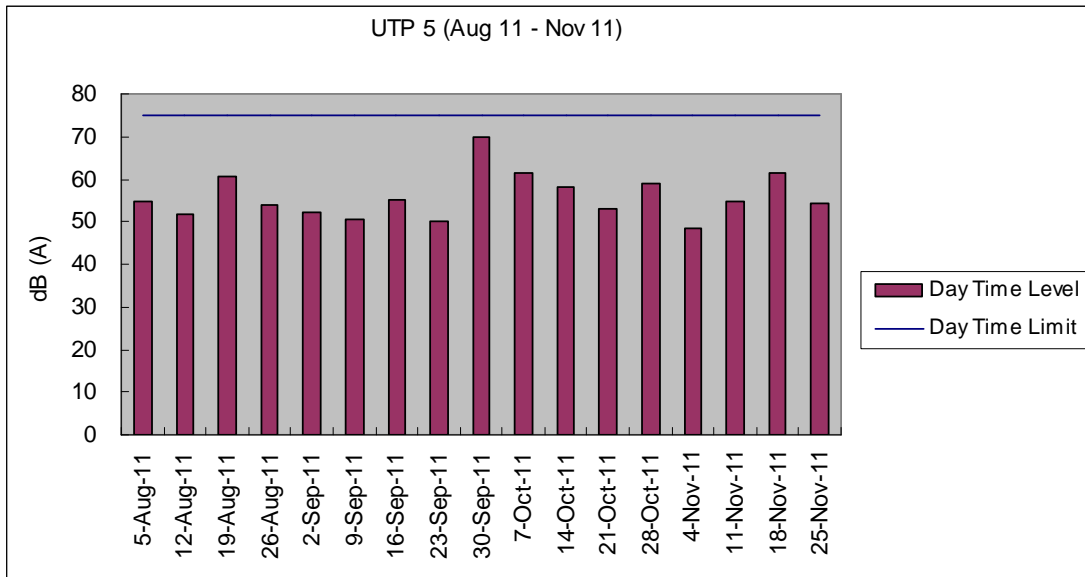
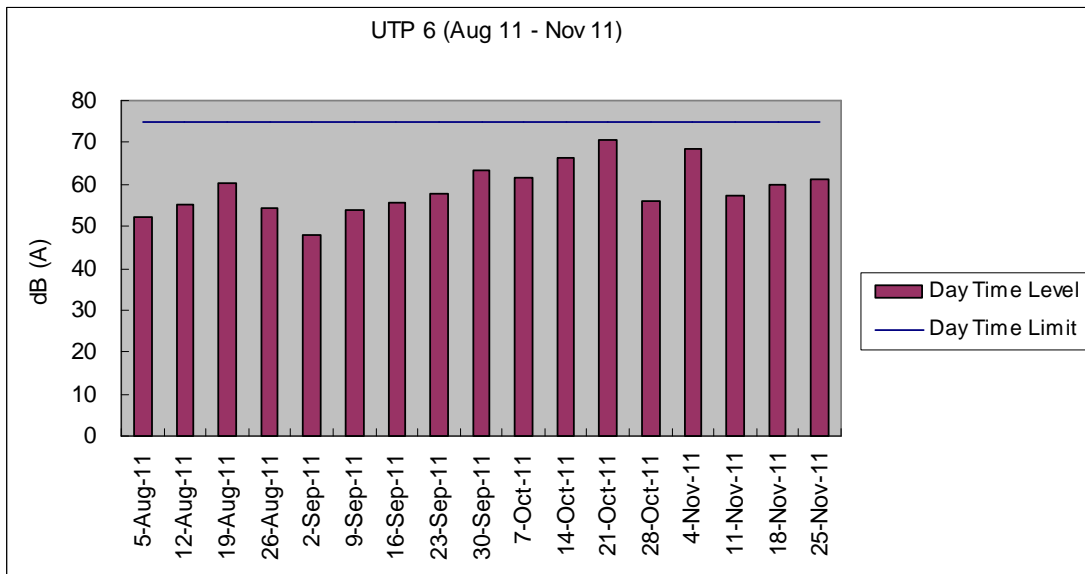
Graphical plot for noise measurements

The followings were the graphical plots for the 11 monitoring locations. Each plot showed the date of measurement taken, day time limit of 75 dB(A) as well as the measured daytime level for each location. The graphs contain the data recorded from August 2011 to November 2011.

Noise monitoring was carried out by the Environmental Team on weekly basis for this reporting month. The scheduled monitoring dates were 4th, 11th, 18th and 25th November 2011. Measured $L_{eq(30min)}$ results ranged from 45.5dB(A) to 68.4dB(A).

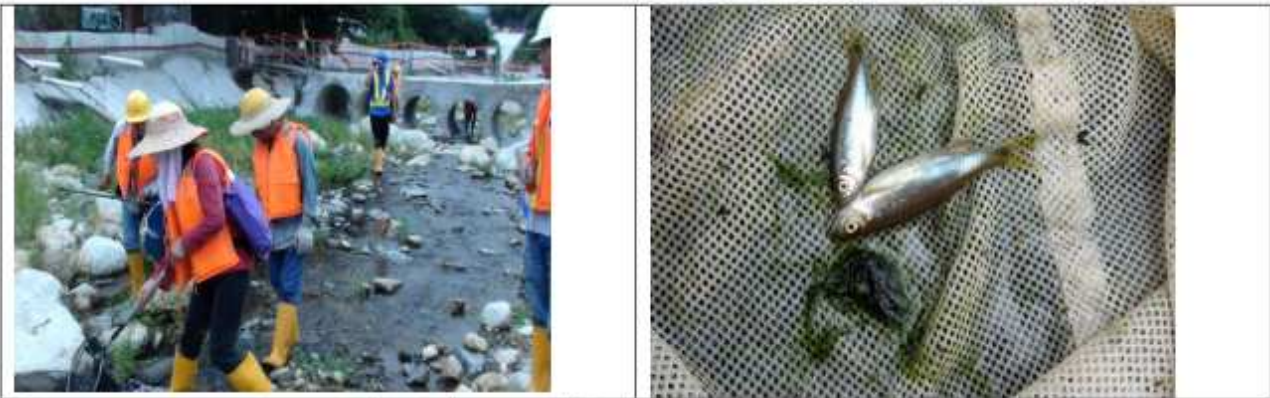
Capture survey at Upper Tai Po River on 1st September 11

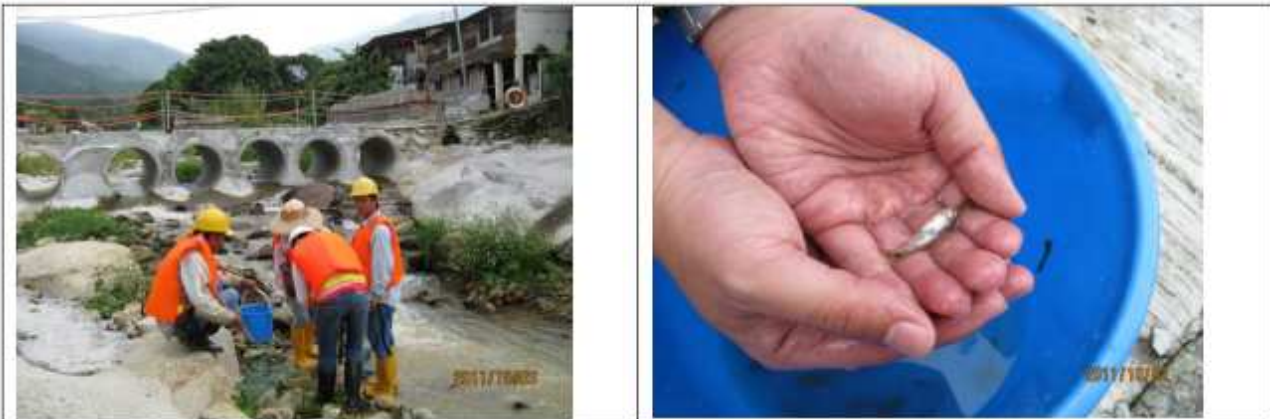
Capture survey at Upper Tai Po River on 3rd October 11
