Contract No. : DC/2007/06
River Improvement Works in Upper Lam Tsuen,
She Shan River and Upper Tai Po River

ENVIRONMENTAL MONITORING AND AUDIT

MONTHLY EM&A REPORT of

UPPER TAI PO RIVER

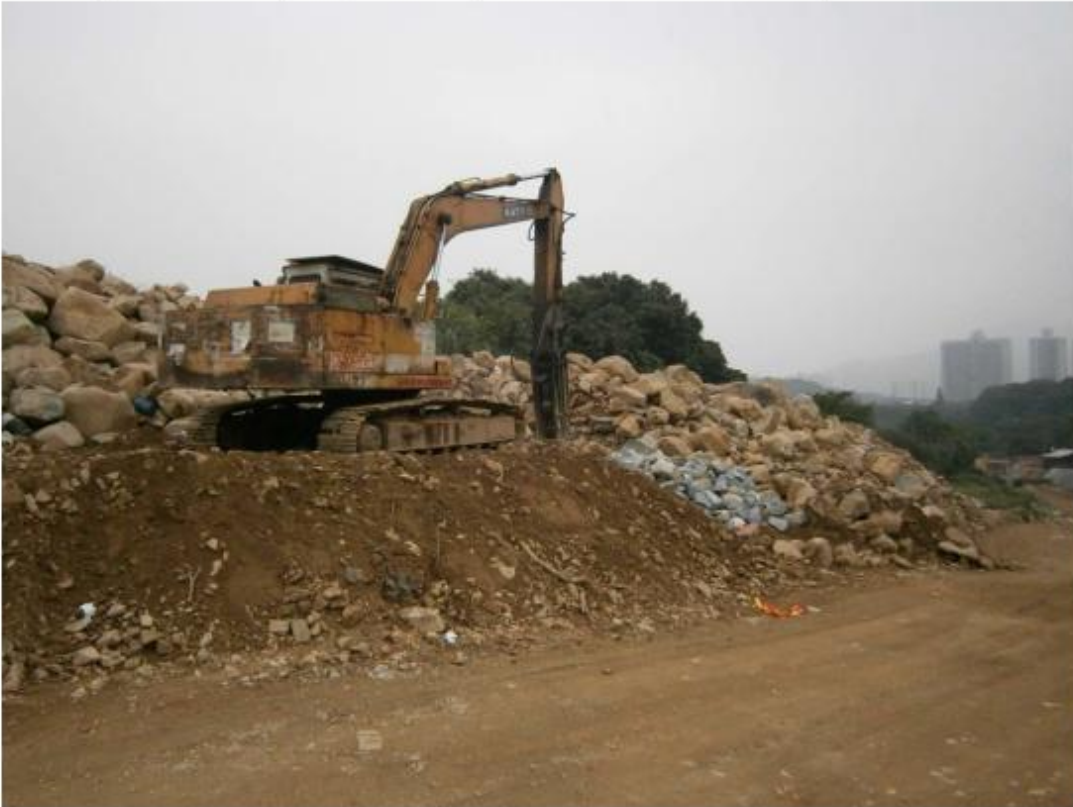
2. ET has conducted a site investigation on 8th February 2012 with representatives from RE, IEC and Contractor to resolve the concern.
3. Findings from the investigation showed the major noise and dust source was the rock breaking activities carried out at approximate ch.0 of UTPR. No mitigation measures on dust and noise impact (i.e. water spraying, warping up of breaker tip with sound insulation material) was observed (Fig 1).

Fig.1 – Rock Breaking activity without mitigation measure on dust and noise impact was observed.

4. To minimize dust and noise generation from the concerned activity, Contractor was recommended to further enhance mitigation measures immediately, which should at least include:

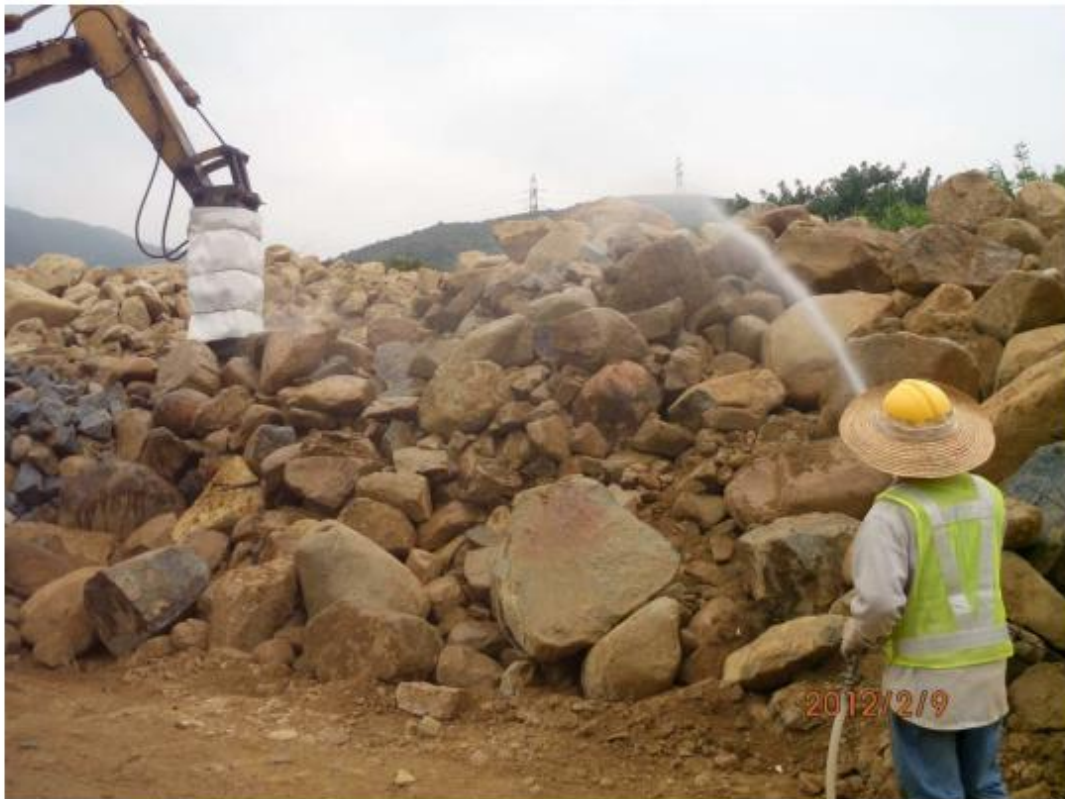
Fig. 2 – Water spraying was provided by frontline staff for dust suppression.

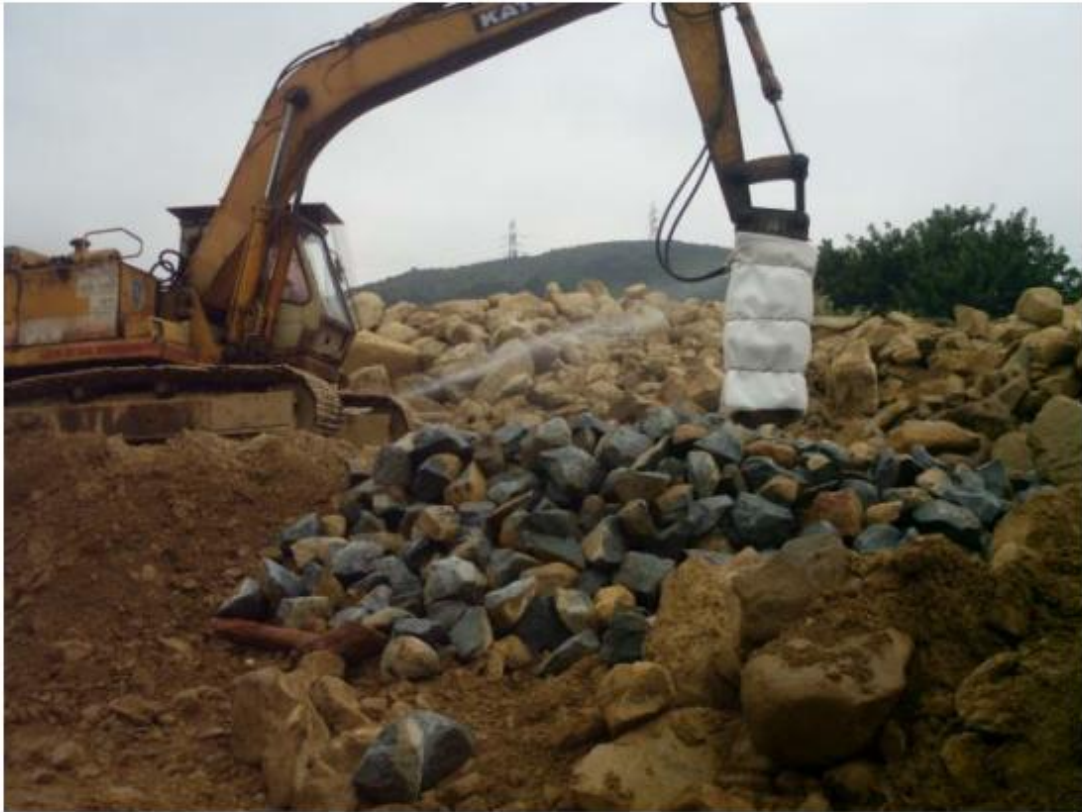
Fig.3 –The breaker tip was wrapped up with sound insulation material to minimize noise generation.

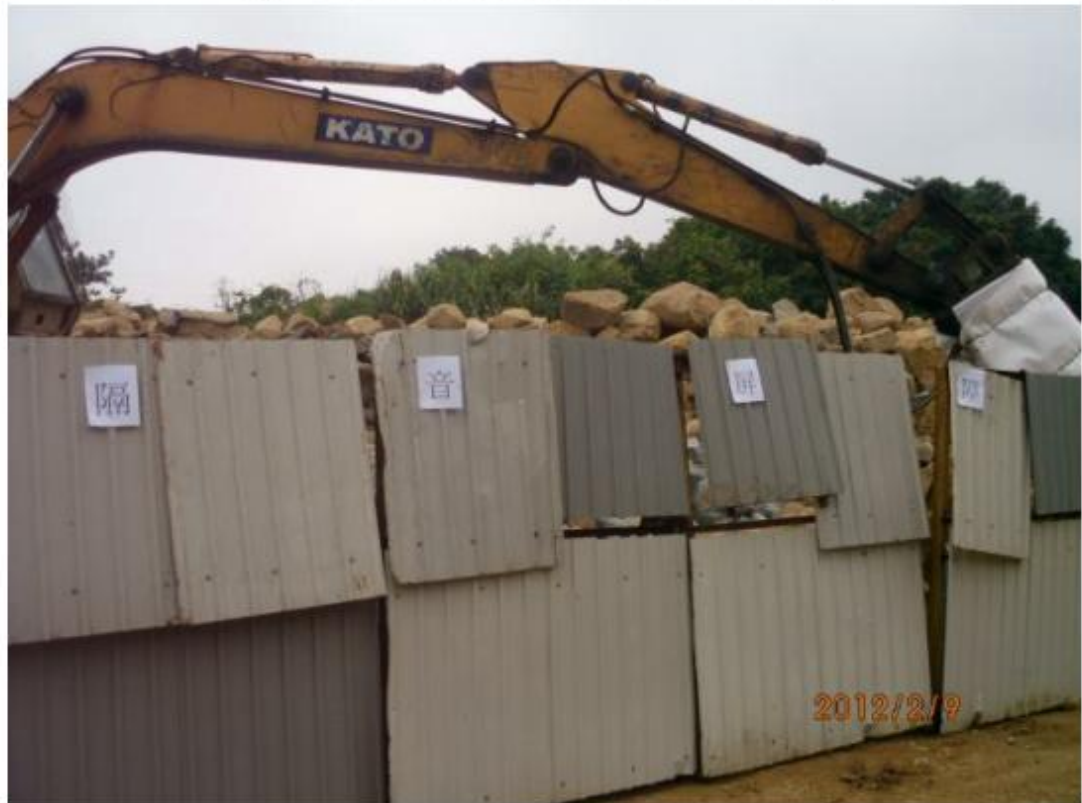
Fig.4 –Temporary noise barrier was erected for noise screening.
