**CONTRACT NO. DC/2007/06 –
RIVER IMPROVEMENT WORKS IN UPPER LAM
TSUEN RIVER, SHE SHAN RIVER AND UPPER TAI PO
RIVER**

**53RD MONTHLY ENVIRONMENTAL MONITORING AND
AUDIT REPORT FOR UPPER TAI PO RIVER –
JANUARY 2013**

PREPARED FOR
**CHIU HING CONSTRUCTION AND TRANSPORTATION
COMPANY LIMITED**

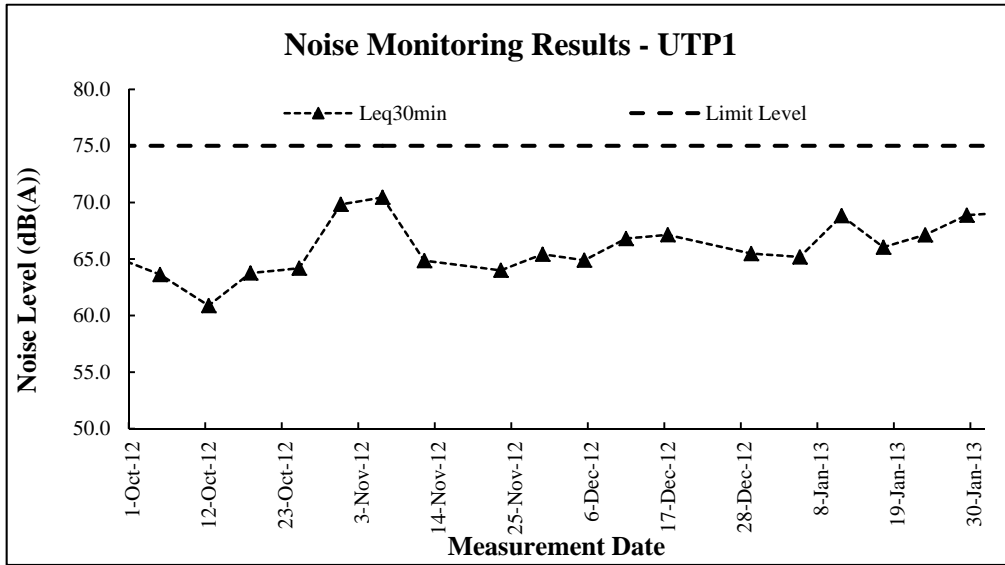
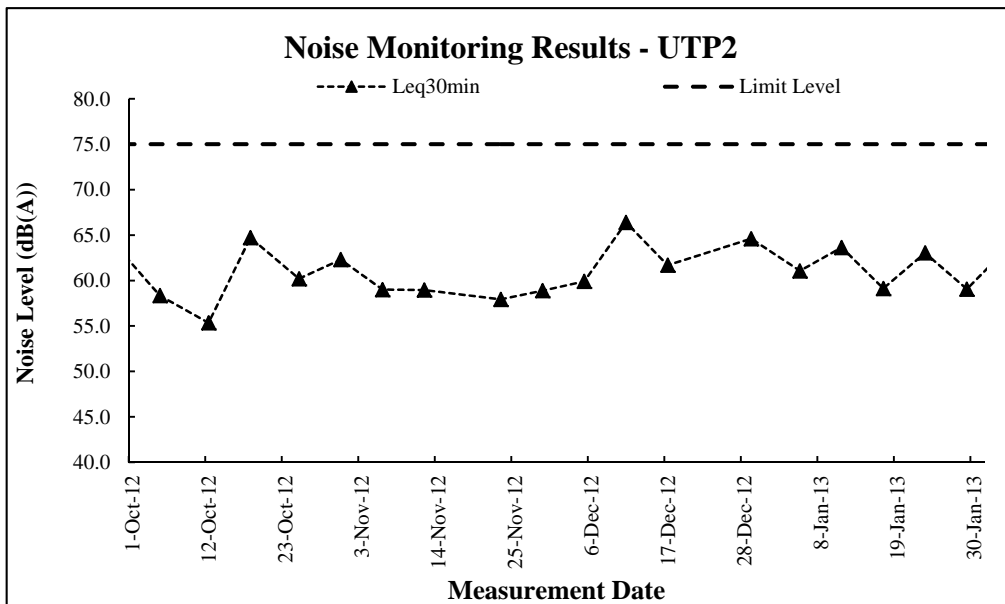
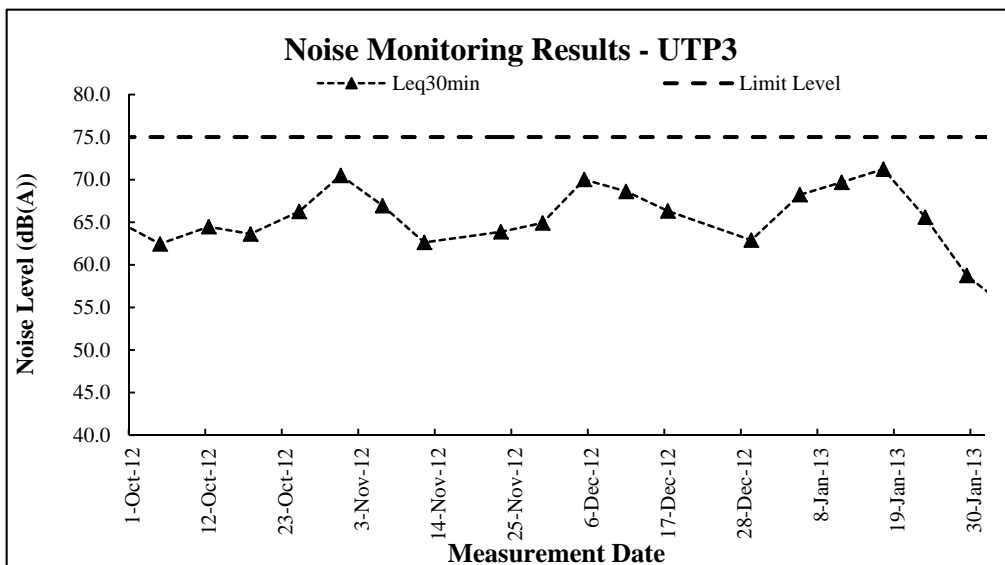
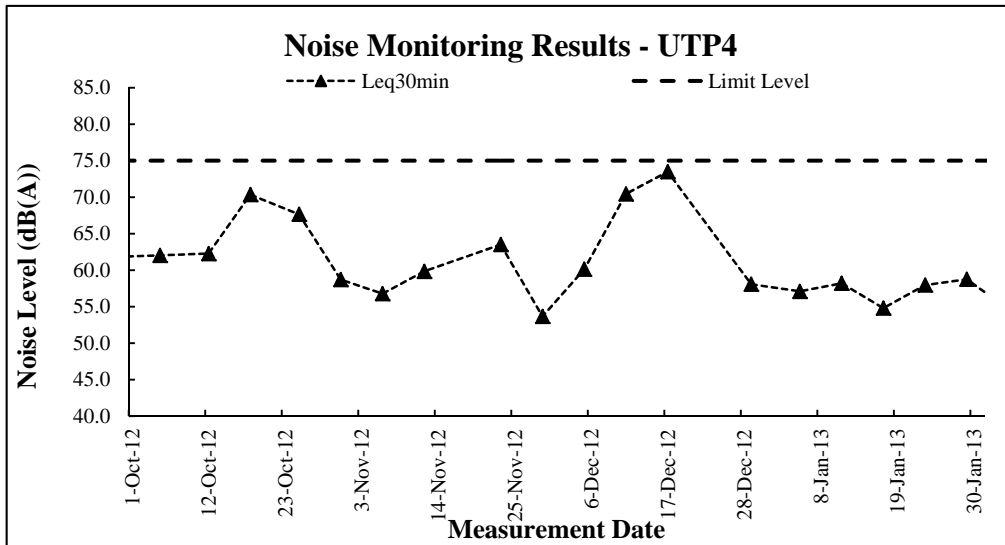
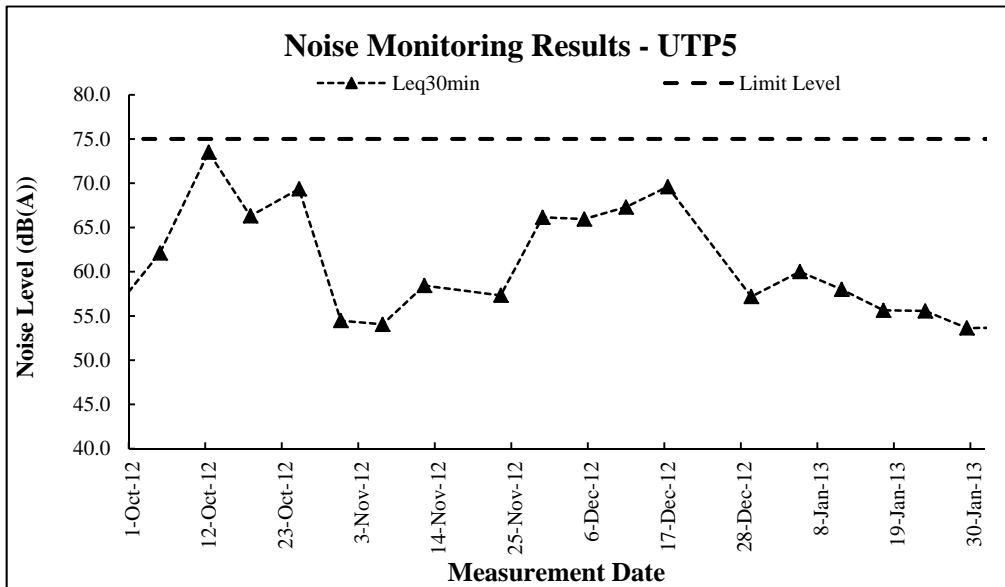
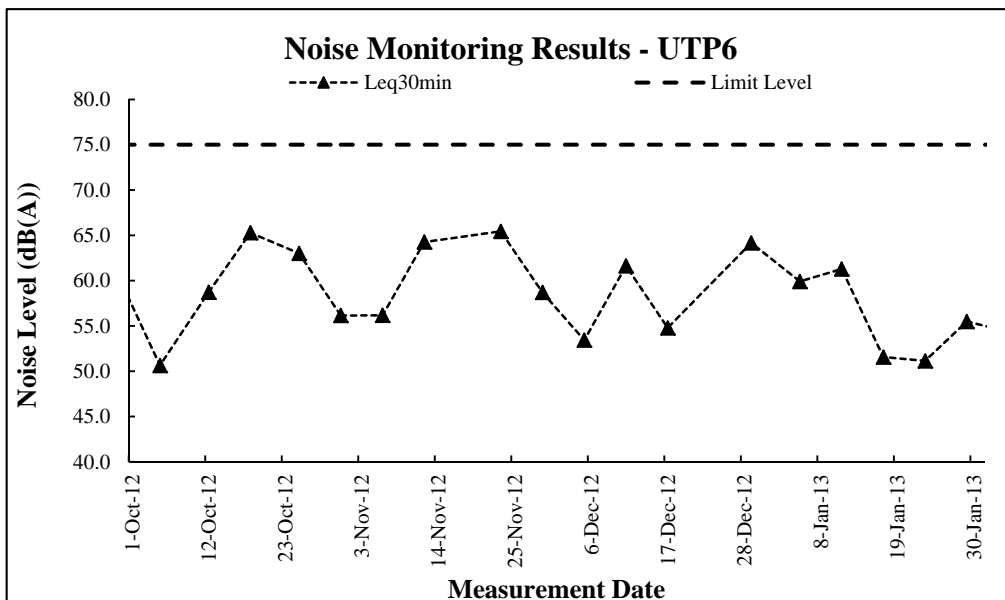
Graphical Plots of Noise Monitoring

4.02 In the Reporting Period, the noise monitoring results at the designated locations are presented in *Tables 4-1 to 4-11* and the graphical plot is shown in *Appendix H*. The observed noise sources during the course of noise monitoring are summarized in in *Appendix J*

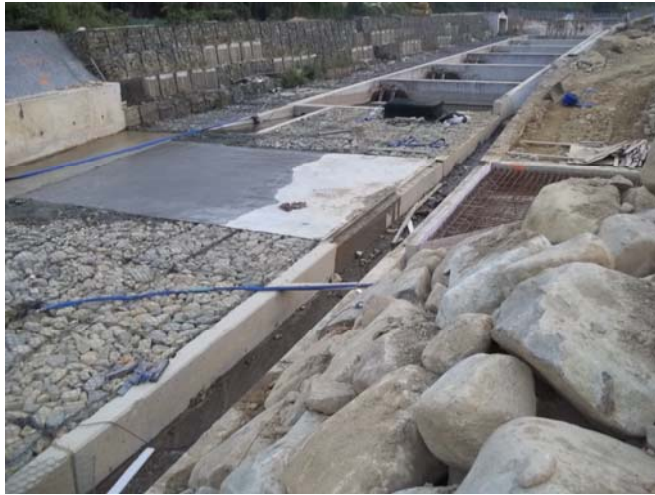
Photo 1: The loose soil at the exposed construction work area near area CH100 was removed and that exposed area has been became a concrete surface. No muddy water was observed at Spot 1 on 16 January.

Status	<ul style="list-style-type: none">- The corrective measures implemented by the Contractor has been examined and confirmed during jointed site inspection by the RE, Contractor, IEC and ET on 16 January. No more muddy water was observed and the performance of water quality at Upper Tai Po River is considered as satisfactory.

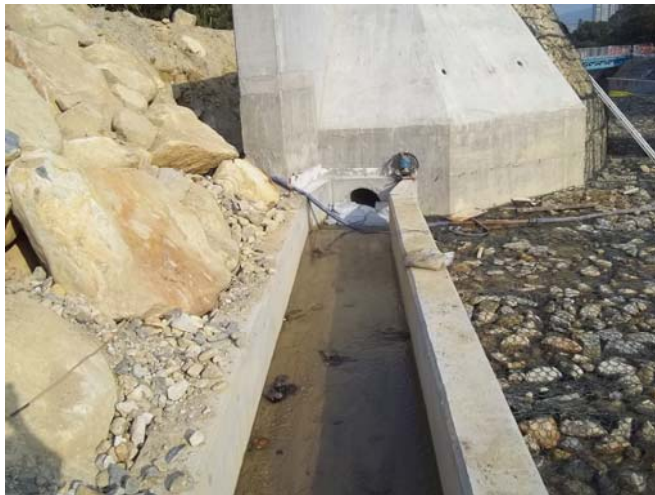
Photo 2: Sand bags were placed near inlet of dry weather channel at area CH100 to prevent muddy water flowing into the downstream of UTPR.

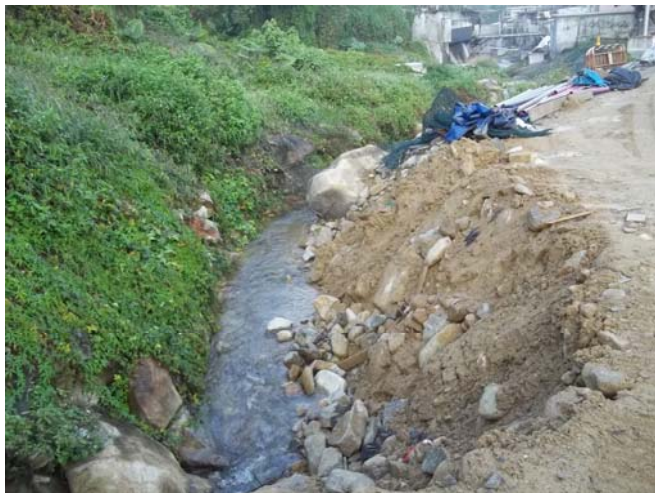
Photo 3: No muddy water was observed at Spot 1 on 16 January.

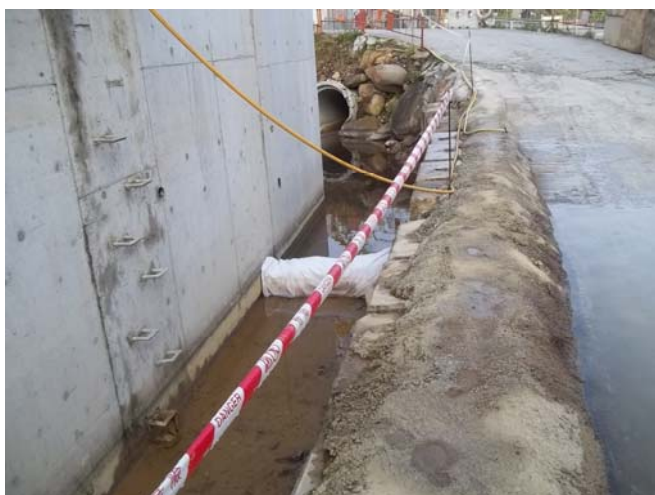
Photo 4: At spot 2 near CH550, earth bund has been constructed in order increase the sedimentation time of river water. No muddy water was observed at Spot 2 on 16 January.

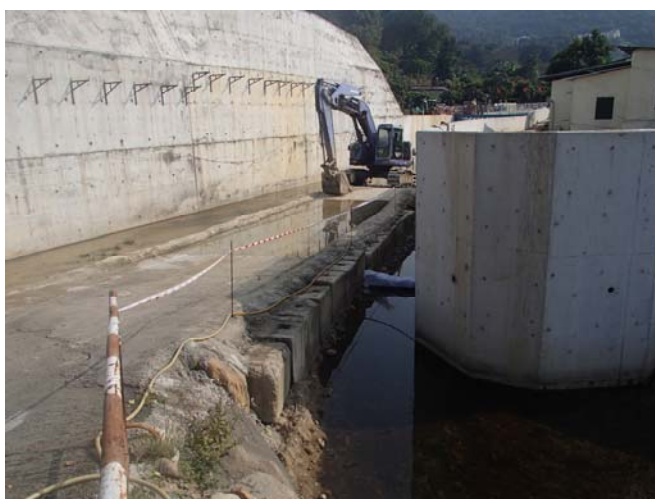
Photo 5: At another side of spot 2 near CH550, no excavation work and muddy water was observed on 16 January. The Contractor is reminded to implement proper mitigation measures if work needs to be carried out.
