**DELIVERY OF RECLAMATION MATERIAL
TO MAINLAND –
ENVIRONMENTAL MONITORING AND AUDIT
(CONTRACT NO.: CV/2005/01)**

TSEUNG KWAN O AREA 137 FILL BANK

MONTHLY EM&A REPORT

(SEPTEMBER 2009)

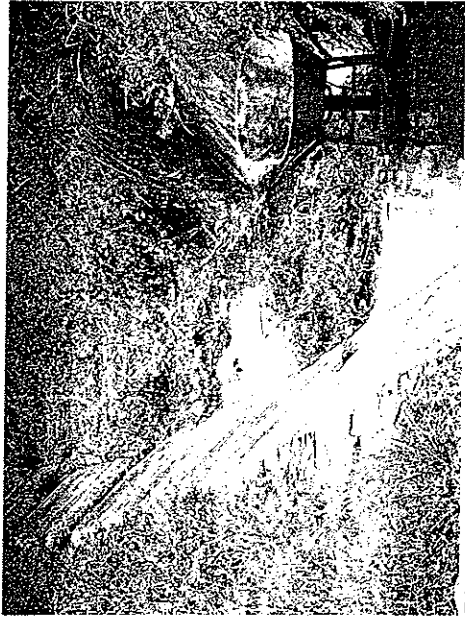
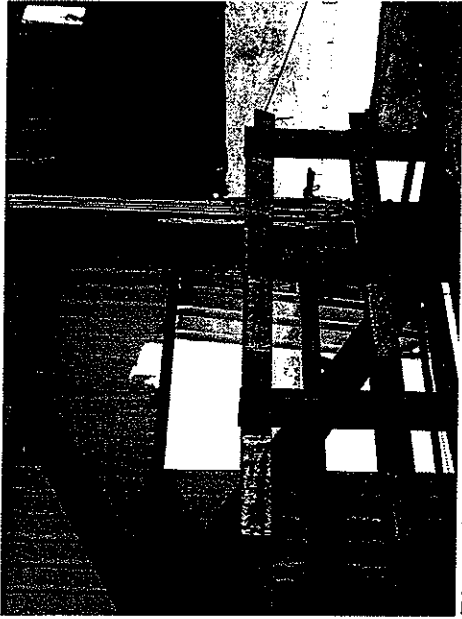
- Tipping halls No.2 and 3 were found damaged during the weekly site inspection on 17 September 2009. The Contractor was reminded to repair the damaged part of tipping halls properly. During the subsequent weekly site inspection on 23 September 2009, the damaged parts of tipping halls were repaired;

- Mud and debris were noted accumulated inside the main drainage channel at water truck filling station during the weekly site inspections on 11 and 17 September 2009. The Contractor was reminded to clean up the accumulated mud and debris properly. During the next weekly site inspection on 23 September 2009, the mud and debris accumulated inside the main drainage channel were cleaned up;

- Silt curtain at BHA was found damaged during the weekly site inspection on 17 September 2009. The Contractor was reminded to repair the damaged silt curtain immediately. During the next weekly site inspection on 23 August 2009, the damaged silt curtain was repaired; and
