CONTRACT NO. CV/2009/02

HANDLING OF SURPLUS PUBLIC FILL

TSEUNG KWAN O AREA 137 FILL BANK

MONTHLY EM&A REPORT NO.5

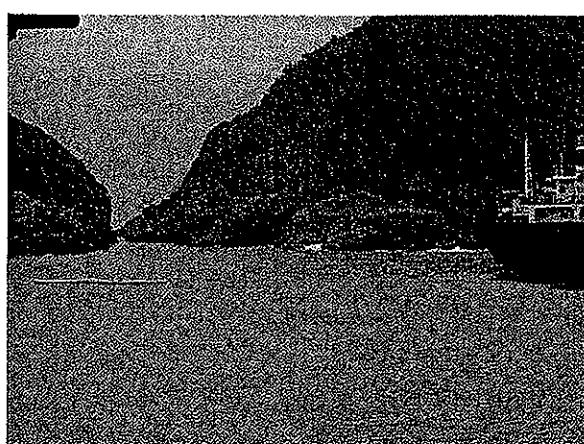
**Photo 4****Silt curtain**

Silt curtain located at site office side was disconnected.

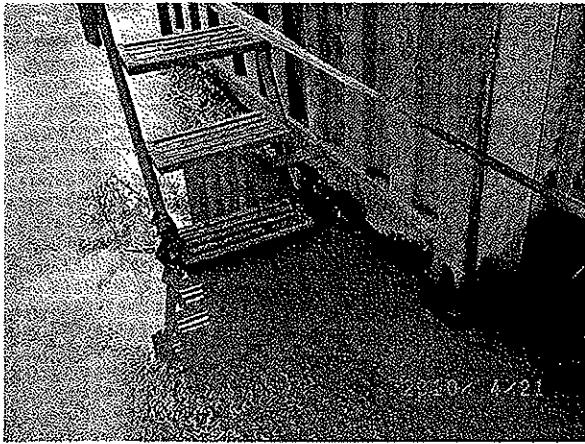
**Photo 1 and 2****Container at Workshop**

Stagnant water were observed surrounding the Container(s) at Workshop area.

The Contractor should clear the stagnant water at Workshop area and maintain the channel free from debris to avoid mosquito breeding.

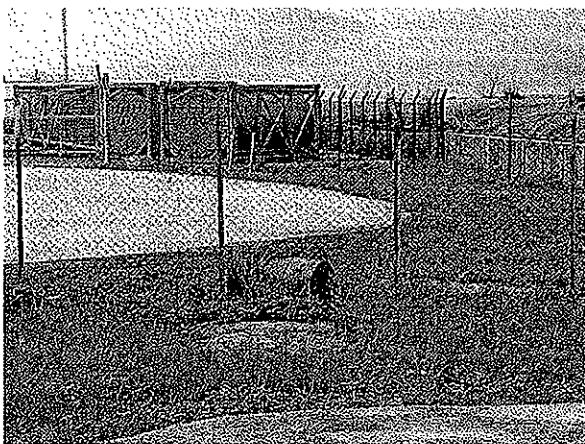
**Photo 3****Carpark Area**

Oil drum was discarded at open area.

The Contractor was reminded to collect the oil drum and ensure no oil spillage to surrounding.

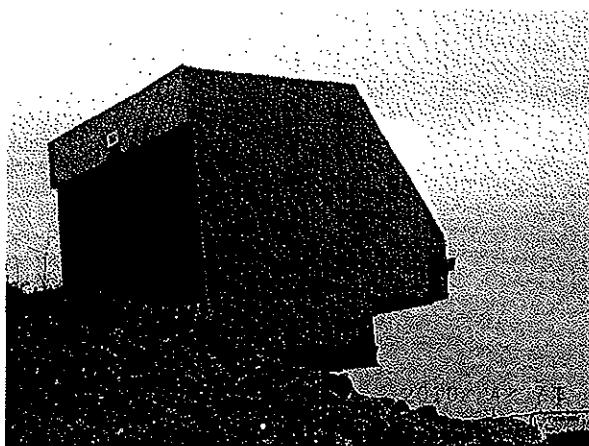
Photo 5 and 6

Pier No. 2

- Steel enclosure of Tipping Hall No.2 was found damaged during the weekly site inspections on 07, 14, 21 and 28 April 2010. The Contractor was reminded to repair and maintain the tipping hall properly. Since the finding was still observed at the last weekly site inspection in this reporting month, it will be verified in the coming month;
