**TEST REPORT**

**HANDLING OF SURPLUS PUBLIC FILL**

**TSEUNG KWAN O AREA 137 FILL BANK**

**MONTHLY EM&A REPORT NO.6**

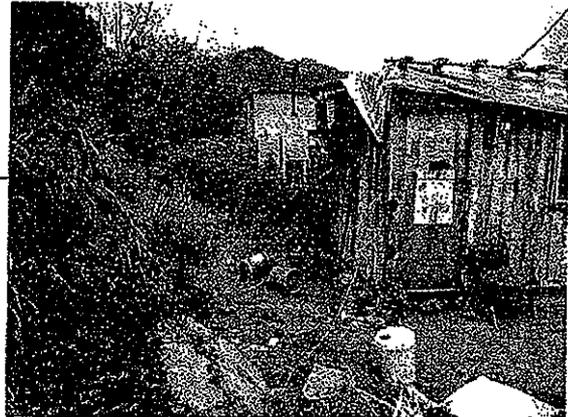
Photo 2

Workshop (E&M)

Emptied oil drums were discarded on ground.

Proper collection and storage of the emptied oil drum is recommended.

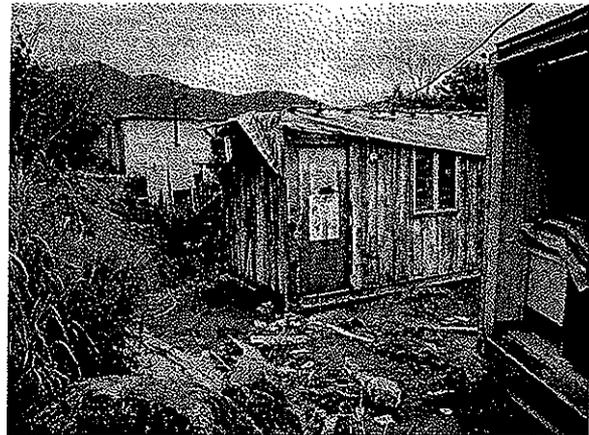
Photo 2

Workshop (E&M)

Oil drums were collected and placed at the designated area. **(Closed)**

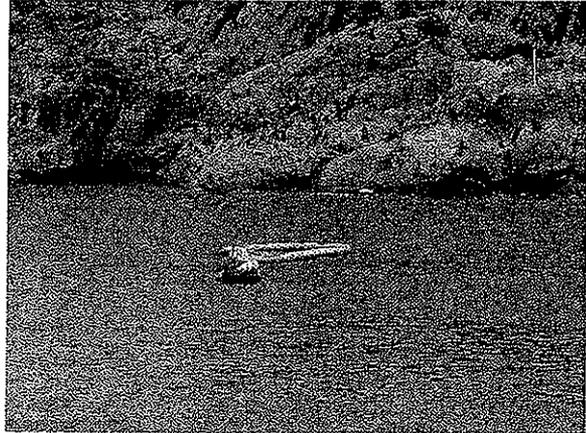
Photo 5

- The right-hand side of silt curtain at BHA (near the Contractor's site office) was found loosed during several weekly site inspections in this reporting month. The Contractor was reminded to fix and maintain the silt curtain properly. Since the finding was still observed at the last weekly site inspection on 26 May 2010, it will be verified in the coming month;

Silt Curtain
