TEST REPORT

HANDLING OF SURPLUS PUBLIC FILL

TSEUNG KWAN O AREA 137 FILL BANK

MONTHLY EM&A REPORT NO.7

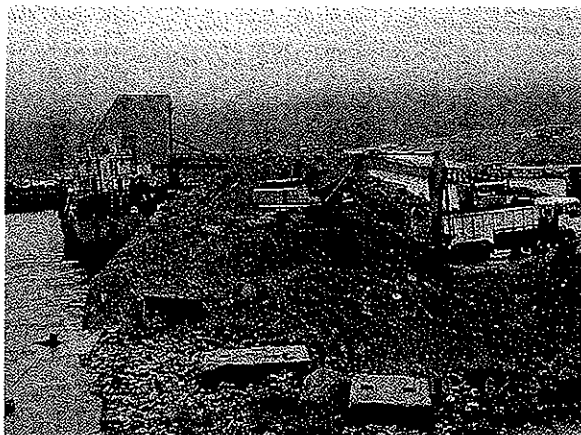
Photo 1

At unloading area

Excessive amount of fill material was still observed at the pier edge at unloading area.

The Contractor was reminded to unload the fill material away from the pier edge in order to prevent the material falling into the sea.

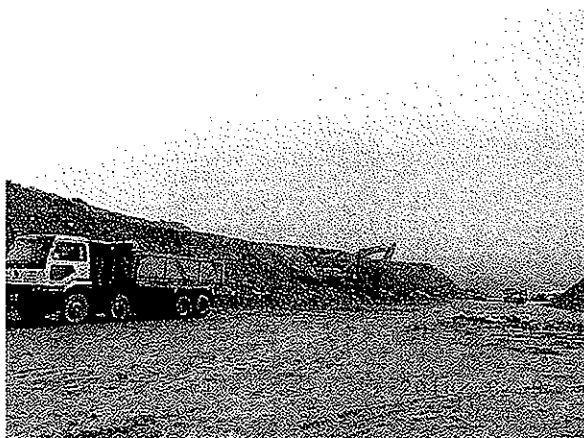
Photo 3 and 4

No new environmental deficiency was identified.

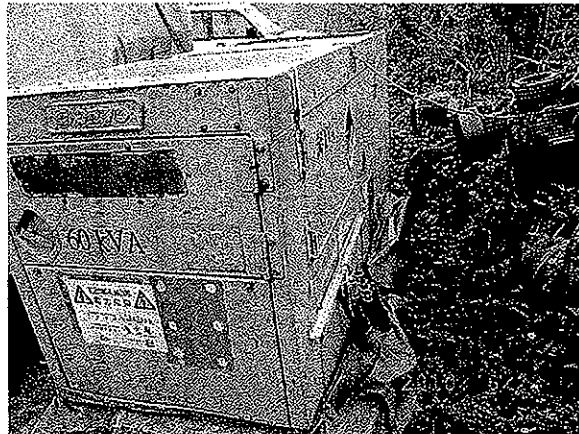
Photo 3

Parking Area

Skirt curtain of the generator was found damaged. The Contractor was reminded to replace the skirt curtain.

- The skirt curtain for a generator at car parking area was found damaged during the weekly site inspection on 23 June 2010. The Contractor was reminded to replace a new skirt curtain for the generator. Since the finding was still observed at the last weekly site inspection on 30 June 2010, it will be verified in the coming month; and
- Sufficient rubbish skips had been provided at site by the Contractor and the site area was found tidy and clean.
