CONTRACT NO. CV/2009/02

HANDLING OF SURPLUS PUBLIC FILL

TSEUNG KWAN O AREA 137 FILL BANK

MONTHLY EM&A REPORT NO.8

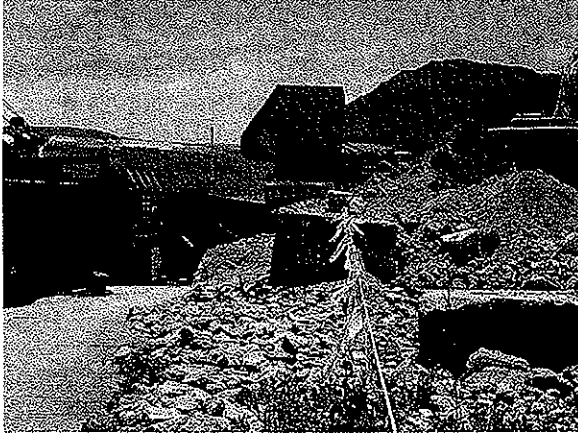
Photo 1

Unloading area

Fill material had been moved away from the pier edge. (Closed)

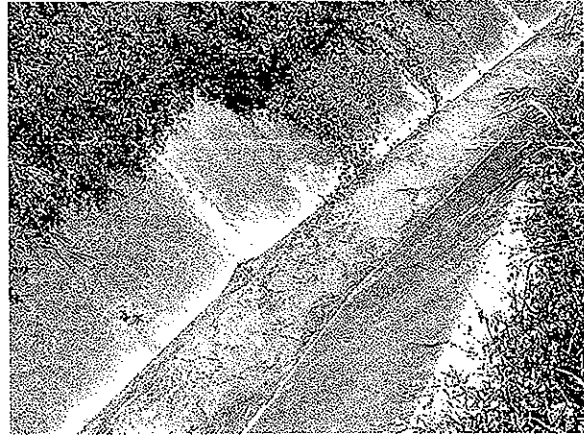
Photo 6

Nullah

Algae were accumulated at the Nullah.

The Contractor was recommended to clean up the algae and well maintain the drainage system at site.

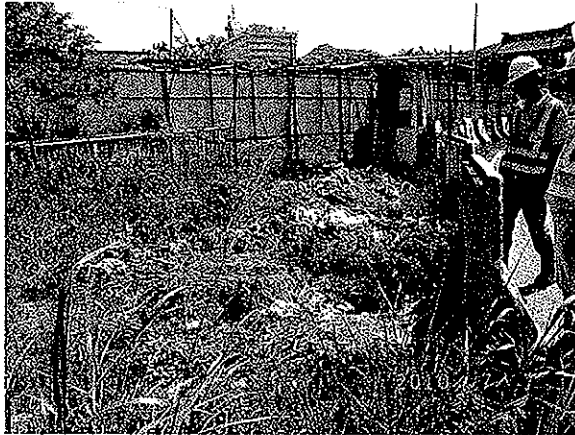
Photo 1

Next to the Guard House

C&D wastes were found stockpile next to the guard house.

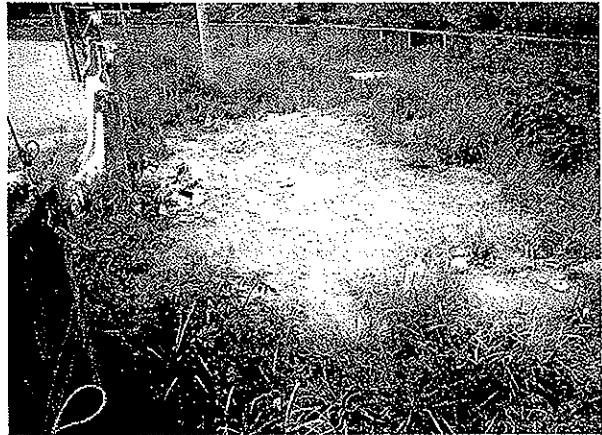
Photo 2

Next to the Guard House

The stockpiled C&D wastes had been removed. (Closed)
