TEST REPORT

CONTRACT NO. CV/2009/02

TSEUNG KWAN O AREA 137 FILL BANK

MONTHLY EM&A REPORT NO.10

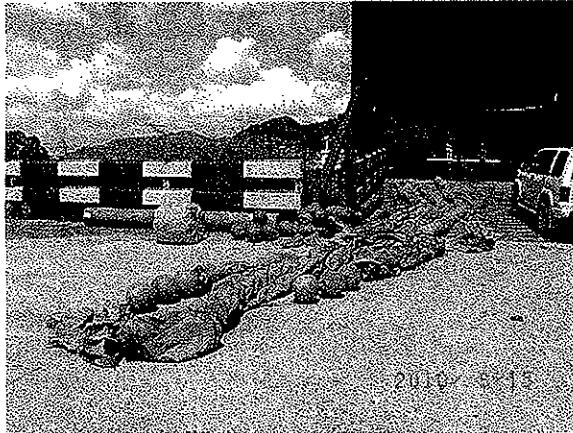
Photo 1 and 2

Silt Curtain (previous item)

Replacement/ repairing of silt curtain were observed in progress.

The Contractor was reminded to reinstate the silt curtain at both sides as soon as possible.

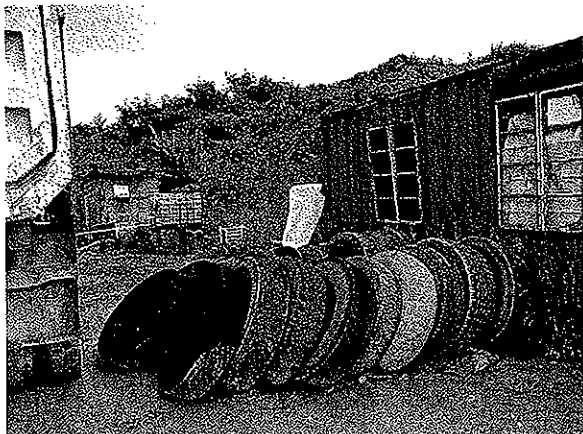
Photo 5 and 6

- Stagnant water was observed inside the abandon tyres placed at car parking area during the weekly site inspection on 22 September 2010. The Contractor was reminded to drain the stagnant water and cover / store the tyres properly in order to avoid water accumulation and mosquito breeding. During the weekly site inspection on 28 September 2010, no tyres were found in car parking area.

Carpark Area

Stagnant water was found at the wasted tyres.

The Contractor should remove the wasted tyres to avoid stagnant water and mosquito breeding.

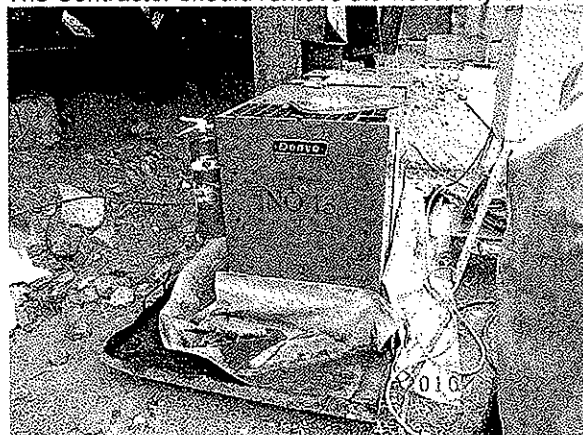
Photo 7

Area A4

Water was observed inside the drip tray and skirt curtain was not properly covered the drip tray.

Skirt curtain should be fixed properly and a suitable size of drip tray should be provided for generator.
