China Harbour – China State Joint Venture

CONTRACT NO. CV/2009/02

HANDLING OF SURPLUS PUBLIC FILL

MONTHLY EM&A REPORT NO.12

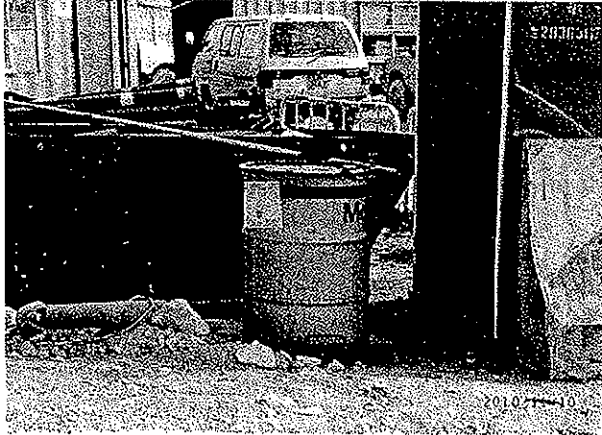
Photo 7

Area A4 near Crushing Plant

Oil tank was stored at open area.

The Contractor should place the oil tank in the Chemical Storage Area.

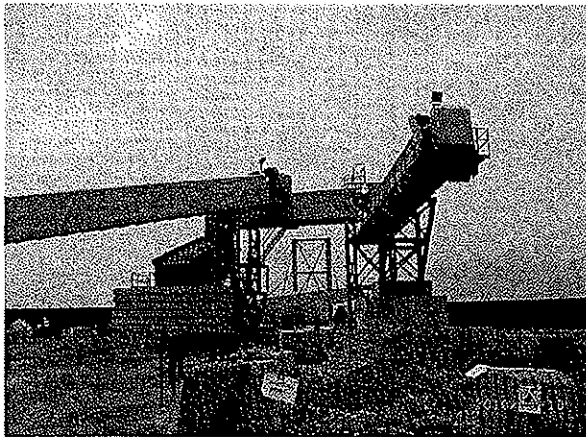
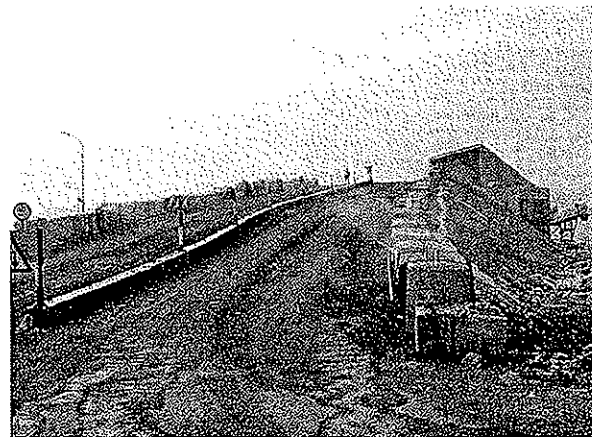
Photo 12 and 13

The situation was improved and the water sprinklers system was installed at site. **(Closed)**

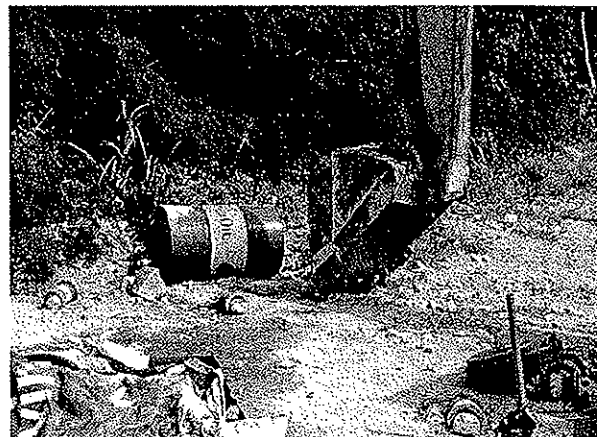
Photo 8

Oil leakage from the generator was observed.

Plant Repairing Area

The Contractor was reminded to inspect the generator immediately and to rectify the leakage situation in order to prevent further contamination happened.

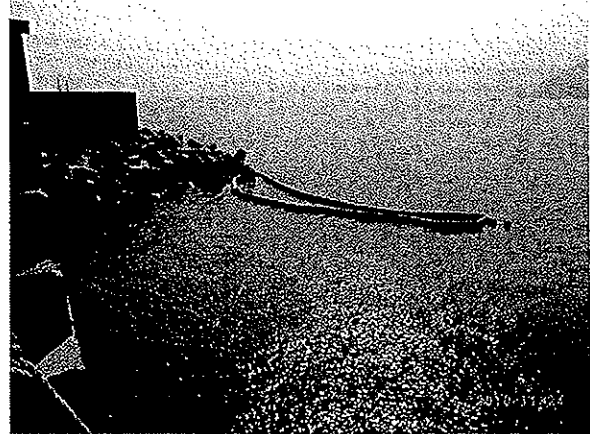
Photo 10

Silt Curtain

Silt curtain near Pier No.1 was found loosed.

The Contractor was reminded to fix the silt curtain properly.

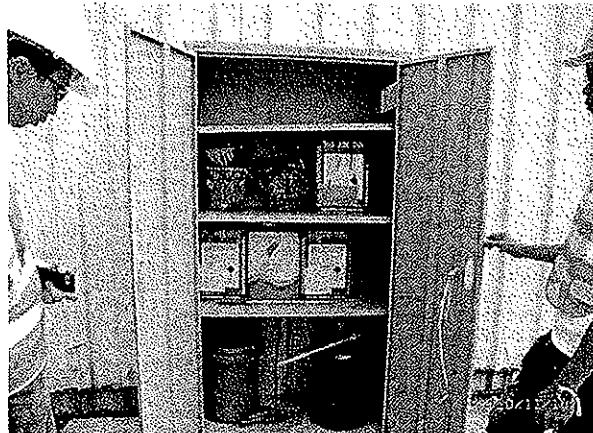
Photo 14

The chemical waste storage cupboard should be provided with drip tray in order to avoid leakage or spillage.

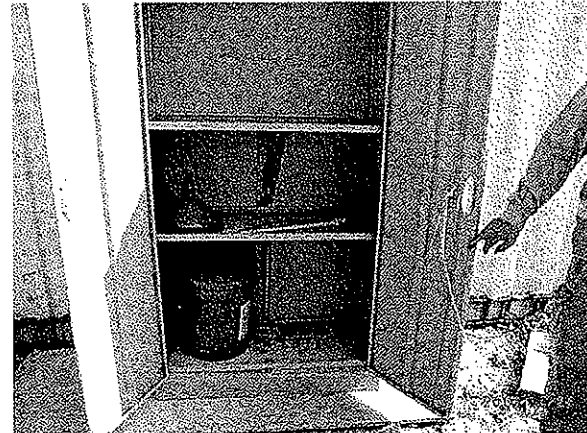
Photo 15

Drip tray had been provided for the chemical waste storage cupboard. **(Closed)**

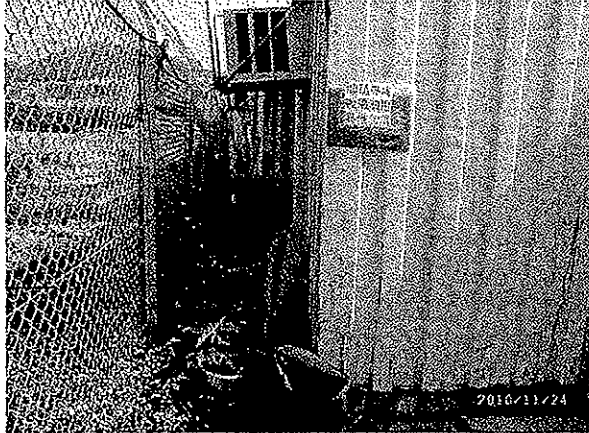
Photo 16

The Contractor was reminded to clear the waste material behind the site office in order to maintain good housekeeping at site.
