TEST REPORT

CONTRACT NO. CV/2009/02

HANDLING OF SURPLUS PUBLIC FILL

MONTHLY EM&A REPORT NO.13

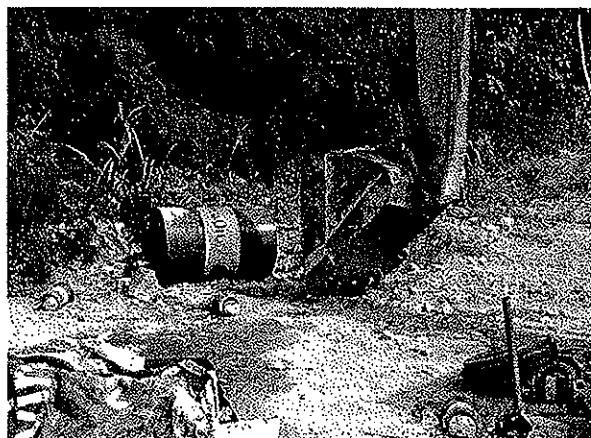
Photo 3

Plant Repairing Area

Oil stain was observed around the drip tray and oil tank was discarded at the side.

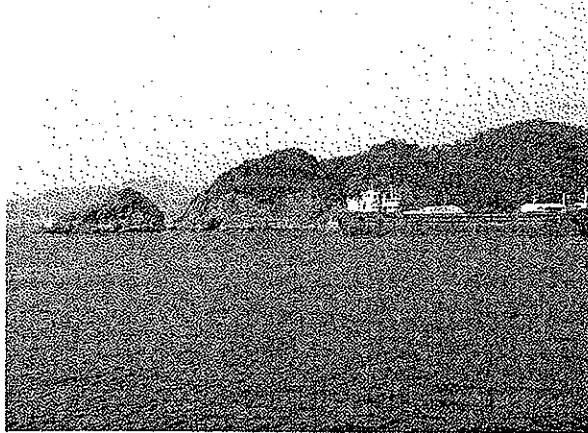
Photo 5

Silt Curtain

The Contractor was reminded to re-install the silt curtain as soon as possible.

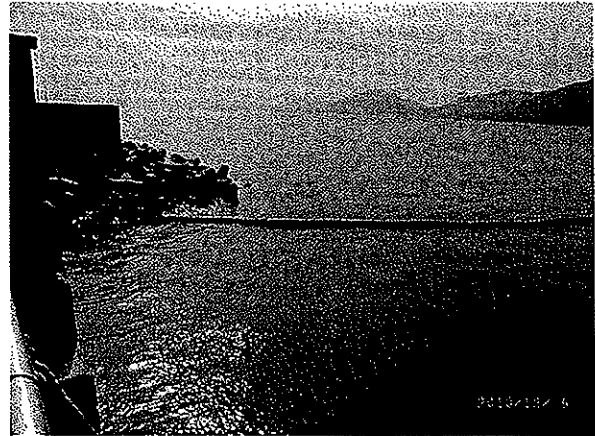
Photo 10

Silt curtain near Pier No.1 was found loosed.

Silt Curtain

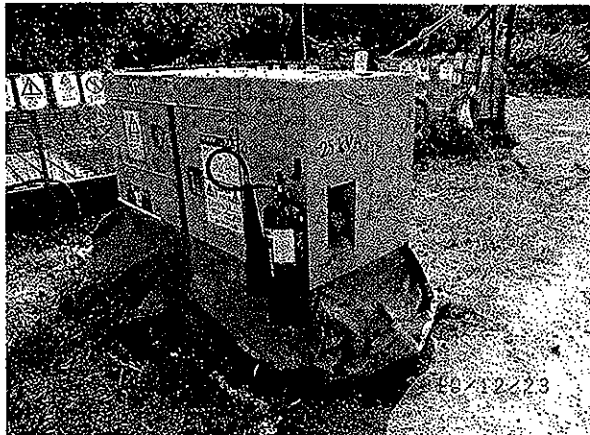
Photo 7

Water Filling Station No. 2

Oil was seeped from the drip tray.

- Leaked oil was noted inside the drip tray of an generator at water truck filling station No.2 during the weekly site inspection on 23 December 2010. The Contractor was reminded to clean up and treat the leaked oil and contaminated sand as chemical waste, and also maintain the drip tray properly to prevent oil leakage. During the subsequent weekly site inspection on 29 December 2010, all leaked oil inside the drip tray was cleared; and

The Contractor should replace the drip tray as soon as possible and clean up the contaminated soil as chemical waste.
