TEST REPORT

CONTRACT NO. CV/2009/02

HANDLING OF SURPLUS PUBLIC FILL

MONTHLY EM&A REPORT NO.15

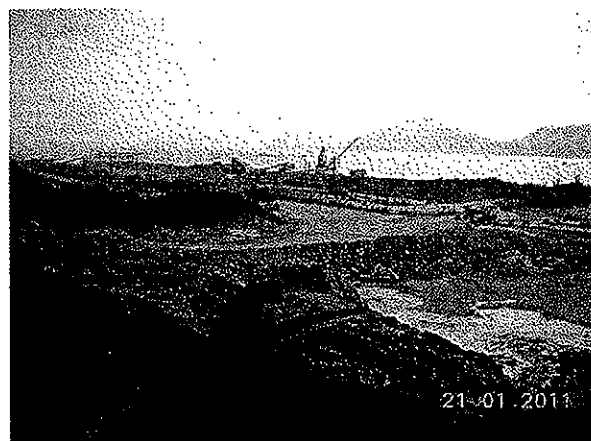
Silt Curtain

No silt curtain was installed. **(Follow up)**

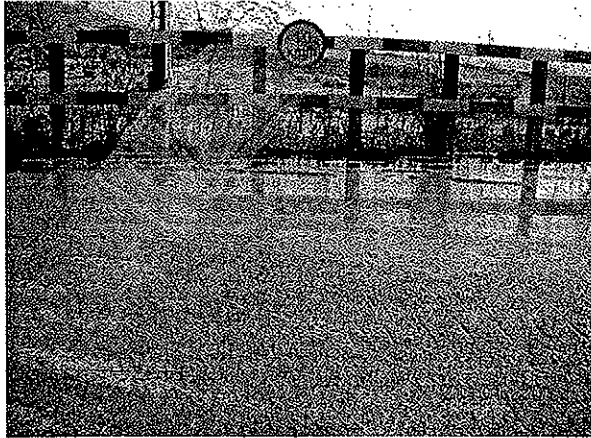
Photo 5

Tipping Hall No.2

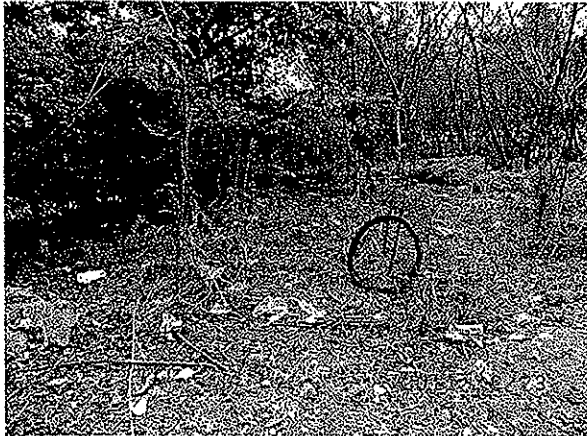
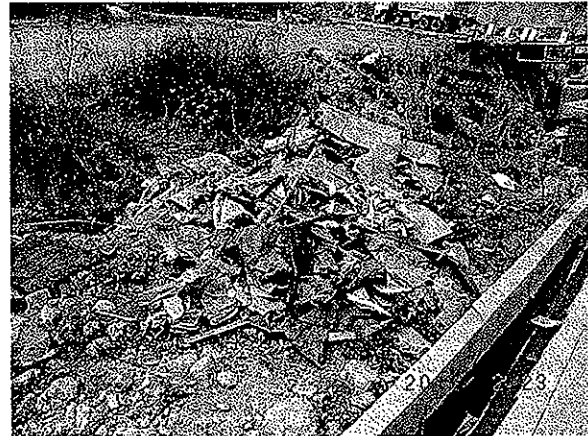
Photo 7 and 8

Debris were found at various locations such as Portion A and near CREO.

The Contractor should improve housekeeping and dispose of the debris properly.

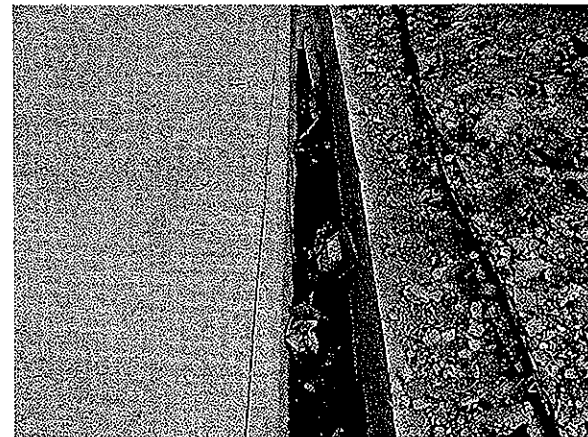
Photo 9 and 10

Portion A and near CREO

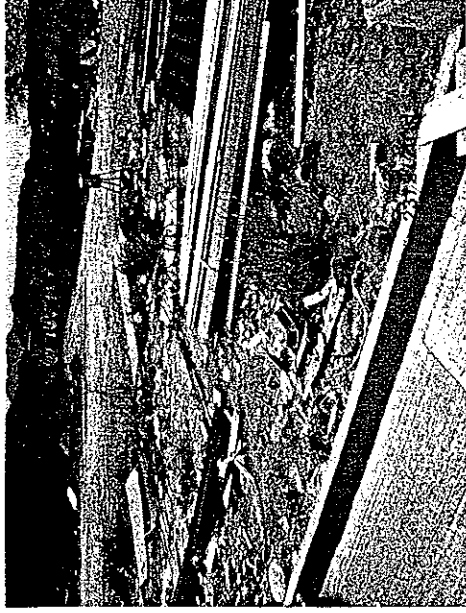
Photo 110223_009 (near drainage channel at new weighbridge)

- C&D waste was noted discarded near the drainage channel at new weighbridge during the weekly site inspection on 23 February 2011. The Contractor was reminded to collect and dispose of the rubbish properly. Since the finding was still observed during the last weekly site inspection on 28 February 2011, it will be verified in the coming month; and
