CONTRACT NO. CV/2009/02

HANDLING OF SURPLUS PUBLIC FILL

TSEUNG KWAN O AREA 137 FILL BANK

MONTHLY EM&A REPORT NO.16

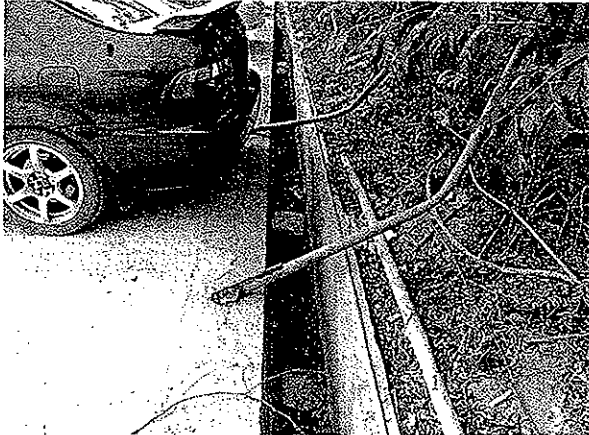
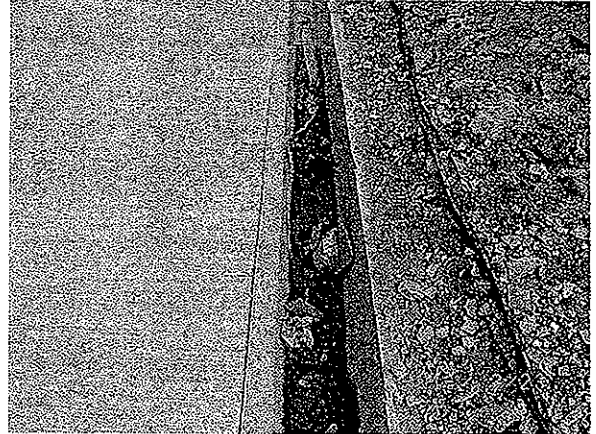
Photo 5 and 6

Debris had been removed and disposed of properly. (Closed)

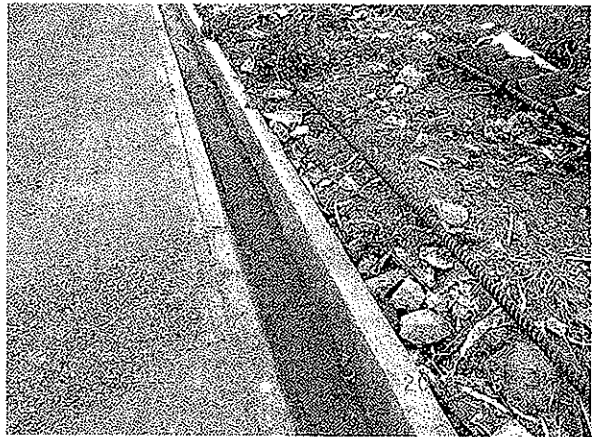
Photo 7 and 8

Debris and leaves were found inside the u-channel.

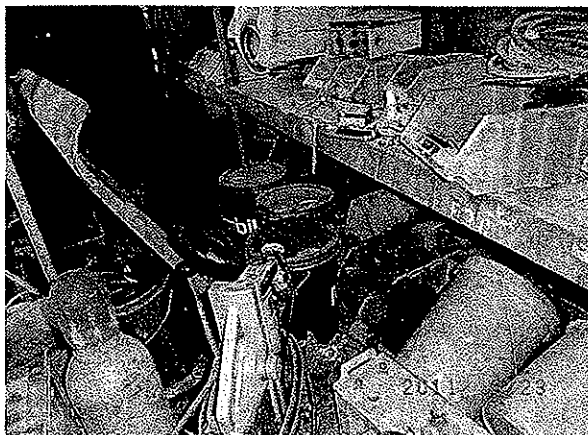
Photo 5 and 6

Improper handling of chemical/ chemical wastes were observed at Workshop

The Contractor was reminded to provide proper handling of chemical/ chemical wastes at Workshop.

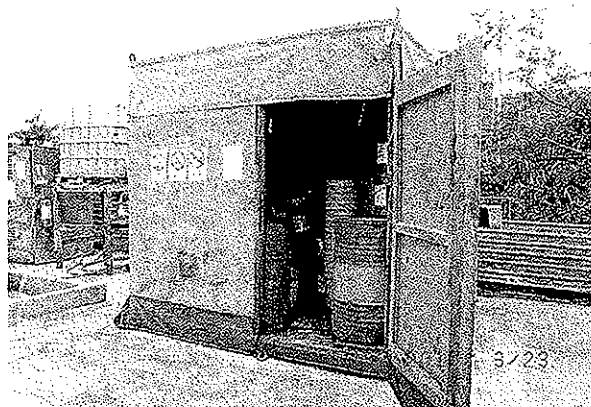
Photo 7

Chemical Waste Storage AreaAccumulation of chemical wastes should be avoided.
The Contractor should dispose of chemical wastes regularly.

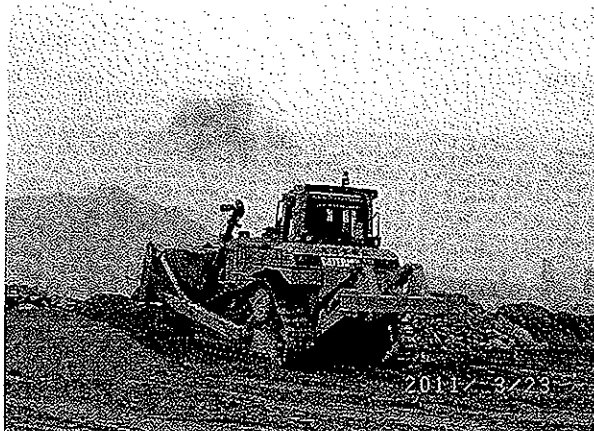
Photo 9

- The enclosure of tipping halls were maintained properly in this reporting month;
- Black smoke emission was observed from a bulldozer at dry public fill dumping zone at A4 during the weekly site inspections on 23 March 2011. The Contractor was reminded to stop to use the defect machine until repaired properly and also reminded to maintain all PME regularly and properly in order to avoid black smoke emission. During the last weekly site inspection on 30 March 2011, no black smoke was noted emitted from the bulldozer at A4;

Black smoke emission was observed from the bulldozer.

The Contractor should carry out inspection and maintenance for the bulldozer.

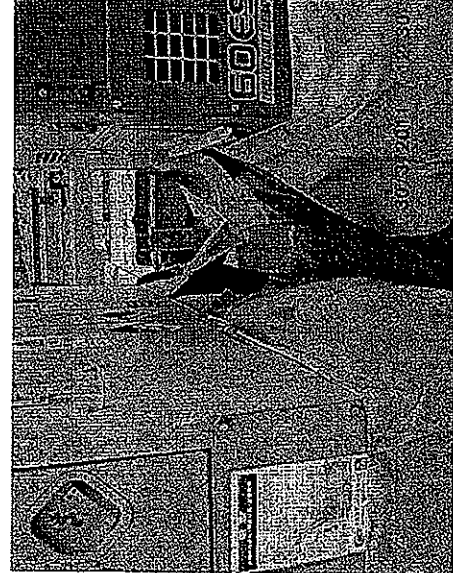
Photo 110330_011 (Generator at weighbridge near Pier No.1)

- Skirt curtain for a generator at weighbridge near Pier No.1 was found damaged during the weekly site inspection on 30 March 2011. The Contractor was reminded to replace the damaged skirt curtain. Since the finding was observed during the last weekly site inspection, it will be verified in the coming month.
