CONTRACT NO. CV/2009/02

HANDLING OF SURPLUS PUBLIC FILL

TSEUNG KWAN O AREA 137 FILL BANK

MONTHLY EM&A REPORT NO.17

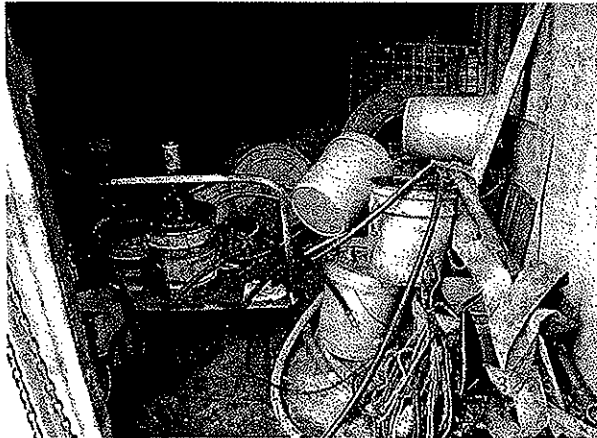
Photo 1

Workshop

Improper handling of chemical/ chemical wastes was observed at Workshop.

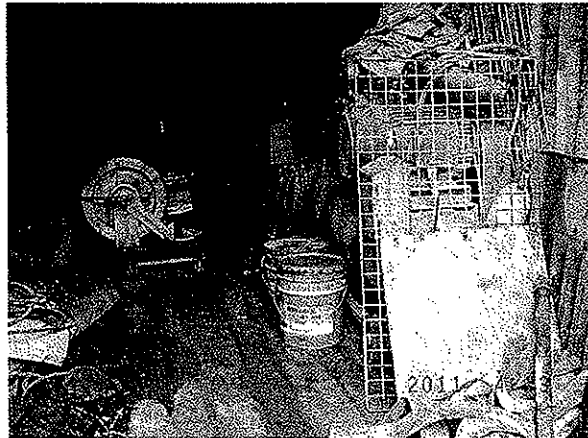
Photo 2

Workshop

Oil containers were found inside workshop container. (Follow up)

The Contractor was reminded to provide proper handling of chemical at Workshop.

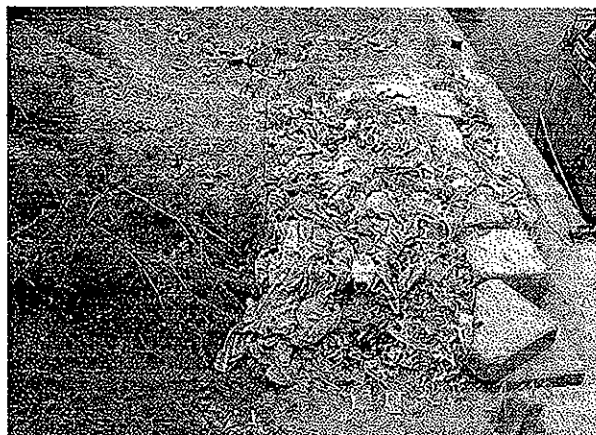
Photo 5

Pier No. 2

C&D wastes were accumulated at Pier No. 2.

- C&D waste was noted discarded at Pier No.2 during the weekly site inspection on 13 April 2011. The Contractor was reminded to collect and dispose of the waste properly. Since the finding was still observed during the last weekly site inspection on 27 April 2011, it will be verified in the coming month; and

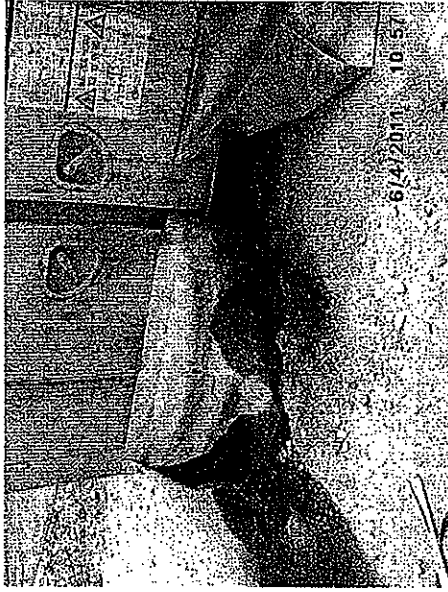
Photo 110406_007 (Area A5)

- Oil leakage was noted from a generator at Area A5 during the weekly site inspection on 06 April 2011. The Contractor was reminded to repair the defect generator and clean up the leak oil and contaminated materials as chemical waste. During the subsequent weekly site inspection on 13 April 2011, no oil leakage was observed;

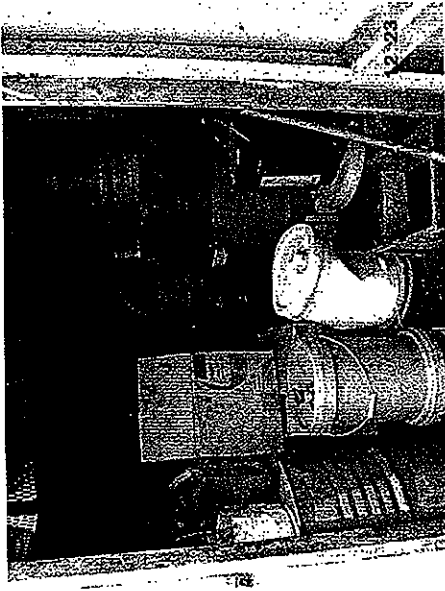
<p>Photo 110427_004 (Chemical waste storage area)</p>

- Too many chemicals were noted inside the chemical waste storage area during the weekly site inspection on 27 April 2011. The Contractor was reminded to arrange manpower to collect and dispose of the chemicals regularly. Since the finding was observed during the last weekly site inspection, it will be verified in the coming month.
