China Harbour – China State Joint Venture

CONTRACT NO. CV/2009/02

HANDLING OF SURPLUS PUBLIC FILL

MONTHLY EM&A REPORT NO.18

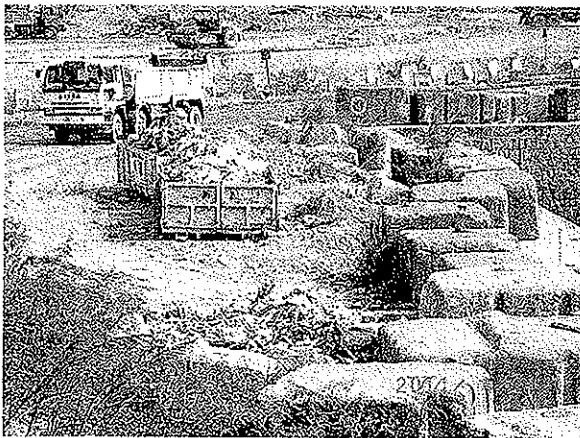
Photo 3

C&D wastes were accumulated at Pier No. 2.

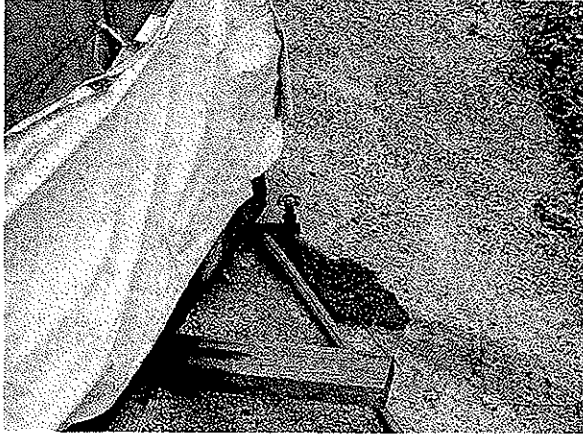
Photo 5

- Oil leakage was noted from a generator at the Contractor's site office during the weekly site inspection on 11 May 2011. The Contractor was reminded to clean up and dispose of the leak oil as chemical waste. During the subsequent weekly site inspection on 18 May 2011, the leak oil was cleaned.

Oil leakage from a generator was observed near Contractor's Site Office.

The Contractor was reminded to clean up the oil stain and avoid oil leakage from machinery.

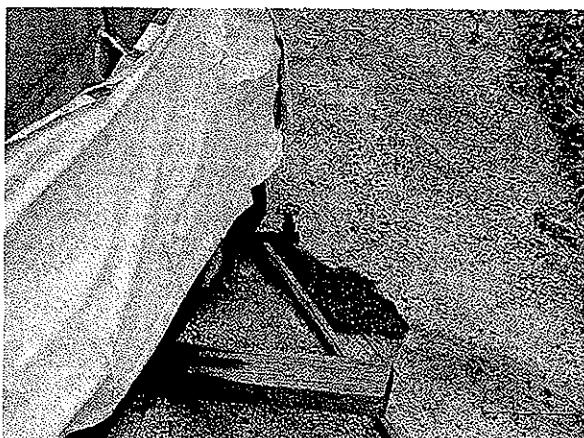
Photo 1

Oil leakage from a generator was observed near Contractor's Site Office.

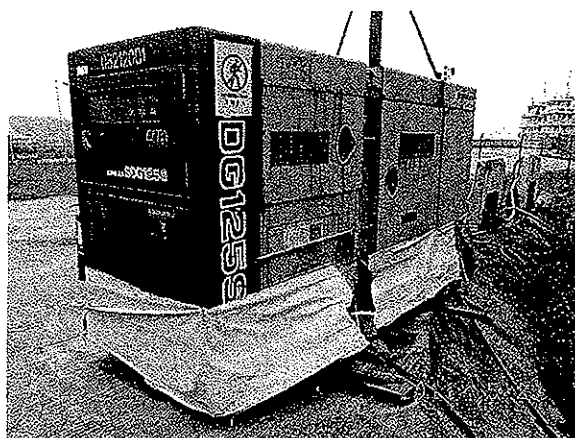
Photo 2

Oil stain was removed and no leakage from generator was observed. **(Closed)**

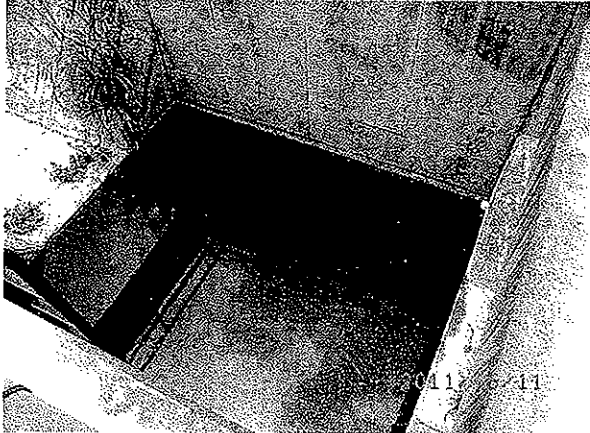
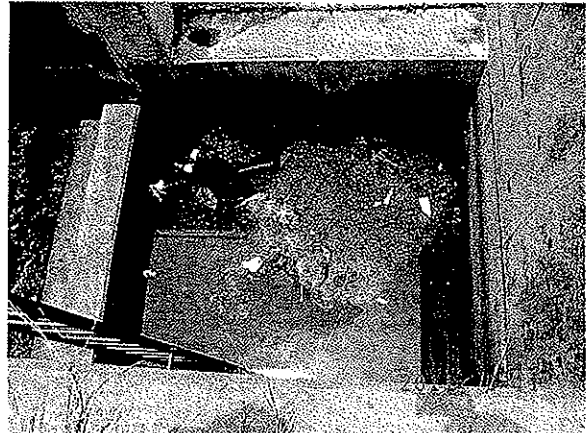
Photo 5 and 6

Standing water and rubbish were accumulated inside the drainage pits at Outfall No. 5.

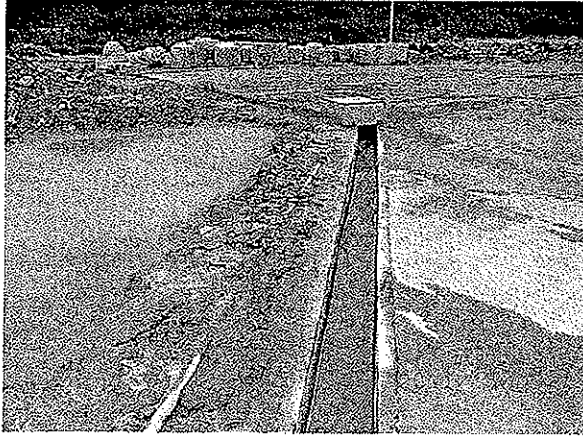
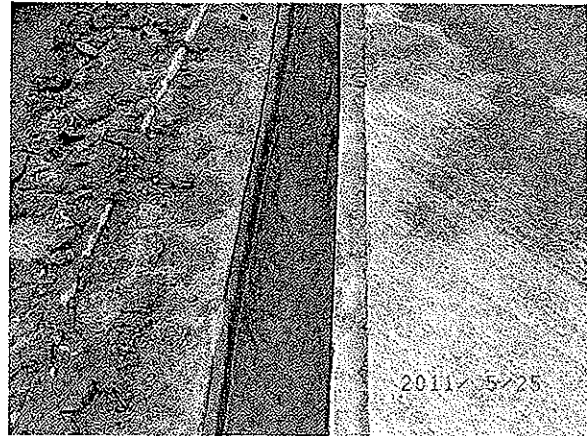
Photo 9 and 10

Silt was accumulated inside the u-channel.

The accumulated silt should be cleared up in order to avoid blockage of the channel.
