HANDLING OF SURPLUS PUBLIC FILL

TSEUNG KWAN O AREA 137 FILL BANK

MONTHLY EM&A REPORT NO.19

(JUNE 2011)

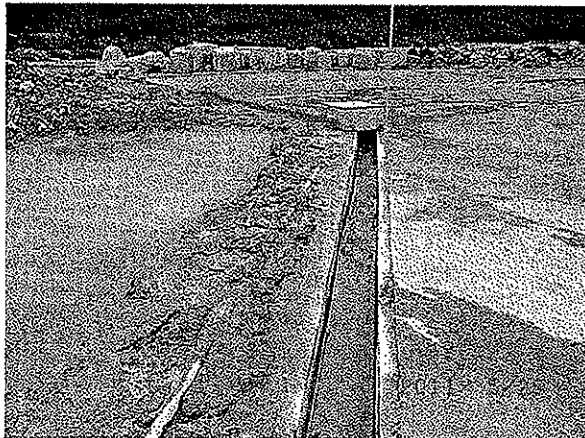
Photo 3

Near A3 wheel washing bay

Silt was accumulated inside the u-channel.

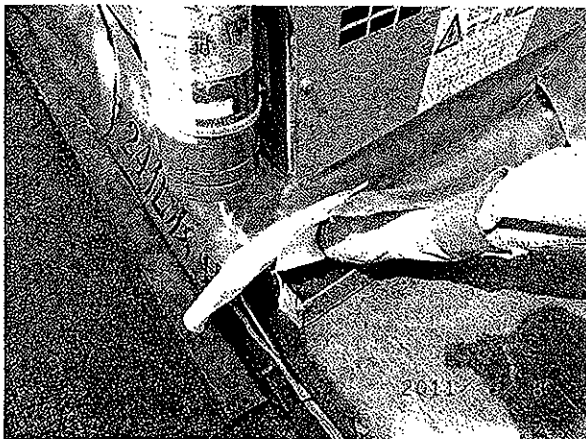
Photo 7

Near Site Office

Water was accumulated inside drip tray.

Skirt curtain should be properly fixed at the generator and covered up the drip tray in order to avoid water accumulation.

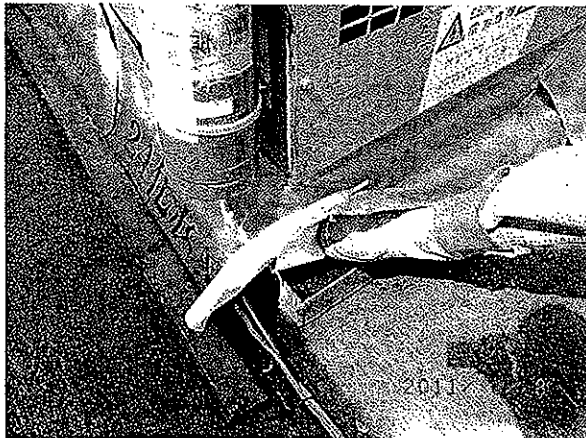
Photo 1

Near Site Office

Water was accumulated inside drip tray.

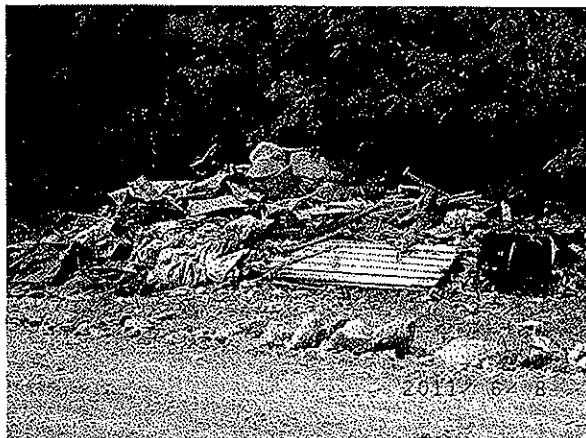
Photo 3

Beside haul road at A3

Debris was accumulated without providing proper measures.

Debris was accumulated beside haul road at A3 without providing proper measures.	Proper disposal facilities should be provided and accumulated of debris should be avoided at site.	The accumulated debris had been disposed.	Closed
	Scrapped tires were found at A3 near CREO and A4 Tipping Area.	The scrapped tires should be removed in order to prevent water accumulation and mosquito from breeding.	The scrapped tires had been removed.	Closed
	Oil contaminated gloves were found inside the skips at Workshop.	The contaminated gloves should be properly collected and treated as chemical waste.	No oil contaminated gloves were found inside the skip.	Closed
	Oil stains were found on the soil ground at Plant Maintenance Area.	Tarpaulin sheet / drip tray should be provided under the machines when waiting for maintenance.	Oil stains had been cleaned and tarpaulin sheets were provided for the malfunctioned plant.	Closed

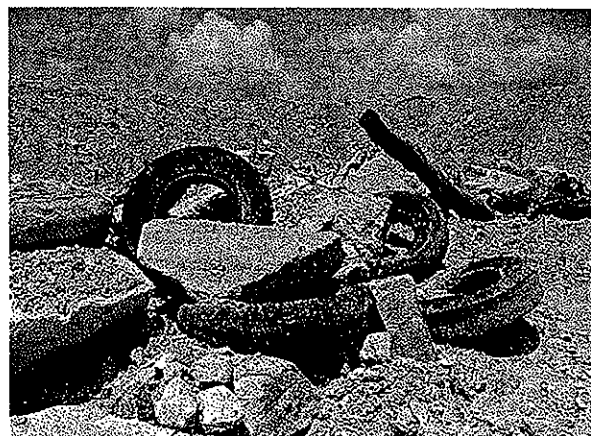
Photo 7

A4 Tipping Area

The scrapped tires should be removed in order to prevent water accumulation and mosquito from breeding.
