CONTRACT NO. CV/2009/02

HANDLING OF SURPLUS PUBLIC FILL

TSEUNG KWAN O AREA 137 FILL BANK

MONTHLY EM&A REPORT NO.20

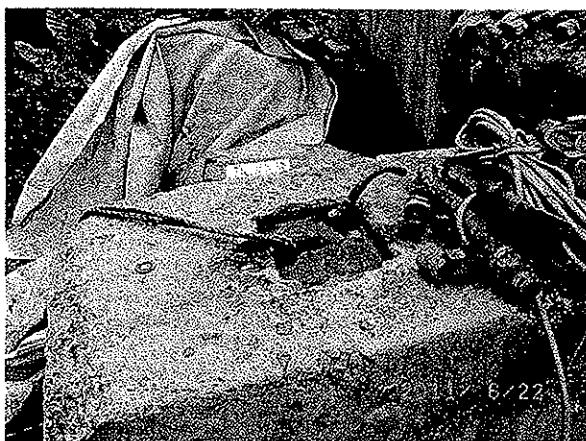
Photo 1
Vehicle Repairing Area
Stagnant water was found on concrete block.

Date	Key Findings	Action(s) Taken recommended by IEC	Action(s) Taken by the Contractor during the site audit	Rectification Status by IEC
06 July 2011	Stagnant water was found on concrete brick at Vehicle Repairing Area.	The Contractor should avoid stagnant water in the site.	Water was removed and the holes had been filled up.	Closed
	Chemical drums without identification were found near Vehicle Repairing Area.	The Contractor should store the chemical drums in the chemical waste container as soon as possible.	Chemical drums had been removed.	Closed
	Oil was leaked from drip tray at DSD pier.	The Contractor should avoid oil leakage from generator.	---	Follow-up
	Channel was blocked and standing water was found near site entrance.	The Contractor should maintain the drainage channel properly.	---	Follow-up
	Silt and mud was deposited in the Nullah.	The Contractor should clean up the deposited silt/mud as soon as possible.	---	Follow-up

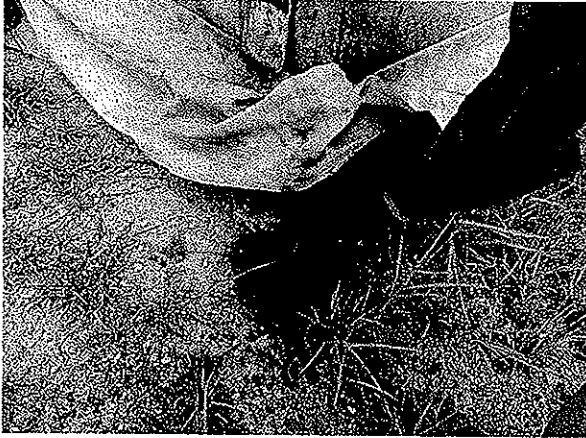
Photo 5

DSD Pier

Oil was leaked from drip tray.

The Contractor should avoid oil leakage from generator.

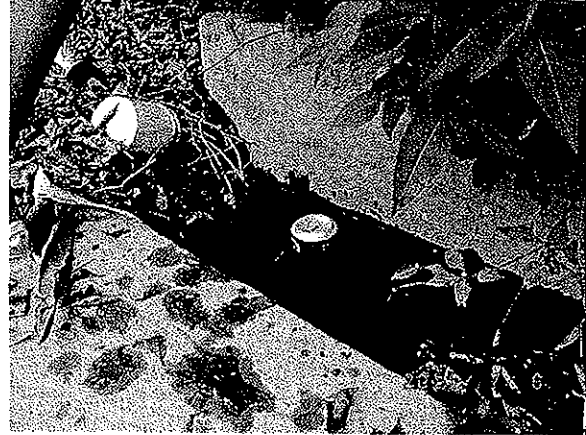
Photo 6

Near Site Entrance

Channel was blocked and standing water was found.

The Contractor should maintain the drainage channel properly.

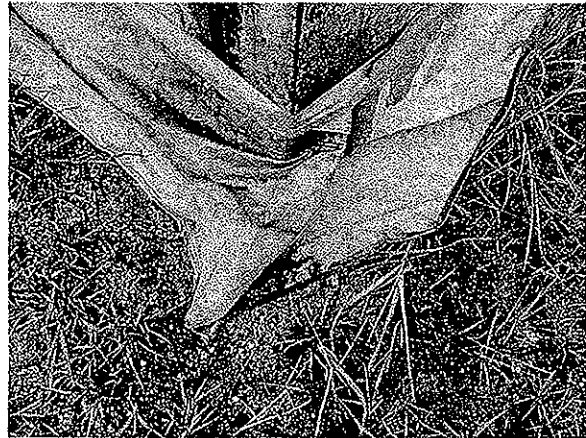
Photo 2

DSD Pier

No leakage from drip tray was observed and oil stain had been removed. **(Closed)**
