**HANDLING OF SURPLUS PUBLIC FILL**

**TSEUNG KWAN O AREA 137 FILL BANK**

**MONTHLY EM&A REPORT NO.24**

**(NOVEMBER 2011)**

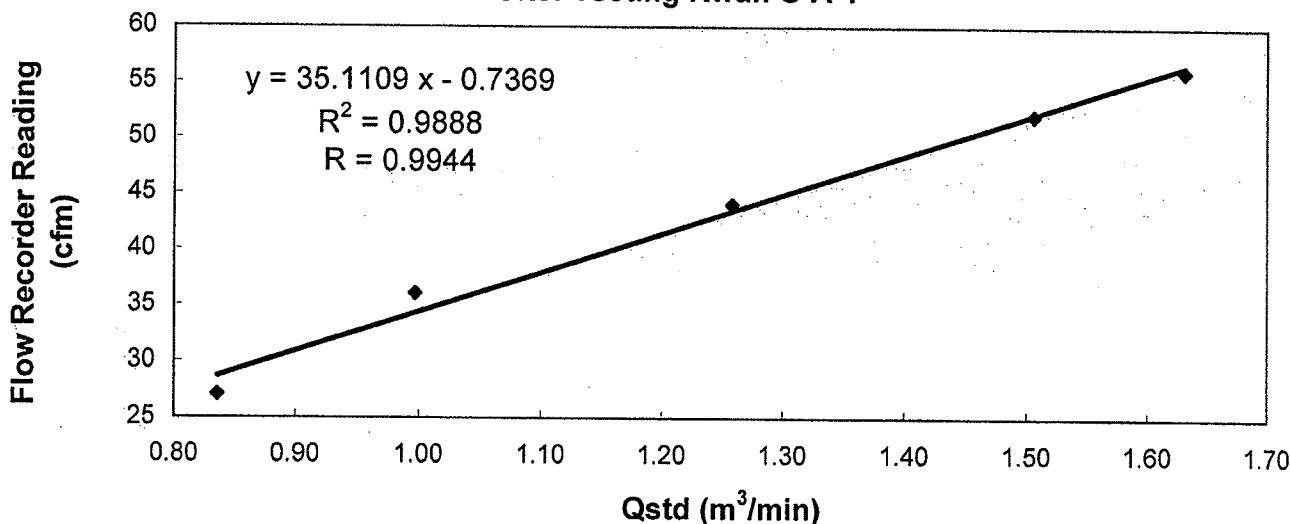
**Sampler 10581 Calibration Curve**  
Site: Tseung Kwan O A-1

Flow recorder reading (cfm)	56	52	44	36	27
Qstd (Actual flow rate, m <sup>3</sup> /min)	1.63	1.51	1.26	1.00	0.84
Pressure :	757.56	mm Hg	Temp. :	303	K

Acceptance Criteria : Correlation coefficient (r) of the calibration curve greater than 0.990 after a 5-point calibration.

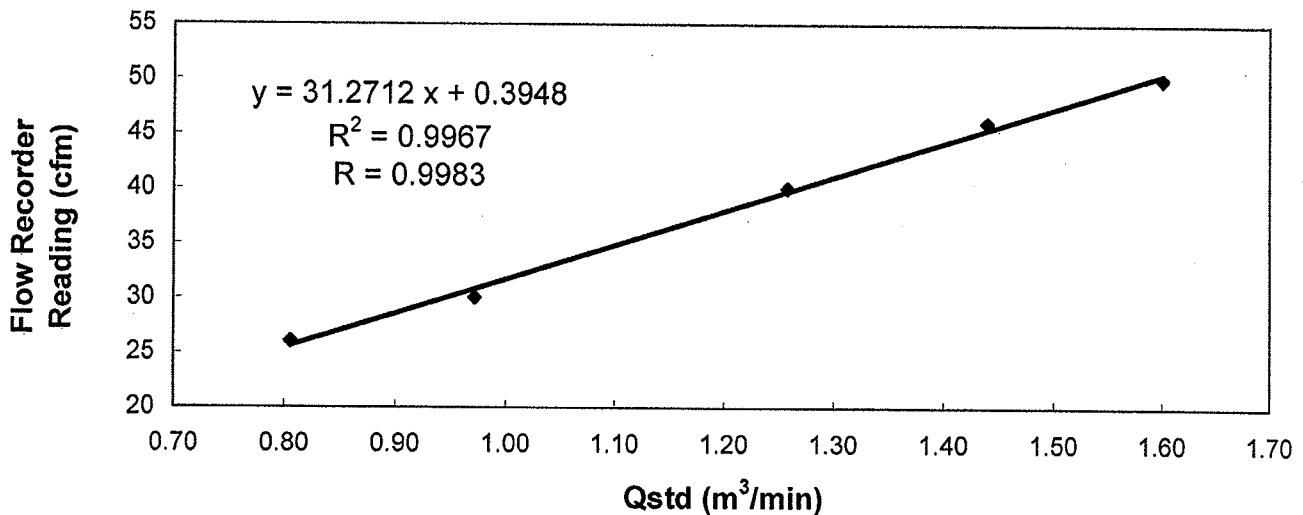
**Sampler 1172 Calibration Curve  
Site: Tseung Kwan O A-2**

Flow recorder reading (cfm)	50	46	40	30	26
Qstd (Actual flow rate, m <sup>3</sup> /min)	1.60	1.44	1.26	0.97	0.81
Pressure :	757.56 mm Hg		Temp. :	303 K

Acceptance Criteria : Correlation coefficient (r) of the calibration curve greater than 0.990 after a 5-point calibration.

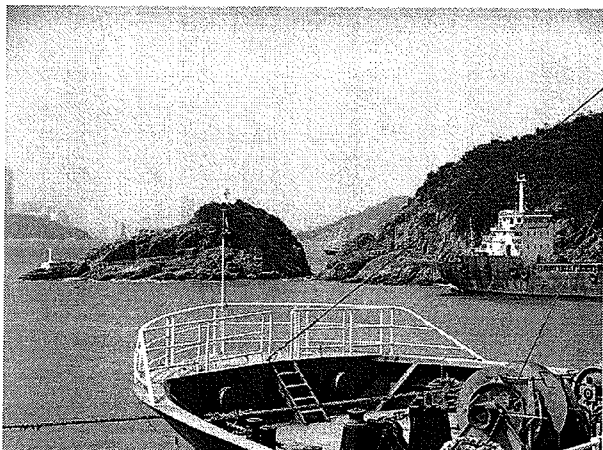
Photo 1

Silt Curtain

Silt curtain was still broken.

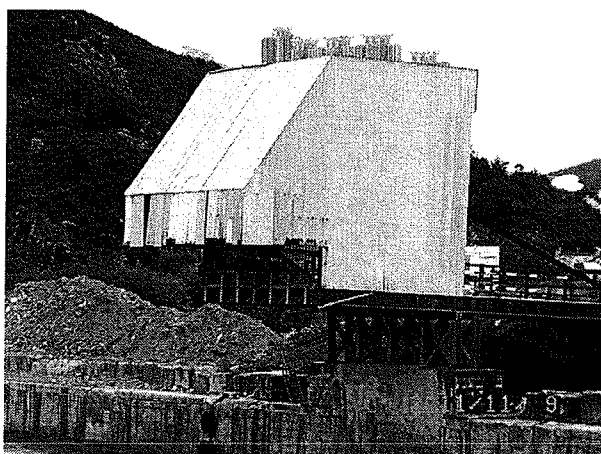
Photo 3

Tipping Hall No.3

Enclosure of Tipping Hall was found damaged.

- The enclosure of Tipping Hall No.3 was found damaged during the several weekly site inspections on 02, 09, 16, 25 and 30 November 2011. The Contractor was reminded to repair the damage part of the tipping hall. Since the finding was still observed at the last weekly site inspection on 30 November 2011, it will be verified in the coming month;

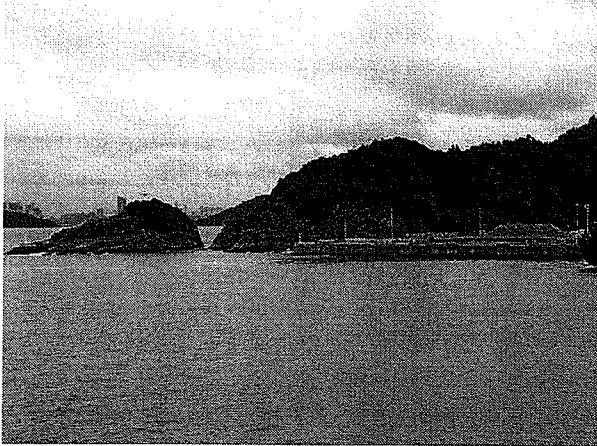
Photo 1

Silt Curtain

Silt curtain was not provided.

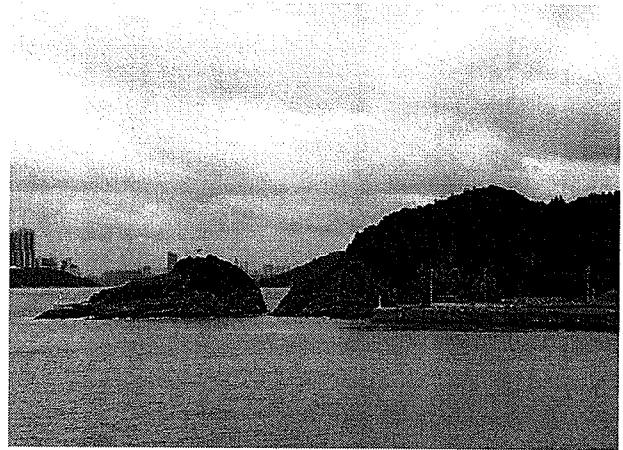
Photo 2

Silt Curtain

The Contractor was urged to provide silt curtain as soon as possible. **(Follow up)**

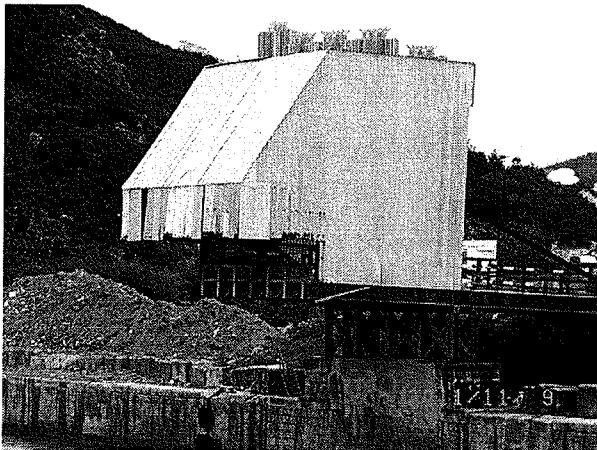
Photo 3

Tipping Hall No.3

Enclosure of Tipping Hall was found damaged.

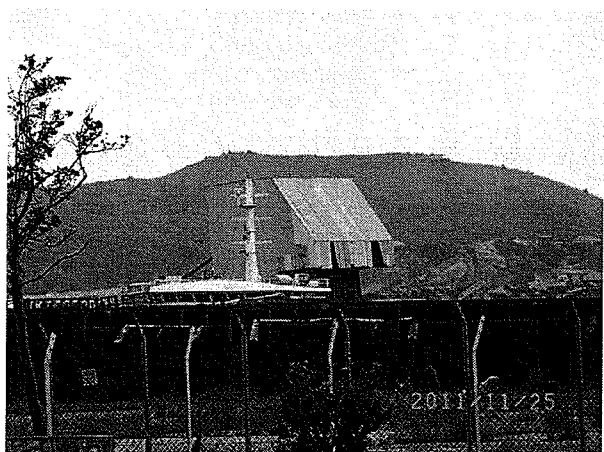
Photo 4

Tipping Hall No.3

The enclosure was not repaired. **(Follow up)**

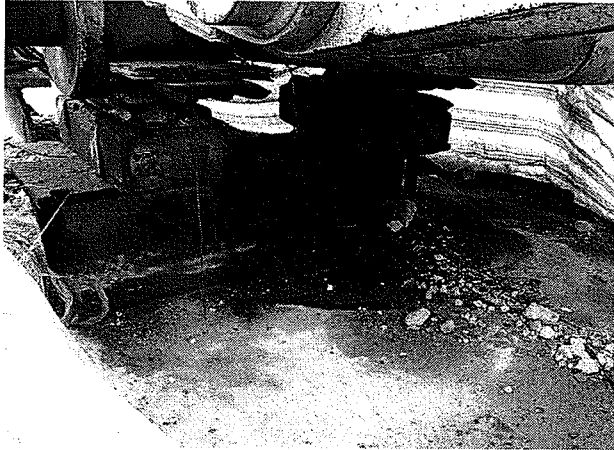
Photo 5

Repairing Area near A6

No impermeable sheet was provided during plant maintenance work.

The Contractor should provide sufficient preventive measures during equipment maintenance works so as to avoid oil leakage on the ground. In the event of any oil leakage, the Contractor should clean up the polluted soil and handle all the materials used for this cleaning works as chemical waste.

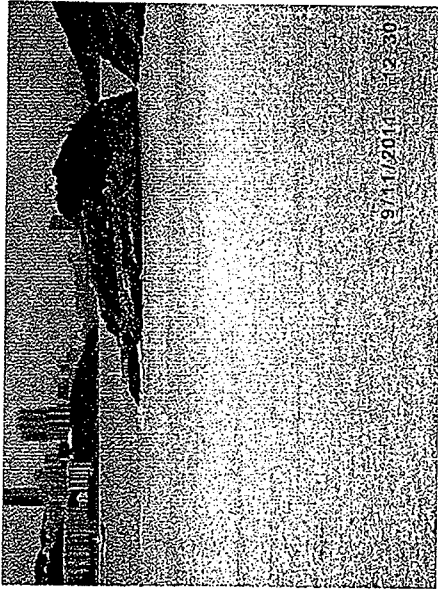
Photo 111109\_001 (Silt curtain near Contractor Site Office)

- Follow up action to the outstanding finding in the previous month, floating booms of silt curtain near the Contractor's site office were still noted damaged during the several weekly site inspections on 02, 09, 16, 25 and 30 November 2011. The Contractor was reminded to repair the silt curtain properly. Since the finding was still observed at the last weekly site inspection on 30 November 2011, it will be verified in the coming month;
- Mud and weed was noted accumulated inside the drainage channel near CREO during the weekly site inspection on 02 November 2011. The Contractor was reminded to clean up the mud and weeds accumulated, and maintain the drainage channel properly. During the subsequent weekly site inspection on 09 November 2011, the accumulated mud and weed were cleared.
