**CONTRACT NO: KL/2009/01**  
**SITE FORMATION FOR**  
**KAI TAK CRUISE TERMINAL DEVELOPMENT**

**QUARTERLY ENVIRONMENTAL MONITORING & AUDIT**  
**REPORT**

- SEPTEMBER TO NOVEMBER 2012 -

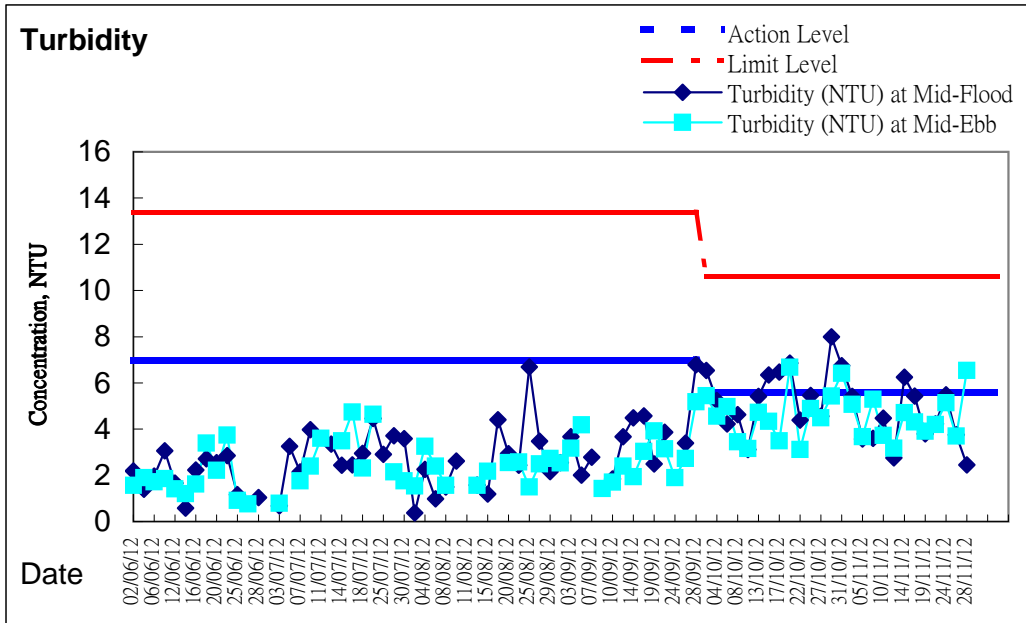
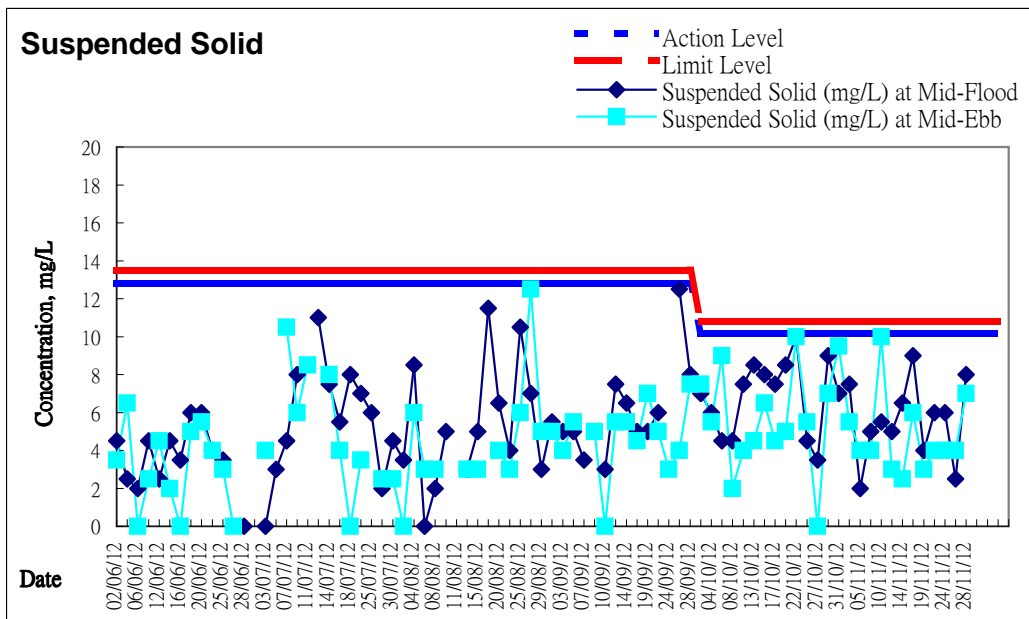
**Graphic Presentation of Water Quality Result of WSD9 - Tai Wan**

- Two sets of Suspended Solid Action and Limit levels for the dry season (the period from October to March) and wet season (the period from April to September).
- New sets Turbidity and SS Action Level and Limit Level for dry and wet season were approved by EPD on 19 Oct 2011

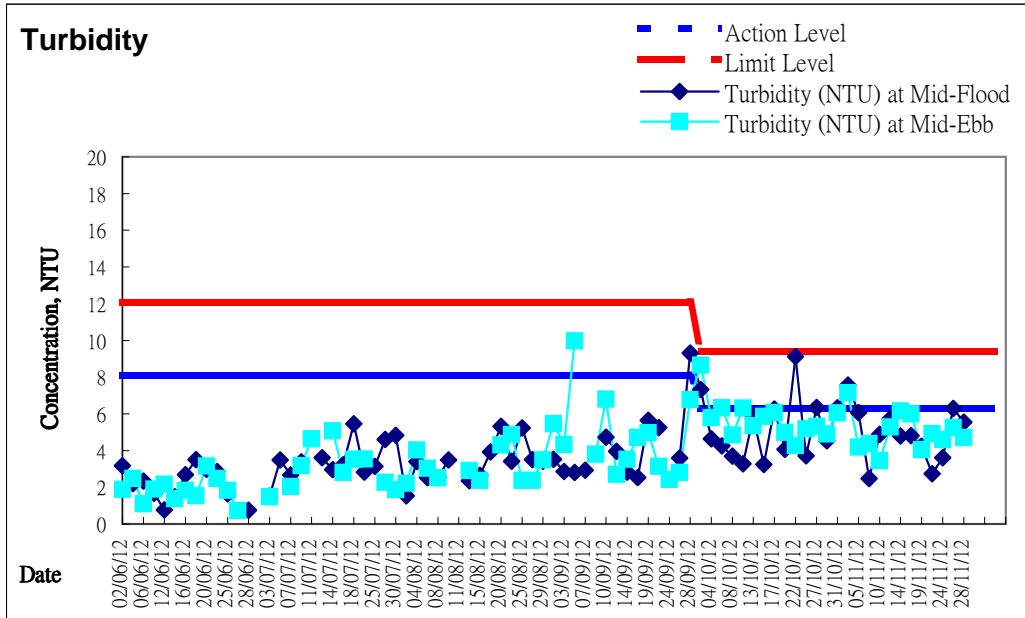
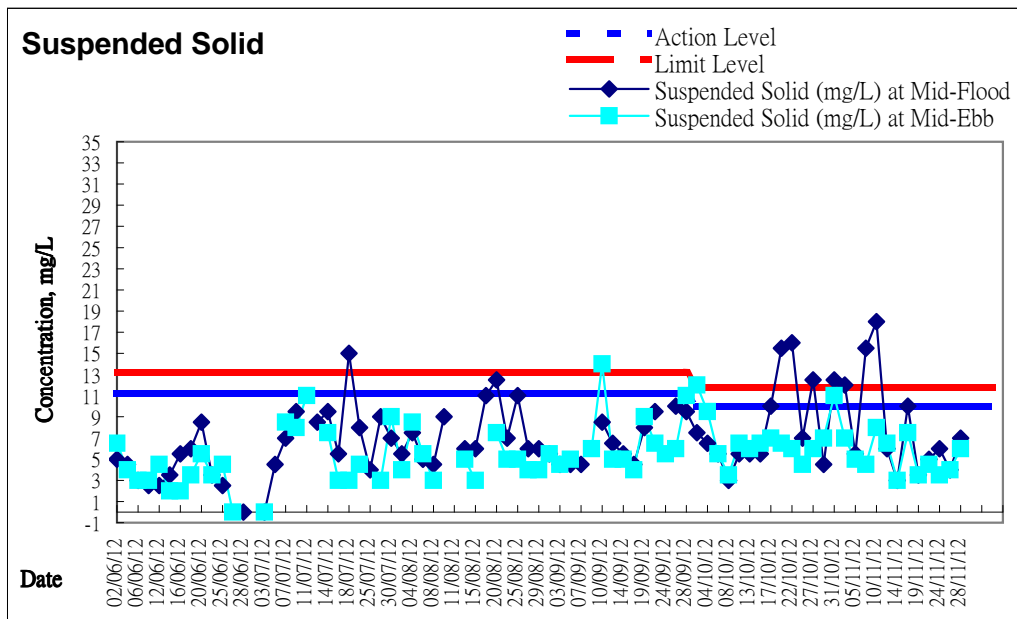
**Graphic Presentation of Water Quality Result of WSD10 - Cha Kwo Ling**

- Two sets of Suspended Solid Action and Limit levels for the dry season (the period from October to March) and wet season (the period from April to September).
- New sets Turbidity and SS Action Level and Limit Level for dry and wet season were approved by EPD on 19 Oct 2011

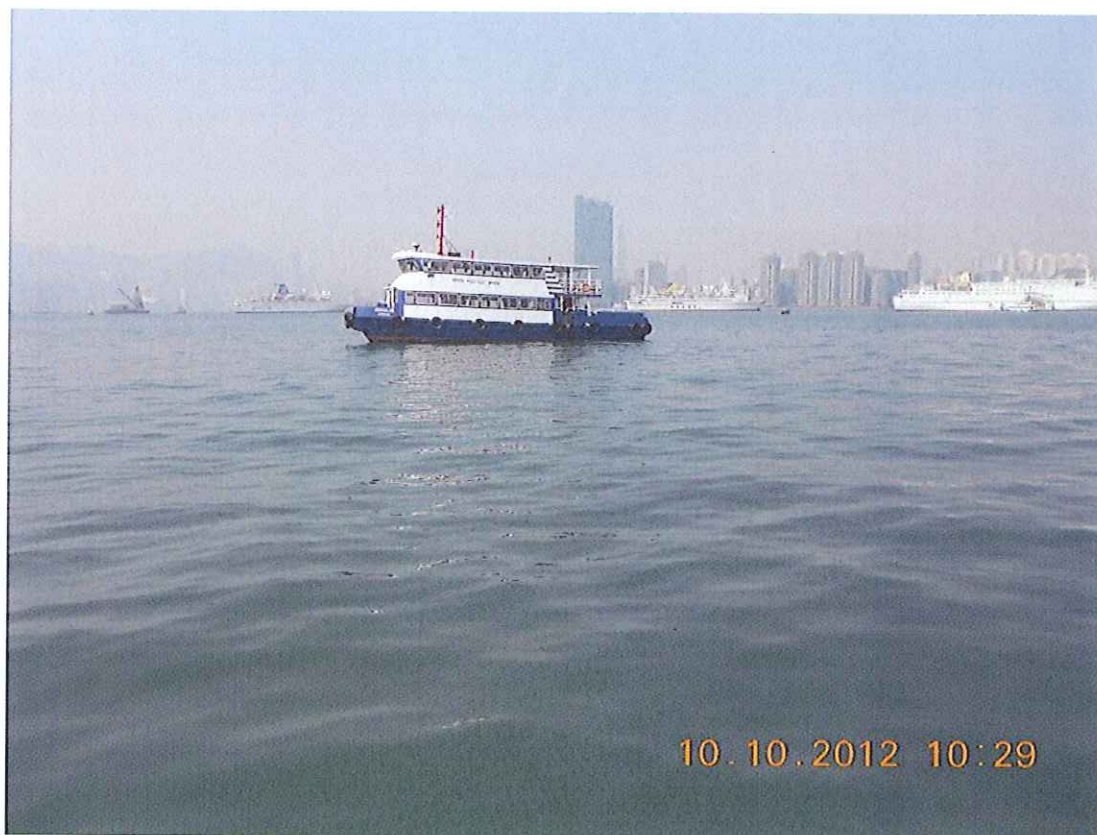
Photograph taken right before sampling at monitoring station C2 shown vessels and marine traffic upstream

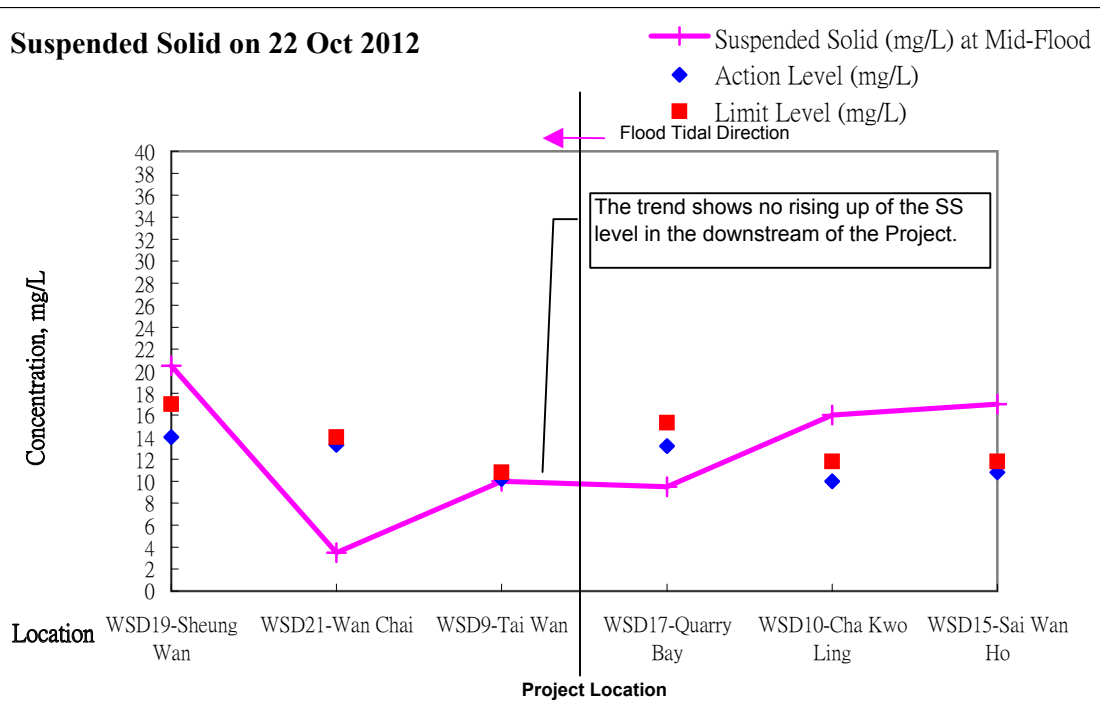
### Suspended Solid on 22 Oct 2012

- xii. For the SS exceedance recorded on 22 Oct 2012 at WSD19 (Mid-flood) revealed that no apparent rise of SS after passing the project site. The rise in SS level might be caused by accumulation of filling materials from nearby transferral of filling materials activities or changes at upstream, as relatively SS concentration were recorded at WSD10 and WSD15, the furthest upstream station.

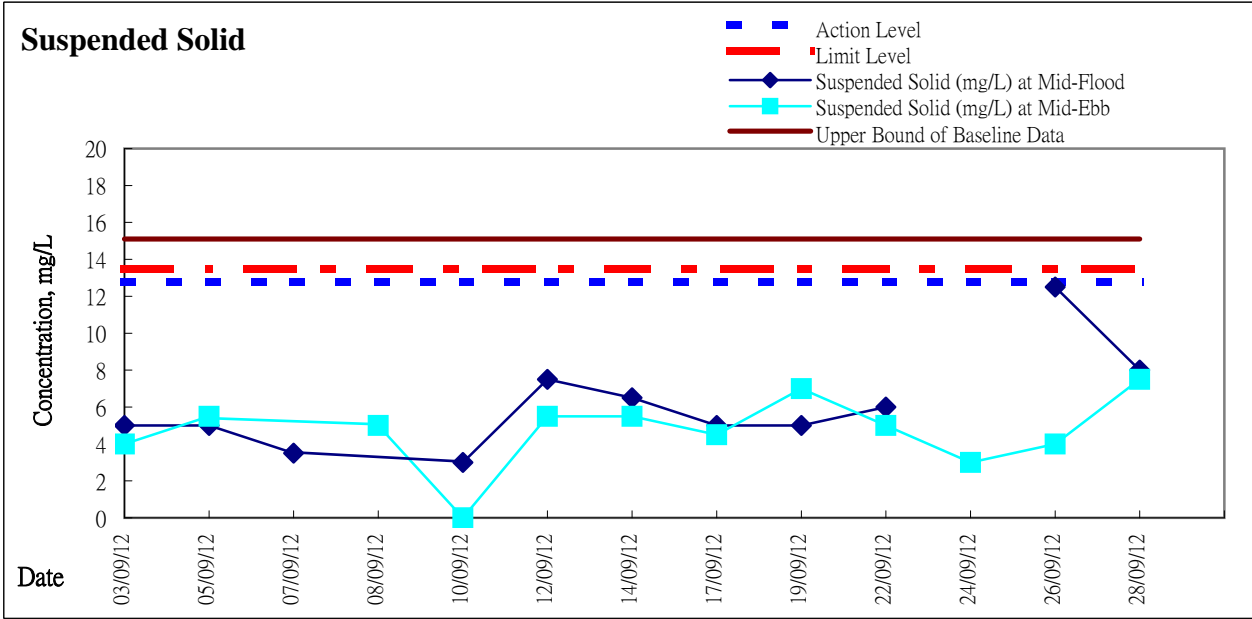
Graphic Presentation of Water Quality Result of WSD9 - Tai Wan with respect to Local Variation

Remarks: WSD9 is located at upstream during the ebb tides while at downstream during flood tides.

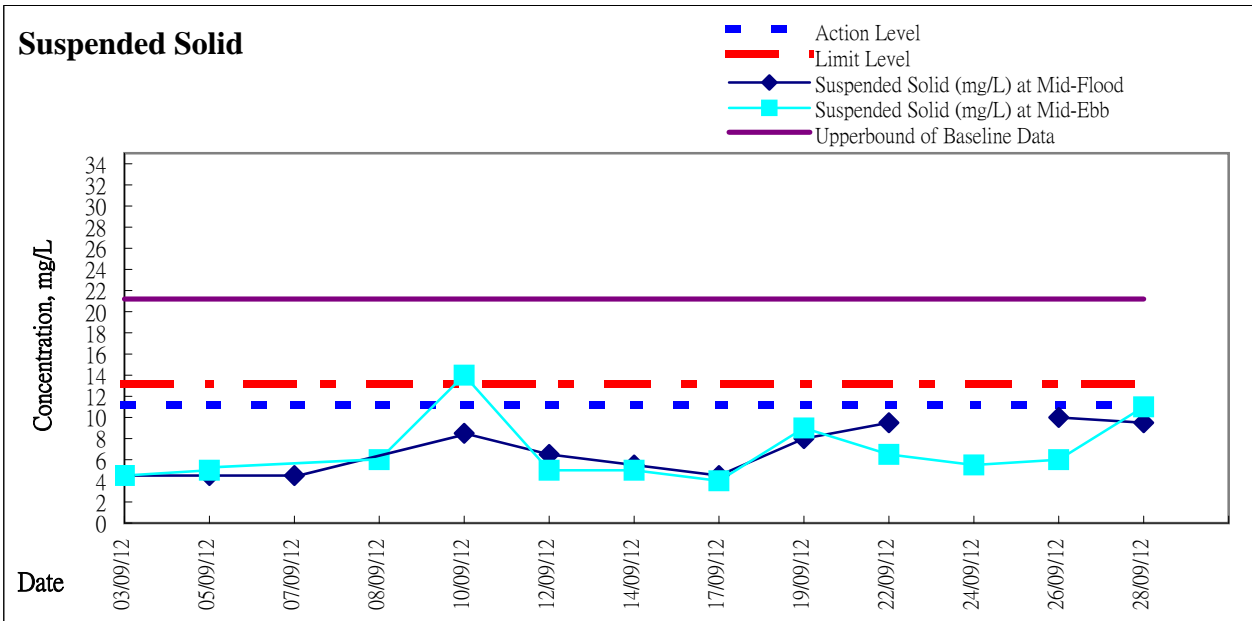
Graphic Presentation of Water Quality Result of WSD10 - Cha Kwo Ling with respect to Local Variation

Remarks: WSD10 is located at upstream during the flood tides while at downstream during ebb tides.

Remarks: Due to hoisting of amber rainstorm warning, the water quality monitoring for flood tide on 24 Sep 2012 was cancelled.

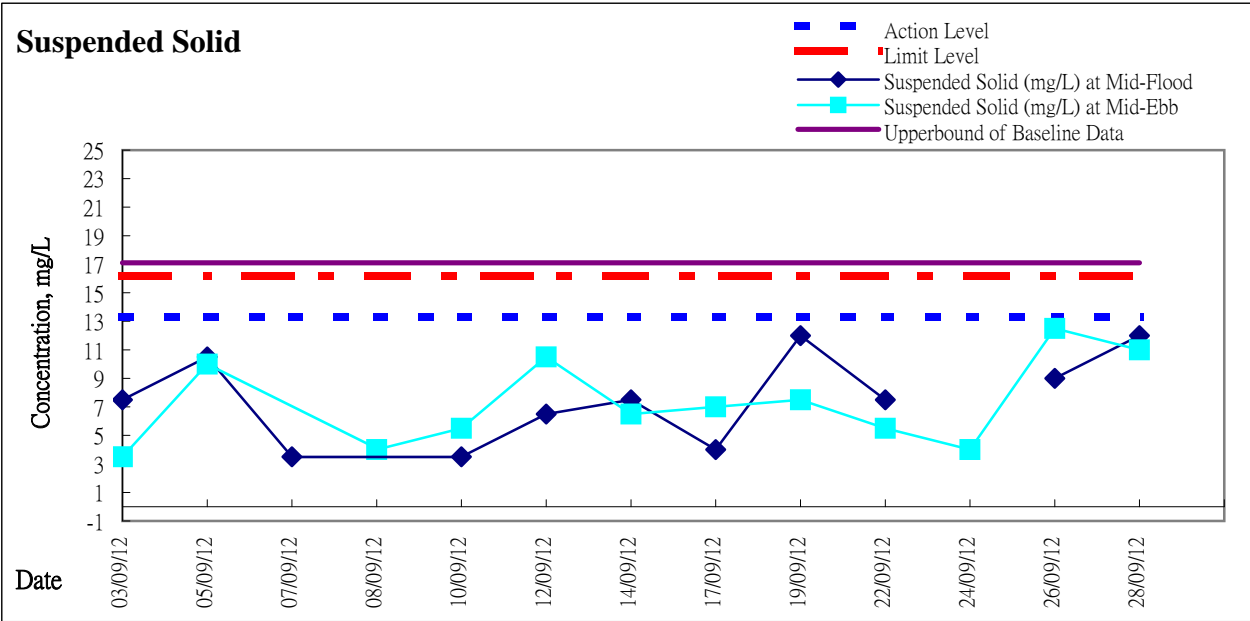
Graphic Presentation of Water Quality Result of WSD19 - Sheung Wan with respect to Local Variation

Remarks: WSD19 is located at upstream during the ebb tides while at downstream during flood tides.

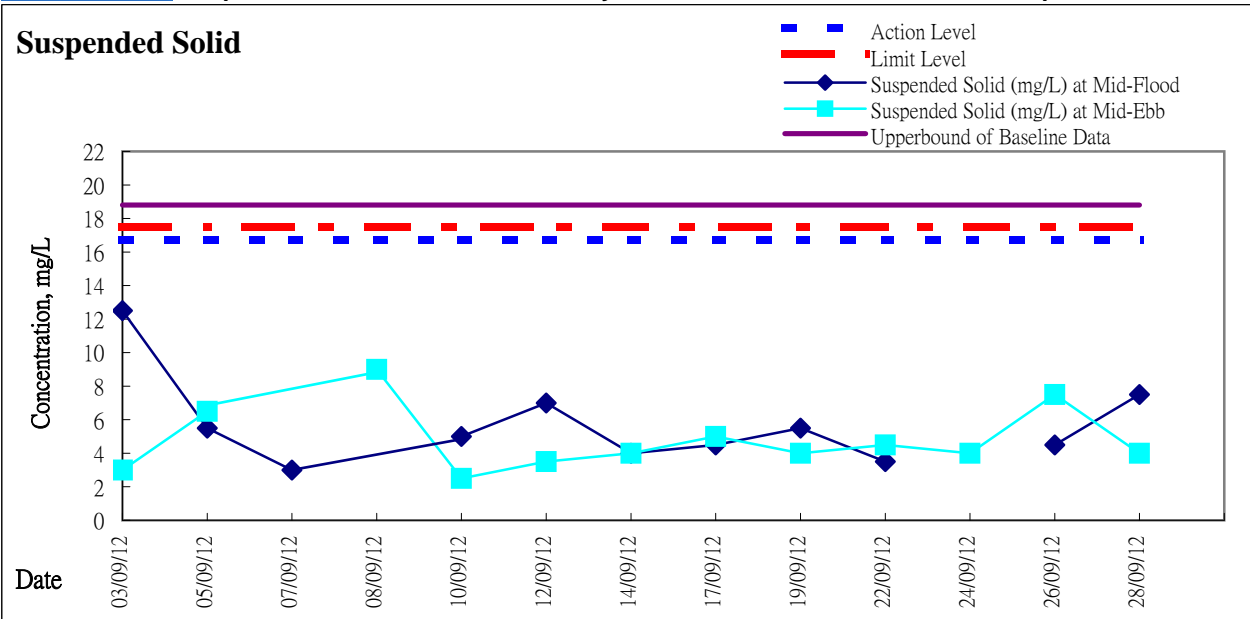
Graphic Presentation of Water Quality Result of WSD21 - Wan Chai with respect to Local Variation

Remarks: WSD21 is located at upstream during the ebb tides while at downstream during flood tides.
