Highways Department

**Contract No.
HY/2007/14 Widening of
Tuen Mun Road at
Tsing Tin Interchange**

Monthly Environmental
Monitoring and Audit
Report - June 2009

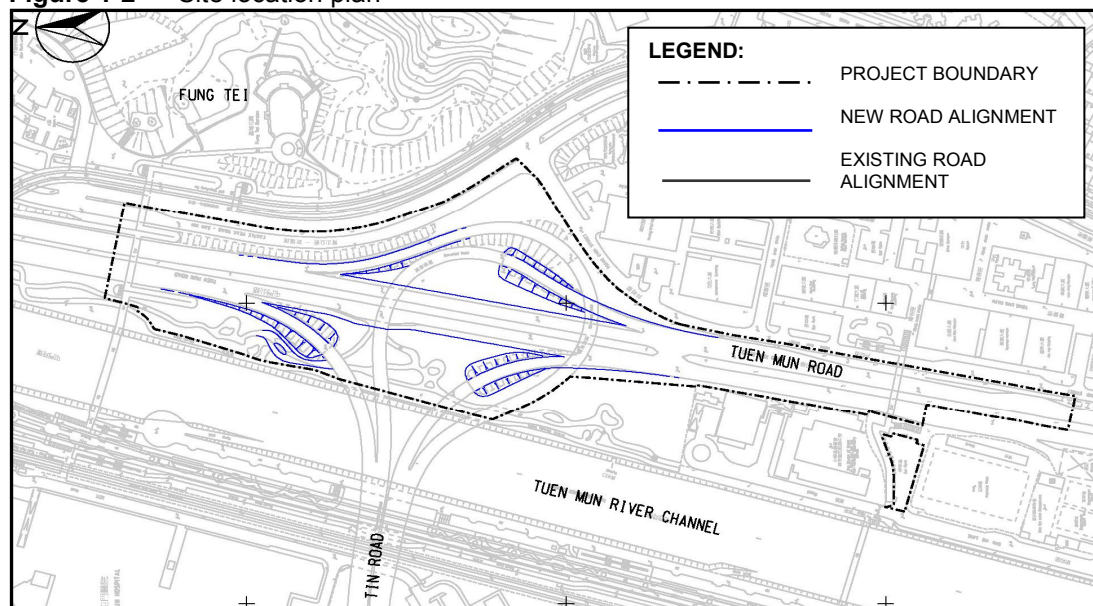
Figure 1-2 Site location plan

The project area and the location of the sensitive receivers and monitoring stations are shown in **Figures 1-2 and 1-3** respectively, while **Table 1-3** shows the detail correspondences of monitoring stations.

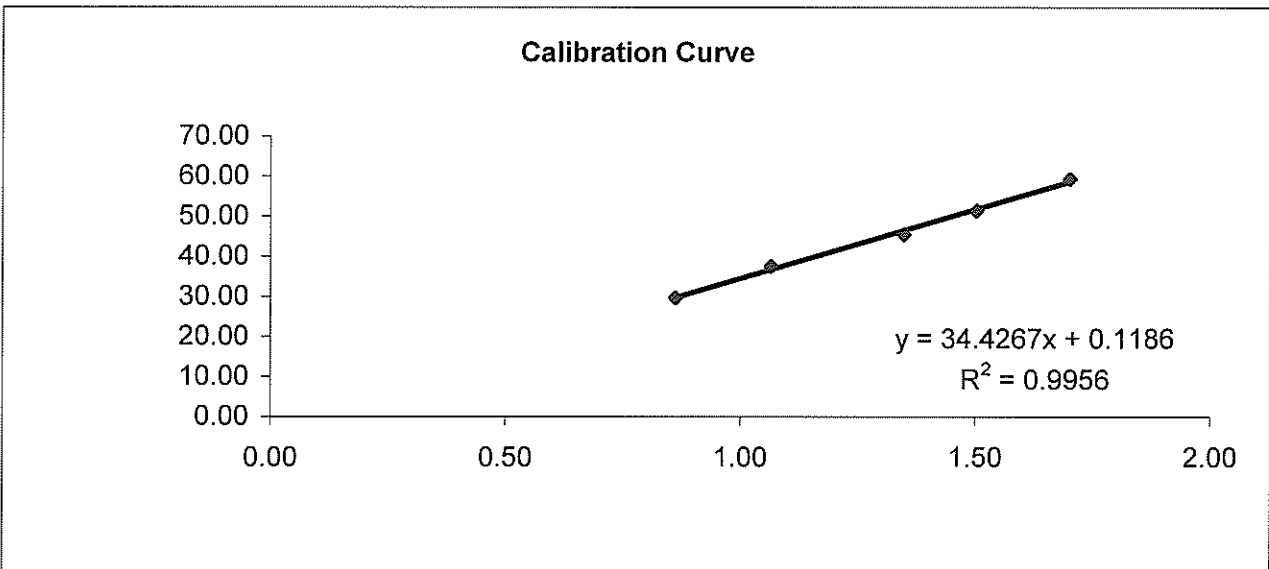
Resistance Plate No.	Manometer Reading (inch H ₂ O)	Flow Recorder Reading (CFM)	Calculated Q _{std} (m ³ /min)	Continuous Flow Recorder Reading IC (CFM)
5	3.00	30.00	0.86	29.70
7	4.60	38.00	1.07	37.62
10	7.40	46.00	1.35	45.54
13	9.20	52.00	1.50	51.48
18	11.80	60.00	1.70	59.40

Sampler slope (m) : **34.4267**
 Sampler intercept (b) : **0.1186**
 Correlation coefficient (R²) : **0.9956**

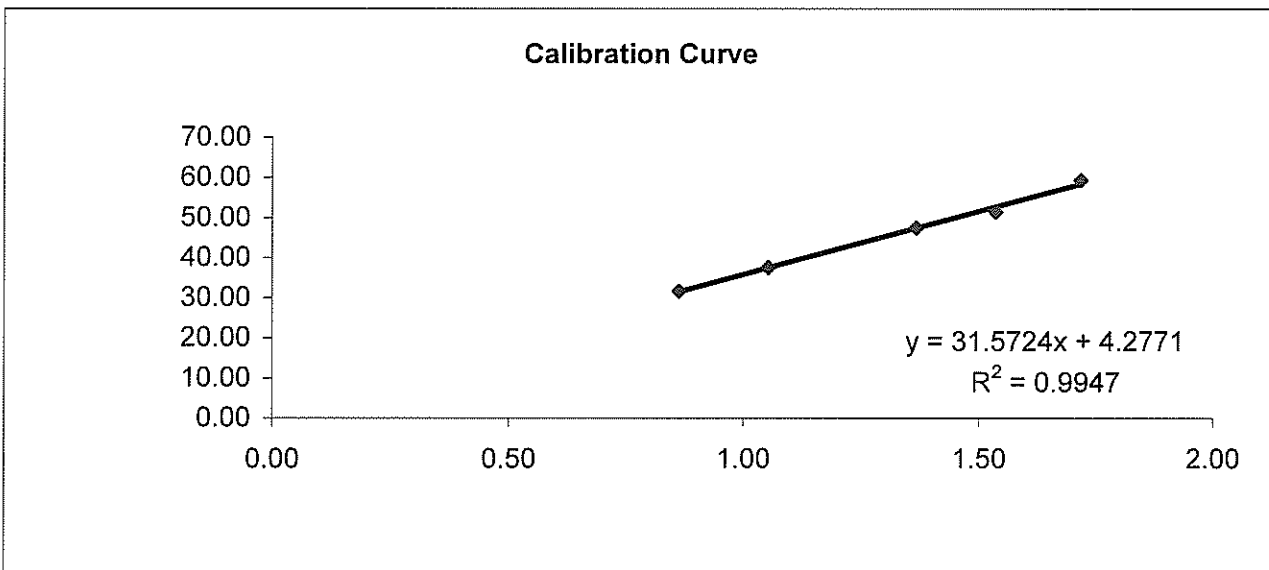
Resistance Plate No.	Manometer Reading (inch H ₂ O)	Flow Recorder Reading (CFM)	Calculated Q _{std} (m ³ /min)	Continuous Flow Recorder Reading IC (CFM)
5	3.00	32.00	0.86	31.68
7	4.50	38.00	1.05	37.62
10	7.60	48.00	1.37	47.52
13	9.60	52.00	1.54	51.48
18	12.00	60.00	1.72	59.40

Sampler slope (m) : **31.5724**
 Sampler intercept (b) : **4.2771**
 Correlation coefficient (R²) : **0.9947**

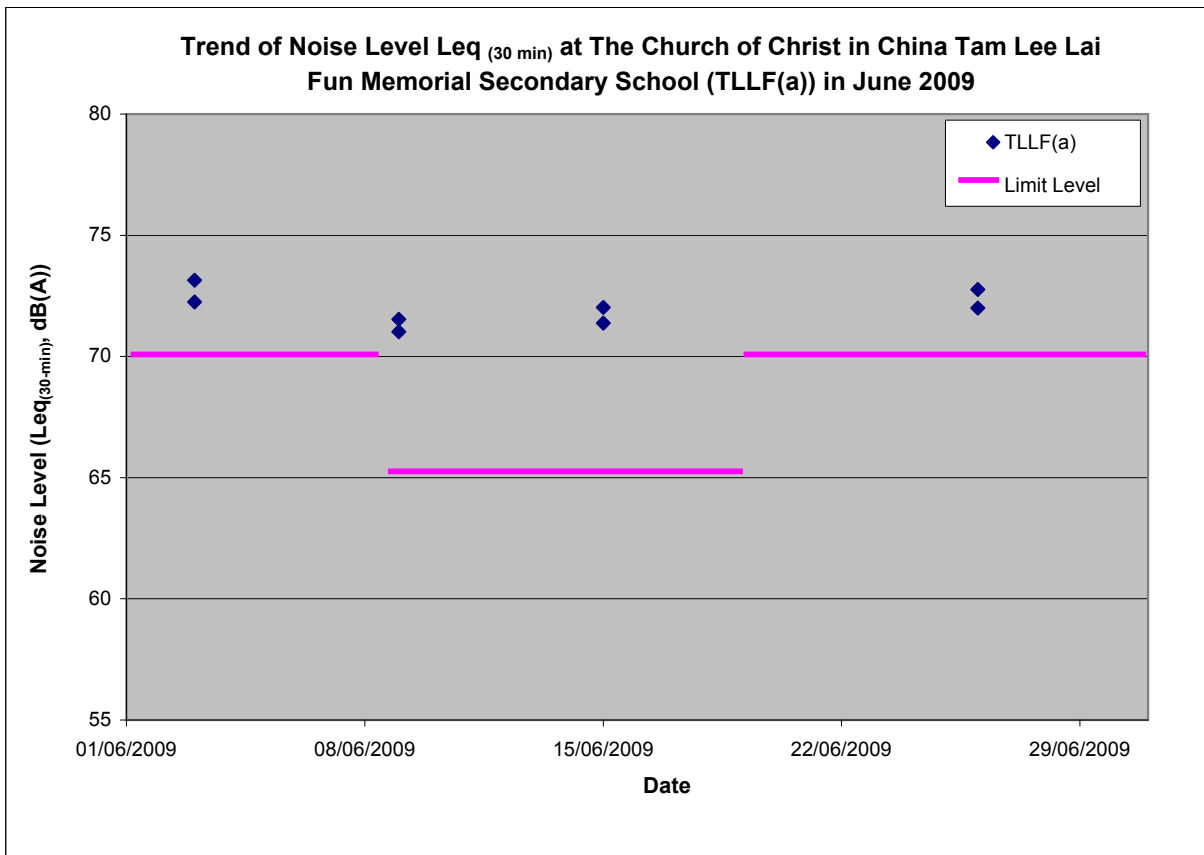
- (1) All Noise result on June 2009 were not project-related exceedance.
- (2) 8-Jun to 19-Jun 2009 was the school examination period, the limit level is 65dB(A).

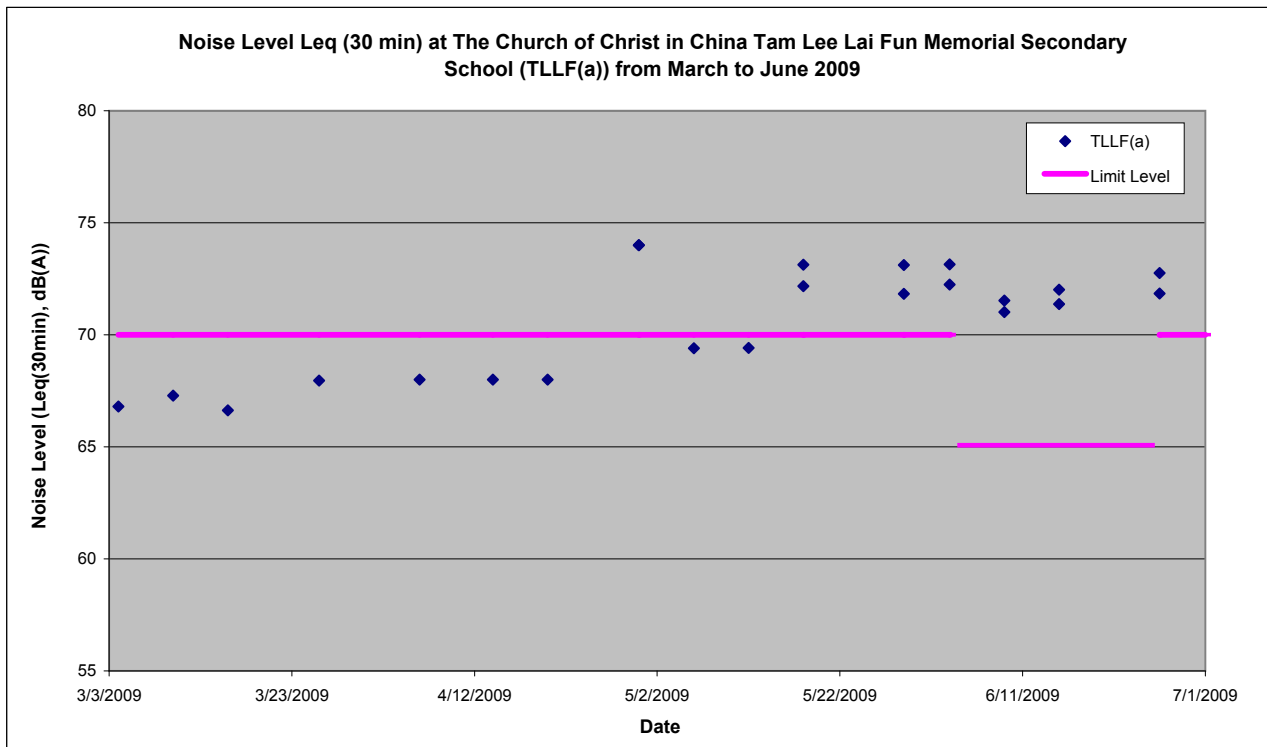
- (1) All noise results exceeding limit level were not project-related.
- (2) 8-Jun to 19-Jun 2009 was the school examination period, the limit level is 65dB(A).
