**Contract No.
HY/2007/14 Widening of
Tuen Mun Road at
Tsing Tin Interchange**

Monthly Environmental
Monitoring and Audit
Report – August 2009

Revision 3

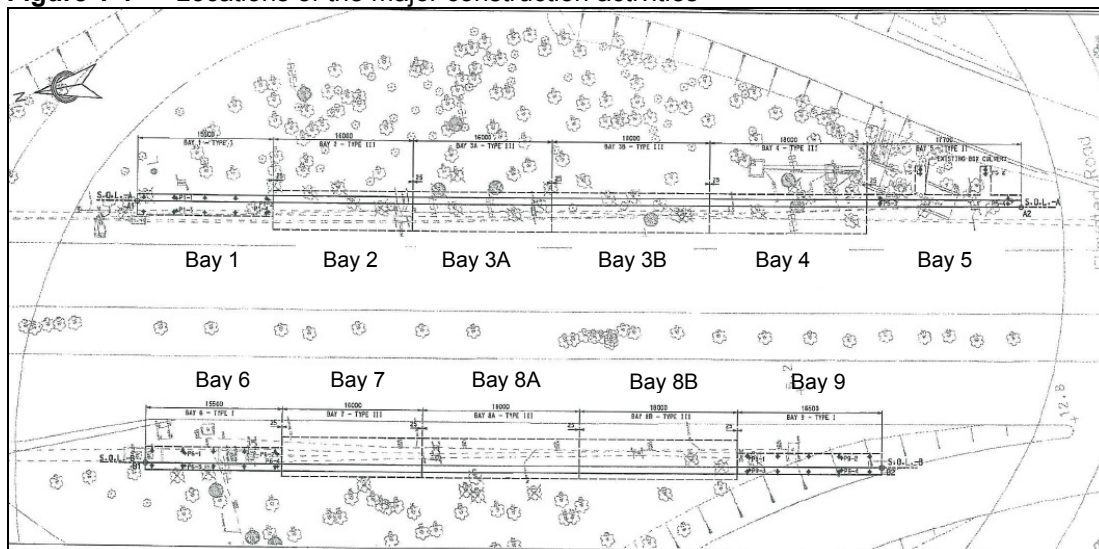
Figure 1-1 Locations of the major construction activities

Construction Activities	Location	Daily Excavation Rate
Site clearance	Whole Site Area	Range: 0 to 31 m ³
Construction of noise barrier	Whole Site Area	
Fabrication of sign gantry	Whole Site Area	
Road pavement and drainage for widen lane	Whole Site Area	
Drainage & road re-construction	Whole Site Area	
Re-compaction of fill slope	Whole Site Area	Not applicable

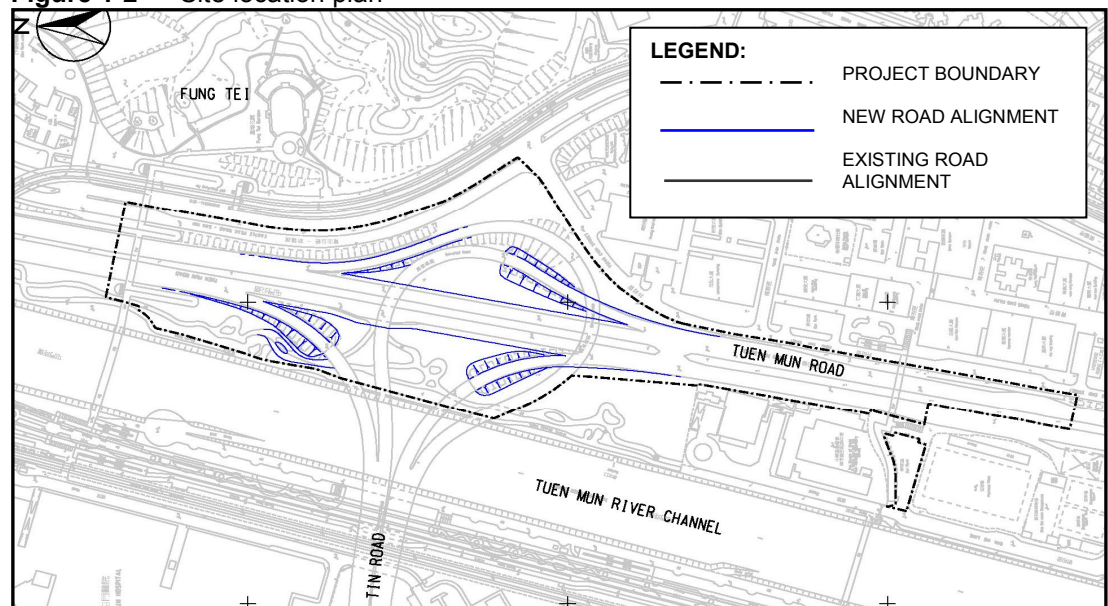
Figure 1-2 Site location plan

The project area and the location of the sensitive receivers and monitoring stations are shown in **Figures 1-2 and 1-3** respectively, while **Table 1-3** shows the detail correspondences of monitoring stations.

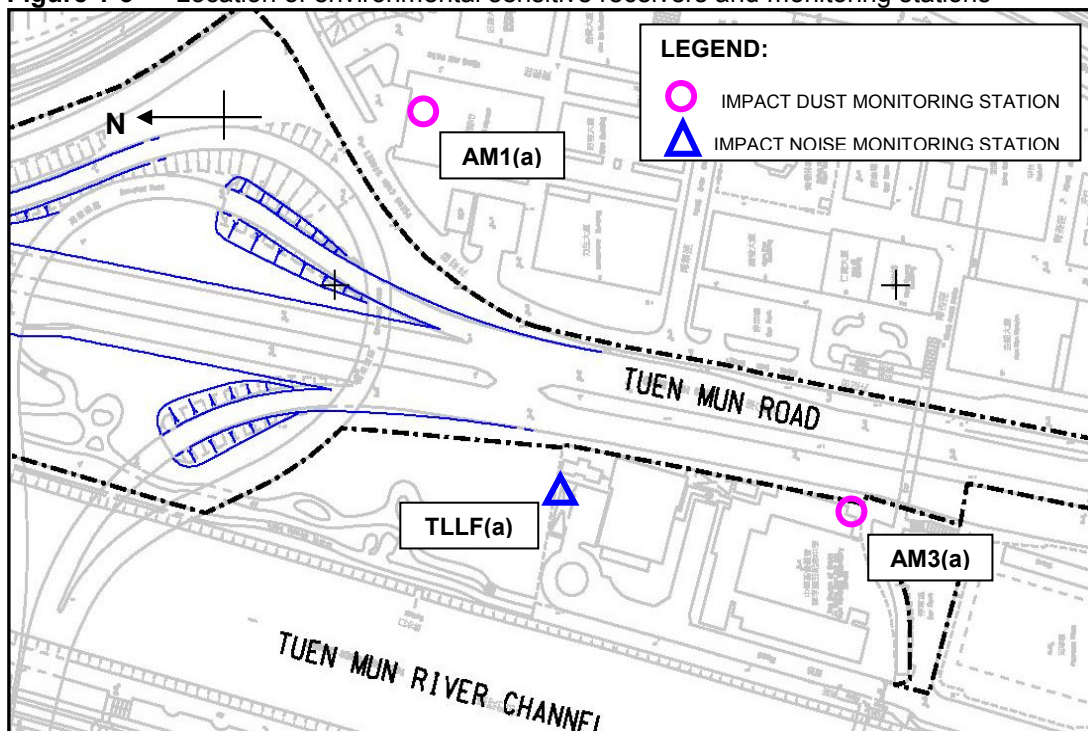
Figure 1-3 Location of environmental sensitive receivers and monitoring stations

ID	Premise	Address	Monitoring Location Detail
Air			
AM1(a)	Kwong Choi Market	2 Tsing Min Path	Roof-top of the market office at the market garden
AM3(a)	The Church of Christ in China Tam Lee Lai Fun Memorial Secondary School	10 San Wo Lane	Ground-floor garden at the corner of the school
Noise			
TLLF(a)	The Church of Christ in China Tam Lee Lai Fun Memorial Secondary School	10 San Wo Lane	Car park of the school, facing to the construction area.

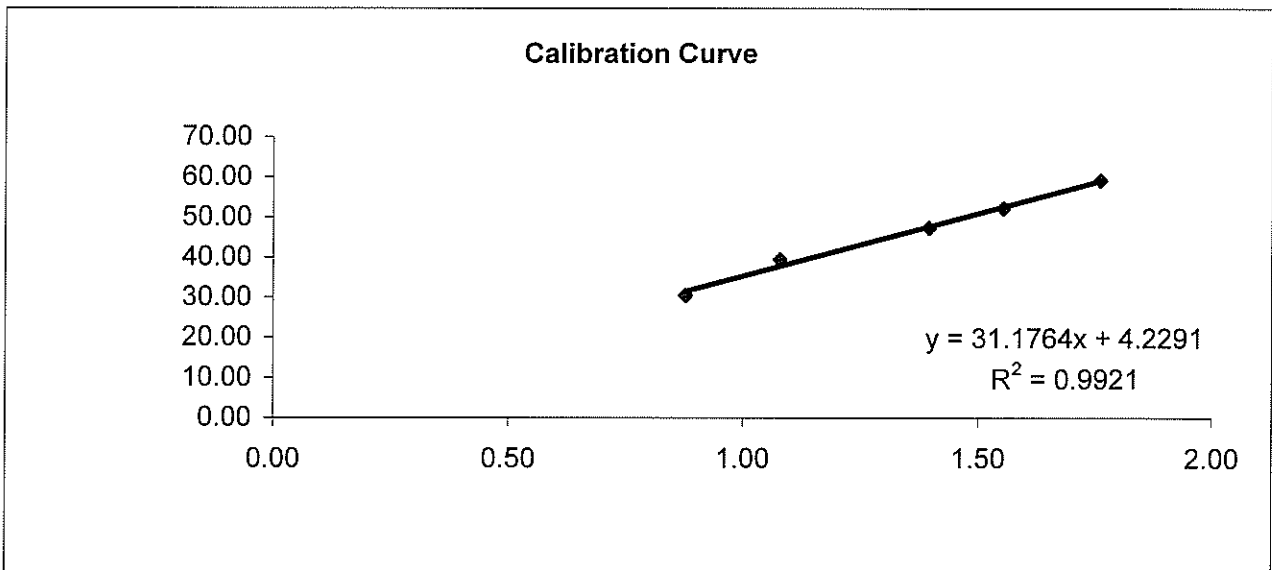
Resistance Plate No.	Manometer Reading (inch H ₂ O)	Flow Recorder Reading (CFM)	Calculated Q _{std} (m ³ /min)	Continuous Flow Recorder Reading IC (CFM)
5	3.10	31.00	0.88	30.60
7	4.70	40.00	1.08	39.49
10	7.90	48.00	1.40	47.38
13	9.80	53.00	1.55	52.32
18	12.60	60.00	1.76	59.23

Linear Regression

Sampler slope (m) : **31.1764**
 Sampler intercept (b) : **4.2291**
 Correlation coefficient (R²) : **0.9921**

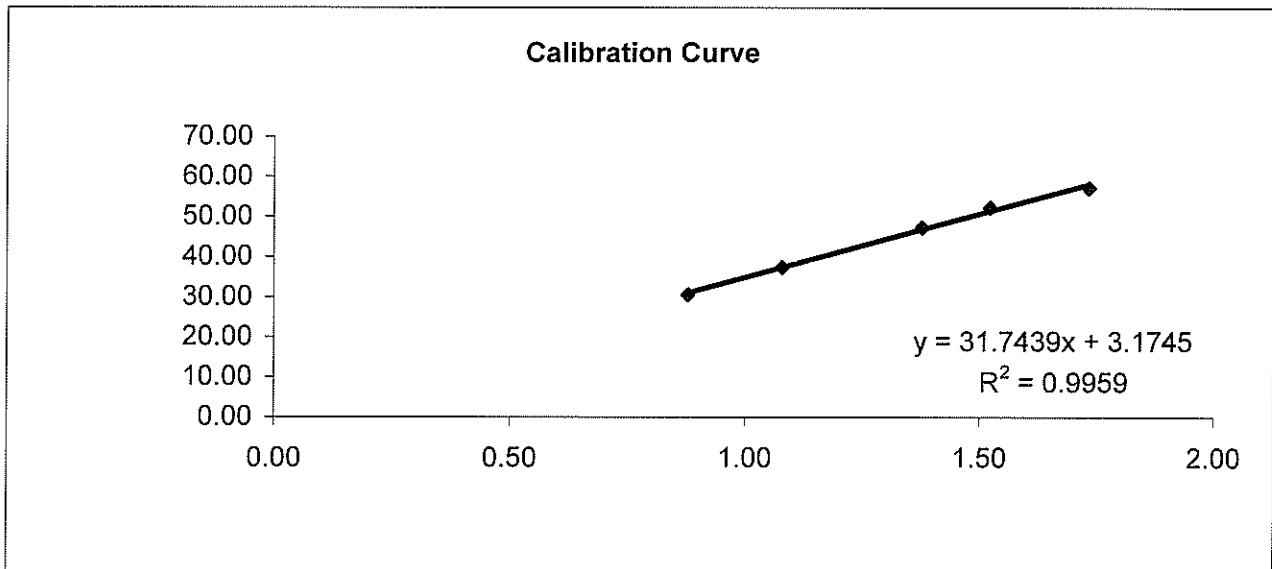
Resistance Plate No.	Manometer Reading (inch H ₂ O)	Flow Recorder Reading (CFM)	Calculated Q _{std} (m ³ /min)	Continuous Flow Recorder Reading IC (CFM)
5	3.10	31.00	0.88	30.60
7	4.70	38.00	1.08	37.51
10	7.70	48.00	1.38	47.38
13	9.40	53.00	1.52	52.32
18	12.20	58.00	1.73	57.25

Linear Regression

Sampler slope (m) : **31.7439**
 Sampler intercept (b) : **3.1745**
 Correlation coefficient (R²) : **0.9959**

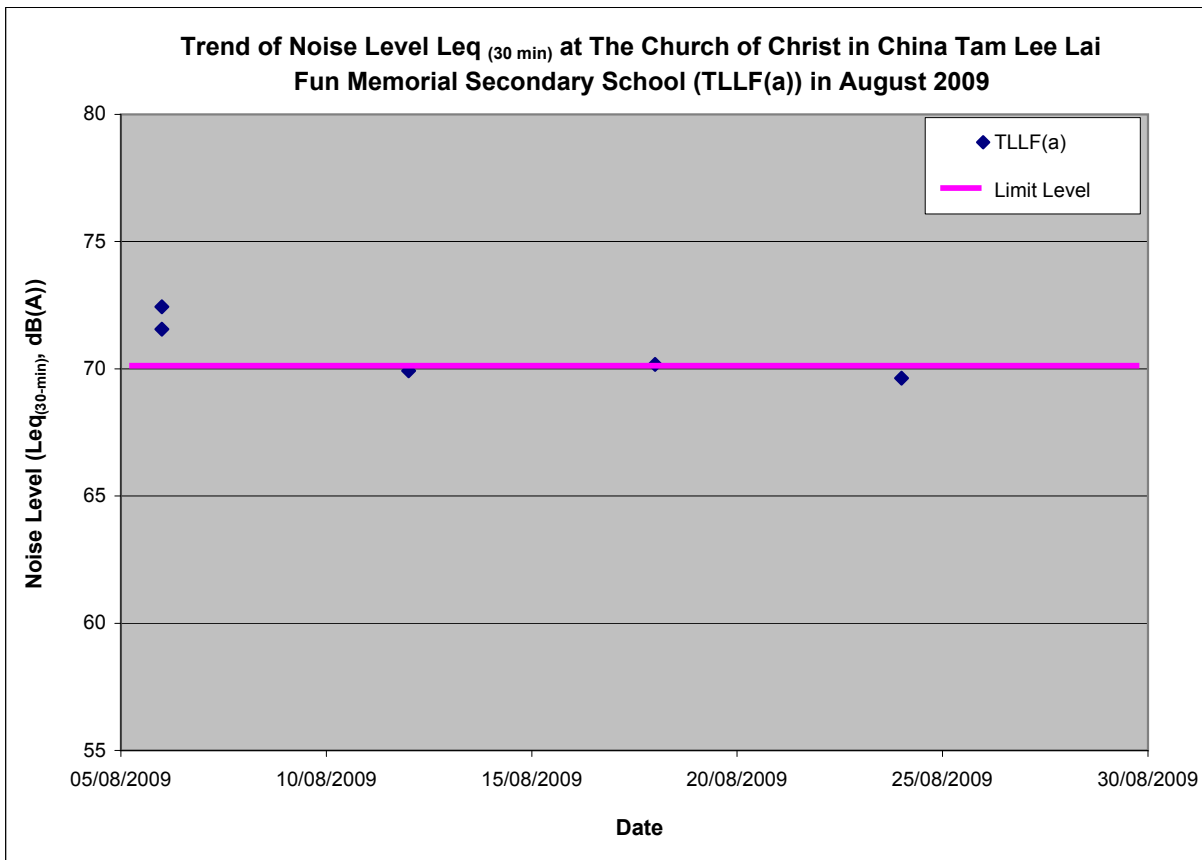
Notes:
(1) All Noise result on August 2009 were not project-related exceedance.

One limit level exceedance for noise measurement during non-restricted hours was recorded on 6 August 2009. On-site observations during the noise monitoring revealed that the noise source was mainly the traffic noise along Tuen Mun Road although it was also observed that the Contractor was undertaking the construction works of noise barriers and road re-construction mainly.

Together with the on-site observations and interpretation from the monitoring results, construction noise was considered insignificant and below the noise limit level. It was therefore concluded that the noise exceedance was not related to the construction activities. No further actions were applicable. It was however recommended that the Contractor shall maintain the existing practices stipulated in the EIA report in order to minimise the potential noise impact in future.

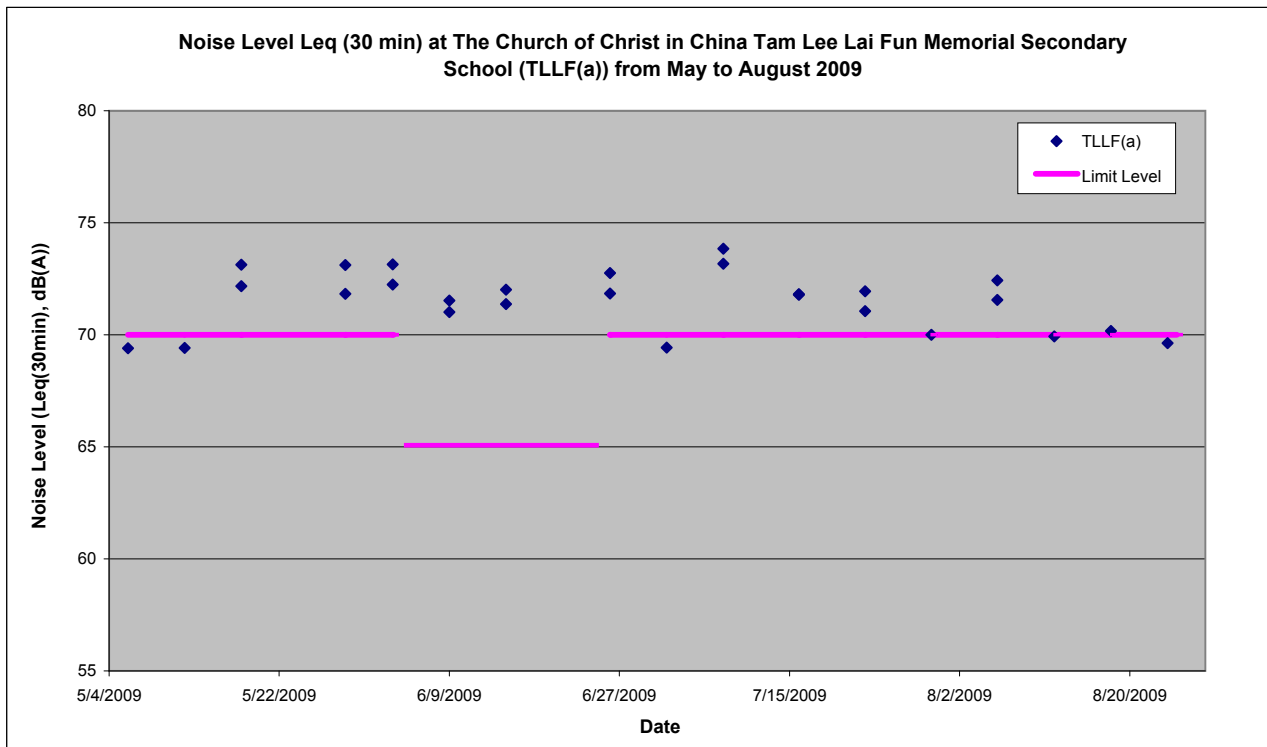
Notes:

- (1) All noise results exceeding limit level were not project-related.
- (2) 8-Jun to 19-Jun 2009 was the school examination period, the limit level is 65dB(A).
