Highways Department

Contract No.
HY/2007/14 Widening of
Tuen Mun Road at
Tsing Tin Interchange

Monthly Environmental
Monitoring and Audit
Report – November 2009

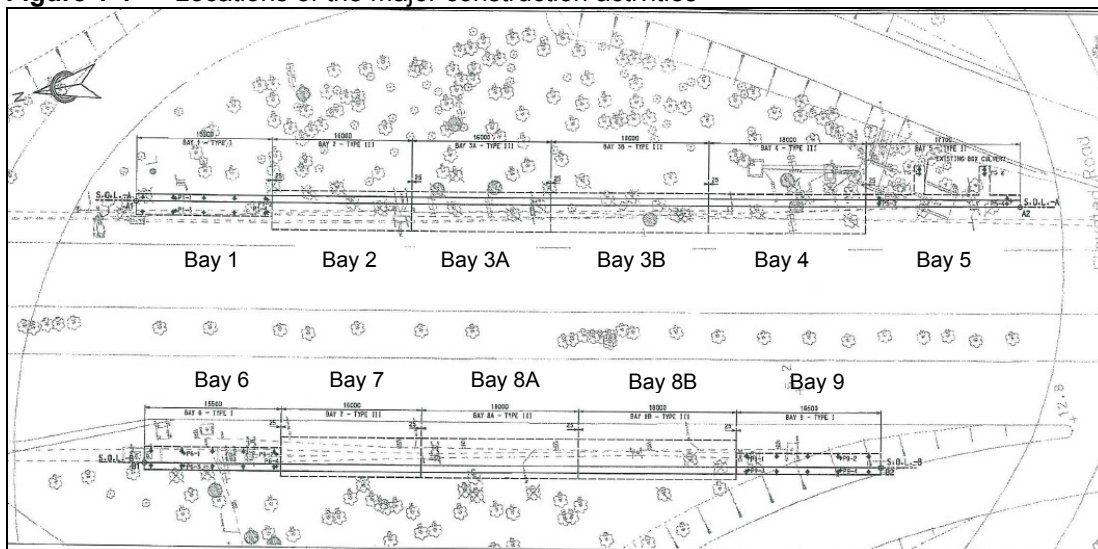
Figure 1-1 Locations of the major construction activities

Construction Activities	Location	Daily Excavation Rate
Site clearance	Whole Site Area	Range: 0 to 20 m ³
Superstructure of noise barrier construction	Whole Site Area	
Drainage & road re-construction	Whole Site Area	
Street furniture installation	Whole Site Area	Not applicable

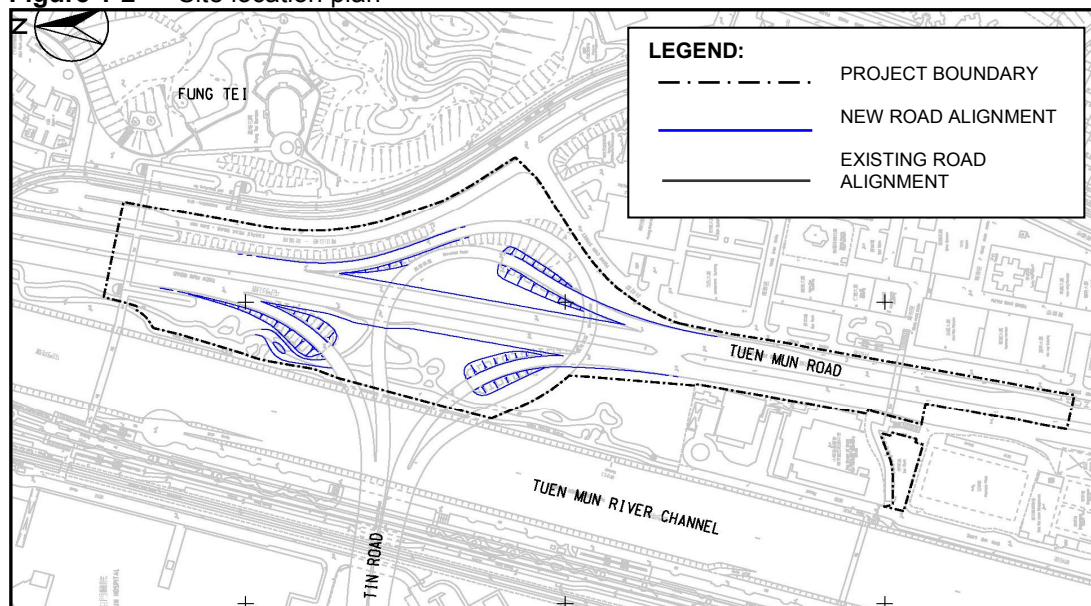
Figure 1-2 Site location plan

The project area and the location of the sensitive receivers and monitoring stations are shown in **Figures 1-2 and 1-3** respectively, while **Table 1-3** shows the detail correspondences of monitoring stations.

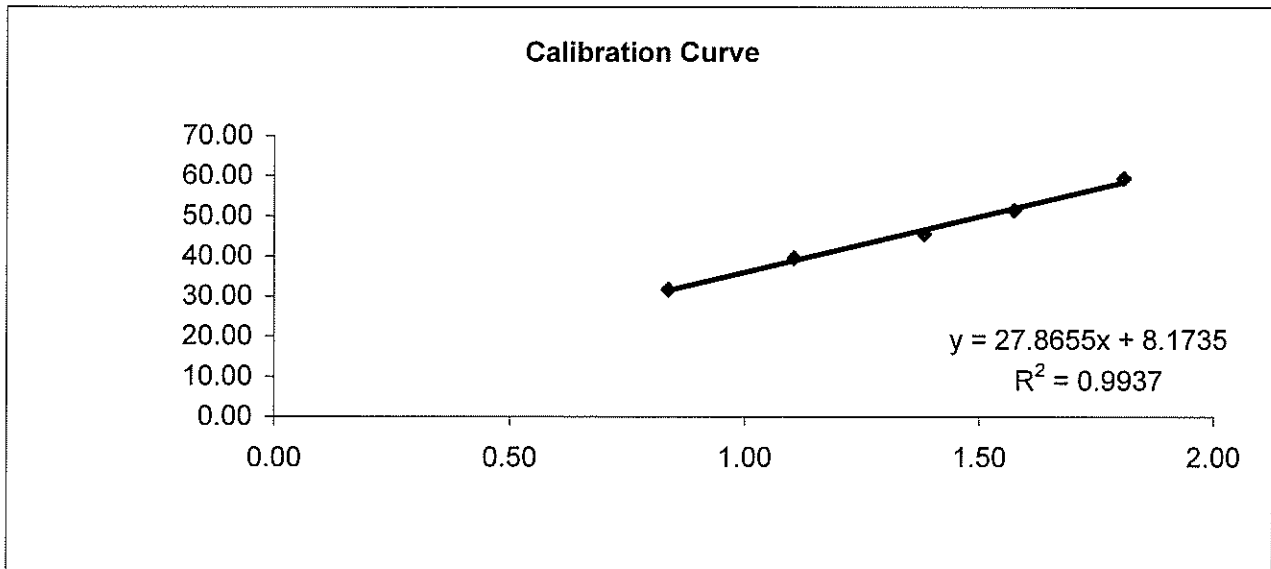
Resistance Plate No.	Manometer Reading (inch H ₂ O)	Flow Recorder Reading (CFM)	Calculated Q _{std} (m ³ /min)	Continuous Flow Recorder Reading IC (CFM)
5	2.80	32.00	0.84	31.69
7	4.90	40.00	1.11	39.62
10	7.70	46.00	1.38	45.56
13	10.00	52.00	1.57	51.50
18	13.20	60.00	1.81	59.42

Sampler slope (m) :	27.8655
Sampler intercept (b) :	8.1735
Correlation coefficient (R ²) :	0.9937

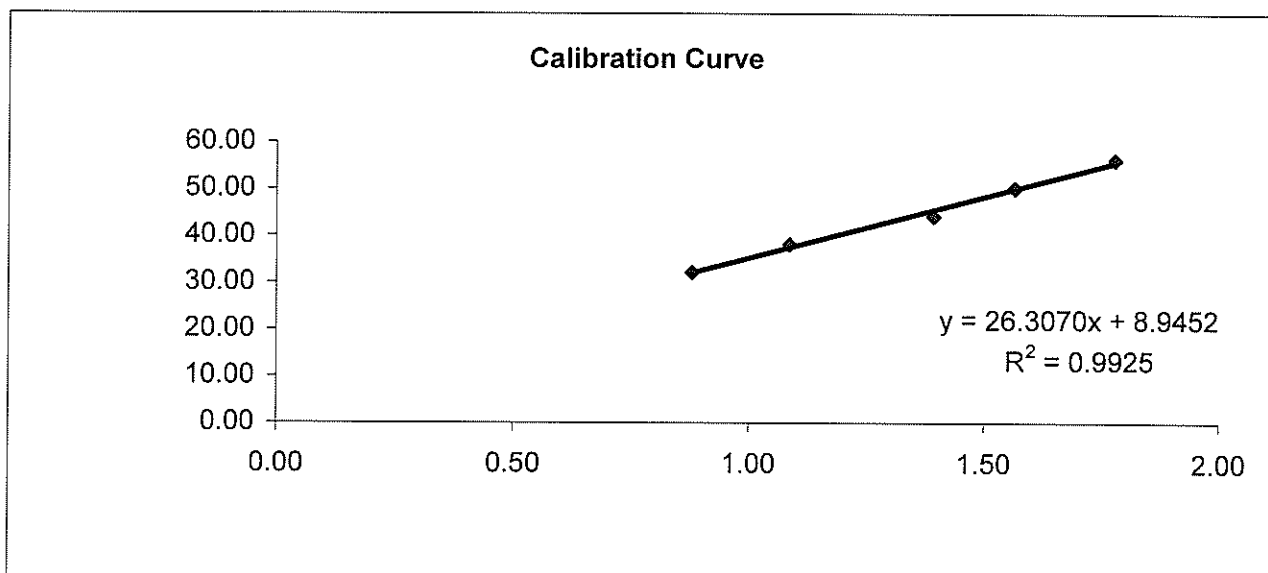
Resistance Plate No.	Manometer Reading (inch H ₂ O)	Flow Recorder Reading (CFM)	Calculated Q _{std} (m ³ /min)	Continuous Flow Recorder Reading IC (CFM)
5	3.00	32.00	0.88	32.15
7	4.60	38.00	1.09	38.18
10	7.60	44.00	1.39	44.21
13	9.60	50.00	1.57	50.23
18	12.40	56.00	1.78	56.26

Sampler slope (m) :	26.3070
Sampler intercept (b) :	8.9452
Correlation coefficient (R ²) :	0.9925

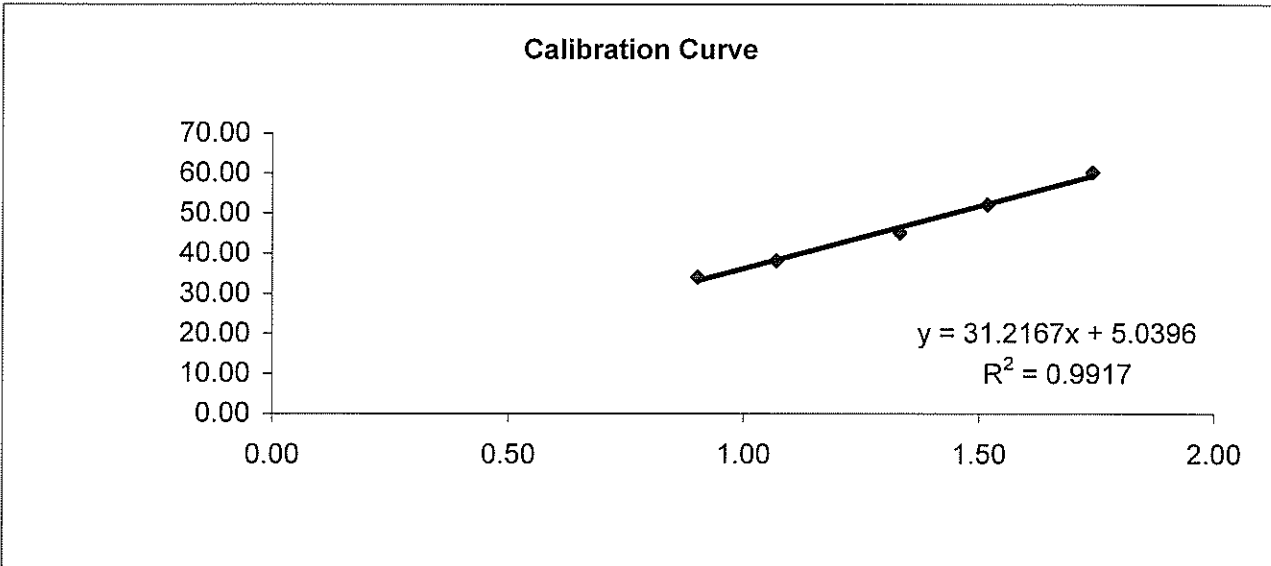
Calibration date	26-Nov-09	Barometric pressure	762 mm Hg
Calibration due date	25-Jan-10	Temperature (°C)	23 °C
Sampler location	TT2 - G/F Tam Lee Lai Fun Memorial School	Temperature (K)	296 K
Sampler model	TE-5170	P _{std}	760 mm Hg
Sampler serial number	0523	T _{std}	298 K
Calibrator model	GMW-2535		
Calibrator serial number	1378		
Slope of the standard curve, m _s	2.00826		
Intercept of the standard curve, b _s	-0.01649

Resistance Plate No.	Manometer Reading (inch H ₂ O)	Flow Recorder Reading (CFM)	Calculated Q _{std} (m ³ /min)	Continuous Flow Recorder Reading IC (CFM)
5	3.20	34.00	0.90	34.16
7	4.50	38.00	1.07	38.18
10	7.00	45.00	1.33	45.21
13	9.10	52.00	1.52	52.24
18	12.00	60.00	1.74	60.28

Sampler slope (m) : **31.2167**
 Sampler intercept (b) : **5.0396**
 Correlation coefficient (R²) : **0.9917**

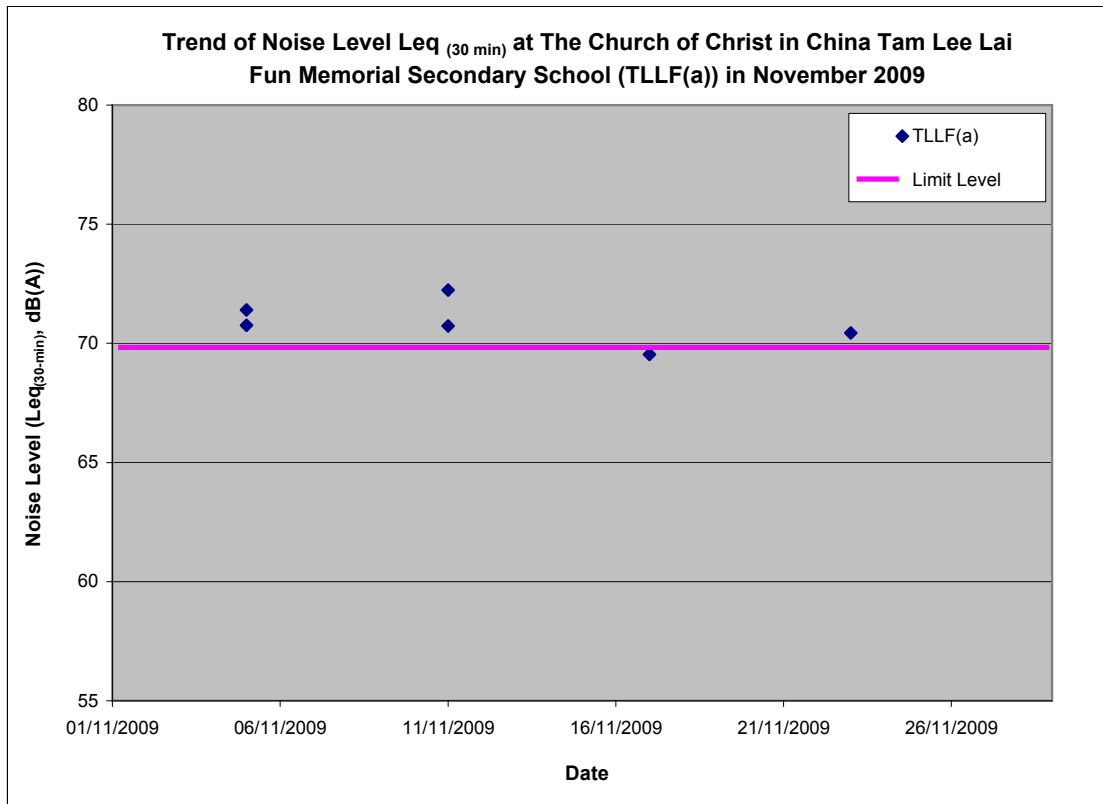
- (1) All Noise results on November 2009 were not project-related exceedance.

Two limit level exceedance for noise measurement during non-restricted hours were recorded on 5 and 11 November 2009. On-site observations during the noise monitoring revealed that the noise source was mainly the traffic noise along Tuen Mun Road although it was also observed that major construction works including slope re-compaction and road reconstruction were implemented. Together with the on-site observations and interpretation from the monitoring results, construction noise was considered insignificant and below the noise limit level. It was therefore concluded that the noise exceedance were not related to the construction activities. No further actions were applicable. It was however recommended that the Contractor shall maintain the existing practices stipulated in the EIA report in order to minimise the potential noise impact in future.

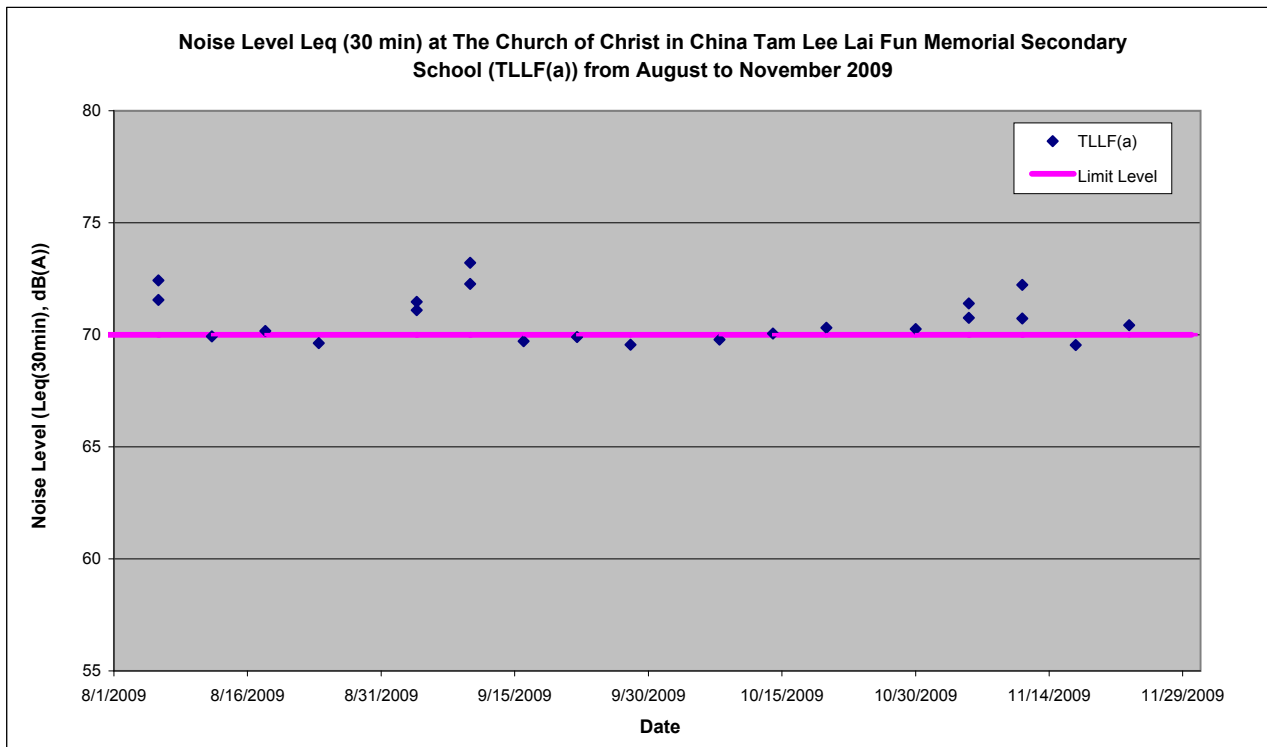
(1) All noise results exceeding limit level were not project-related.
