China Harbour Engineering Company Limited

Contract No. DC/2009/09
Construction of Tai Po Sewage Treatment
Works – Stage V Phase II B

**Quarterly Environmental Monitoring
and Audit Summary Report
(January to March 2011)**

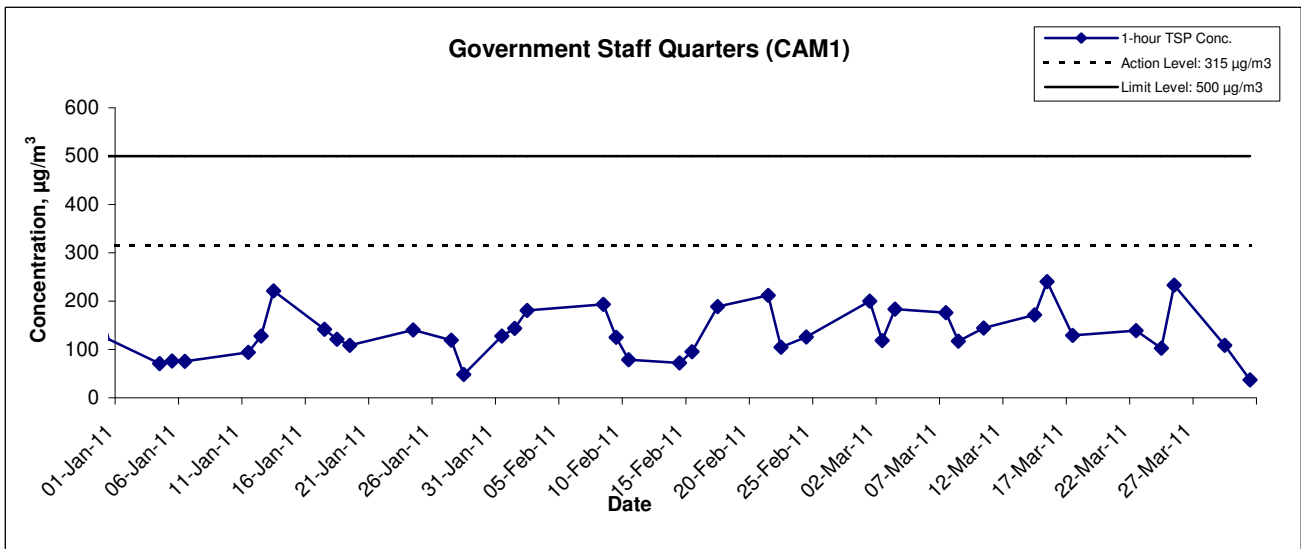
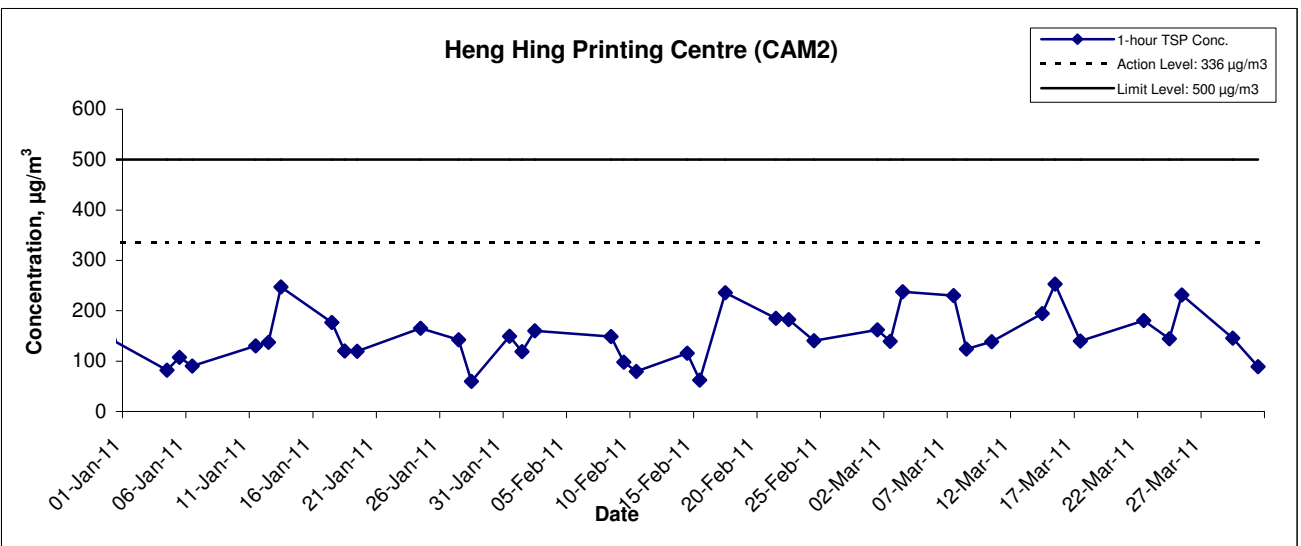
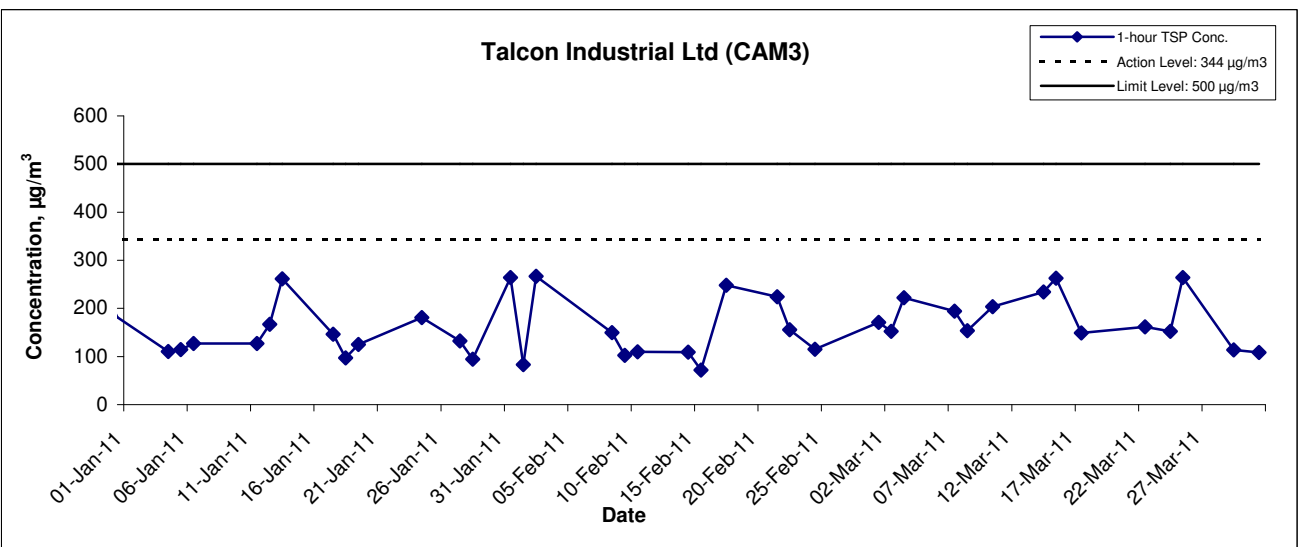
Title Contract No. DC/2009/09 Construction of Tai Po Sewage Treatment Works - Stage V Phase II B Graphical Presentation of 1-hour TSP Impact Monitoring Results	Scale N.T.S	Project No. MA0010	
	Date Mar 11	Appendix D

1-hr TSP Concentration Levels

- 3.2 Air quality monitoring was conducted as scheduled in the reporting period.
- 3.3 Graphical presentations of 1-hr TSP and 24-hr TSP monitoring results are shown in **Appendices D** and **E**, respectively.
- 3.4 All measured 1-hr and 24-hr TSP levels were below the Action/Limit Levels. No exceedance was recorded in the reporting quarter.

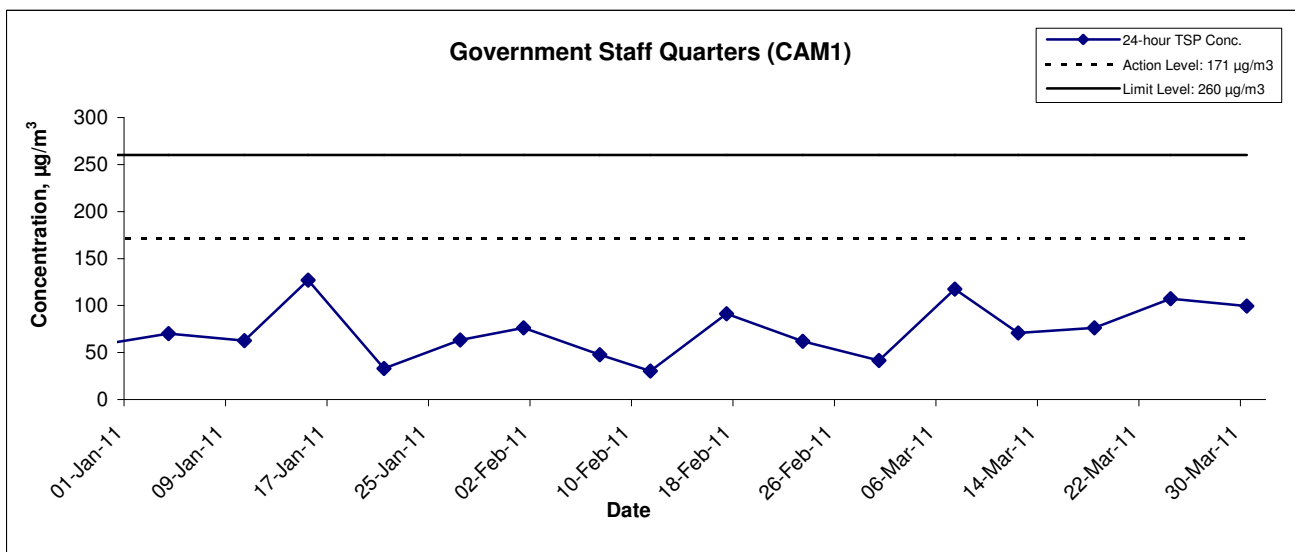
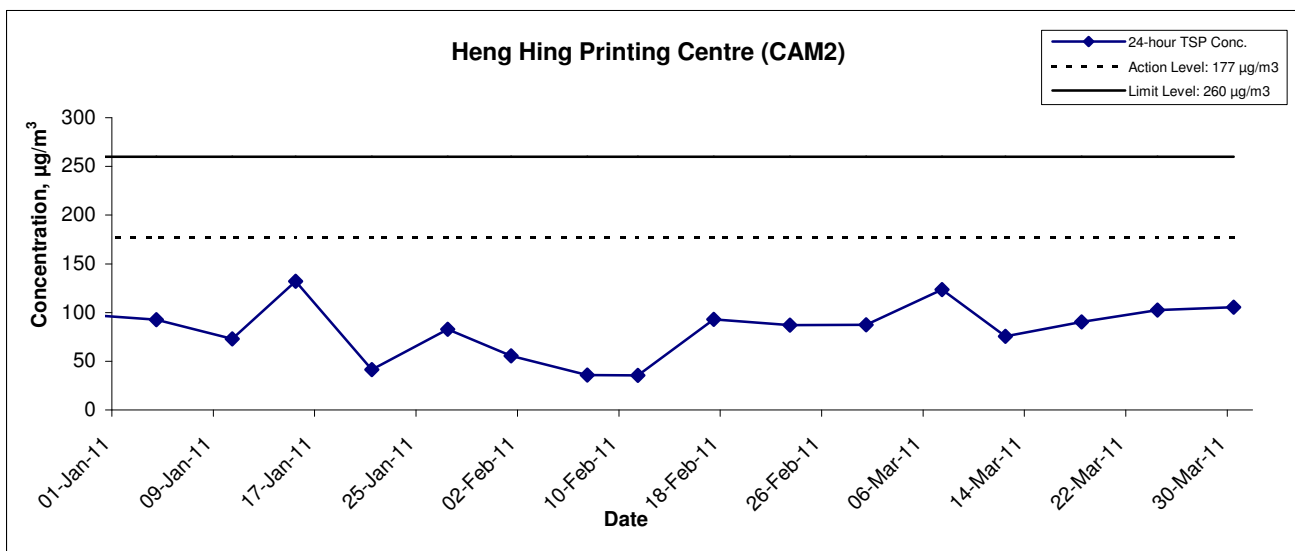
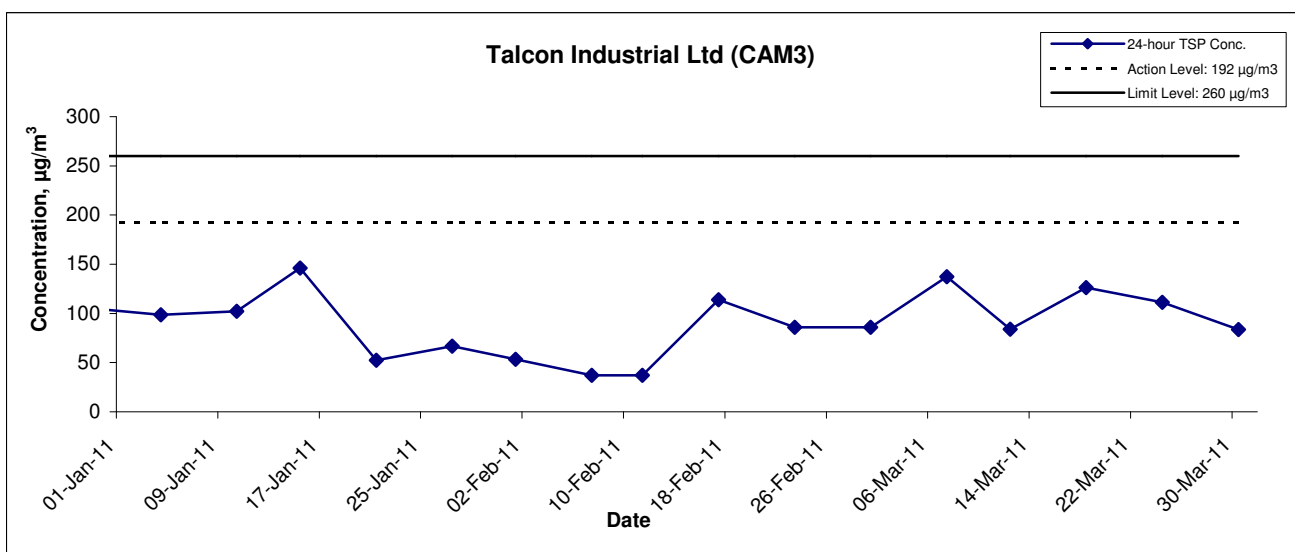
Title Contract No. DC/2009/09 Construction of Tai Po Sewage Treatment Works - Stage V Phase II B Graphical Presentation of 24-hour TSP Impact Monitoring Results	Scale N.T.S	Project No. MA0010	CINOTECH
	Date Mar 11	Appendix E

24-hr TSP Concentration Levels

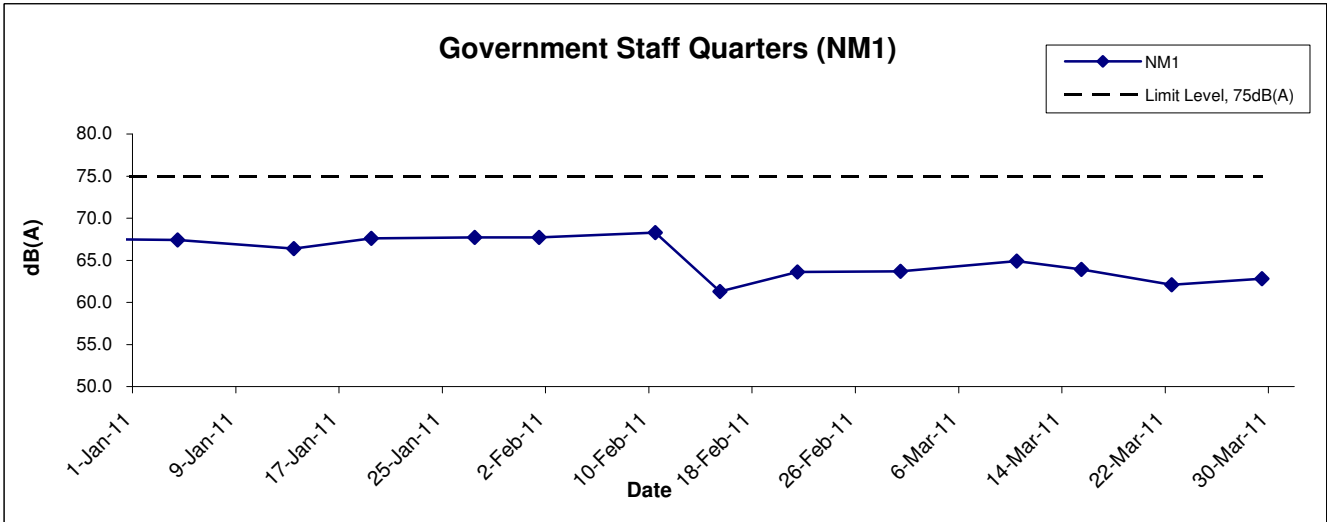
Title Contract No. DC/2009/09 Construction of Tai Po Sewage Treatment Works - Stage V Phase II B Graphical Presentation of Construction Noise Monitoring Results	Scale N.T.S	Project No. MA0010	
	Date Mar 11	Appendix F

Noise Levels

- 3.5 All construction noise monitoring was conducted as scheduled in the reporting period.
- 3.6 Graphical representations of the monitoring results are shown in **Appendix F**. No Action Level (public complaint) / Limit Level exceedance was recorded in the reporting period.

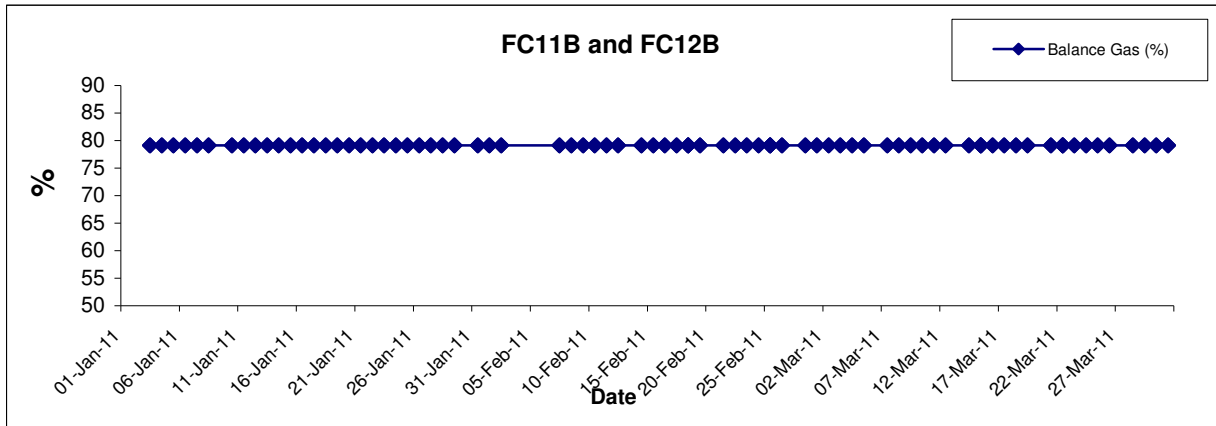
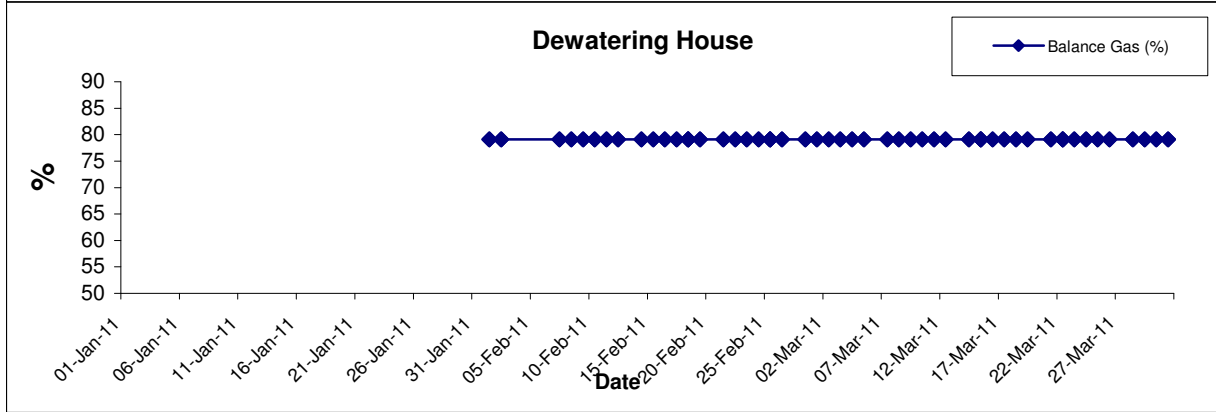
Title Contract No. DC/2009/09 Construction of Tai Po Sewage Treatment Works - Stage V Phase II B Graphical Presentation of Landfill Gas Measurement	Scale N.T.S	Project No. MA0010	CINOTECH
	Date Mar 11	Appendix G

Balance Gas

- 3.7 All Landfill gas measurements were performed by the Safety Officer of the civil works Contractor (CHEC) in the reporting period.
- 3.8 Graphical representations of the monitoring results are shown in **Appendix G**. No Action/Limit Level exceedance was recorded in the reporting period.

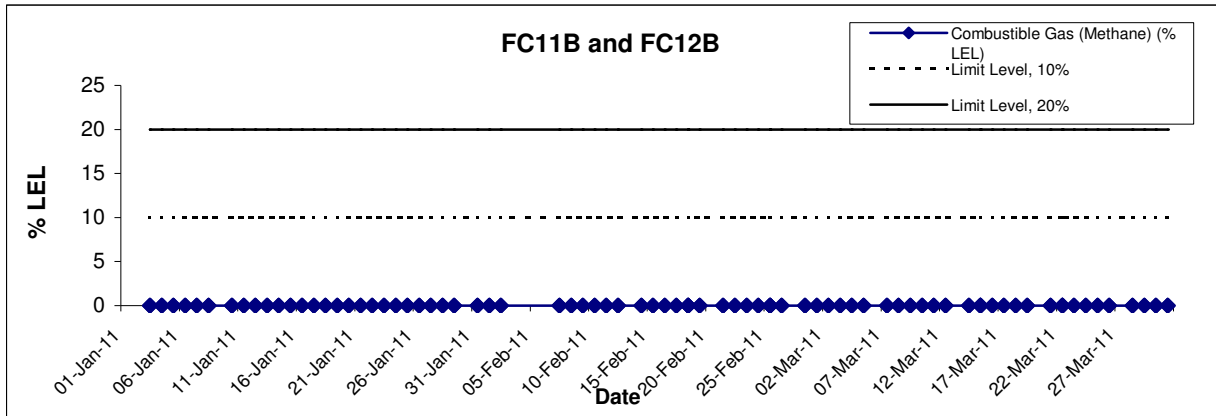
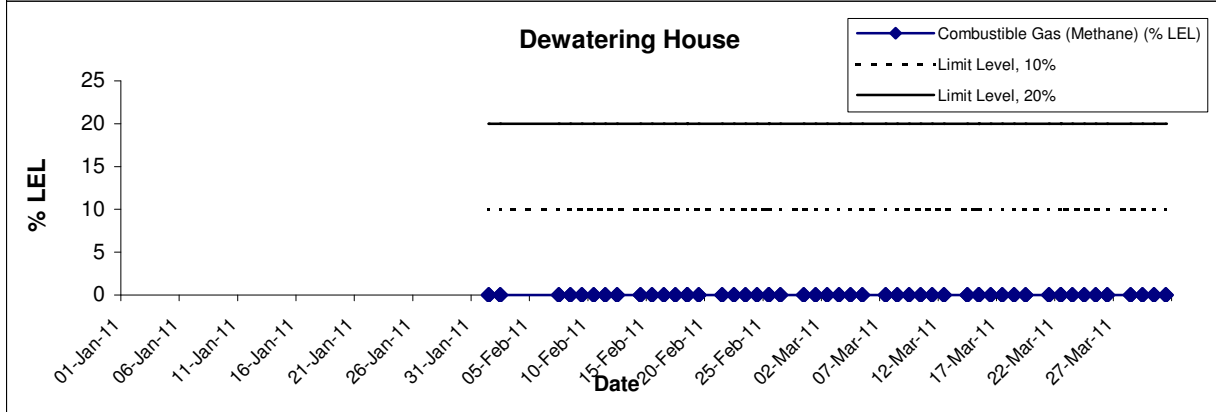
Title Contract No. DC/2009/09 Construction of Tai Po Sewage Treatment Works - Stage V Phase II B Graphical Presentation of Landfill Gas Measurement	Scale N.T.S	Project No. MA0010	CINOTECH
	Date Mar 11	Appendix G

Combustible Gas (Methane)

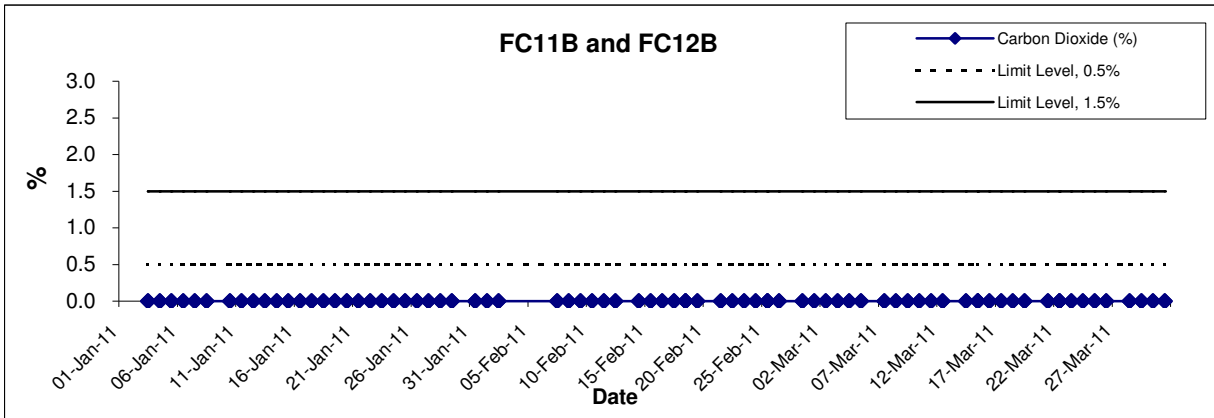
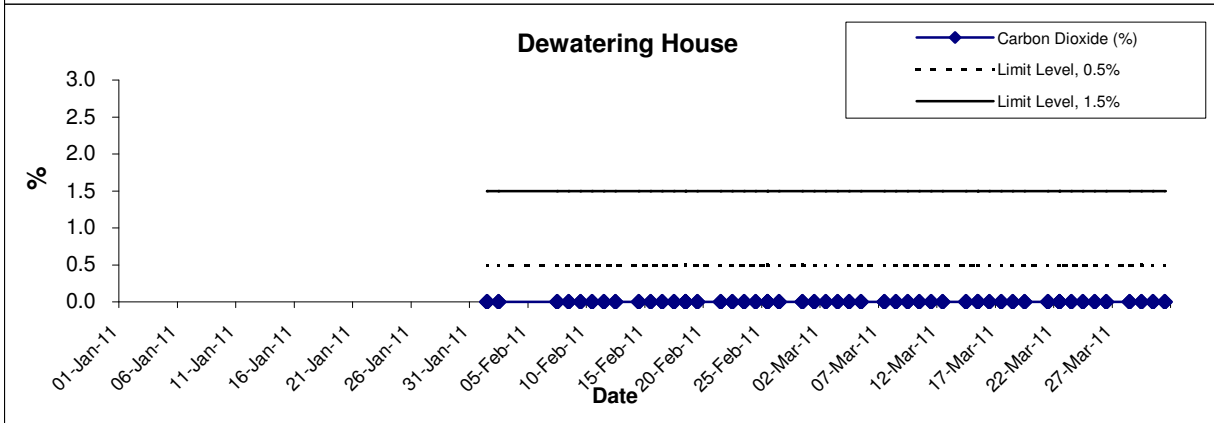
Title Contract No. DC/2009/09 Construction of Tai Po Sewage Treatment Works - Stage V Phase II B Graphical Presentation of Landfill Gas Measurement	Scale N.T.S	Project No. MA0010	CINOTECH
	Date Mar 11	Appendix G

Carbon Dioxide

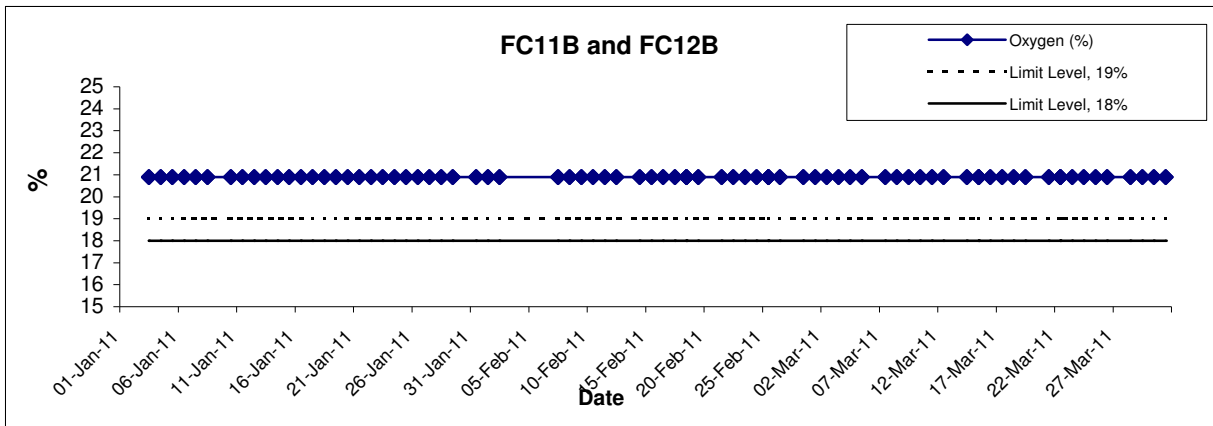
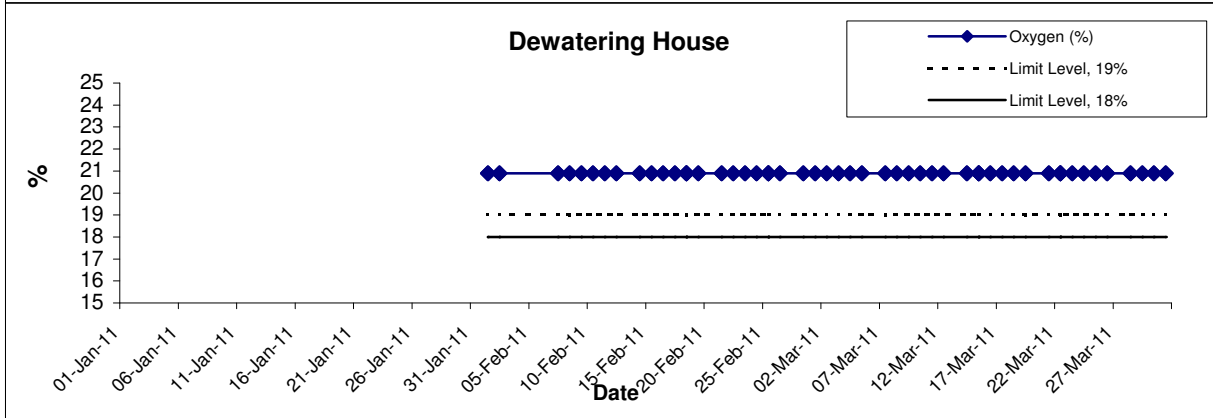
Title Contract No. DC/2009/09 Construction of Tai Po Sewage Treatment Works - Stage V Phase II B Graphical Presentation of Landfill Gas Measurement	Scale N.T.S	Project No. MA0010	CINOTECH
	Date Mar 11	Appendix G

Oxygen
