**Contract No. HY/2012/07  
Tuen Mun – Chek Lap Kok Link –  
Southern Connection Viaduct Section**

*Tenth Quarterly Environmental Monitoring &  
Audit (EM&A) Report*

02 November 2016

**Contract No. HY/2012/07 TM-CLKL Southern Connection Viaduct  
Section  
10th Quarterly EM&A Summary Report (March 2016 to May 2016)**

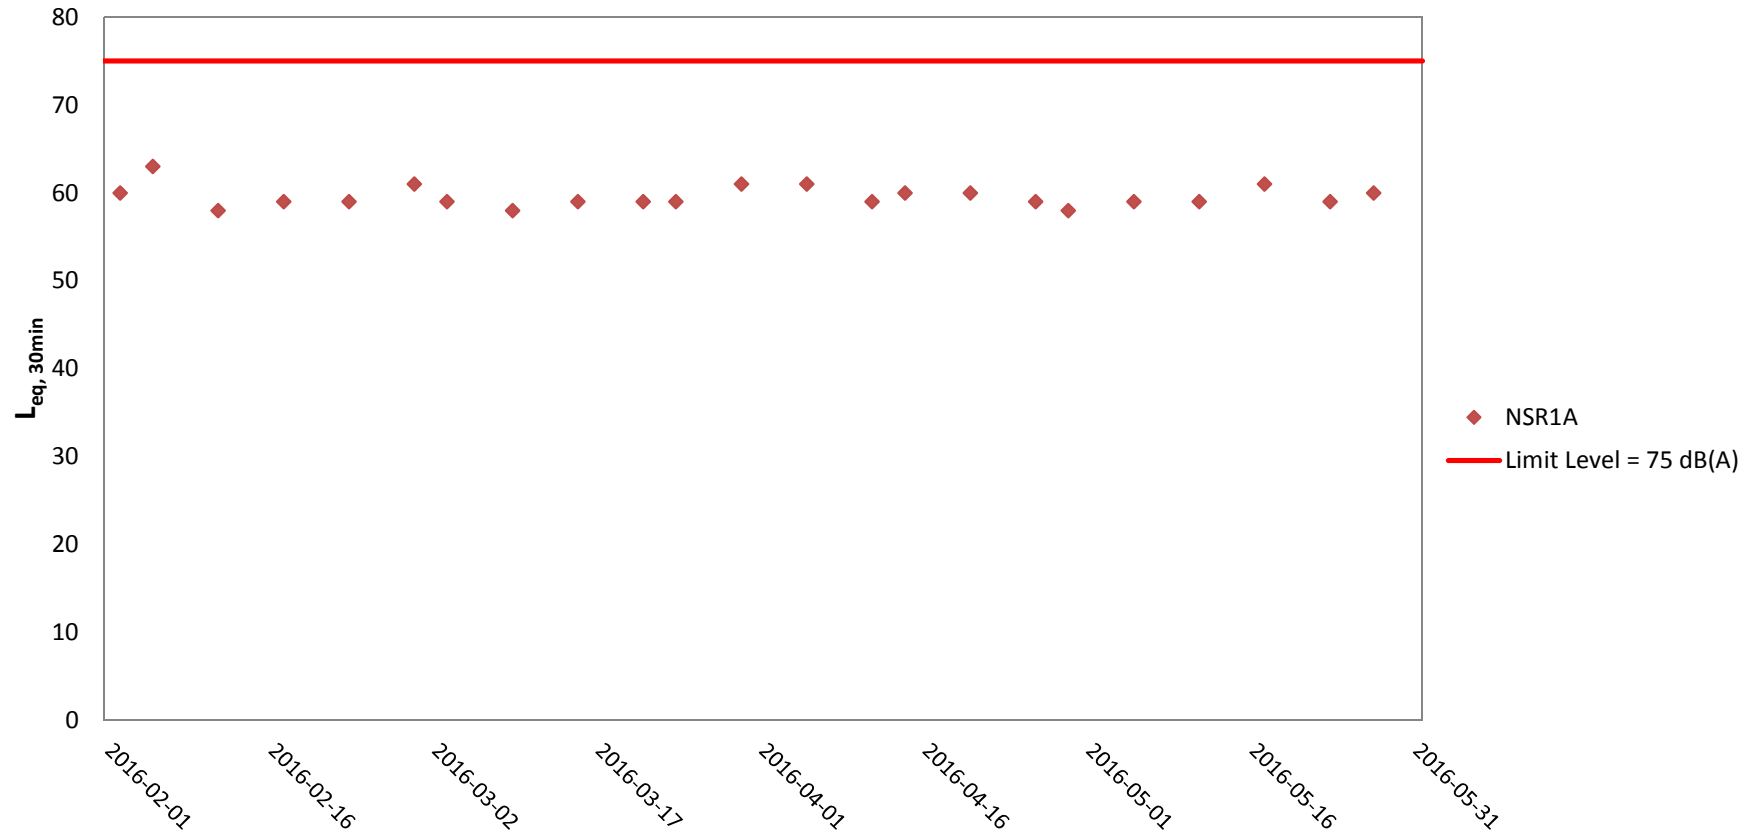
## Noise Monitoring Results at NSR 1A ( $L_{eq, 30min}$ )

*Weather condition within the reporting period varied between sunny to rainy.*

*Major construction works undertaken within the reporting period include Pier construction; Re-alignment of Cheung Tung Road; Construction of land section of berth at Southern Landfall; Installation of pier head and deck segments; and Slope work of Viaducts A, B & C.*

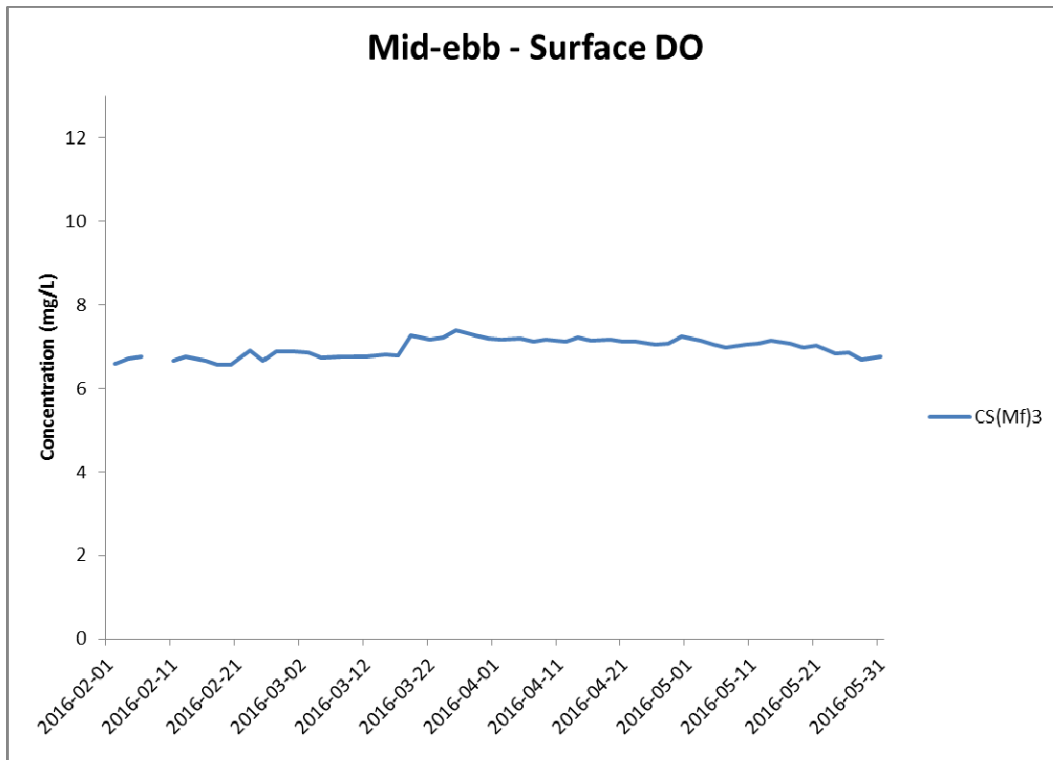
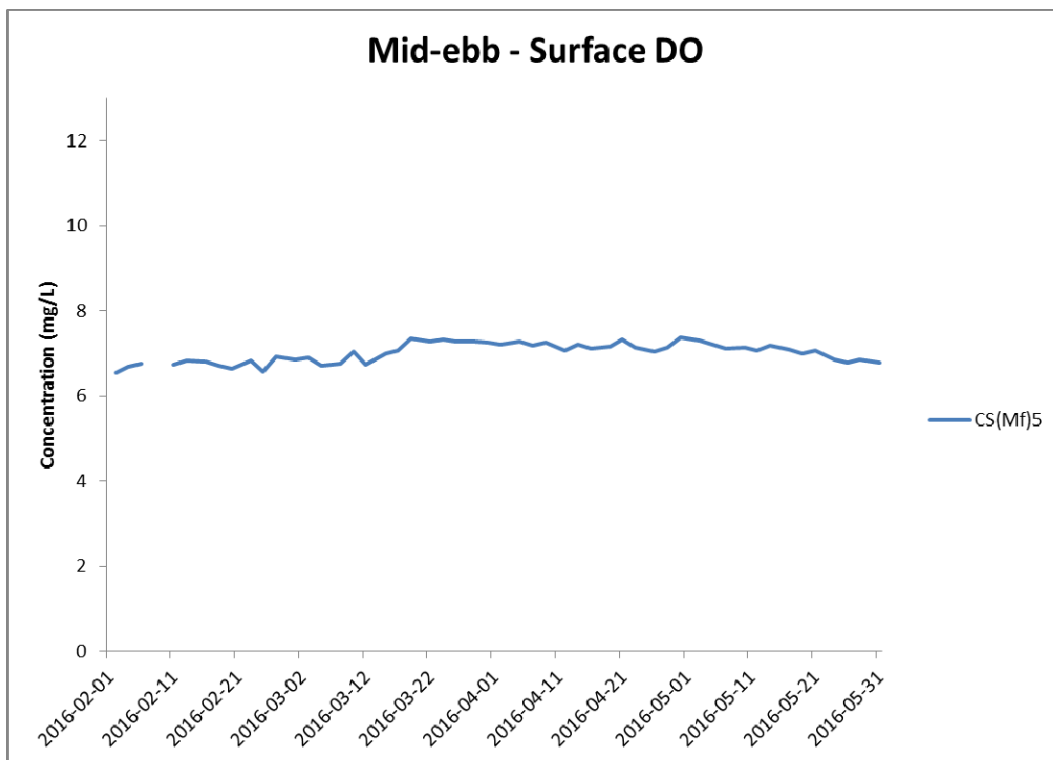
**Figure H1 Impact Monitoring - Mean Level of Dissolved Oxygen (mg/L) in surface waters during mid-ebb tide between 1 February and 31 May 2016 at CS(Mf)3 and CS(Mf)5.**

*WQM was cancelled on 9 February 2016 due to suspension of marine works. (Weather condition varied between sunny to rainy within the reporting period.) Marine works within the reporting period include Construction and installation of pile caps; Uninstallation of marine piling platform; Pier construction; Construction of marine section of berth at Southern Landfall; Launching gantry operation; and Installation of deck segment and pier head segment.*

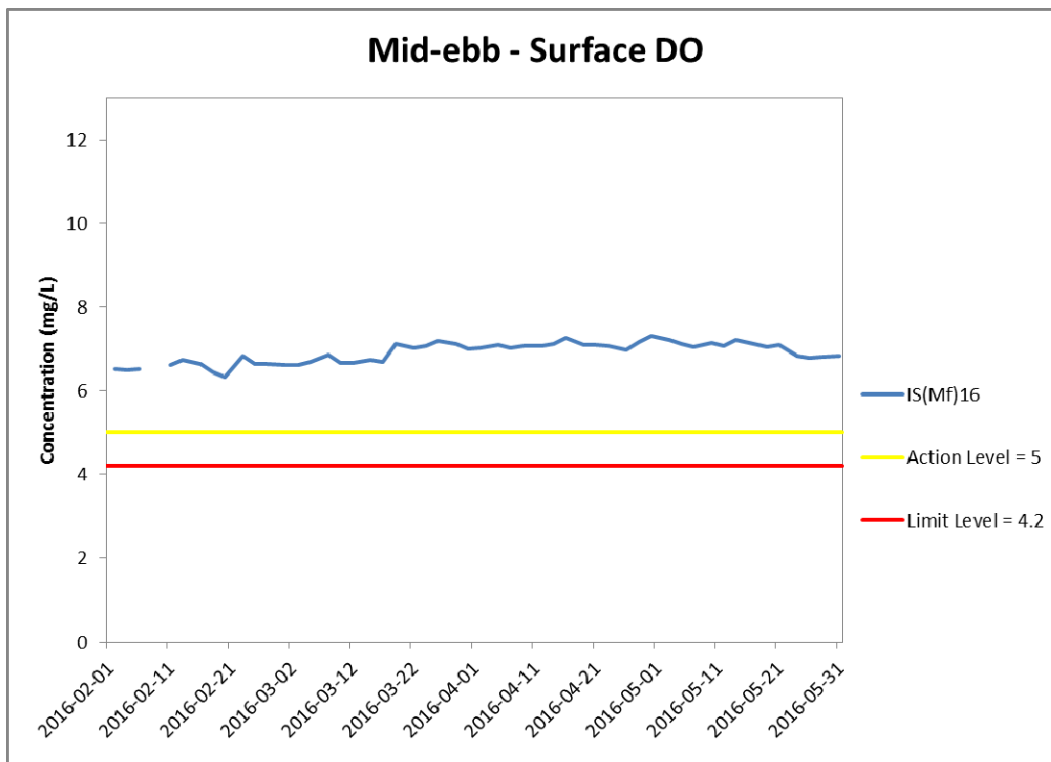
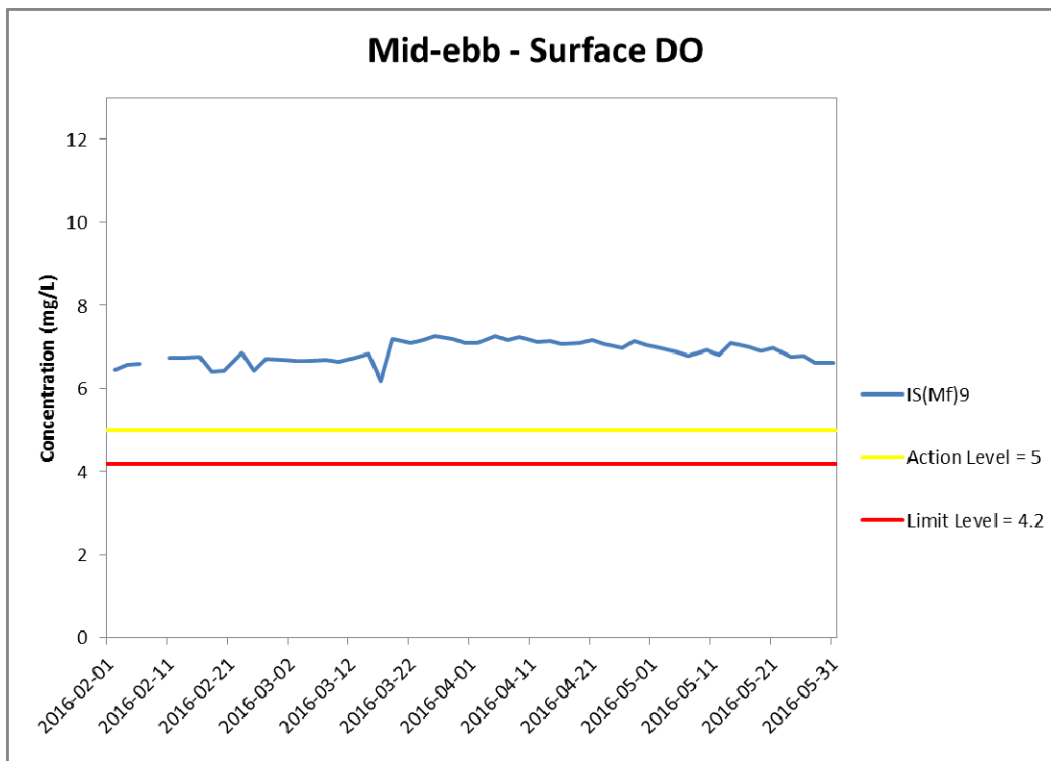
**Figure H2 Impact Monitoring – Mean Level of Dissolved Oxygen (mg/L) in surface waters during mid-ebb tide between 1 February and 31 May 2016 at IS(Mf)16 and IS(Mf)9.**

*WQM was cancelled on 9 February 2016 due to suspension of marine works. (Weather condition varied between sunny to rainy within the reporting period.) Marine works within the reporting period include Construction and installation of pile caps; Uninstallation of marine piling platform; Pier construction; Construction of marine section of berth at Southern Landfall; Launching gantry operation; and Installation of deck segment and pier head segment.*

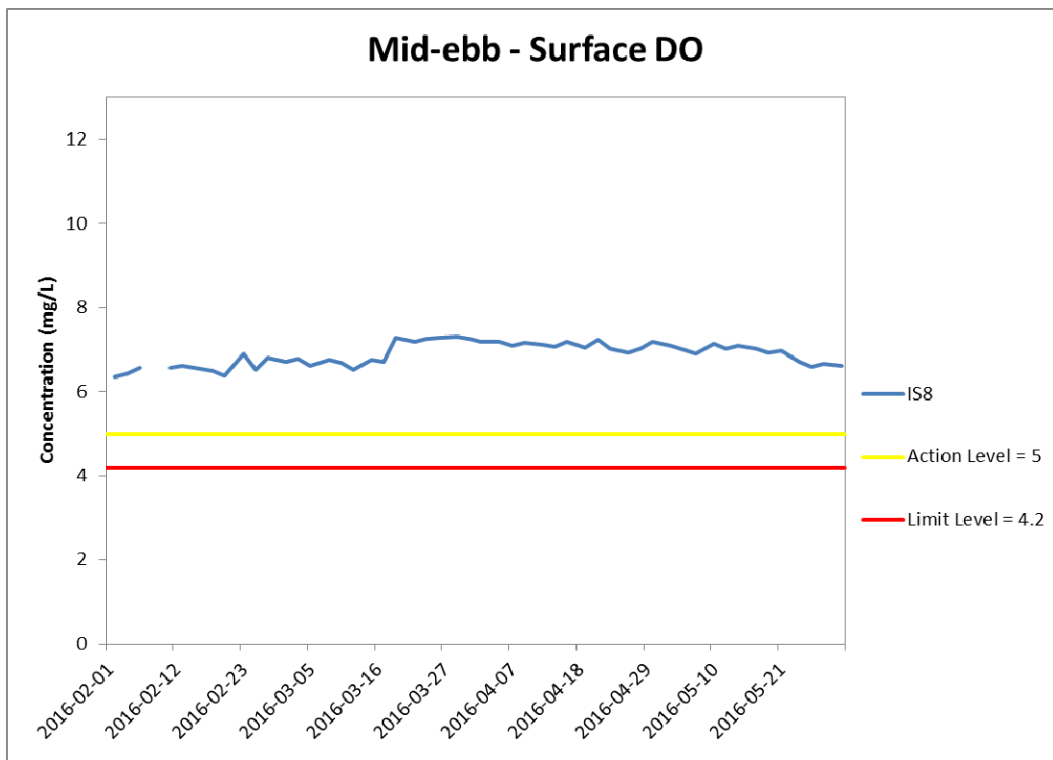
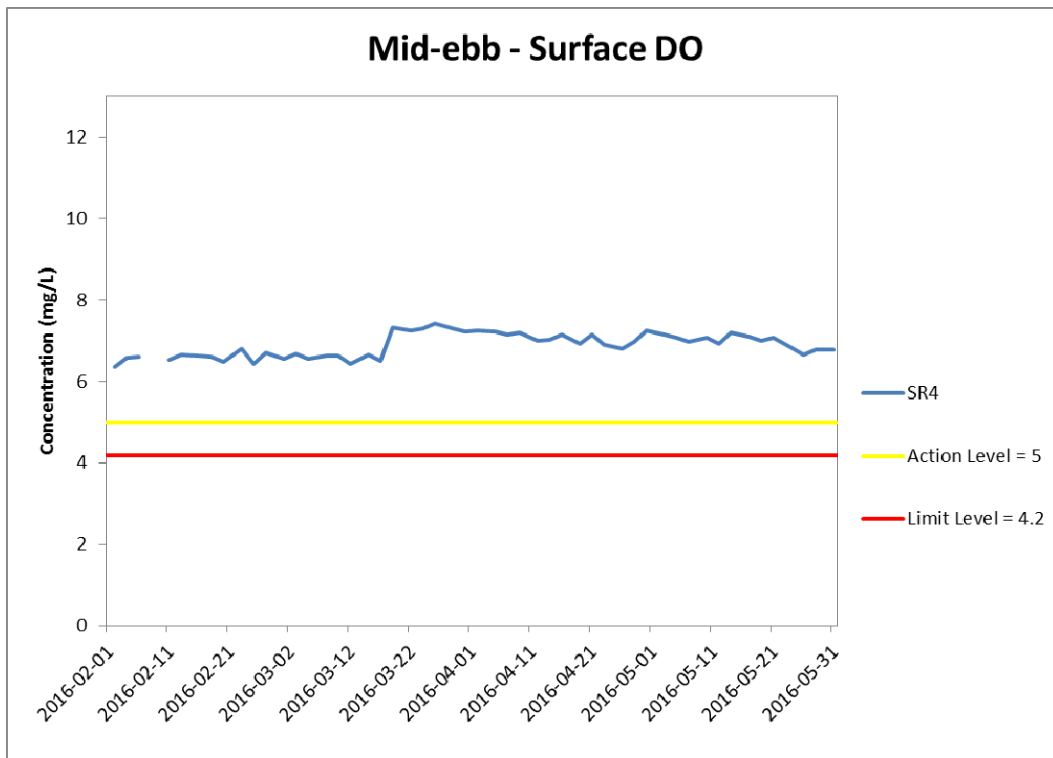
**Figure H3 Impact Monitoring – Mean Level of Dissolved Oxygen (mg/L) in surface waters during mid-ebb tide between 1 February and 31 May 2016 at IS8 and SR4.**

*WQM was cancelled on 9 February 2016 due to suspension of marine works. (Weather condition varied between sunny to rainy within the reporting period.) Marine works within the reporting period include Construction and installation of pile caps; Uninstallation of marine piling platform; Pier construction; Construction of marine section of berth at Southern Landfall; Launching gantry operation; and*

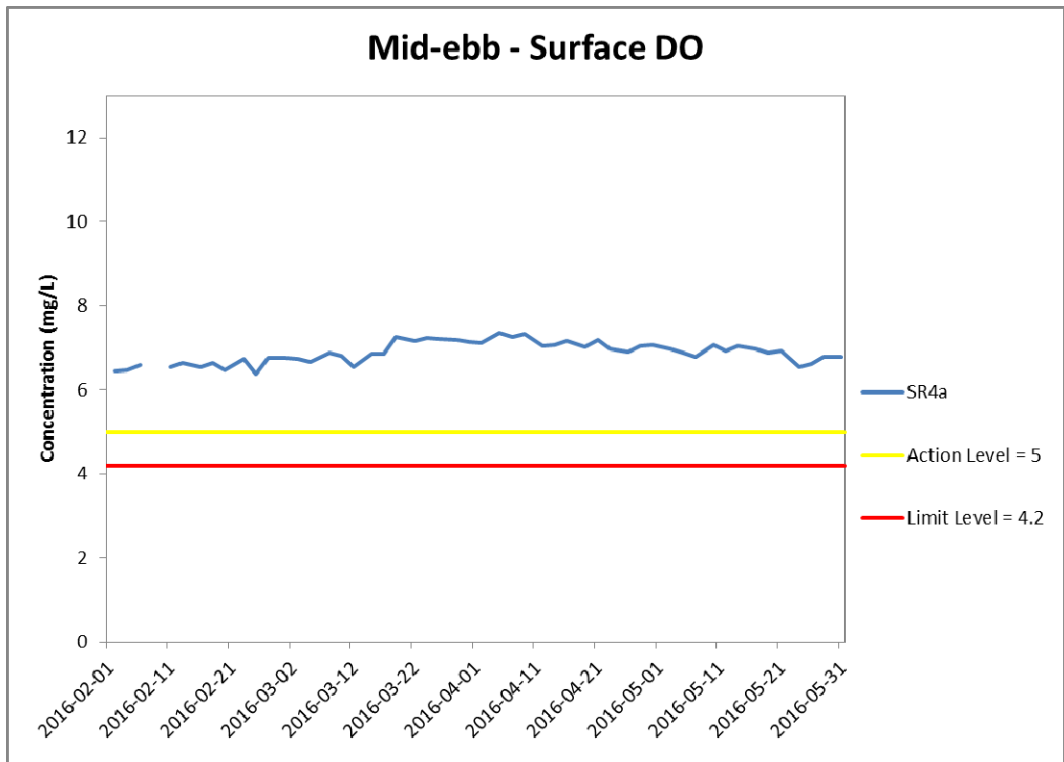
**Figure H4 Impact Monitoring - Mean Level of Dissolved Oxygen (mg/L) in surface waters during mid-ebb tide between 1 February and 31 May 2016 at SR4a.**

*WQM was cancelled on 9 February 2016 due to suspension of marine works. (Weather condition varied between sunny to rainy within the reporting period.) Marine works within the reporting period include Construction and installation of pile caps; Uninstallation of marine piling platform; Pier construction; Construction of marine section of berth at Southern Landfall; Launching gantry operation; and Installation of deck segment and pier head segment.*

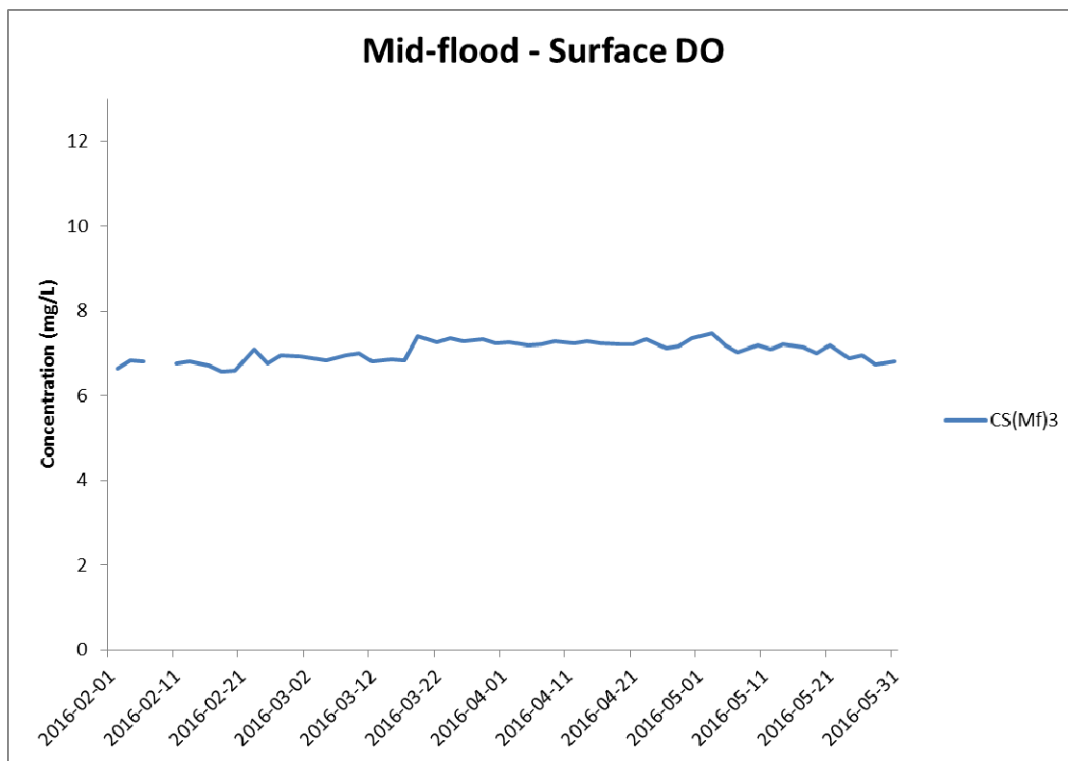
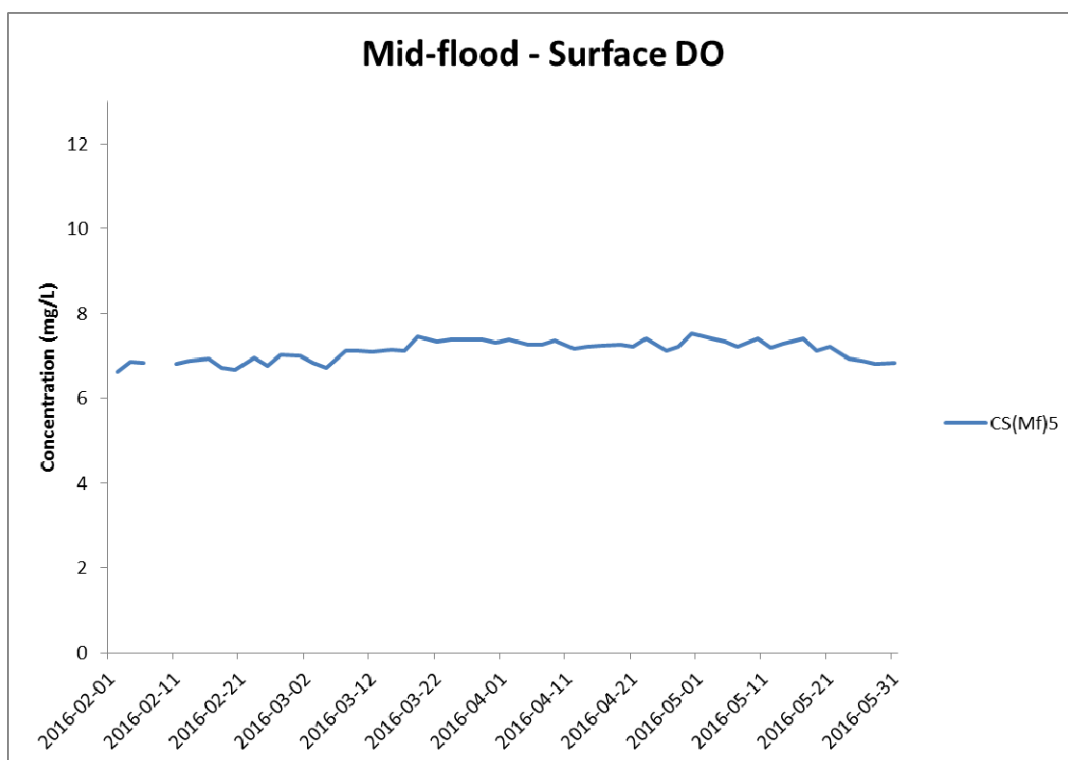
**Figure H5 Impact Monitoring - Mean Level of Dissolved Oxygen (mg/L) in surface waters during mid-flood tide between 1 February and 31 May 2016 at CS(Mf)3 and CS(Mf)5.**

WQM was cancelled on 9 February 2016 due to suspension of marine works. (Weather condition varied between sunny to rainy within the reporting period.) Marine works within the reporting period include Construction and installation of pile caps; Uninstallation of marine piling platform; Pier construction; Construction of marine section of berth at Southern Landfall; Launching gantry operation; and Installation of deck segment and pier head segment.

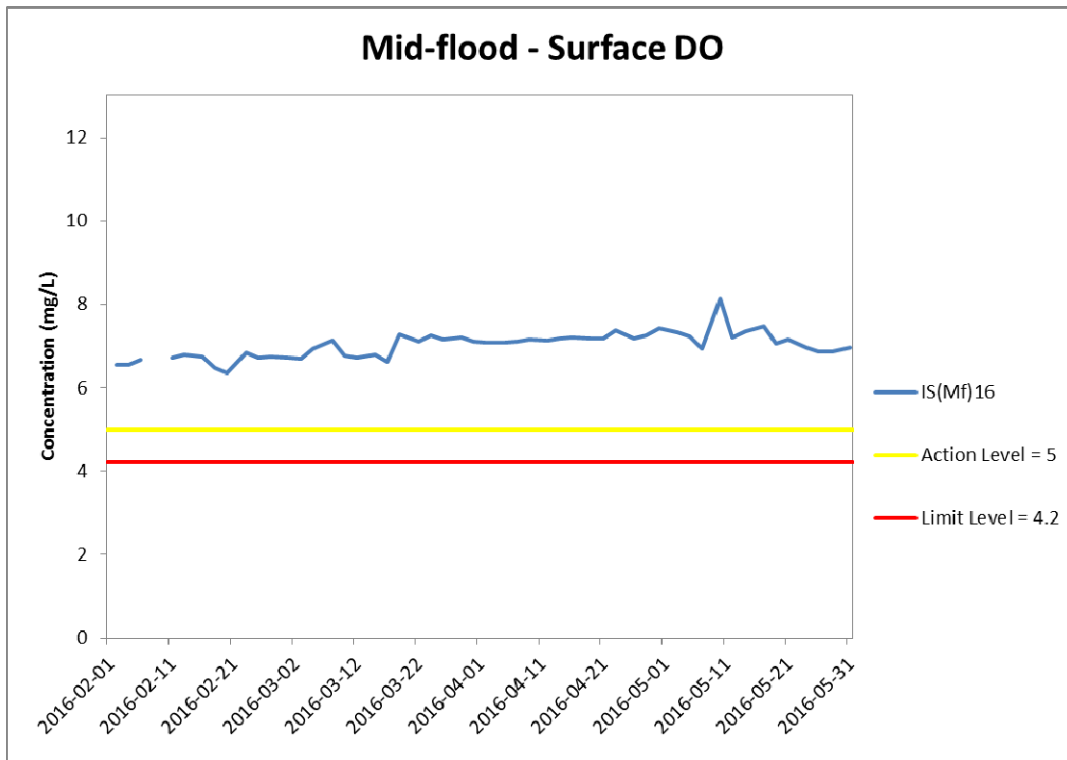
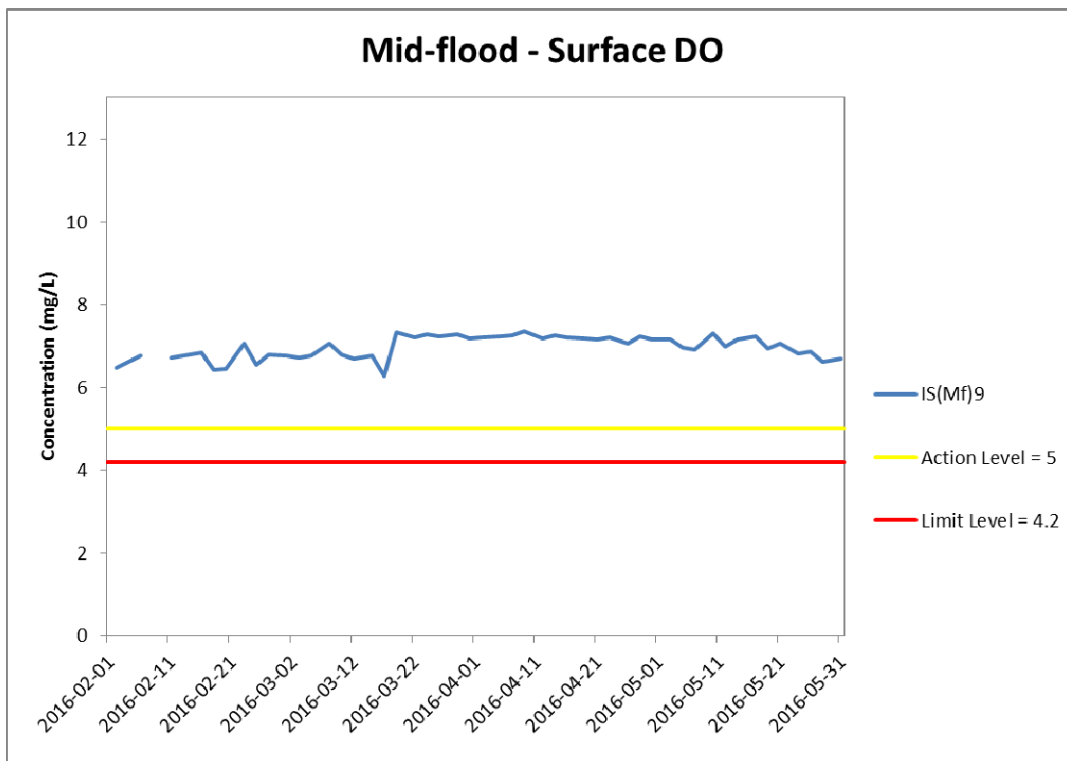
**Figure H6 Impact Monitoring – Mean Level of Dissolved Oxygen (mg/L) in surface waters during mid-flood tide between 1 February and 31 May 2016 at IS(Mf)16 and IS(Mf)9.**

*WQM was cancelled on 9 February 2016 due to suspension of marine works. (Weather condition varied between sunny to rainy within the reporting period.) Marine works within the reporting period include Construction and installation of pile caps; Uninstallation of marine piling platform; Pier construction; Construction of marine section of berth at Southern Landfall; Launching gantry operation; and Installation of deck segment and pier head*

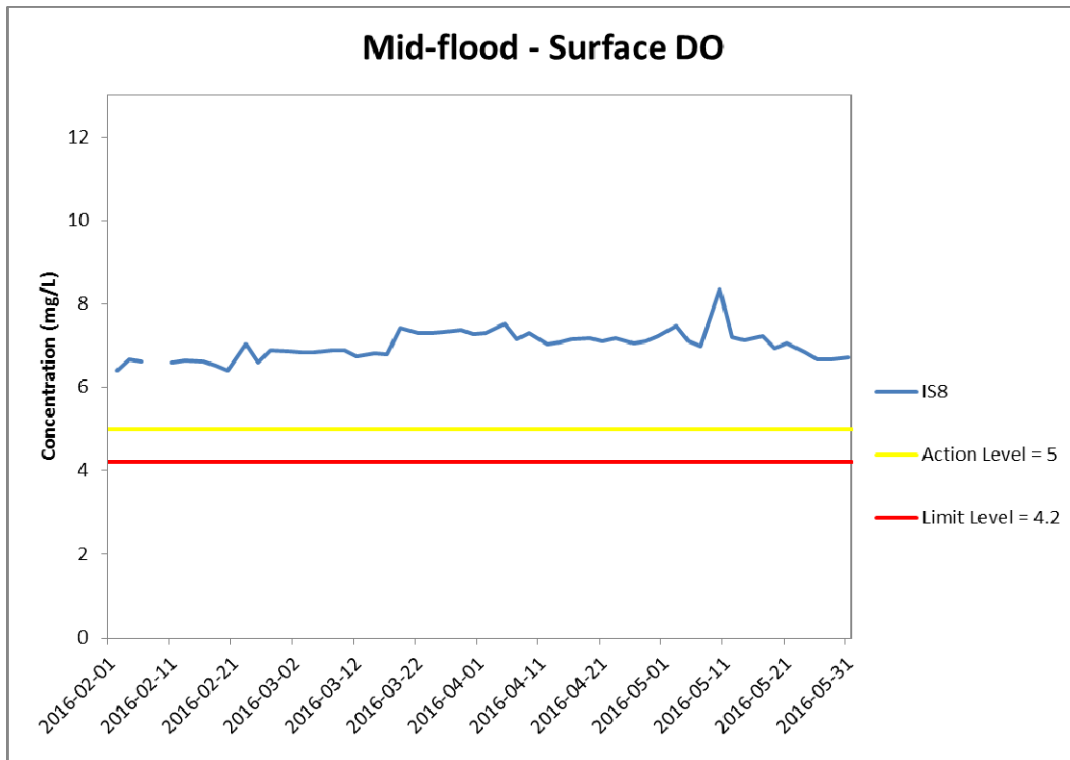
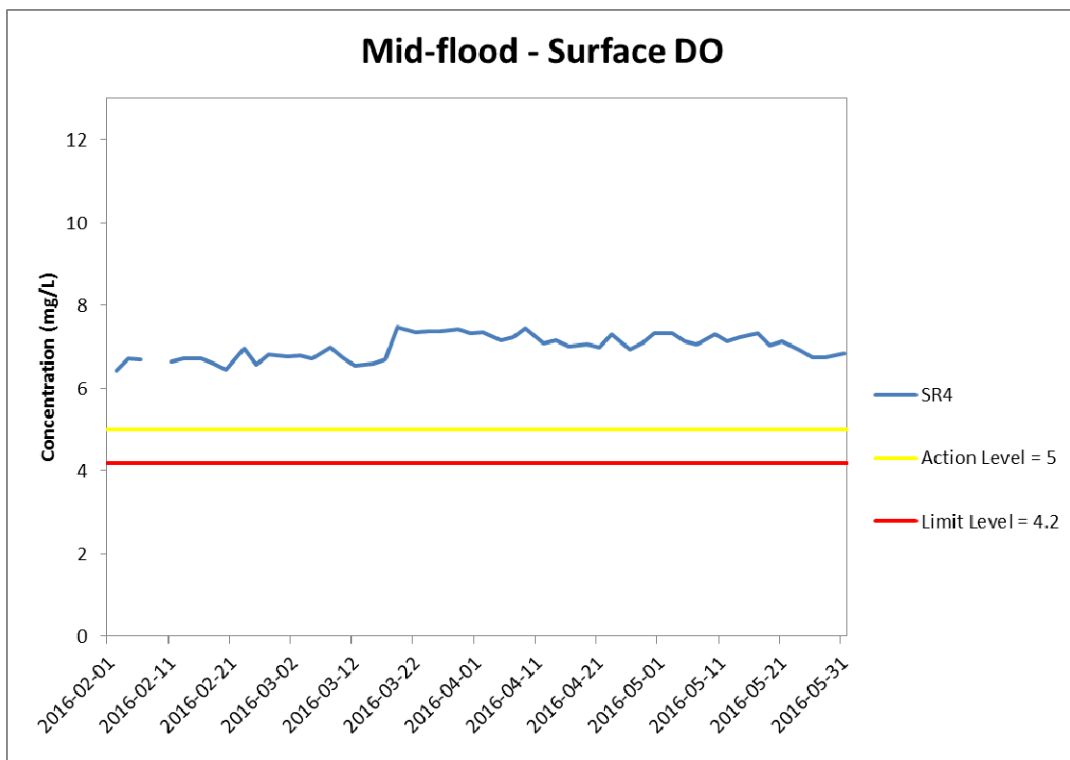
**Figure H7 Impact Monitoring - Mean Level of Dissolved Oxygen (mg/L) in surface waters during mid-flood tide between 1 February and 31 May 2016 at IS8 and SR4.**

*WQM was cancelled on 9 February 2016 due to suspension of marine works. (Weather condition varied between sunny to rainy within the reporting period.) Marine works within the reporting period include Construction and installation of pile caps; Uninstallation of marine piling platform; Pier construction; Construction of marine section of berth at Southern Landfall; Launching gantry operation; and Installation of deck segment and pier head segment.*

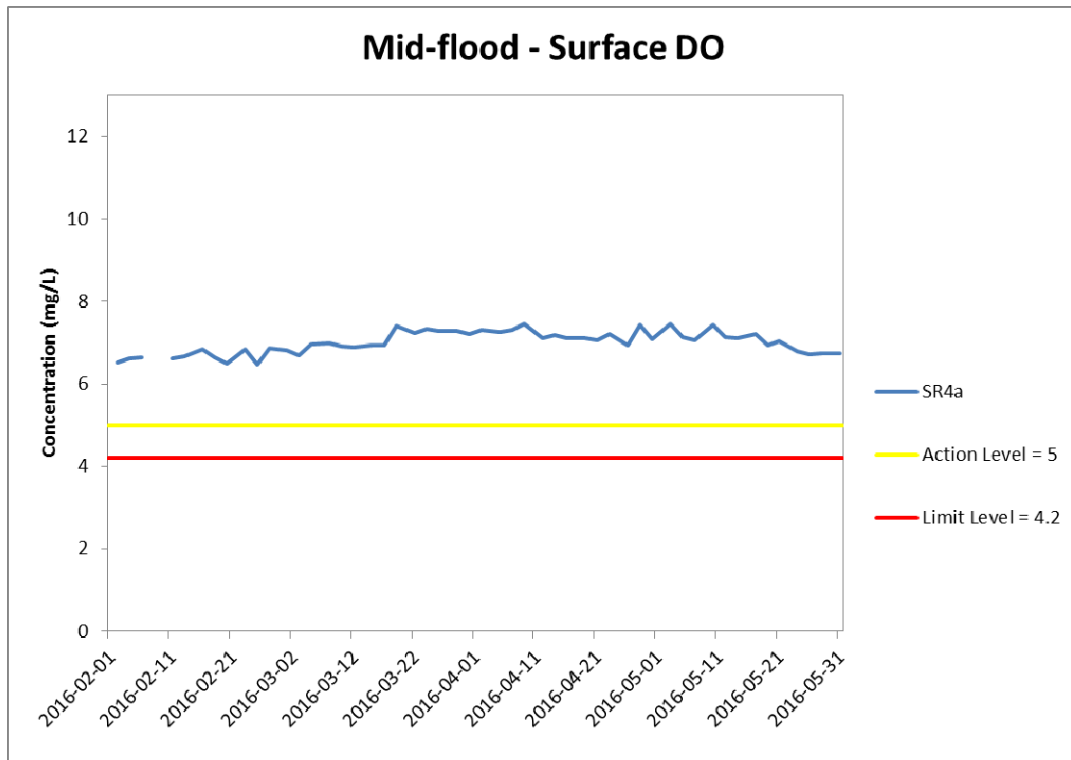
**Figure H8 Impact Monitoring - Mean Level of Dissolved Oxygen (mg/L) in surface waters during mid-flood tide between 1 February and 31 May 2016 at SR4a.**

*WQM was cancelled on 9 February 2016 due to suspension of marine works. (Weather condition varied between sunny to rainy within the reporting period.) Marine works within the reporting period include Construction and installation of pile caps; Uninstallation of marine piling platform; Pier construction; Construction of marine section of berth at Southern Landfall; Launching gantry operation; and Installation of deck segment and pier head segment.*

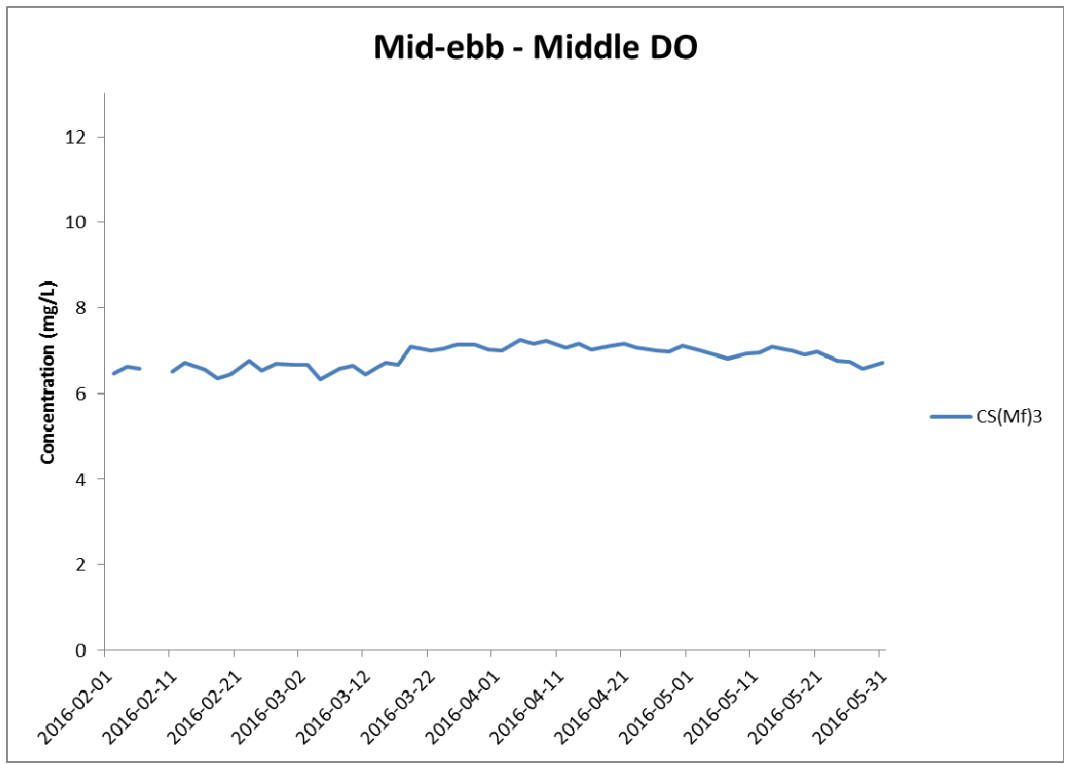
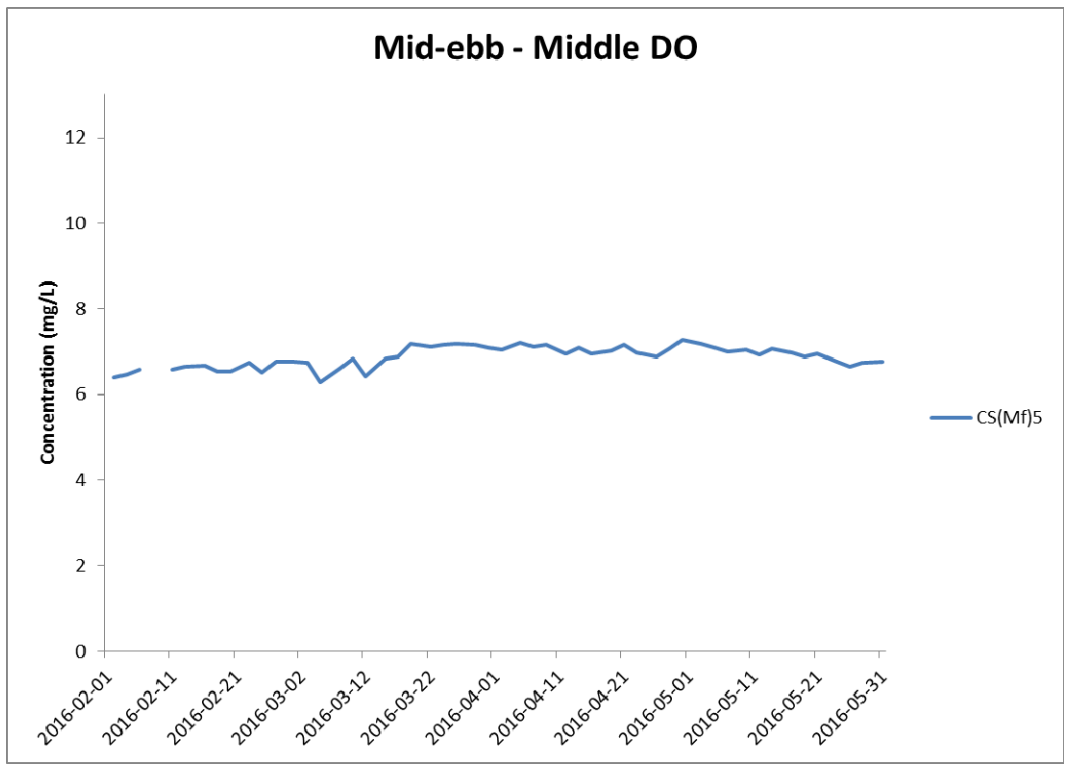
**Figure H9 Impact Monitoring - Mean Level of Dissolved Oxygen (mg/L) in mid-depth waters during mid-ebb tide between 1 February and 31 May 2016 at CS(Mf)3 and CS(Mf)5.**

*WQM was cancelled on 9 February 2016 due to suspension of marine works. (Weather condition varied between sunny to rainy within the reporting period.) Marine works within the reporting period include Construction and installation of pile caps; Uninstallation of marine piling platform; Pier construction; Construction of marine section of berth at Southern Landfall; Launching gantry operation; and Installation of deck segment and pier head segment.*

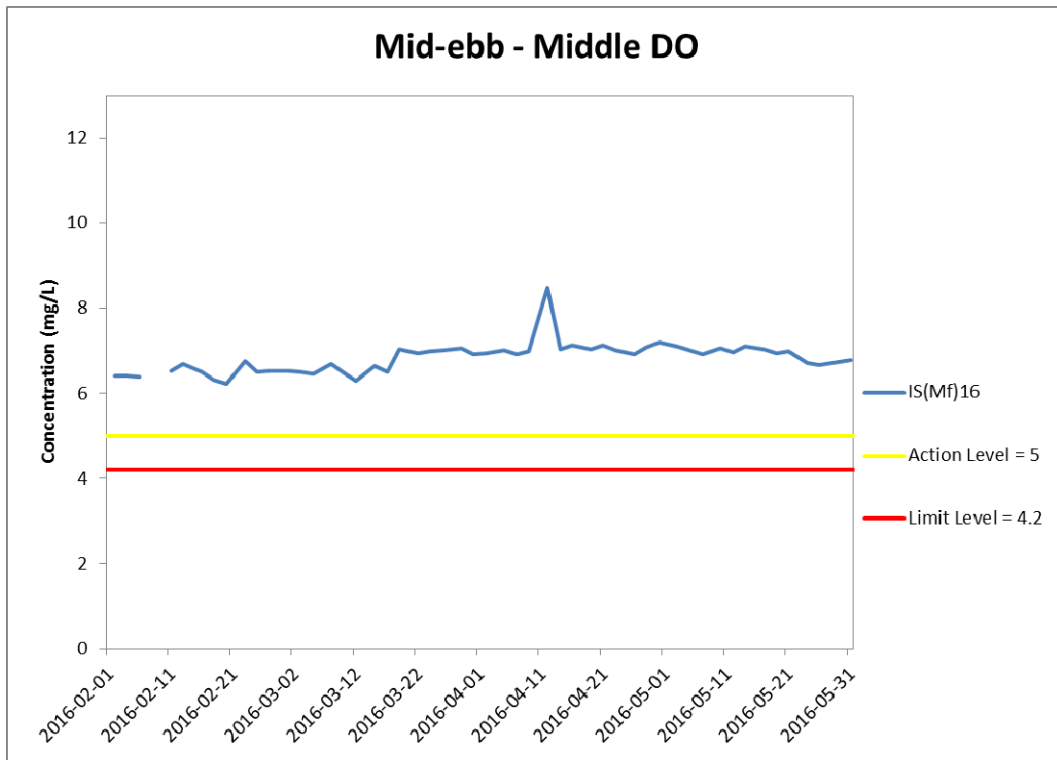
**Figure H10 Impact Monitoring – Mean Level of Dissolved Oxygen (mg/L) in mid-depth waters during mid-ebb tide between 1 February and 31 May 2016 at IS(Mf)16.**

*WQM was cancelled on 9 February 2016 due to suspension of marine works. (Weather condition varied between sunny to rainy within the reporting period.) Marine works within the reporting period include Construction and installation of pile caps; Uninstallation of marine piling platform; Pier construction; Construction of marine section of berth at Southern Landfall; Launching gantry operation; and Installation of deck segment and pier head segment.*

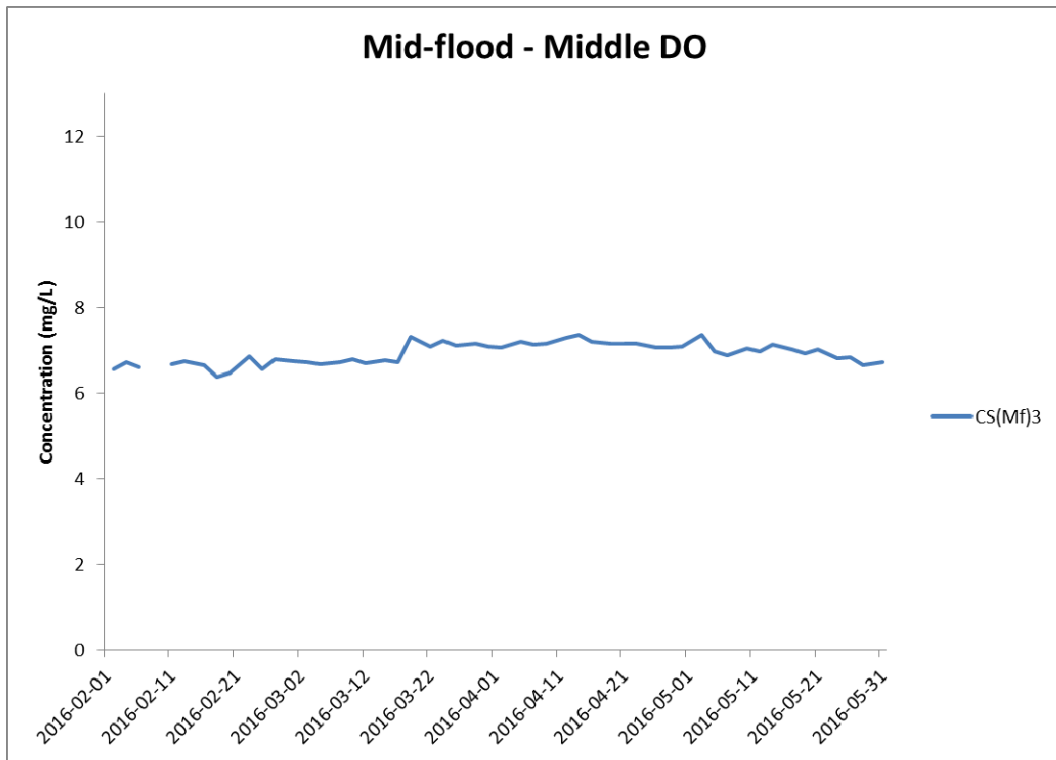
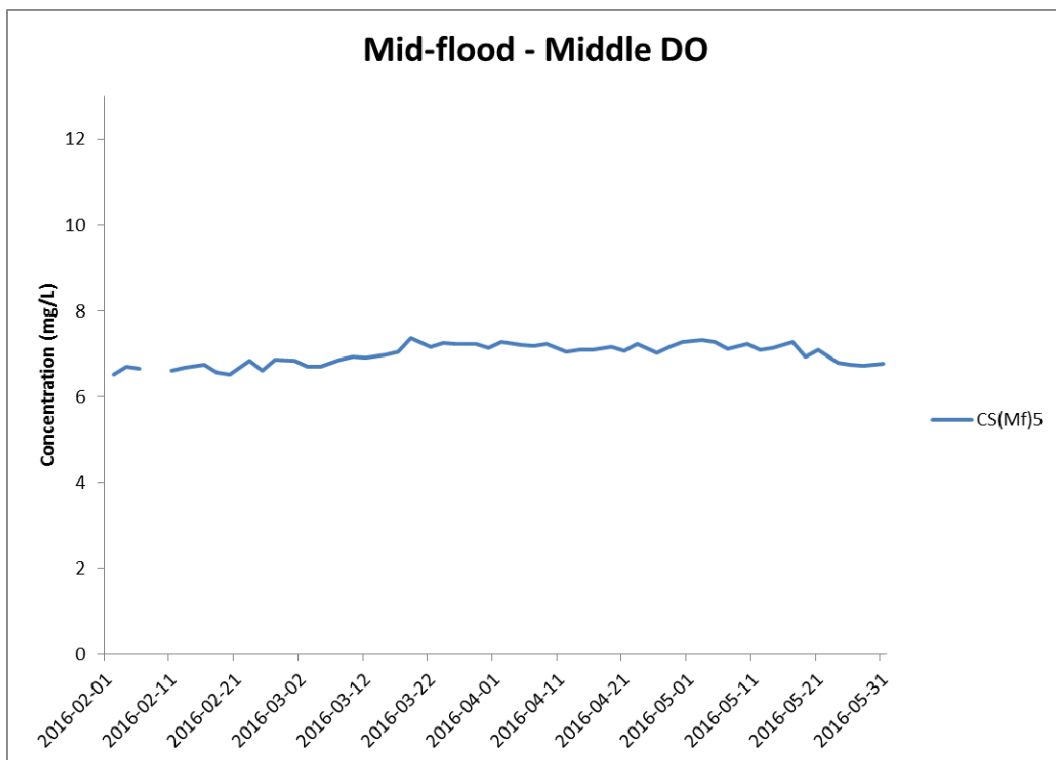
**Figure H11 Impact Monitoring - Mean Level of Dissolved Oxygen (mg/L) in mid-depth waters during mid-flood tide between 1 February and 31 May 2016 at CS(Mf)3 and CS(Mf)5.**

*WQM was cancelled on 9 February 2016 due to suspension of marine works. (Weather condition varied between sunny to rainy within the reporting period.) Marine works within the reporting period include Construction and installation of pile caps; Uninstallation of marine piling platform; Pier construction; Construction of marine section of berth at Southern Landfall; Launching gantry operation; and Installation of deck segment and pier head segment.*

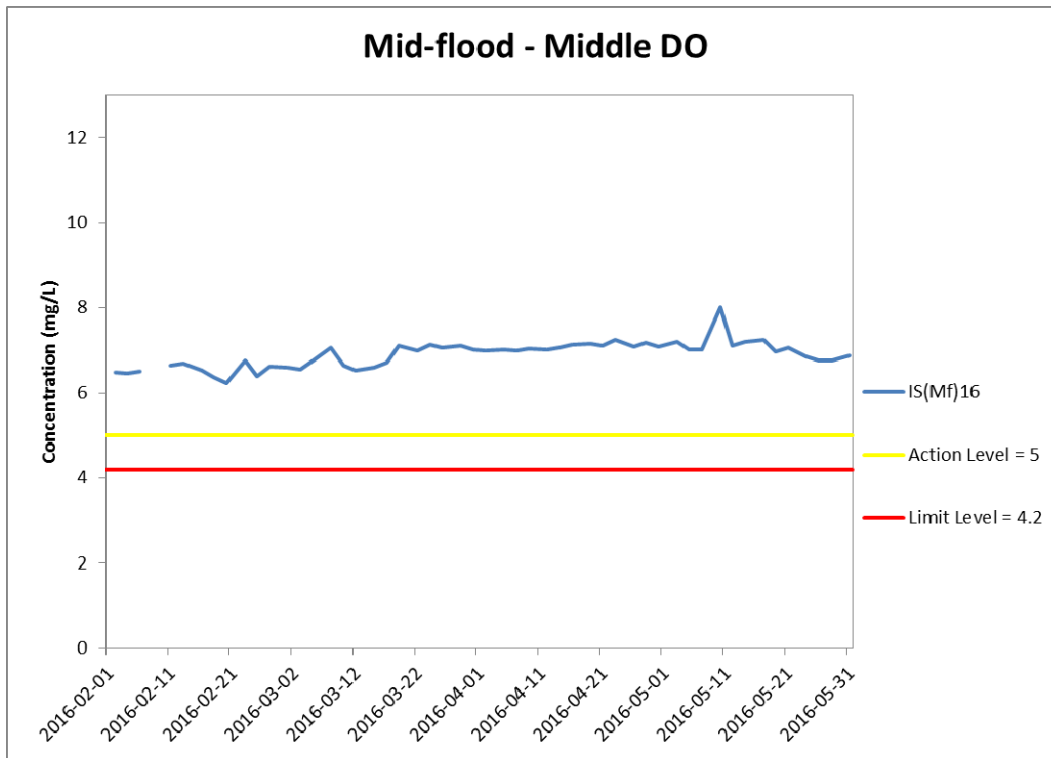
**Figure H12 Impact Monitoring - Mean Level of Dissolved Oxygen (mg/L) in mid-depth waters during mid-flood tide between 1 February and 31 May 2016 at IS(Mf)16.**

*WQM was cancelled on 9 February 2016 due to suspension of marine works. (Weather condition varied between sunny to rainy within the reporting period.) Marine works within the reporting period include Construction and installation of pile caps; Uninstallation of marine piling platform; Pier construction; Construction of marine section of berth at Southern Landfall; Launching gantry operation; and Installation of deck segment and pier head segment.*

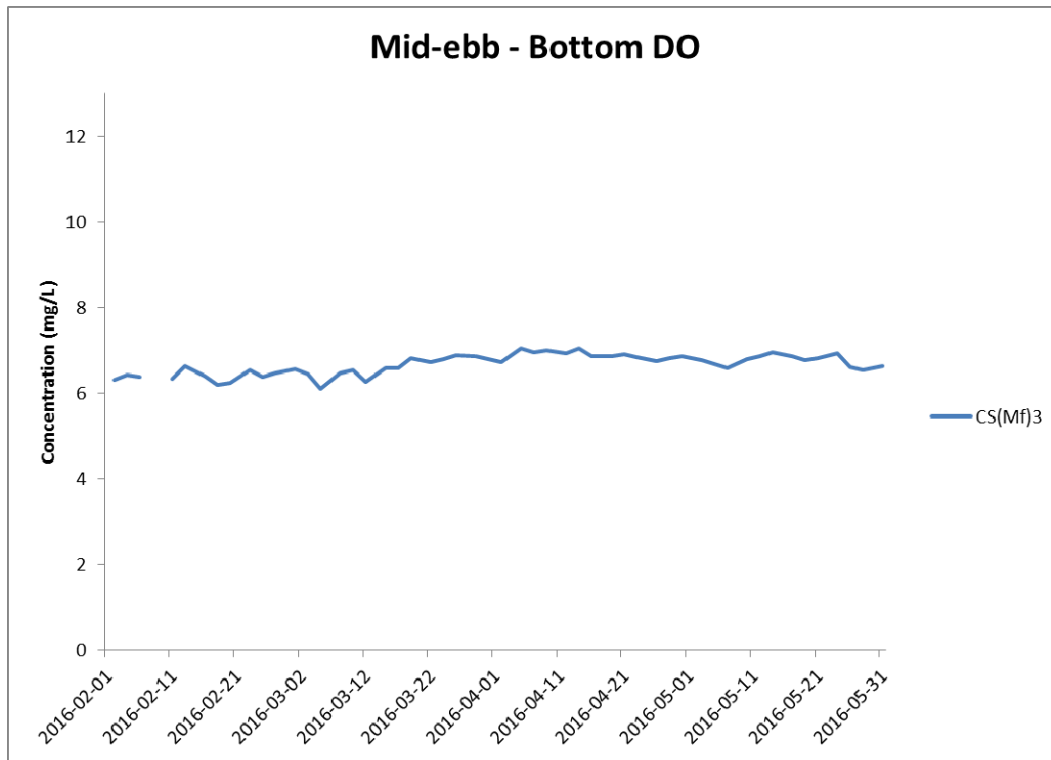
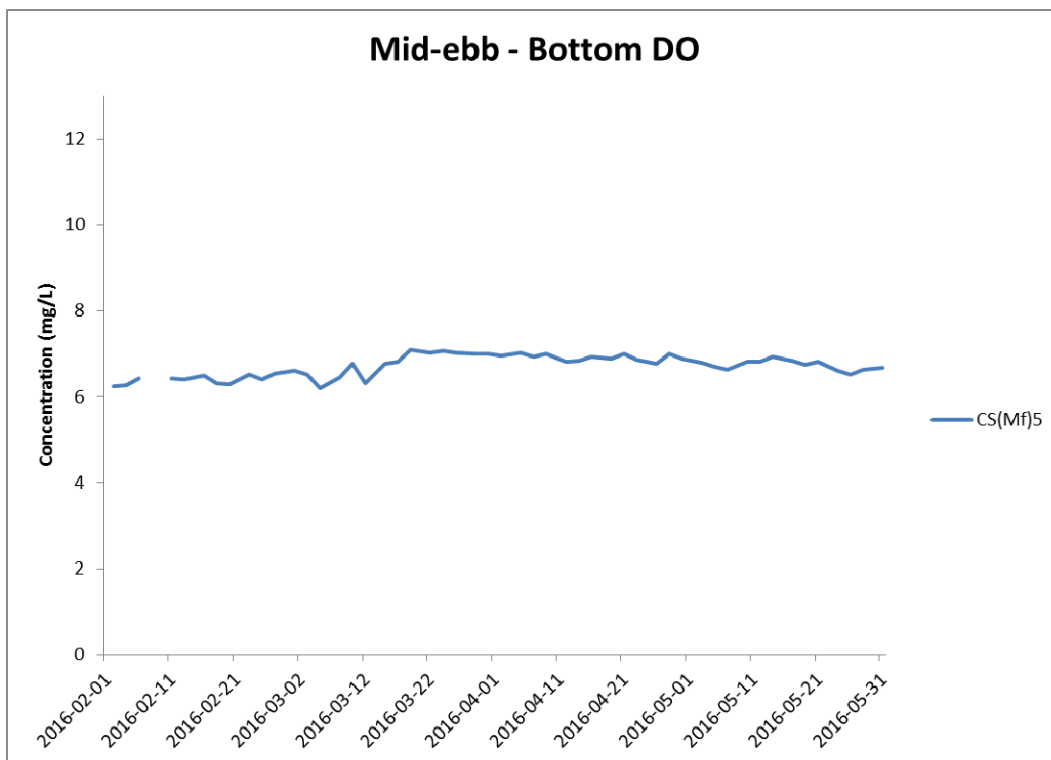
**Figure H13 Impact Monitoring - Mean Level of Dissolved Oxygen (mg/L) in bottom waters during mid-ebb tide between 1 February and 31 May 2016 at CS(Mf)3 and CS(Mf)5.**

*WQM was cancelled on 9 February 2016 due to suspension of marine works. (Weather condition varied between sunny to rainy within the reporting period.) Marine works within the reporting period include Construction and installation of pile caps; Uninstallation of marine piling platform; Pier construction; Construction of marine section of berth at Southern Landfall; Launching gantry operation; and Installation of deck segment and pier head segment.*
