**Contract No. HY/2012/07  
Tuen Mun – Chek Lap Kok Link –  
Southern Connection Viaduct Section**

*Tenth Quarterly Environmental Monitoring &  
Audit (EM&A) Report*

02 November 2016

**Contract No. HY/2012/07 TM-CLKL Southern Connection Viaduct  
Section  
10th Quarterly EM&A Summary Report (March 2016 to May 2016)**

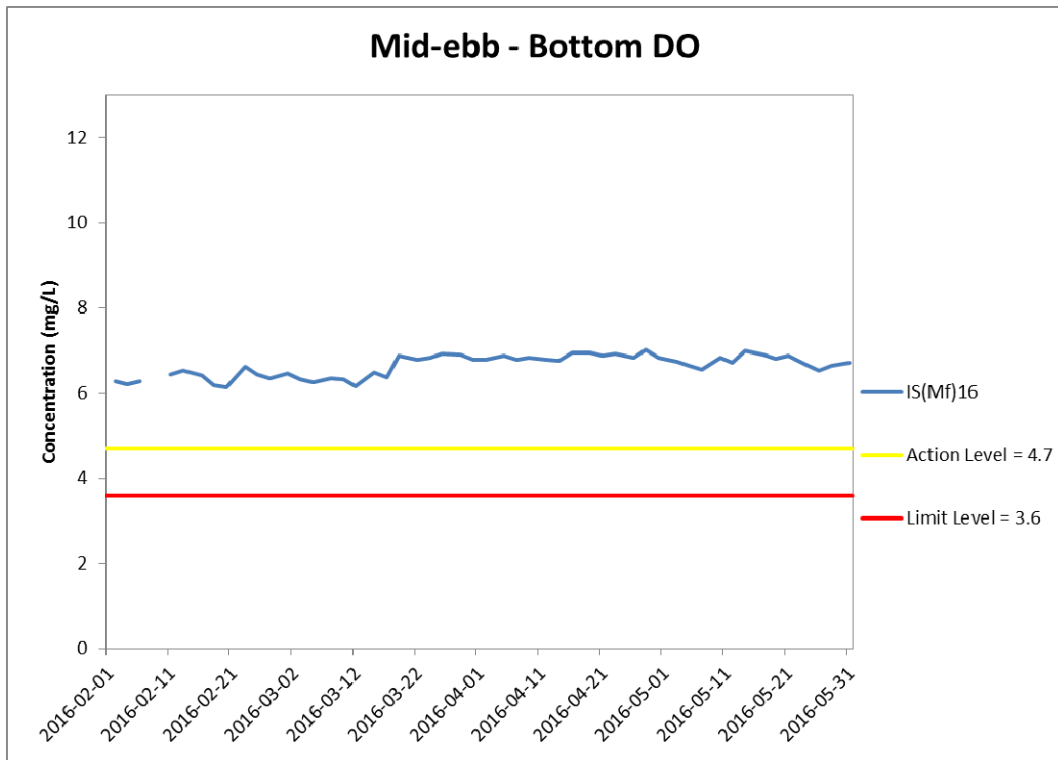
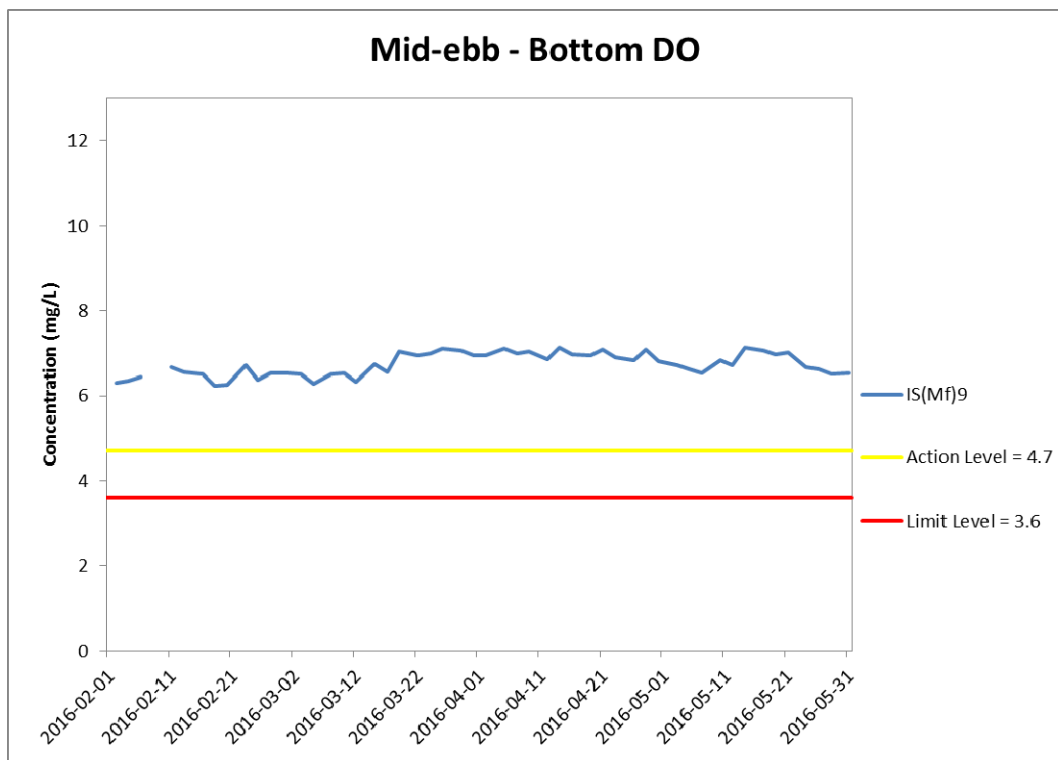
**Figure H14 Impact Monitoring - Mean Level of Dissolved Oxygen (mg/L) in bottom waters during mid-ebb tide between 1 February and 31 May 2016 at IS(Mf)16 and IS(Mf)9.**

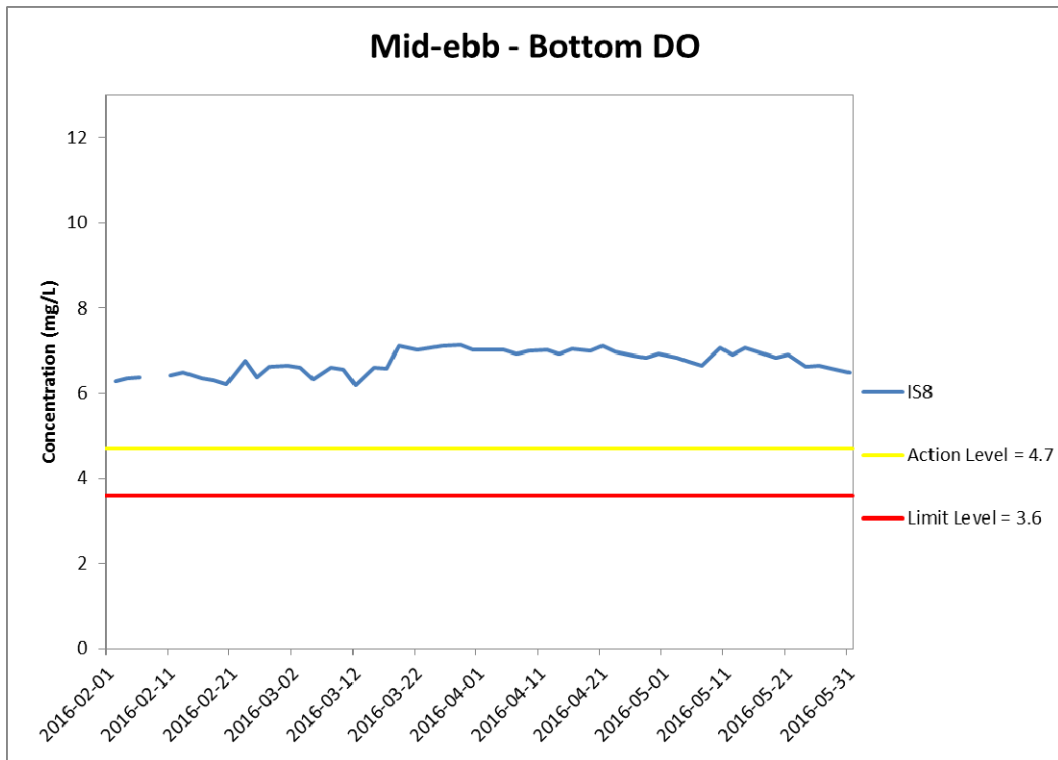
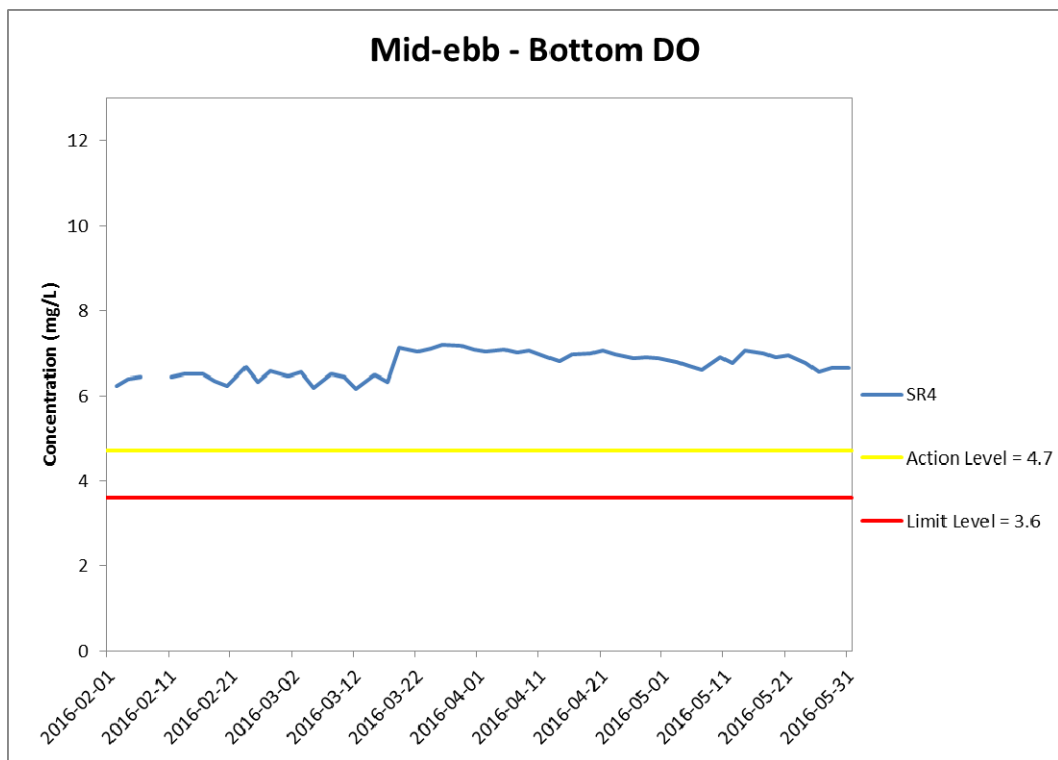
**Figure H15 Impact Monitoring - Mean Level of Dissolved Oxygen (mg/L) in bottom waters during mid-ebb tide between 1 February and 31 May 2016 at IS8 and SR4.**

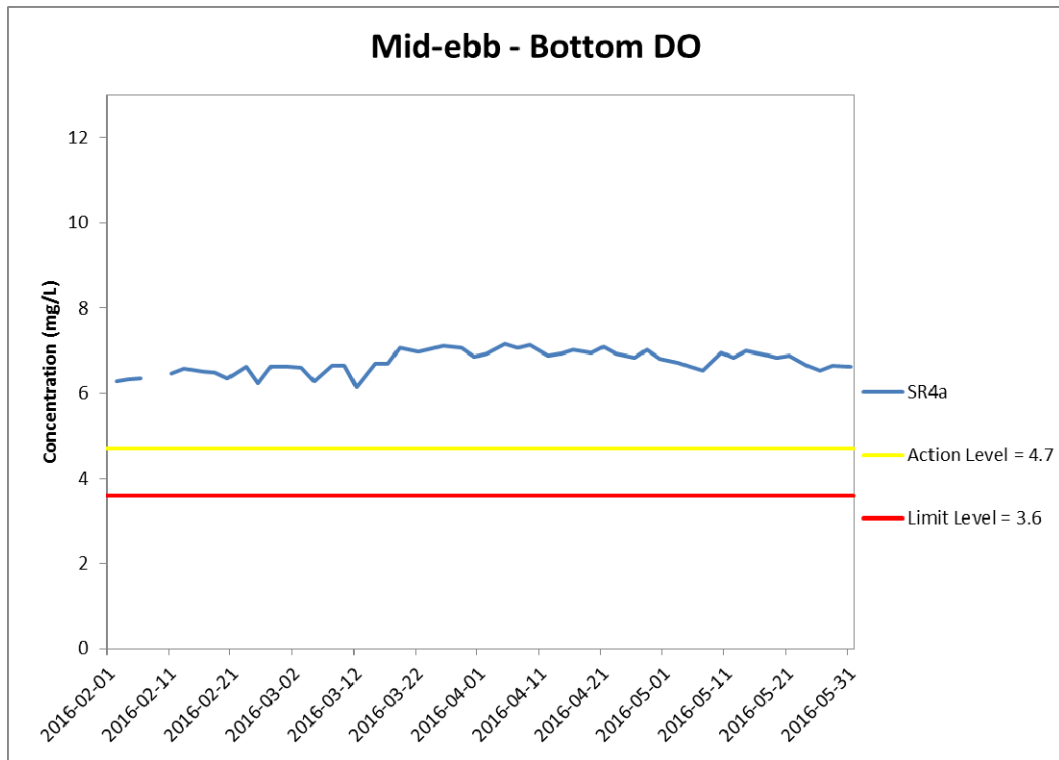
**Figure H16 Impact Monitoring – Mean Level of Dissolved Oxygen (mg/L) in bottom waters during mid-ebb tide between 1 February and 31 May 2016 at SR4a.**

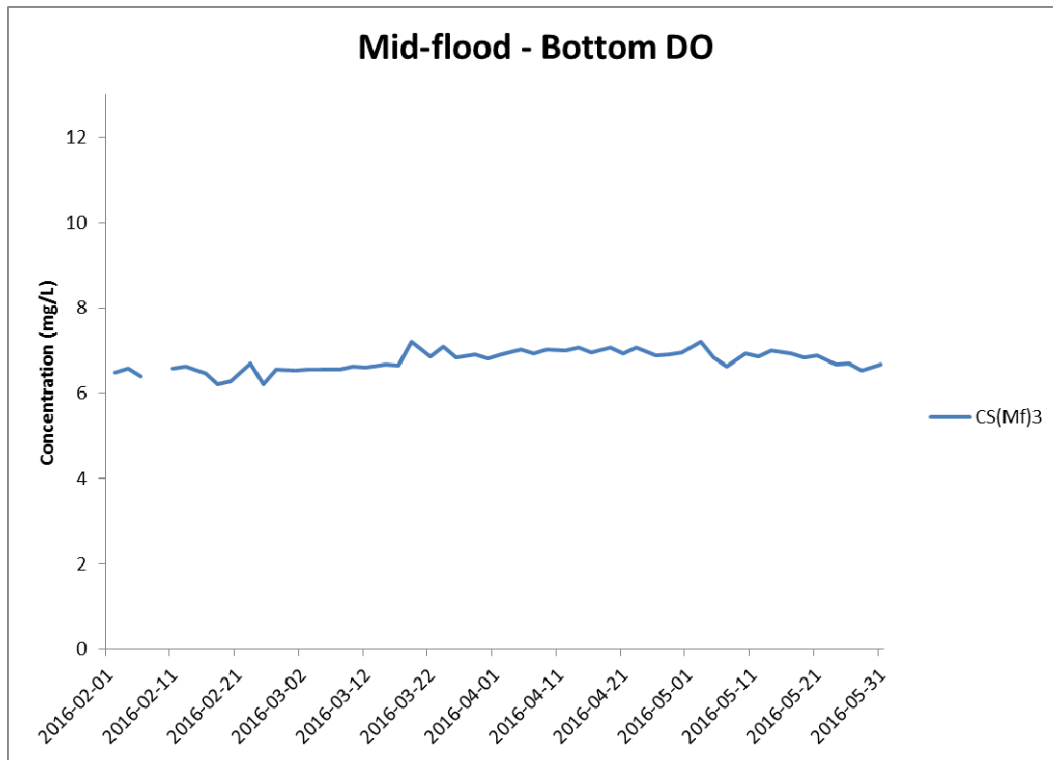
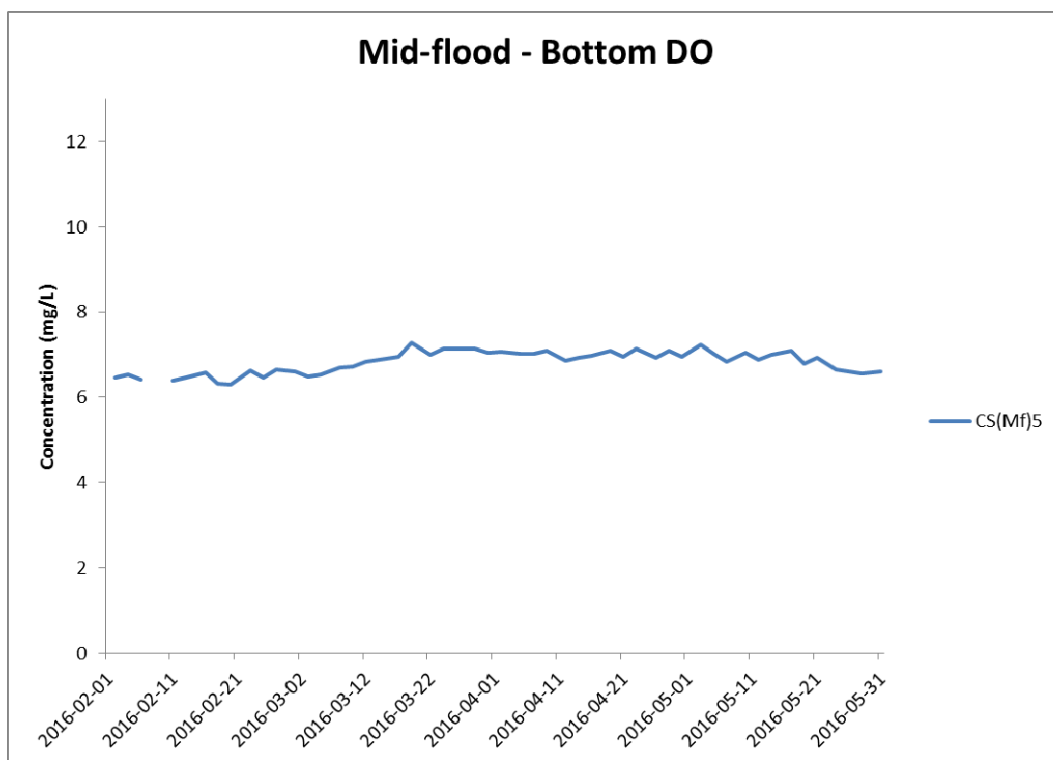
**Figure H17 Impact Monitoring – Mean Level of Dissolved Oxygen (mg/L) in bottom waters during mid-flood tide between 1 February and 31 May 2016 at CS(Mf)3 and CS(Mf)5.**

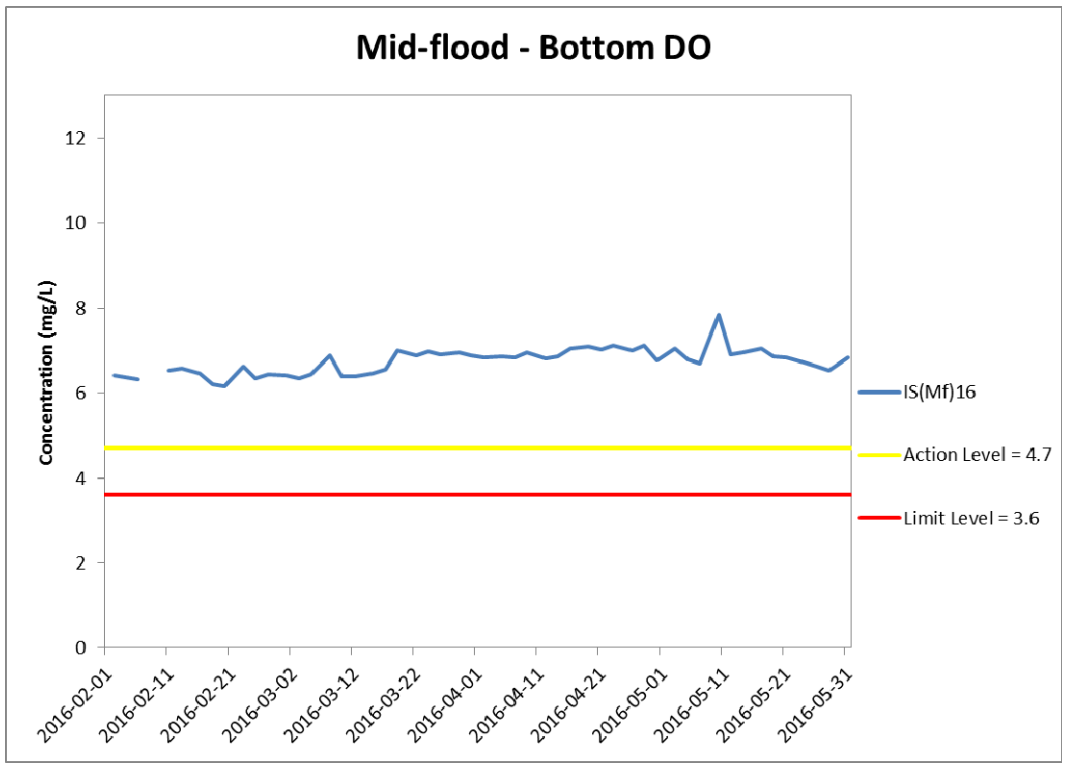
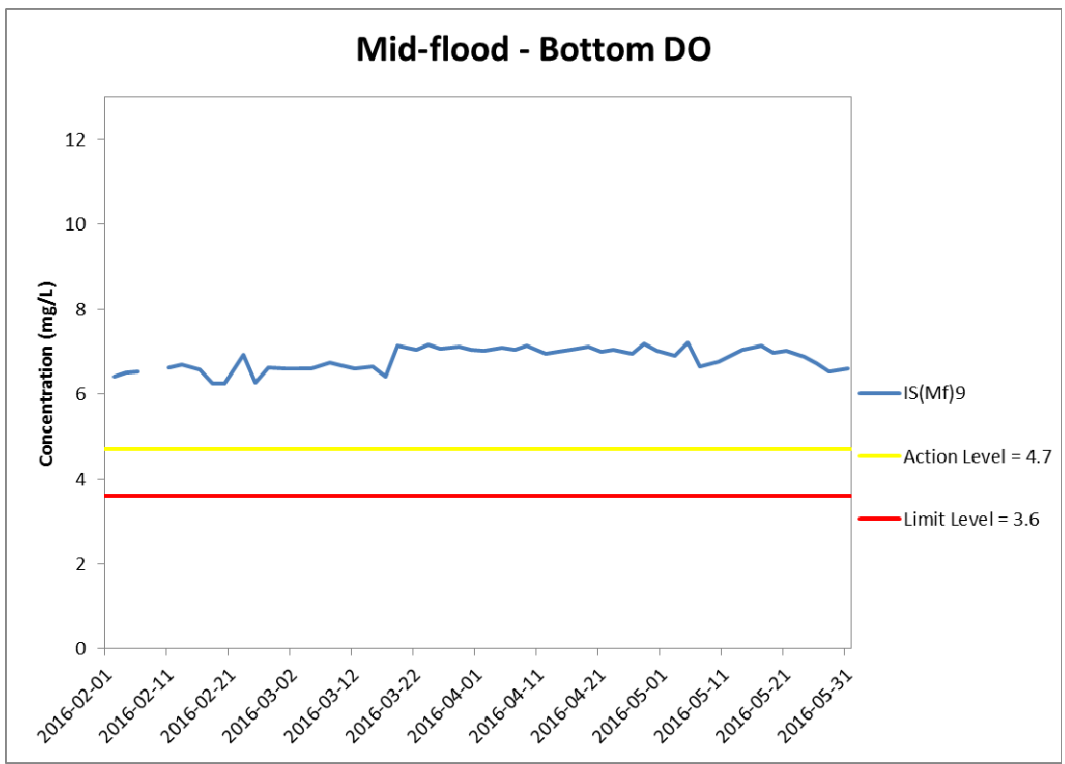
**Figure H18 Impact Monitoring – Mean Level of Dissolved Oxygen (mg/L) in bottom waters during mid-flood tide between 1 February and 31 May 2016 at IS(Mf)16 and IS(Mf)9.**

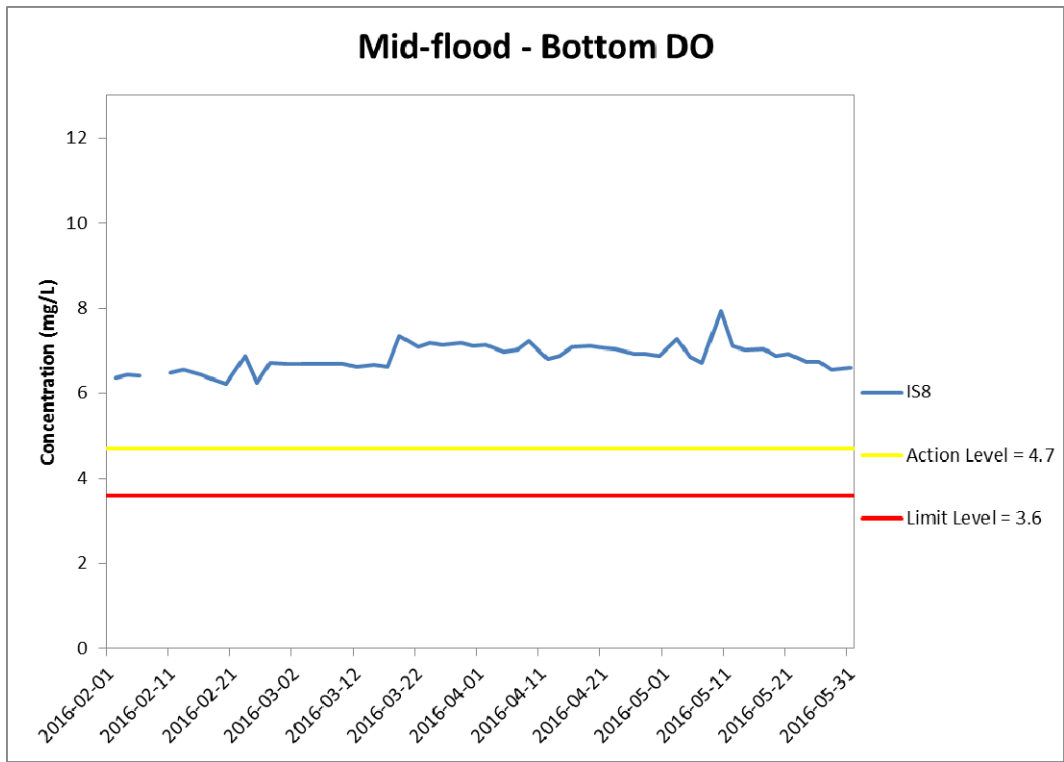
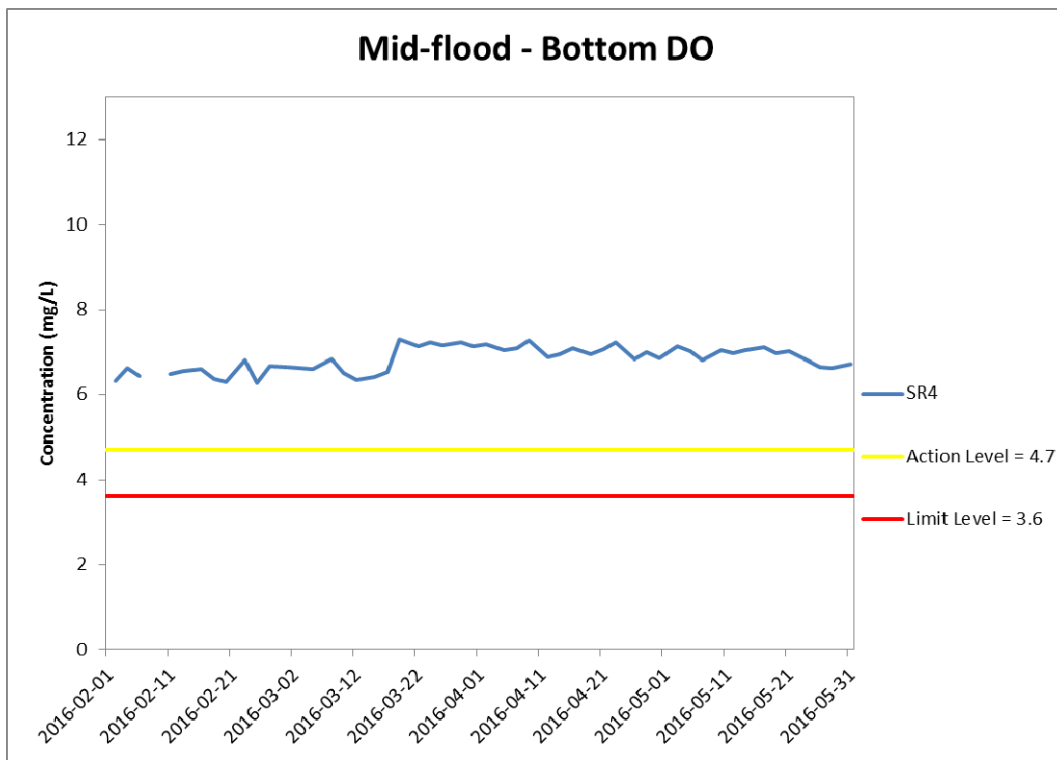
**Figure H19 Impact Monitoring – Mean Level of Dissolved Oxygen (mg/L) in bottom waters during mid-flood tide between 1 February and 31 May 2016 at IS8 and SR4.**

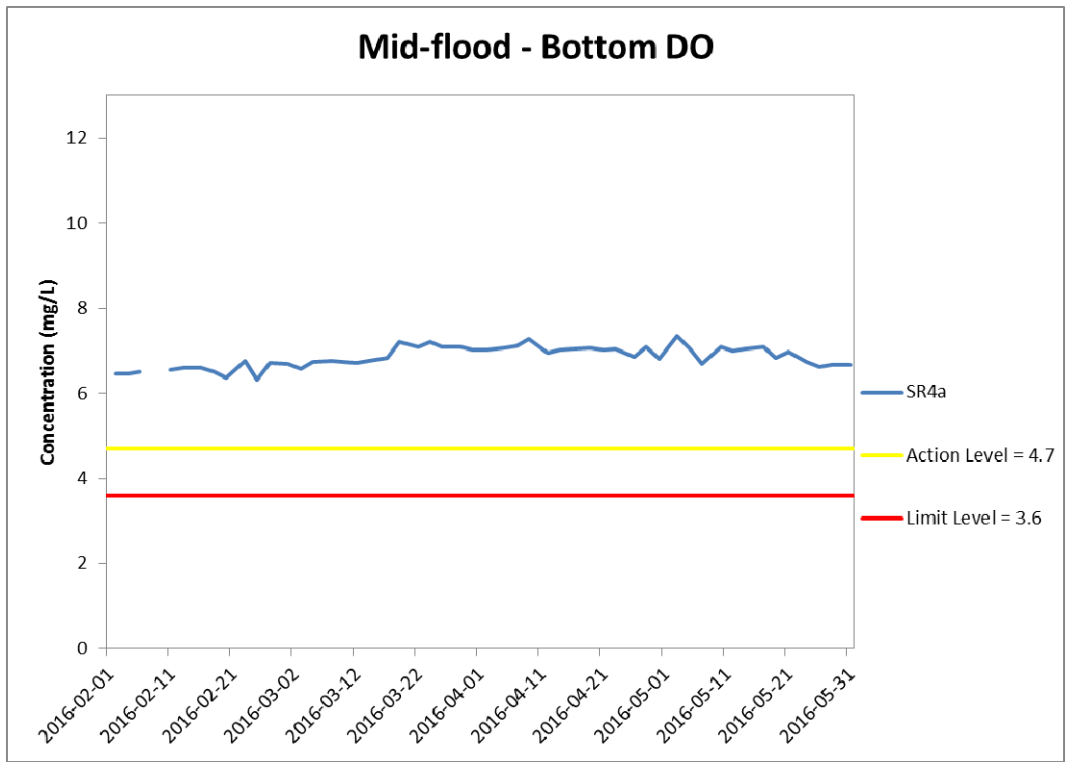
**Figure H20 Impact Monitoring – Mean Level of Dissolved Oxygen (mg/L) in bottom waters during mid-flood tide between 1 February and 31 May 2016 at SR4a.**

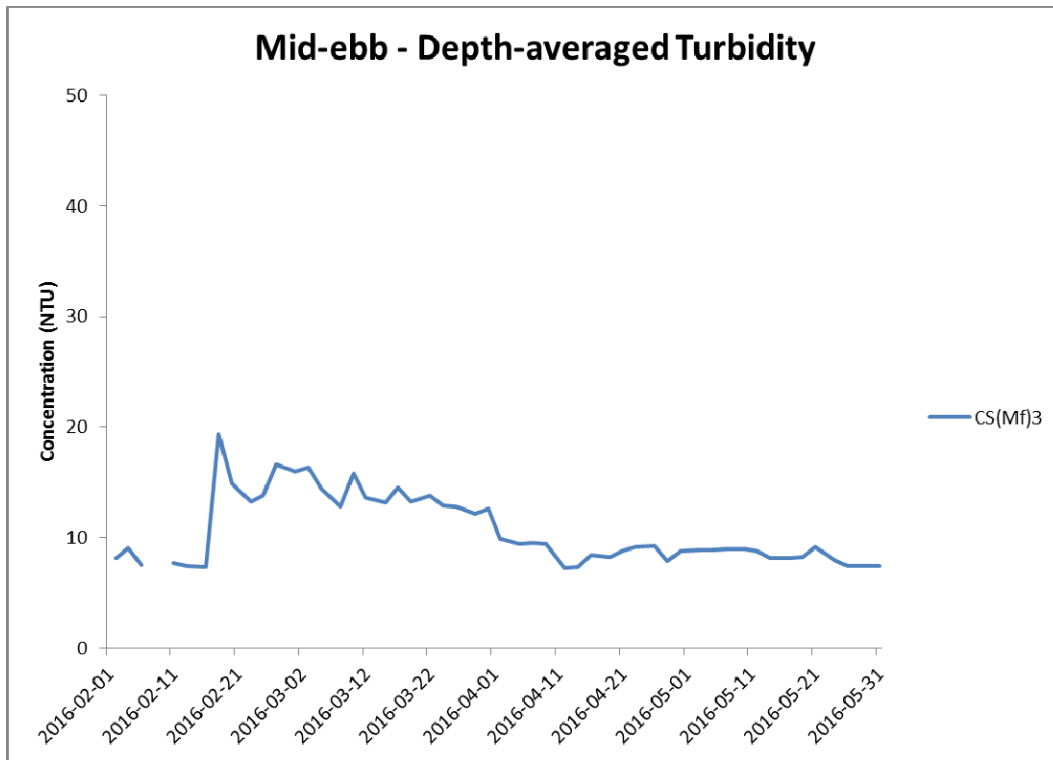
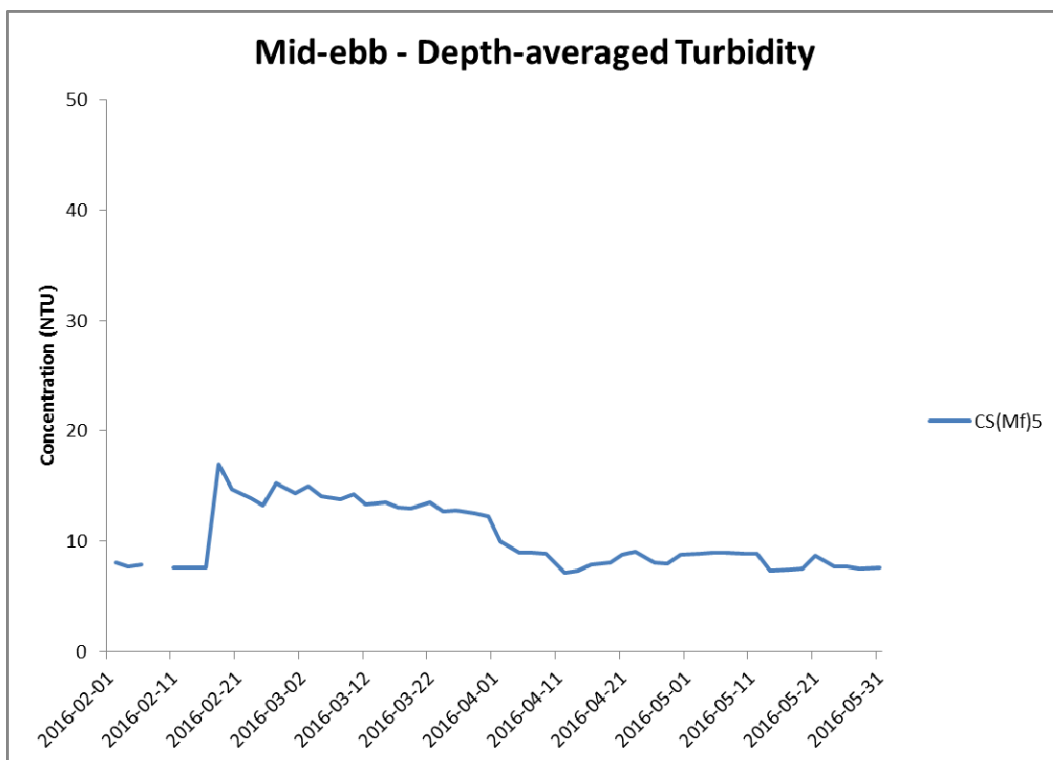
**Figure H21 Impact Monitoring – Mean Level of depth-averaged Turbidity (NTU) during mid-ebb tide between 1 February and 31 May 2016 at CS(Mf)3 and CS(Mf)5.**

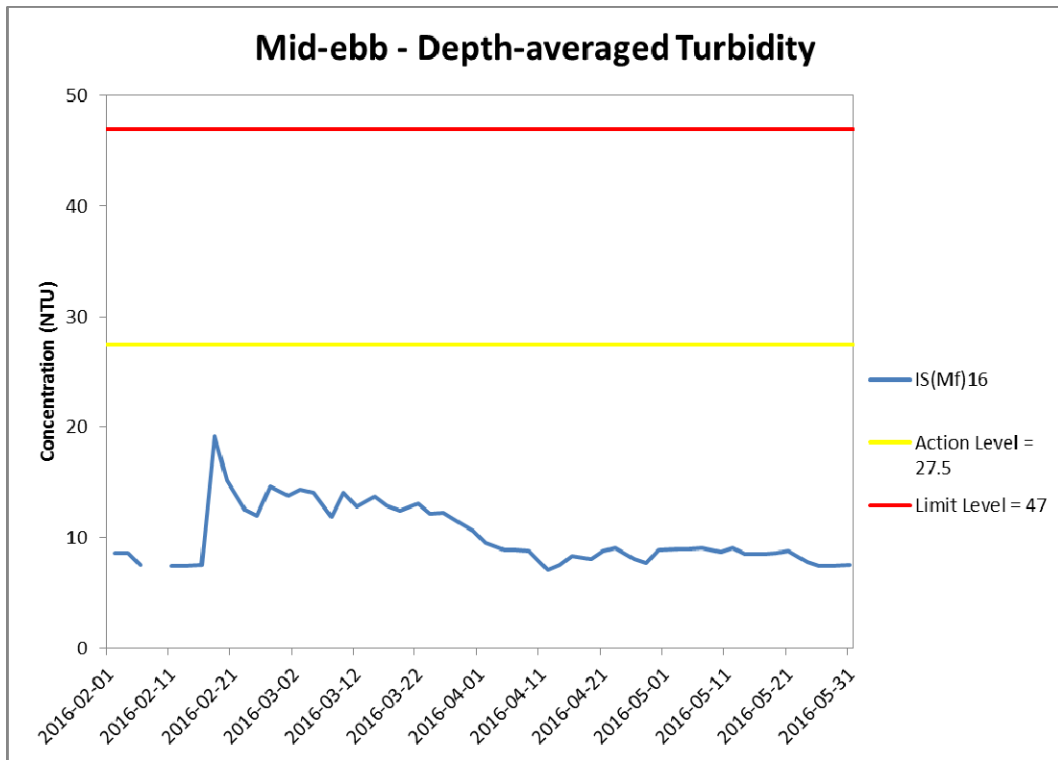
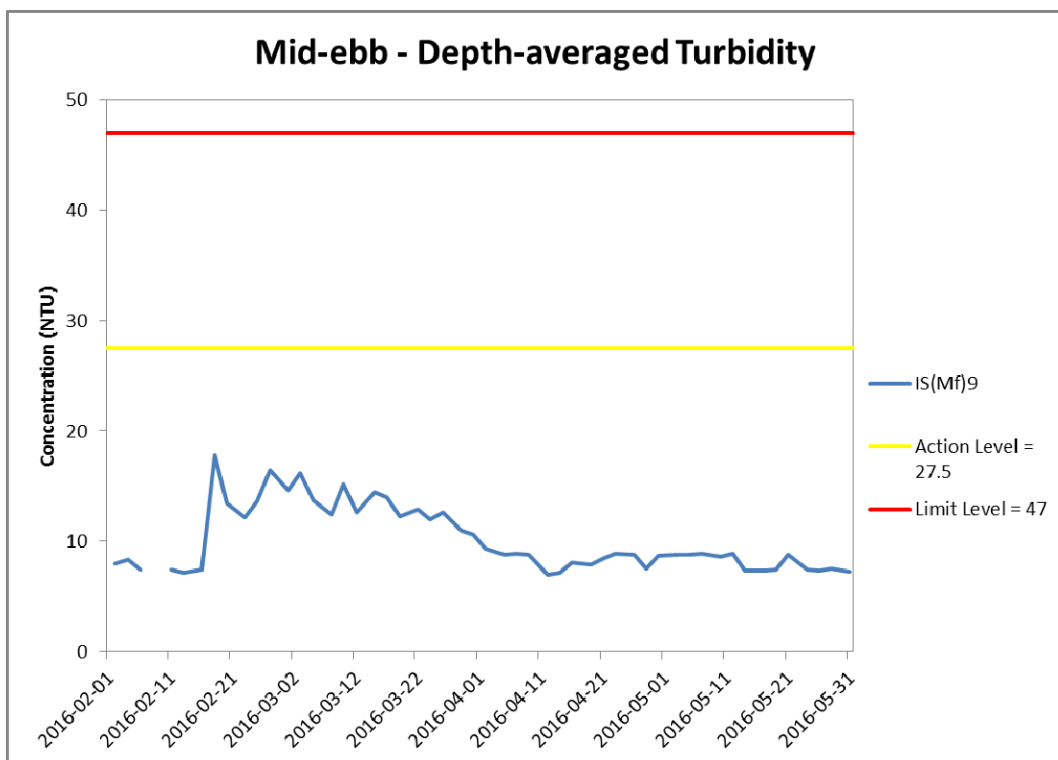
**Figure H22 Impact Monitoring – Mean Level of depth-averaged Turbidity (NTU) during mid-ebb tide between 1 February and 31 May 2016 at IS(Mf)16 and IS(Mf)9.**

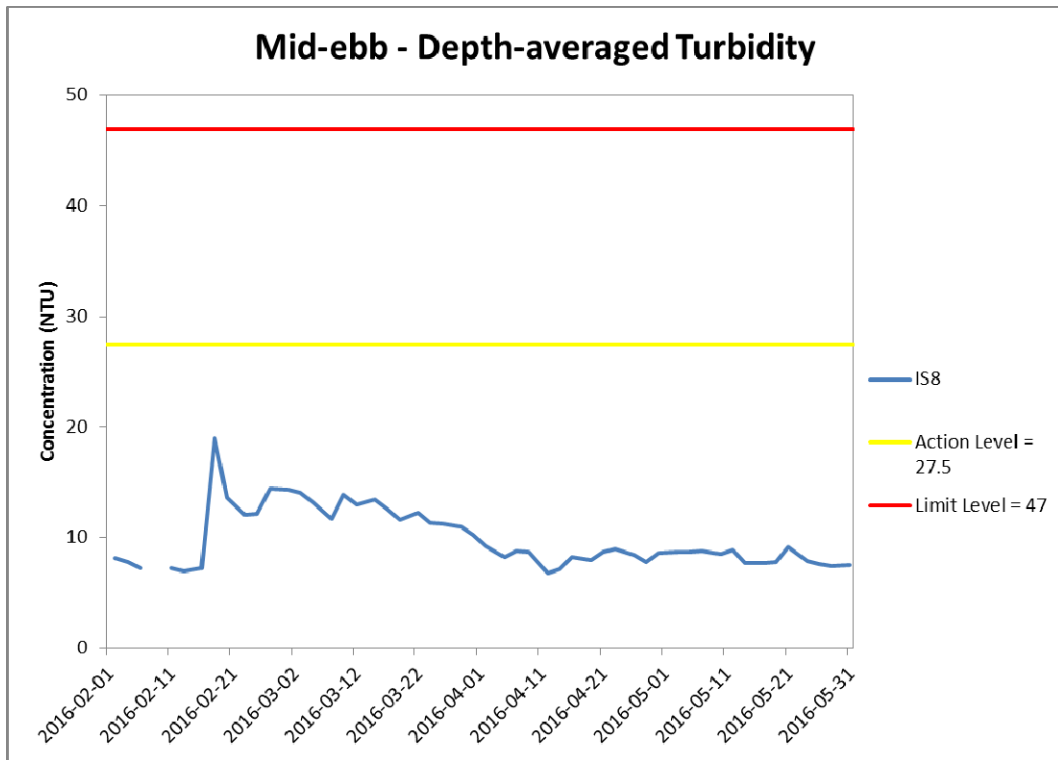
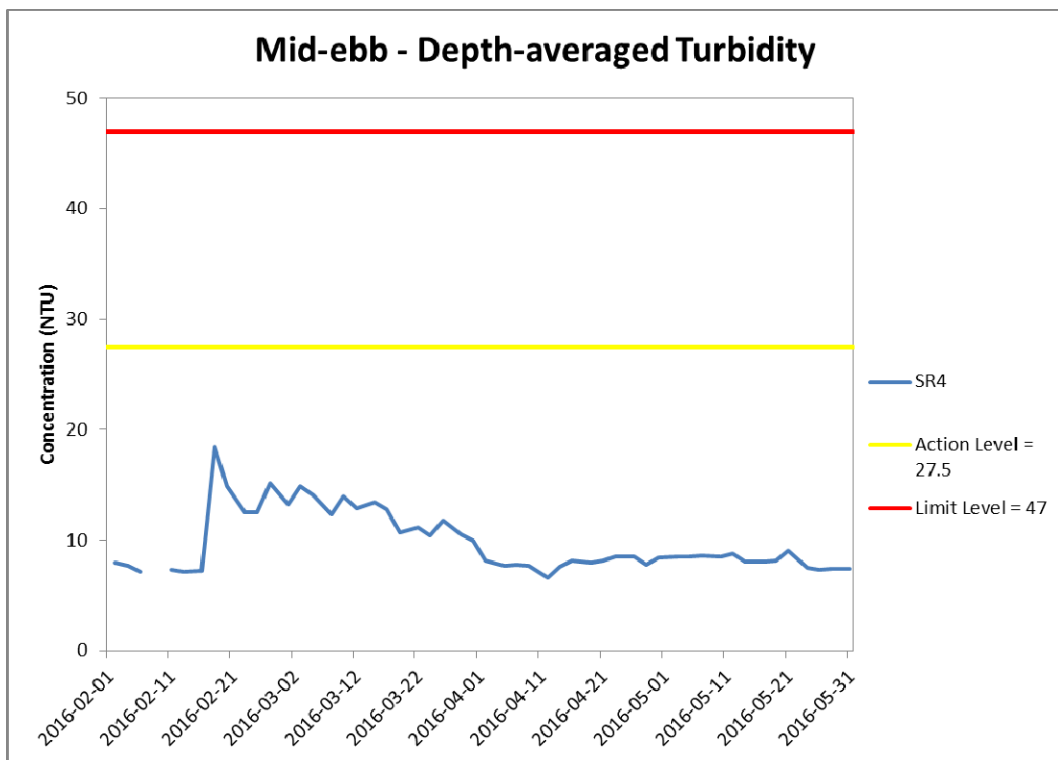
**Figure H23 Impact Monitoring – Mean Level of depth-averaged Turbidity (NTU) during mid-ebb tide between 1 February and 31 May 2016 at IS8 and SR4.**

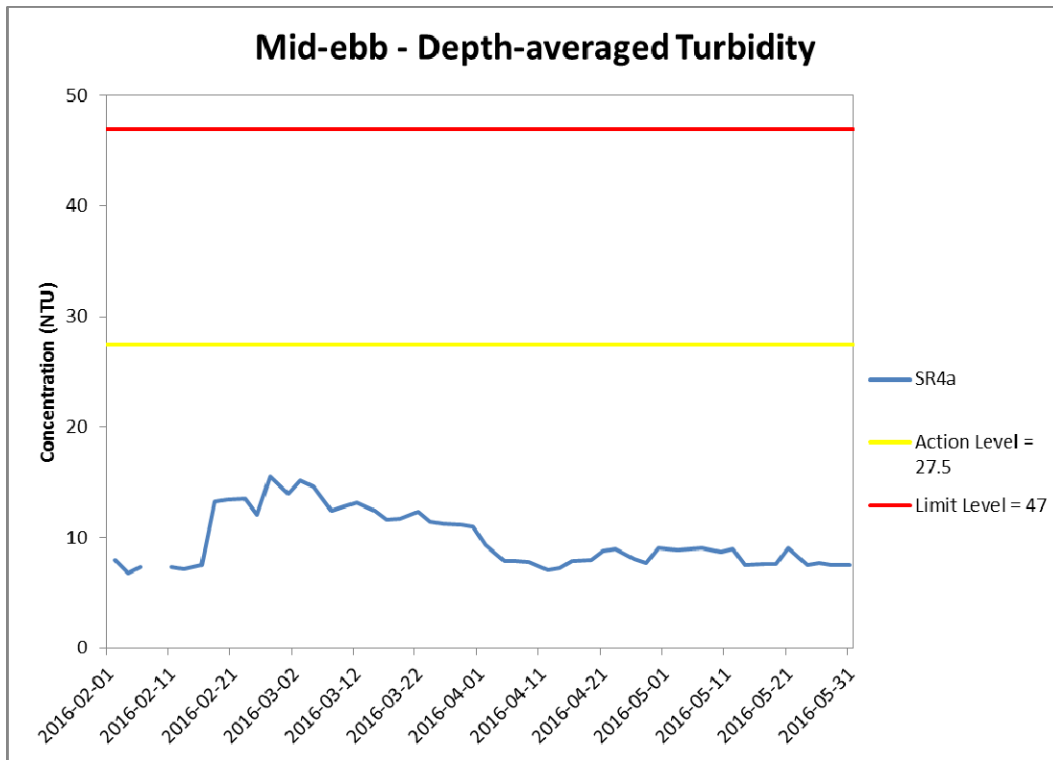
**Figure H24 Impact Monitoring – Mean Level of depth-averaged Turbidity (NTU) during mid-ebb tide between 1 February and 31 May 2016 at SR4a.**

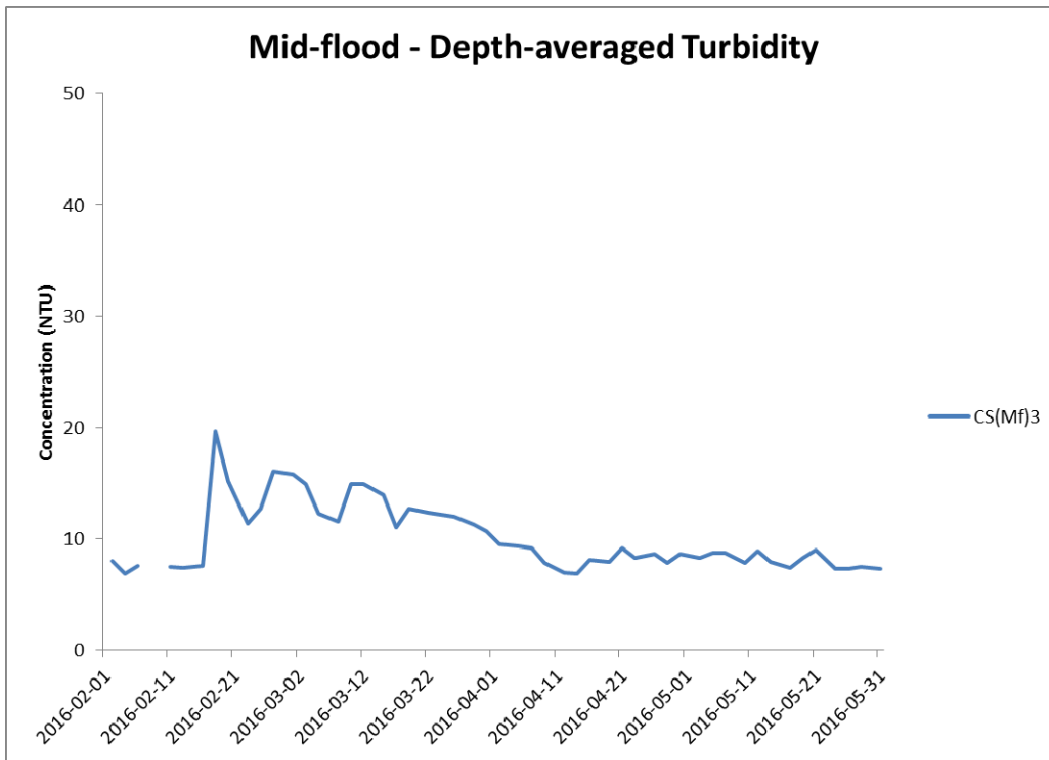
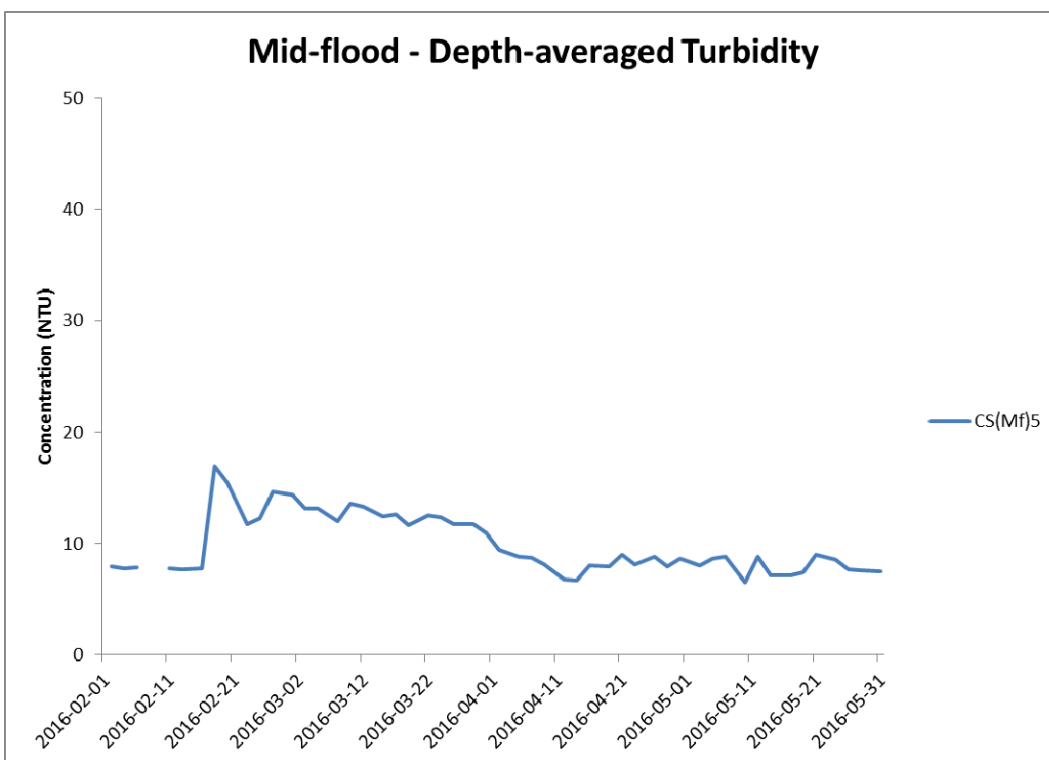
**Figure H25 Impact Monitoring – Mean Level of depth-averaged Turbidity (NTU) during mid-flood tide between 1 February and 31 May 2016 at CS(Mf)3 and CS(MF)5.**

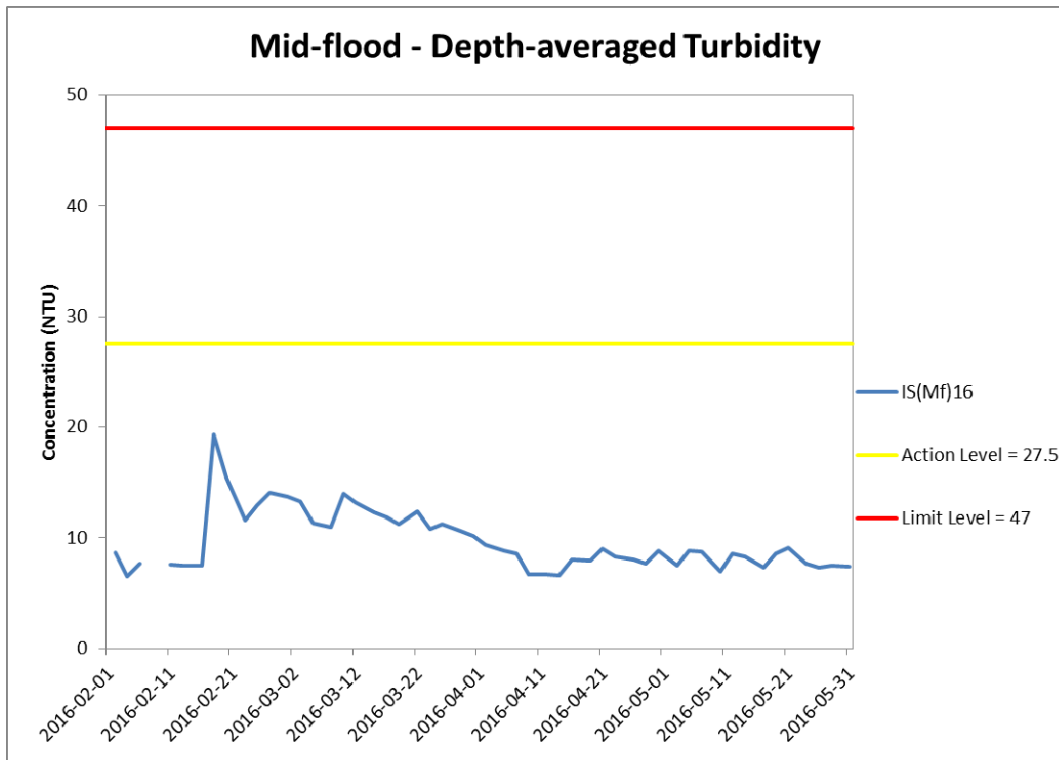
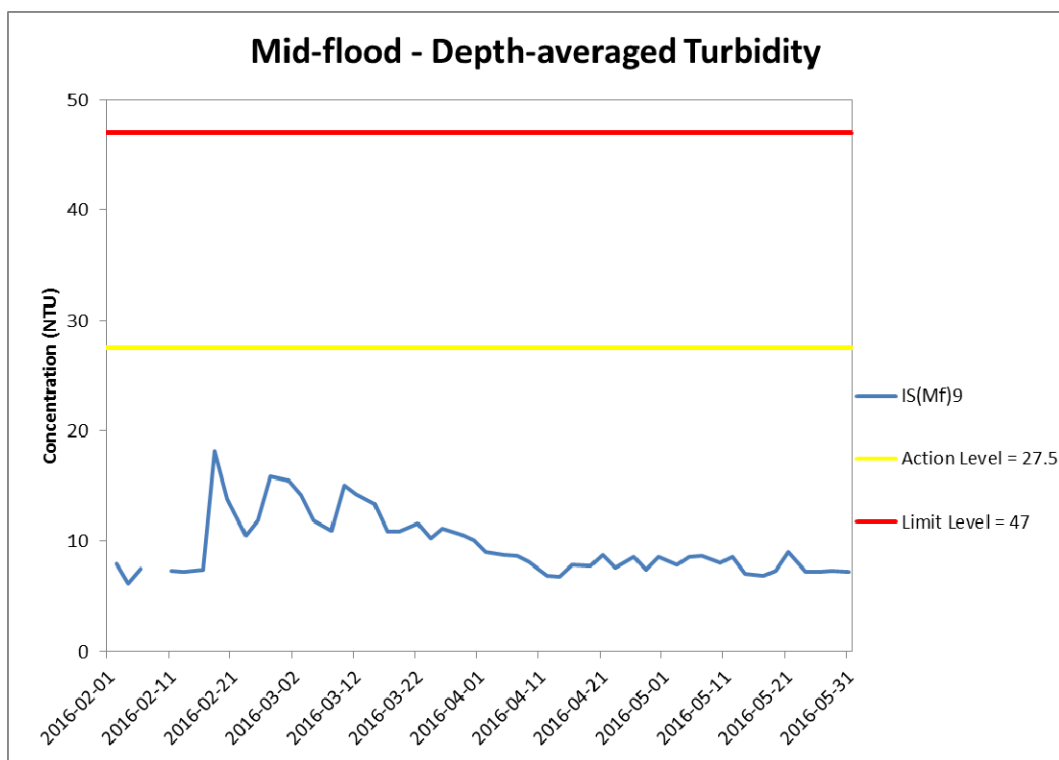
**Figure H26 Impact Monitoring - Mean Level of depth-averaged Turbidity (NTU) during mid-flood tide between 1 February and 31 May 2016 at IS(Mf)16 and IS(Mf)9.**

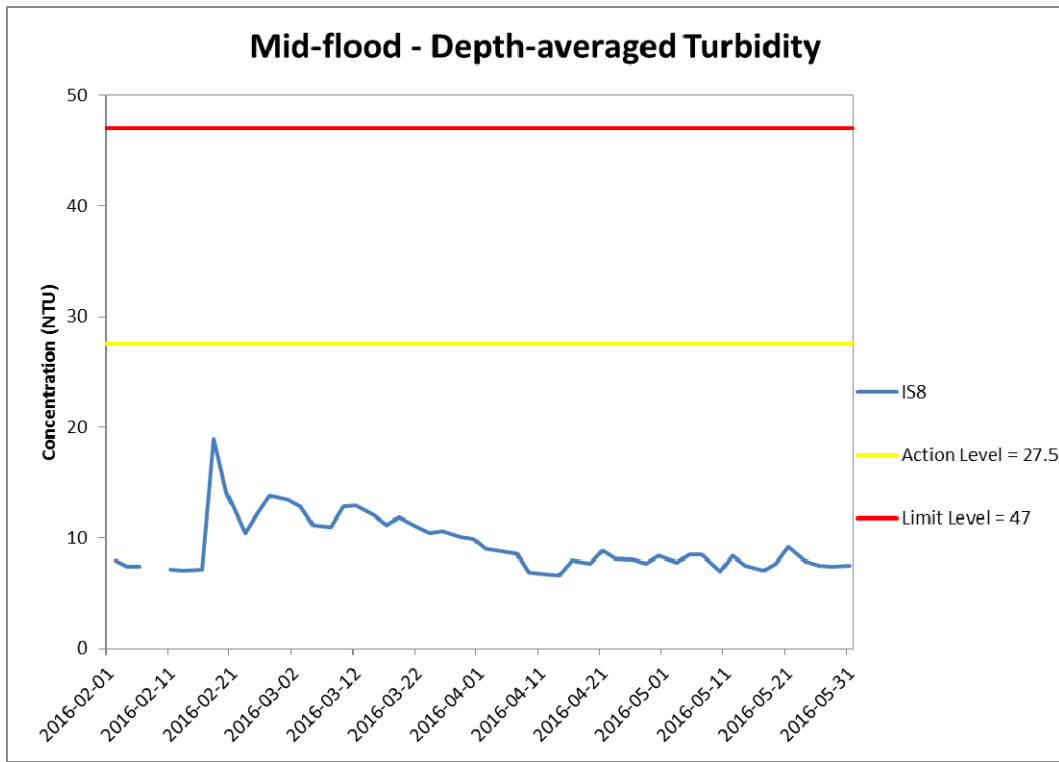
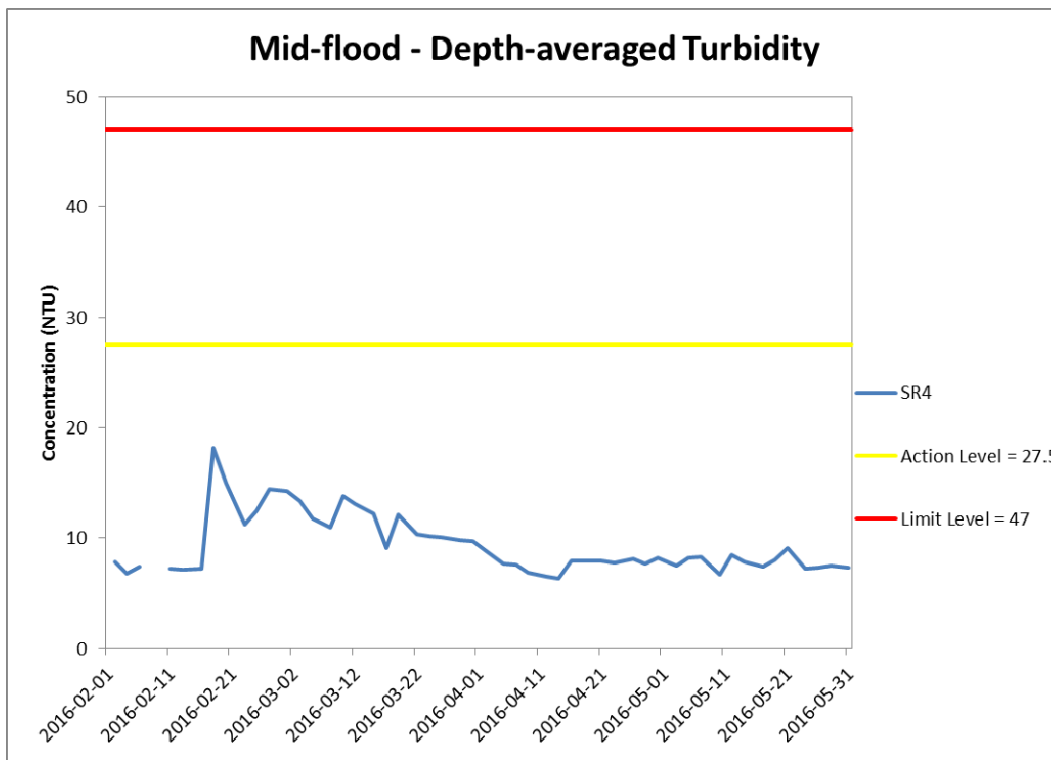
**Figure H27 Impact Monitoring – Mean Level of depth-averaged Turbidity (NTU) during mid-flood tide between 1 February and 31 May 2016 at IS8 and SR4.**

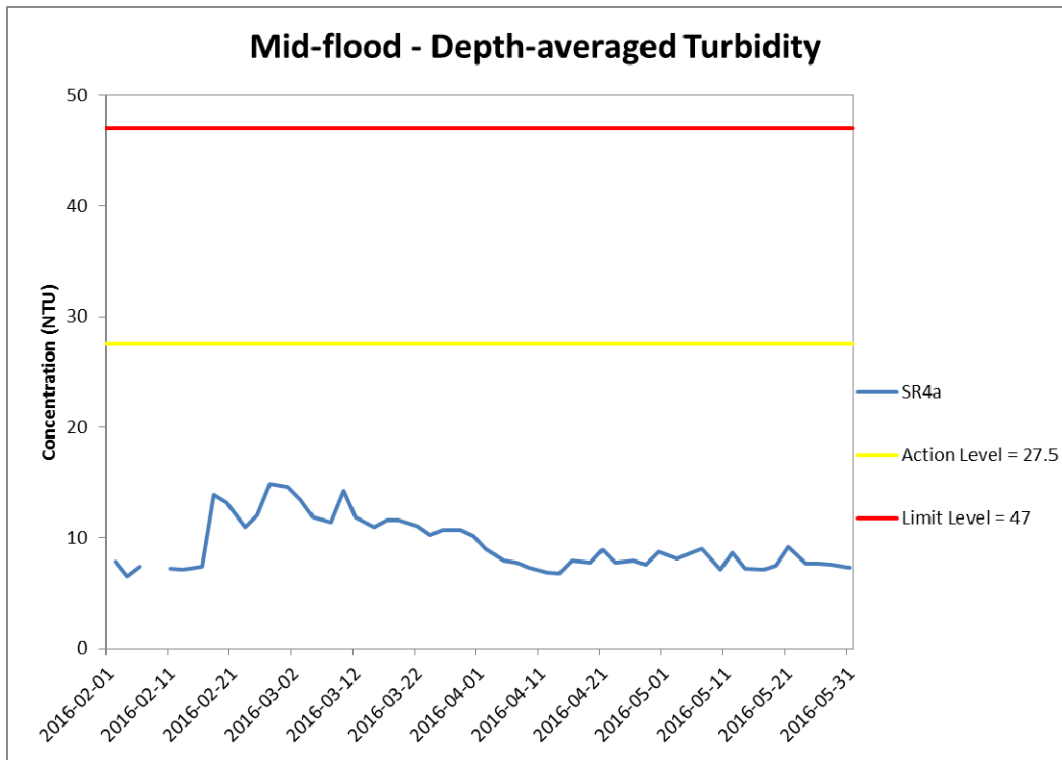
**Figure H28 Impact Monitoring – Mean Level of depth-averaged Turbidity (NTU) during mid-flood tide between 1 February and 31 May 2016 at SR4a.**

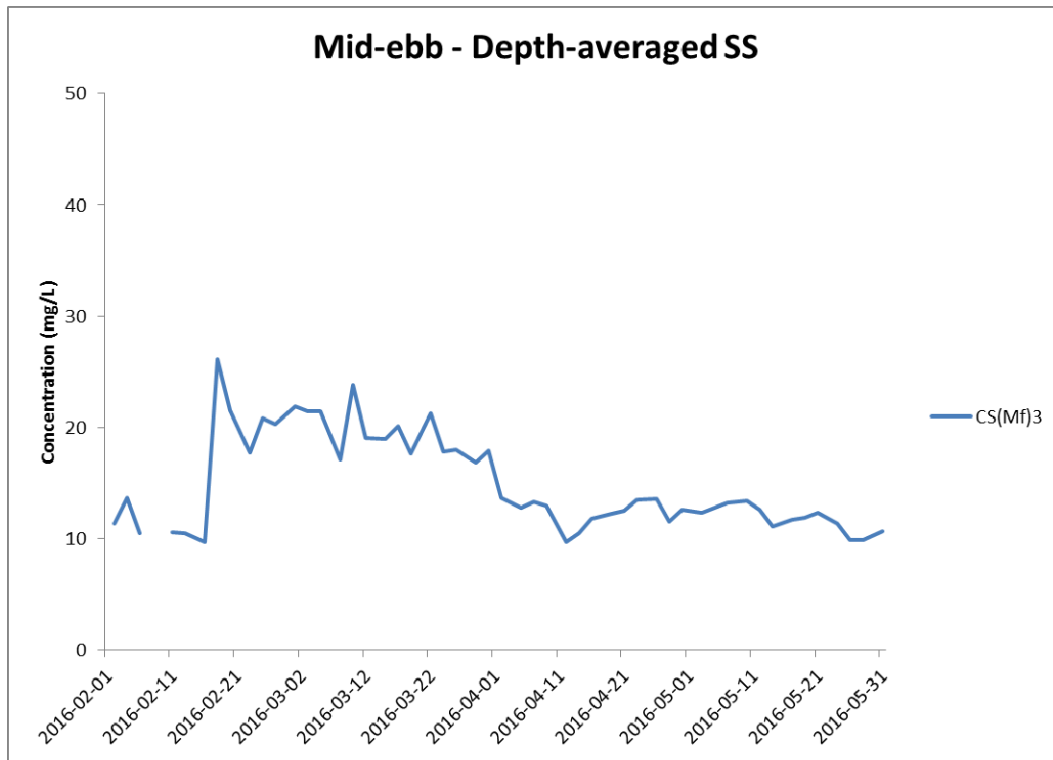
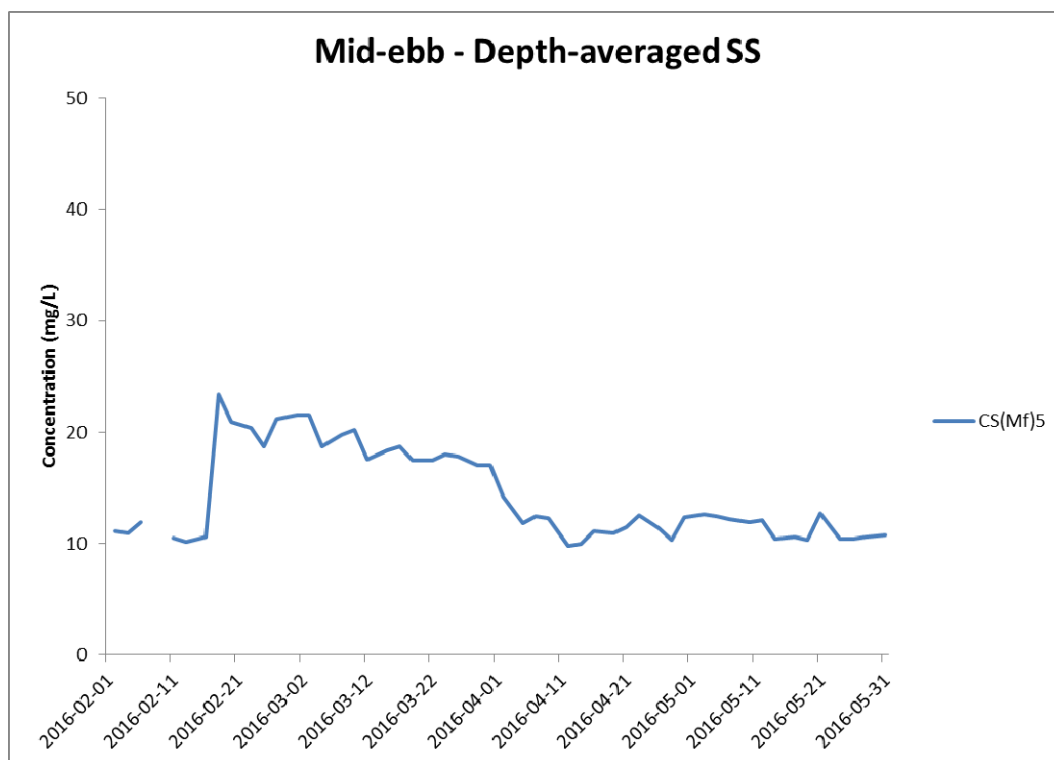
**Figure H29 Impact Monitoring – Mean depth-averaged level of Suspended Solids (mg/L) during mid-ebb tide between 1 February and 31 May 2016 at CS(Mf)3 and CS(Mf)5.**
