**Contract No. HY/2012/07  
Tuen Mun – Chek Lap Kok Link –  
Southern Connection Viaduct Section**

*Tenth Quarterly Environmental Monitoring &  
Audit (EM&A) Report*

02 November 2016

**Contract No. HY/2012/07 TM-CLKL Southern Connection Viaduct  
Section  
10th Quarterly EM&A Summary Report (March 2016 to May 2016)**

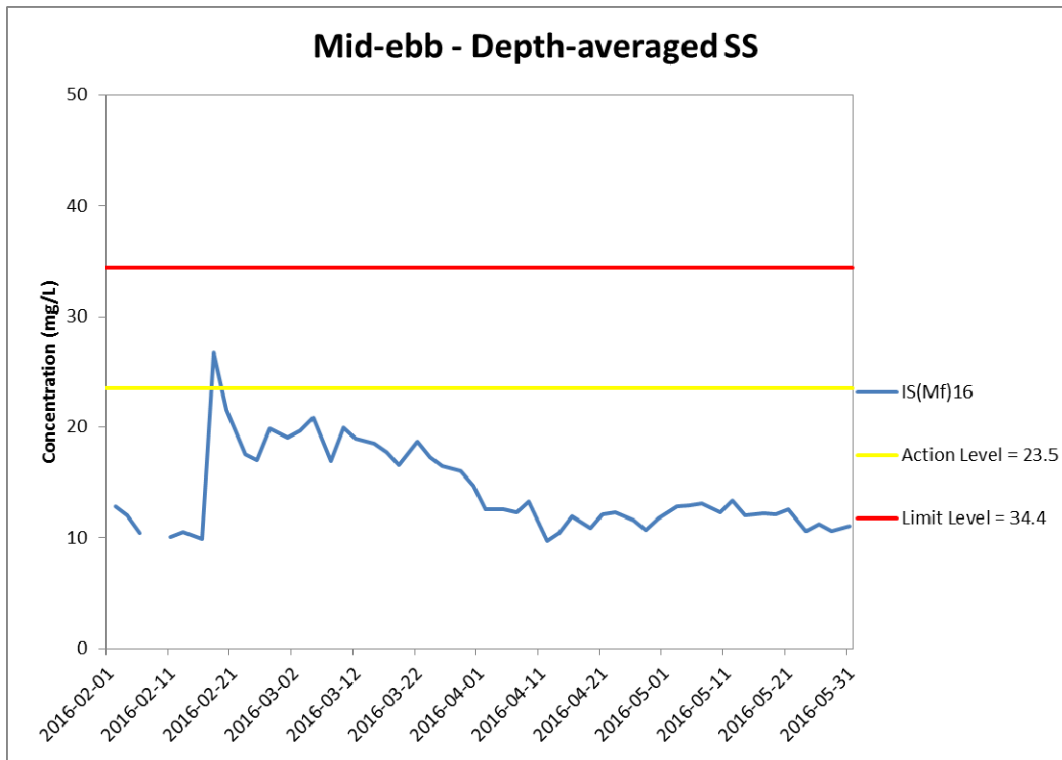
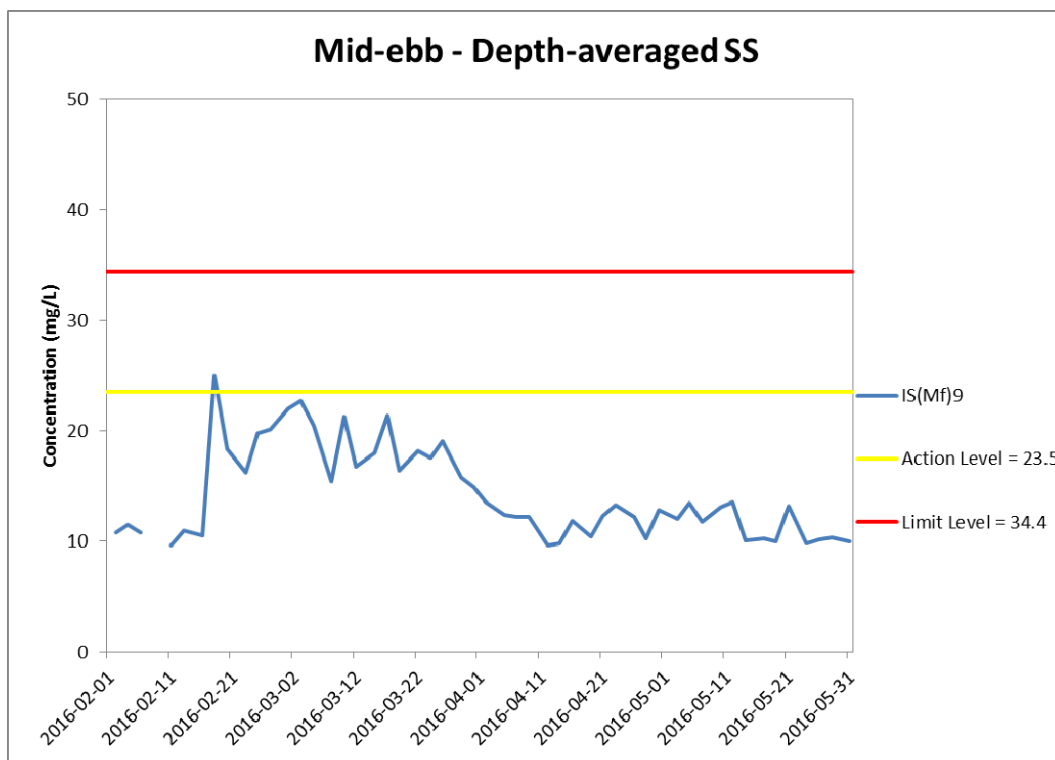
**Figure H30 Impact Monitoring - Mean depth-averaged level of Suspended Solids (mg/L) during mid-ebb tide between 1 February and 31 May 2016 at IS(Mf)16 and IS(Mf)9.**

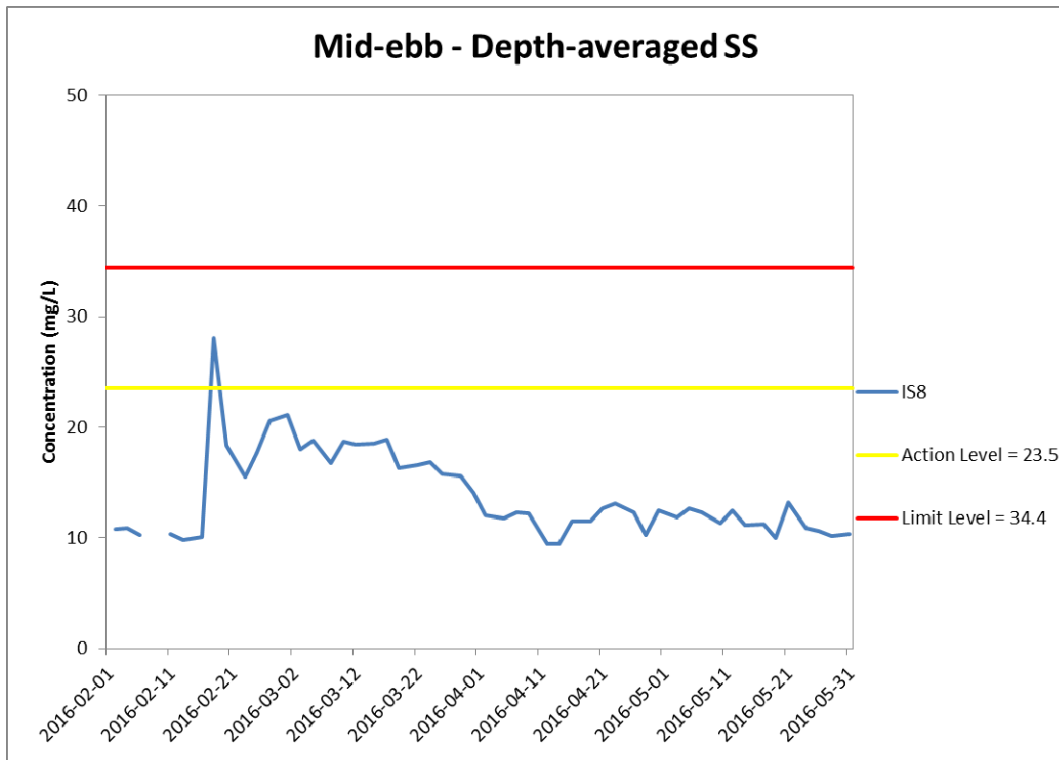
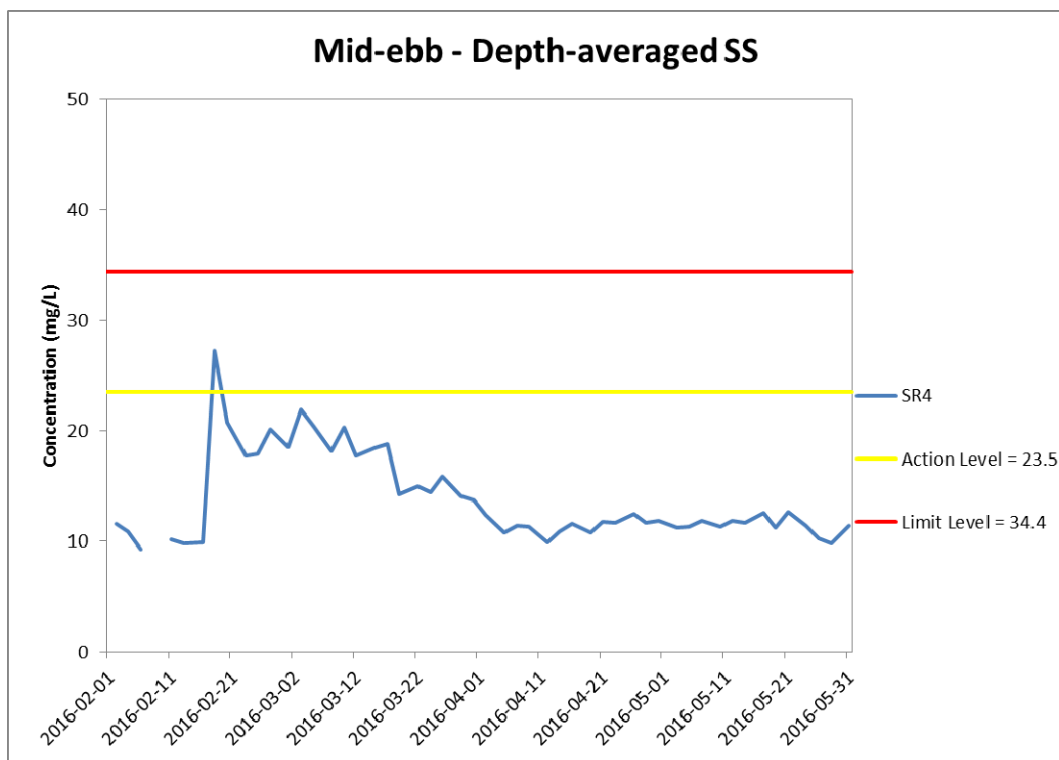
**Figure H31 Impact Monitoring - Mean depth-averaged level of Suspended Solids (mg/L) during mid-ebb tide between 1 February and 31 May 2016 at IS8 and SR4.**

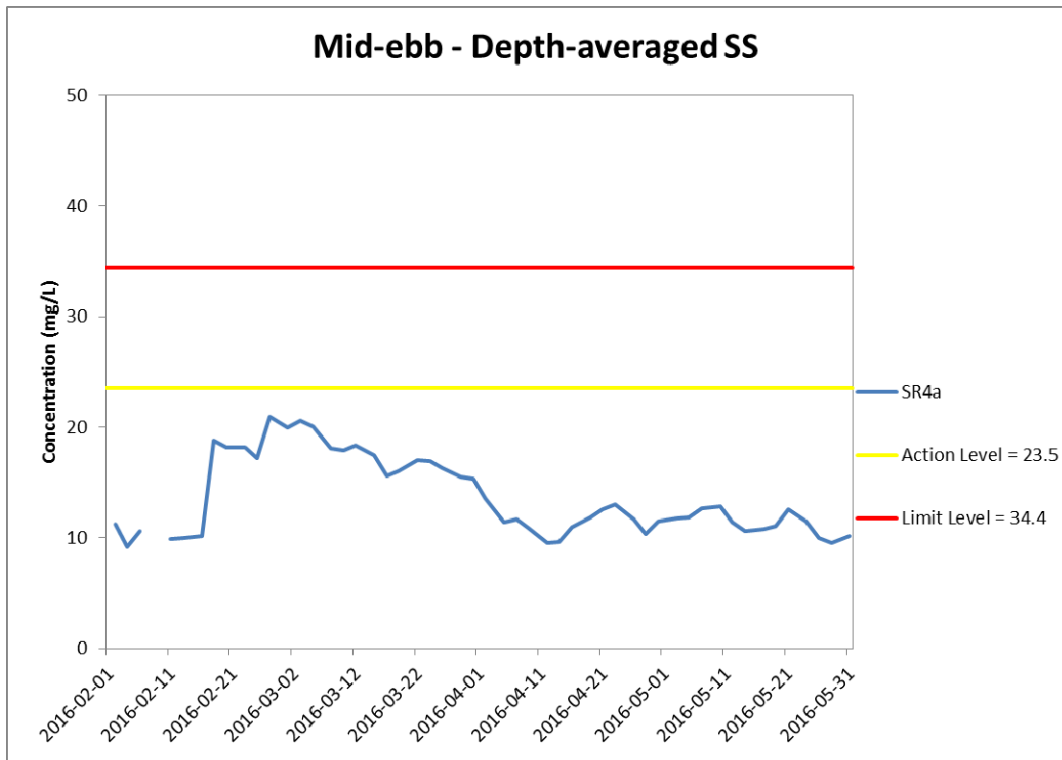
**Figure H32 Impact Monitoring – Mean depth-averaged level of Suspended Solids (mg/L) during mid-ebb tide between 1 February and 31 May 2016 at SR4a.**

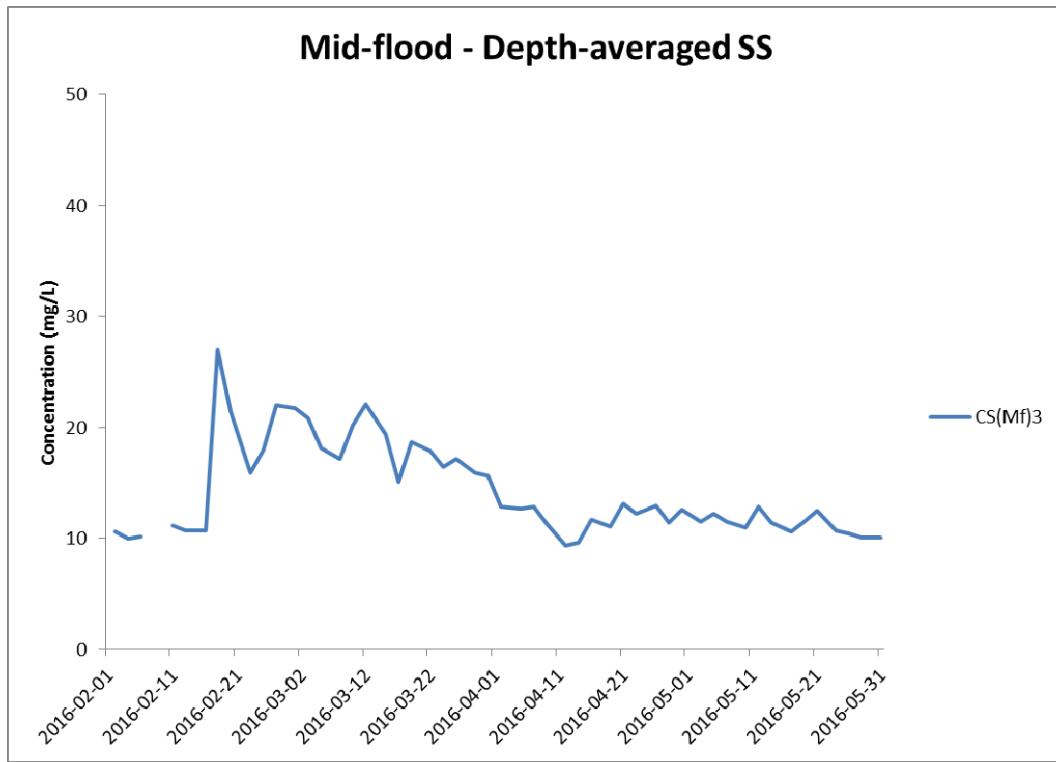
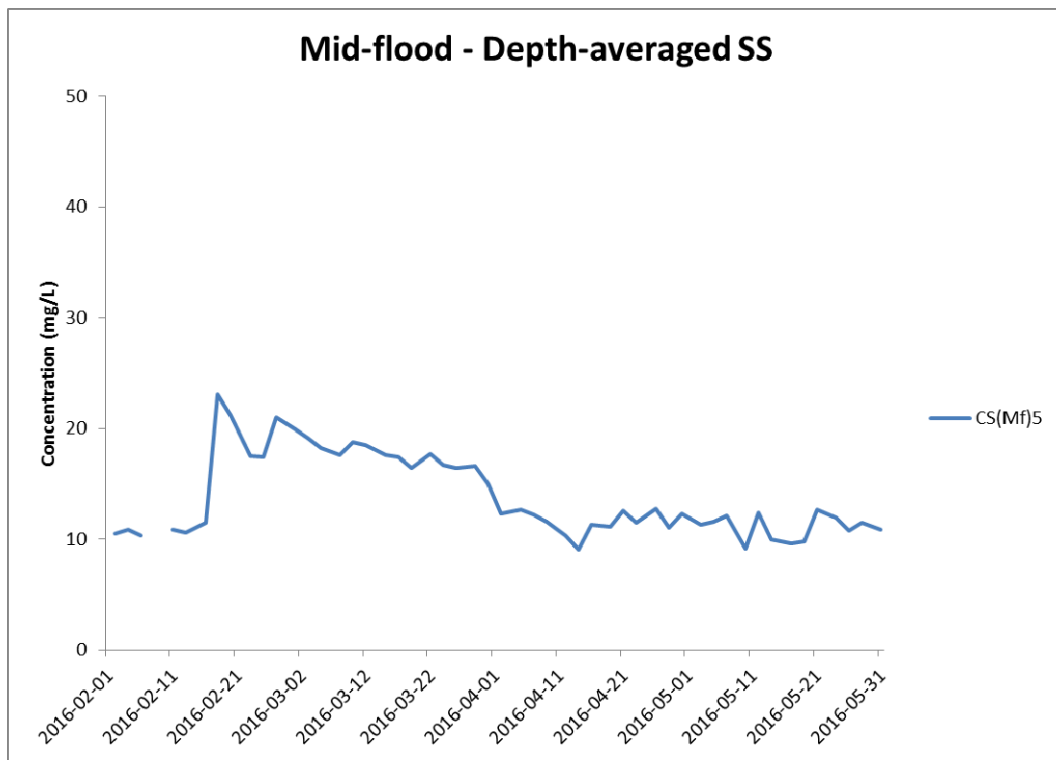
**Figure H33 Impact Monitoring – Mean depth-averaged level of Suspended Solids (mg/L) during mid-flood tide between 1 February and 31 May 2016 at CS(Mf)3 and CS(Mf)5.**

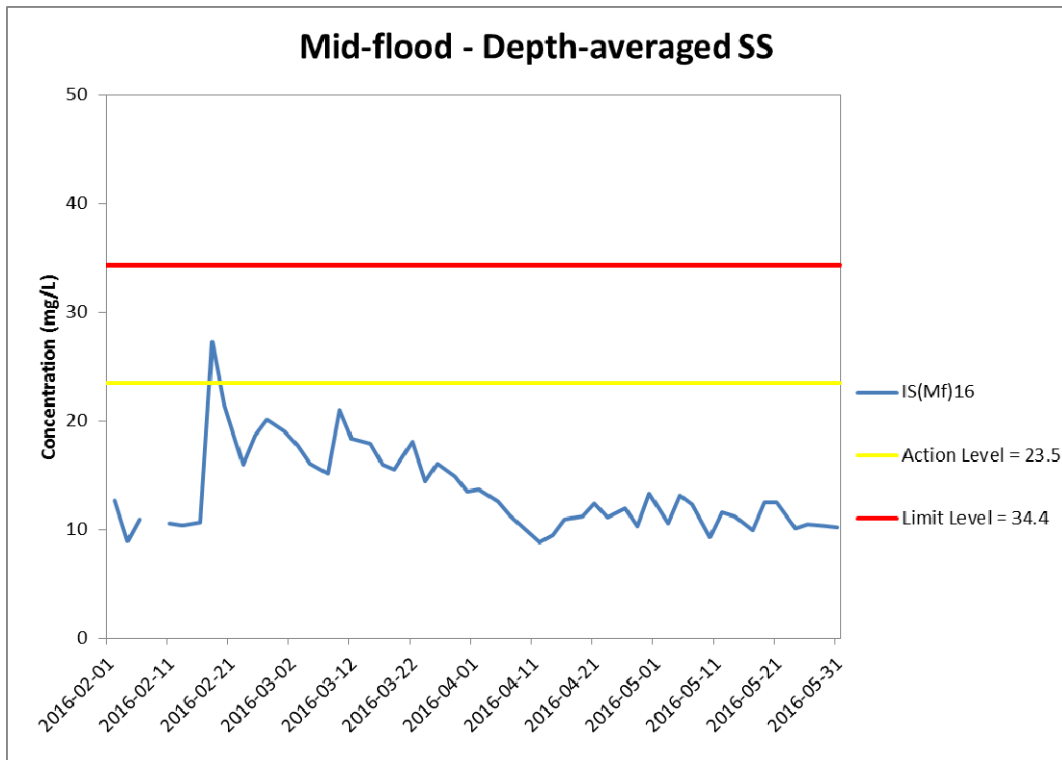
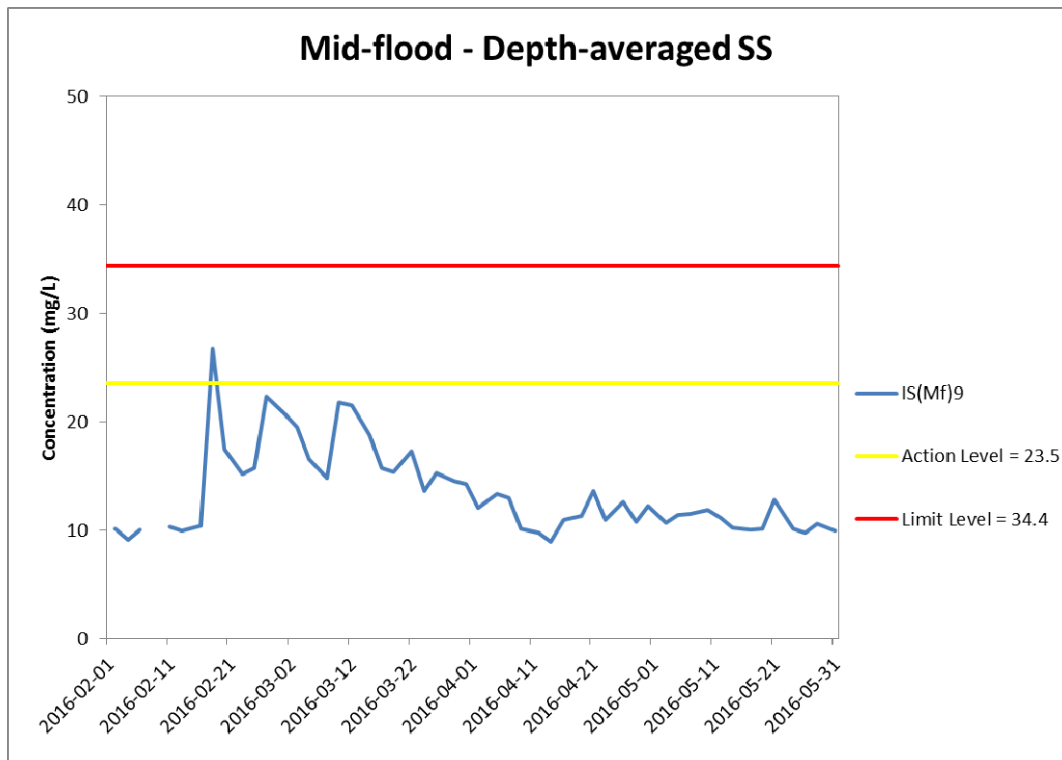
**Figure H34 Impact Monitoring - Mean depth-averaged level of Suspended Solids (mg/L) during mid-flood tide between 1 February and 31 May 2016 at IS(Mf)16 and IS(Mf)9.**

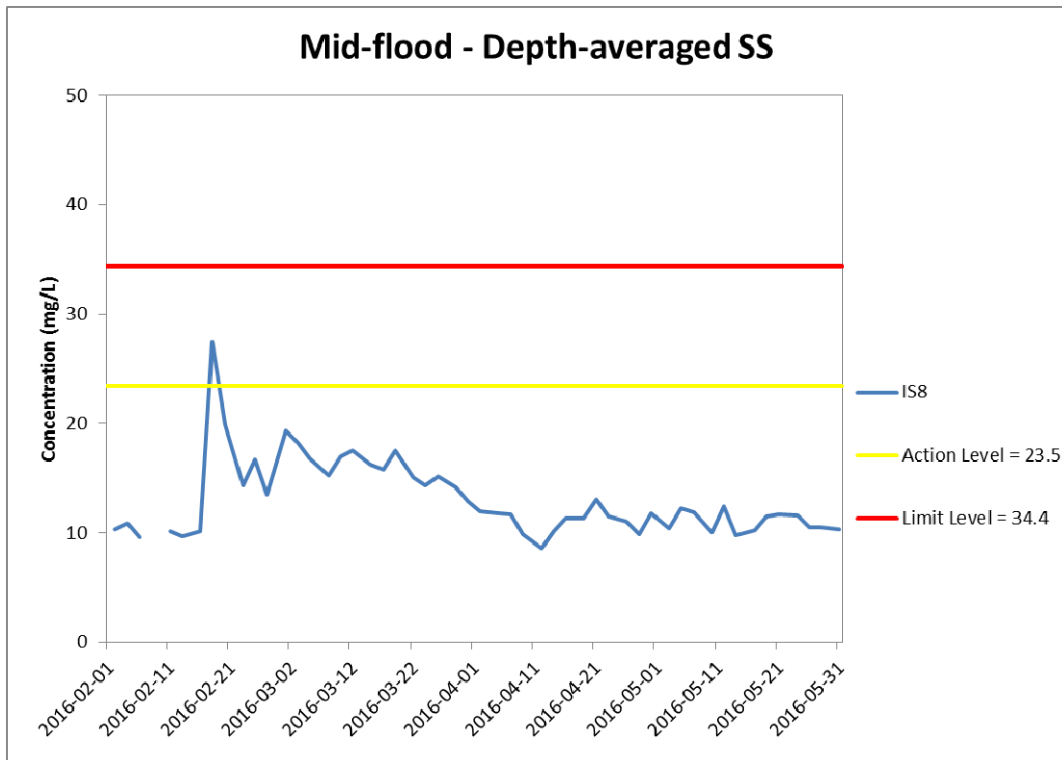
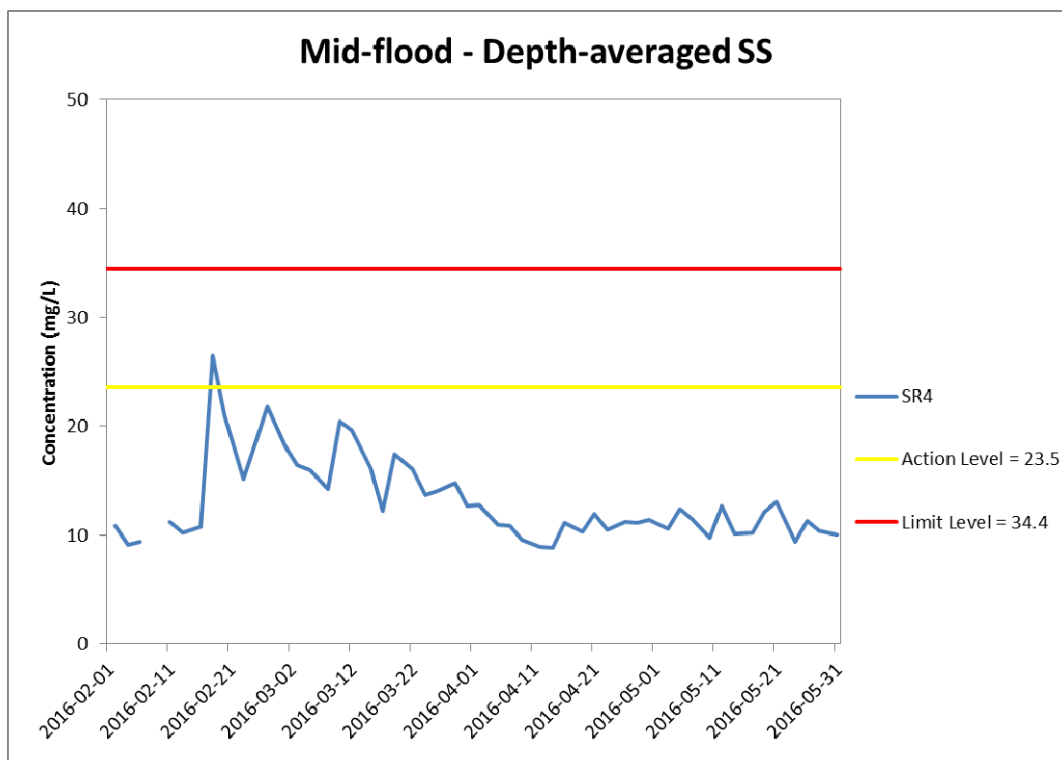
**Figure H35 Impact Monitoring - Mean depth-averaged level of Suspended Solids (mg/L) during mid-flood tide between 1 February and 31 May 2016 at IS8 and SR4.**

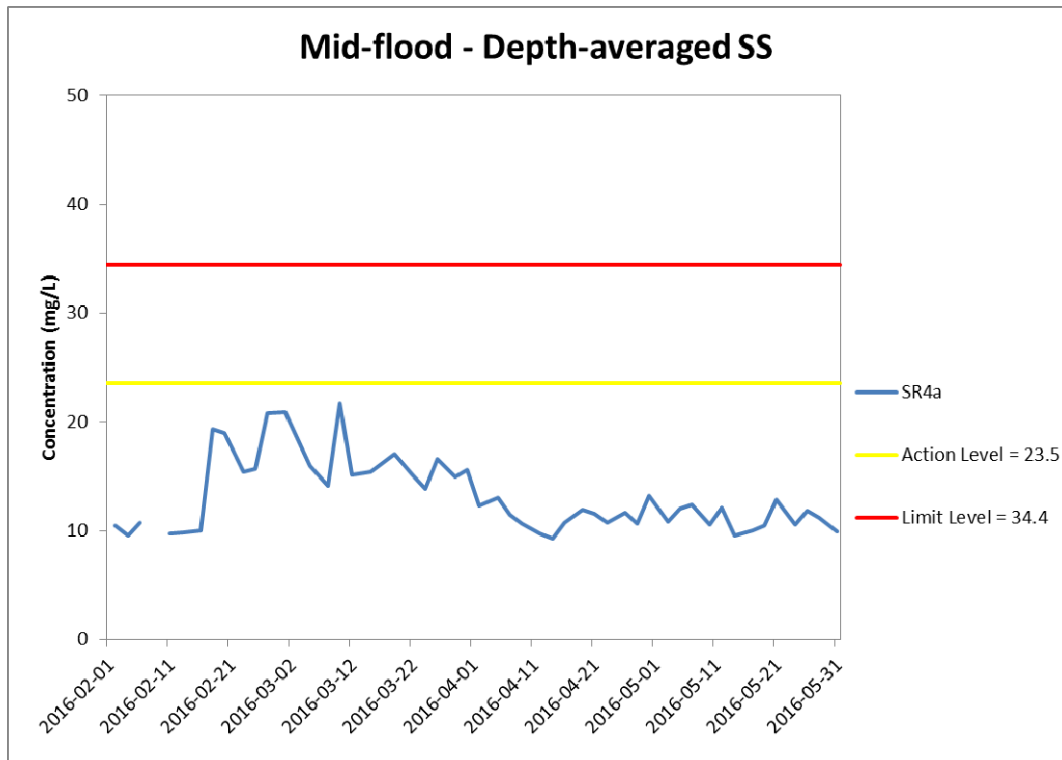
**Figure H36 Impact Monitoring - Mean depth-averaged level of Suspended Solids (mg/L) during mid-flood tide between 1 February and 31 May 2016 at SR4a.**

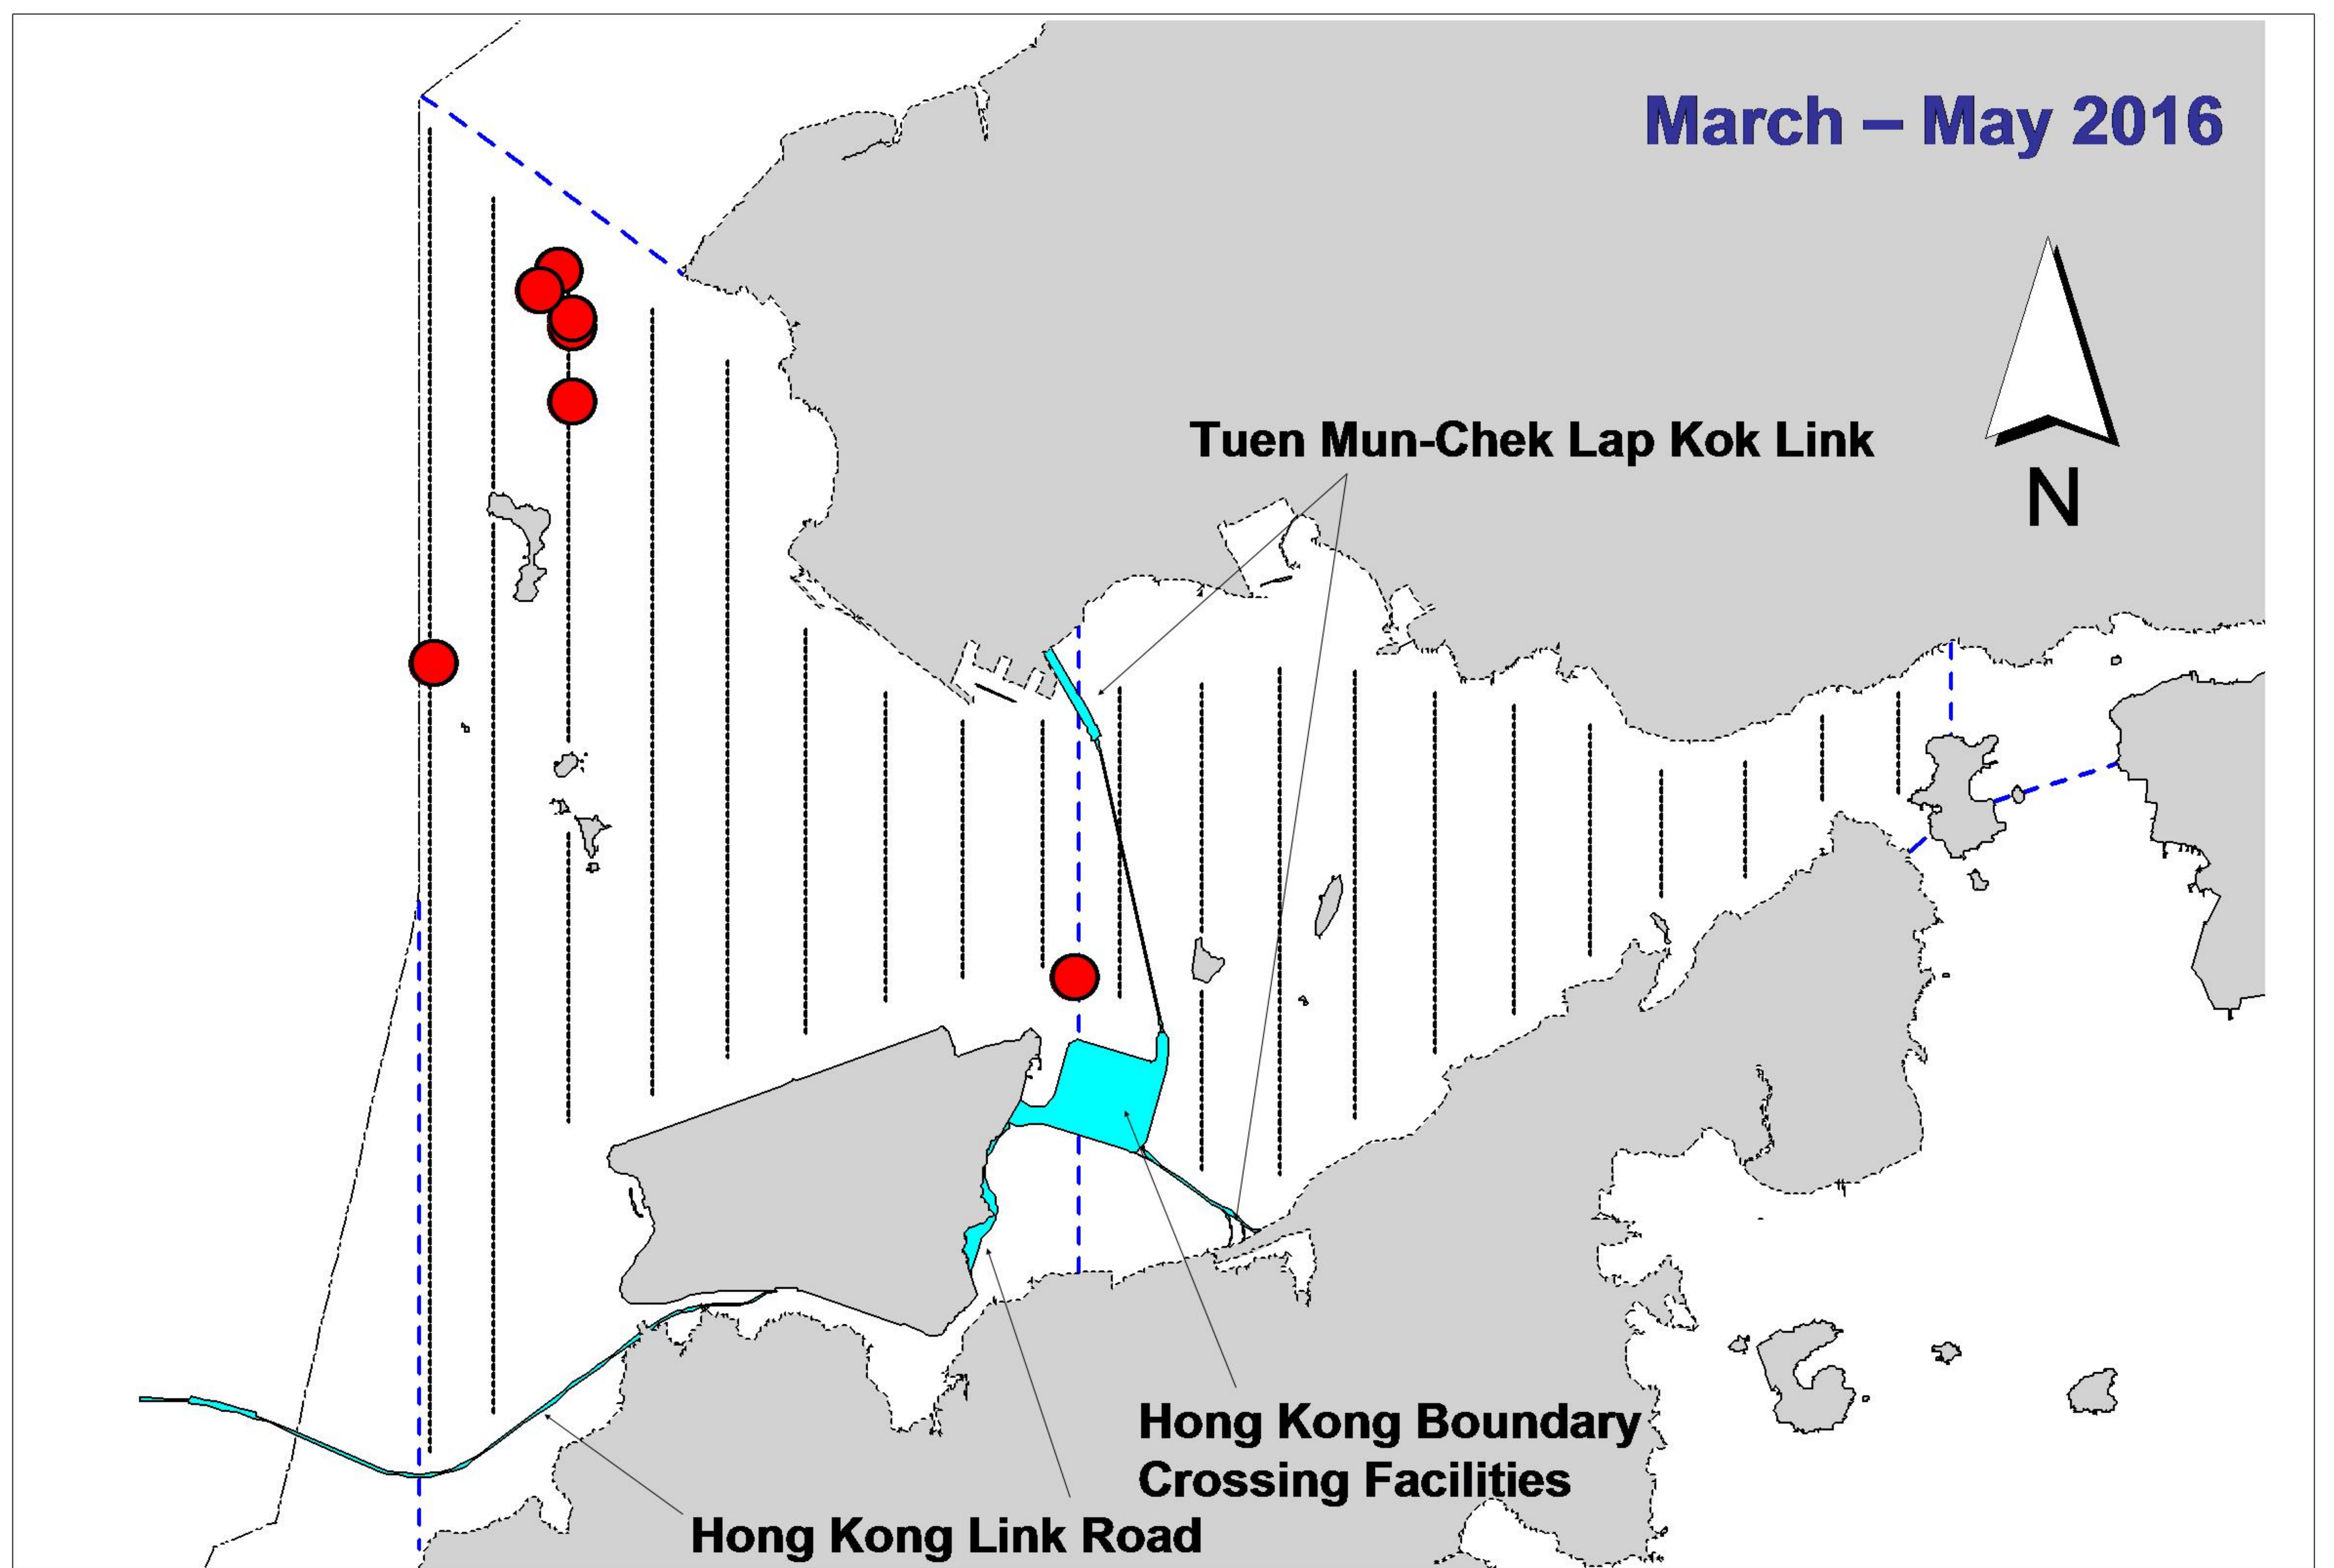
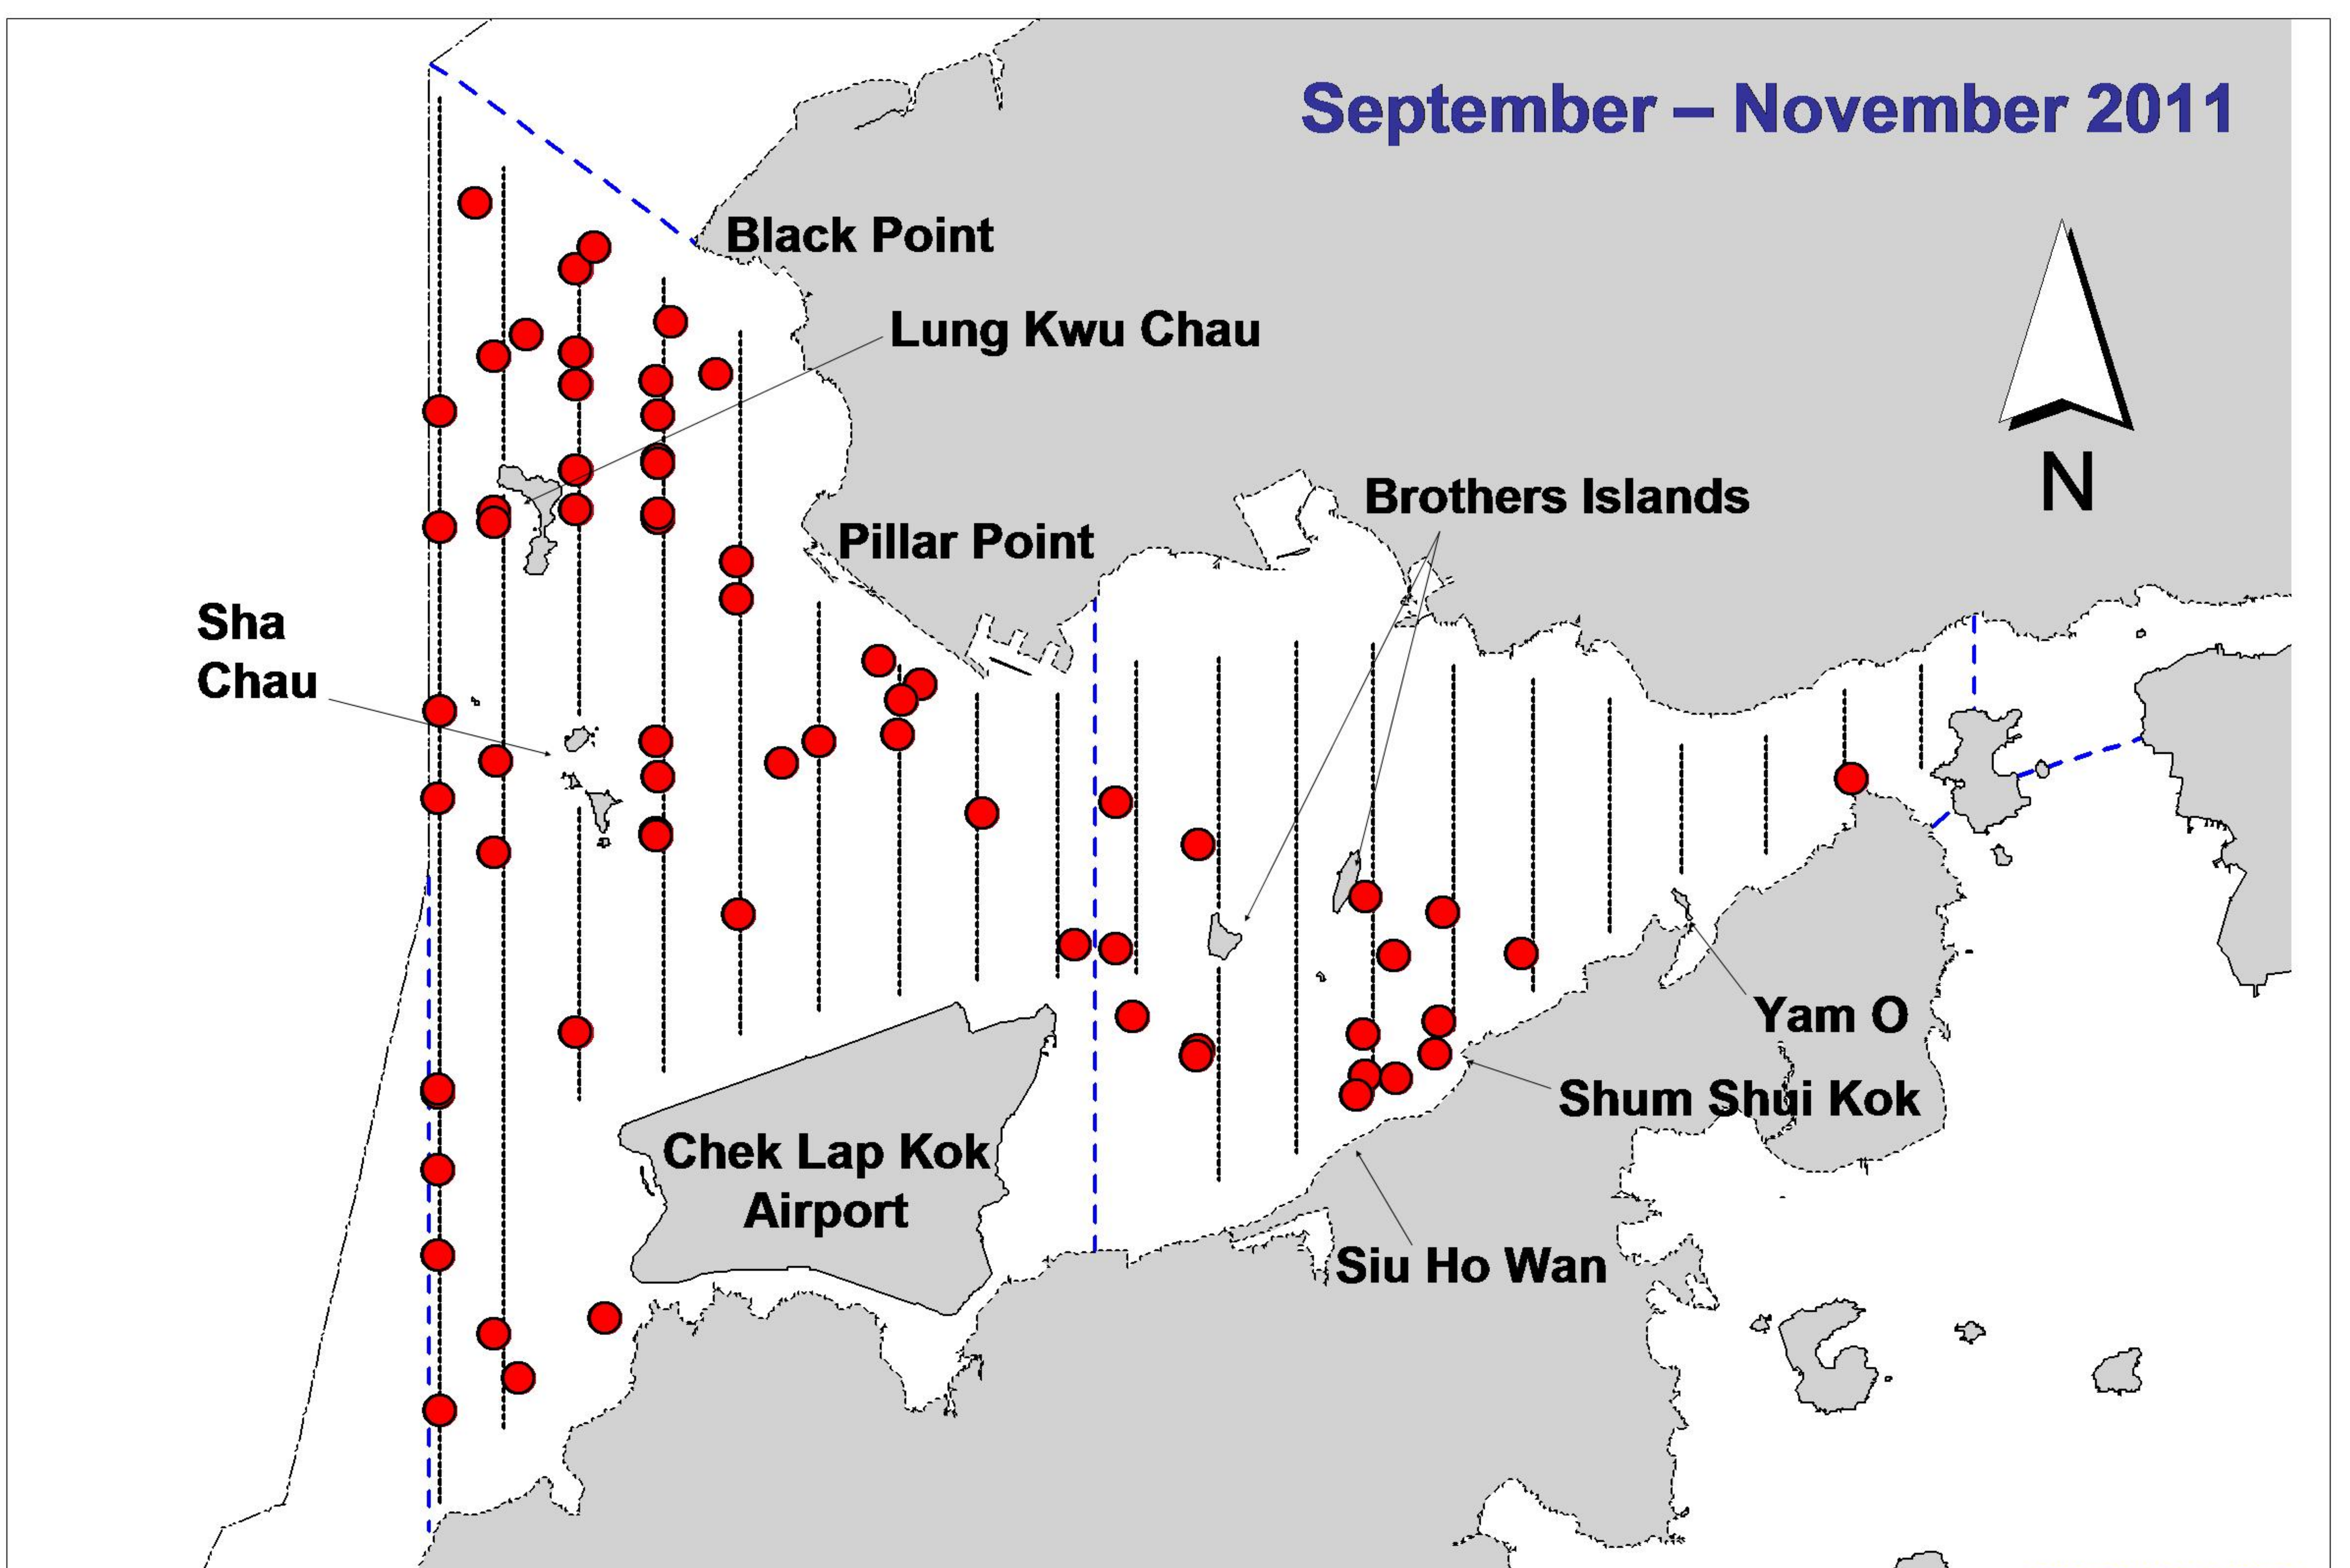
Figure 1. Distribution of Chinese white dolphin sighting in Northwest and Northeast Lantau during HKLR03 impact phase (top) and baseline monitoring surveys (bottom)
