**Contract No. HY/2012/07
Tuen Mun – Chek Lap Kok Link –
Southern Connection Viaduct Section**

*Eleventh Quarterly Environmental Monitoring &
Audit (EM&A) Report*

2 December 2016

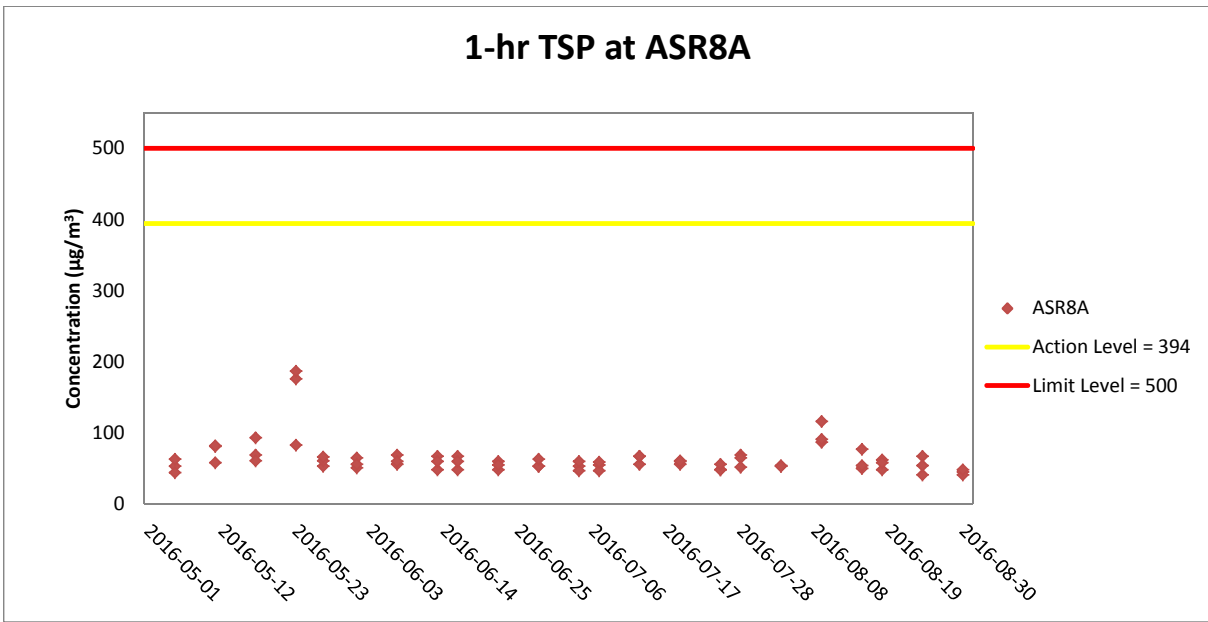
Impact Air Quality
Monitoring Graphical
Presentation

Weather condition within the reporting period varied between sunny to rainy.

Major construction works undertaken within the reporting period include Pier construction; Re-alignment of Cheung Tung Road; Construction of land section of berth at Southern Landfall; Installation of pier head and deck segments; and Slope work of Viaducts A, B & C.

Marine works within the reporting period include Construction and installation of pile caps; Uninstallation of marine piling platform; Pier construction; Launching gantry operation; and Installation of deck segment and pier head segment.

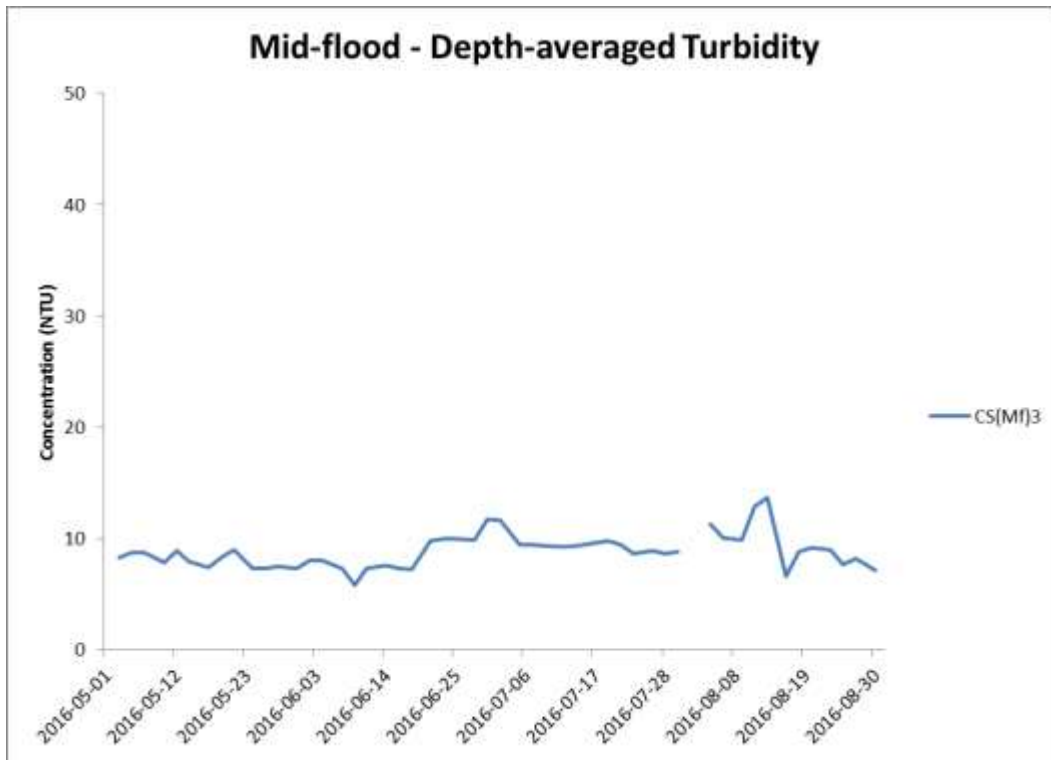
Figure H25 Impact Monitoring – Mean Level of depth-averaged Turbidity (NTU) during mid-flood tide between 1 May and 31 August 2016 at CS(Mf)3 and CS(MF)5.

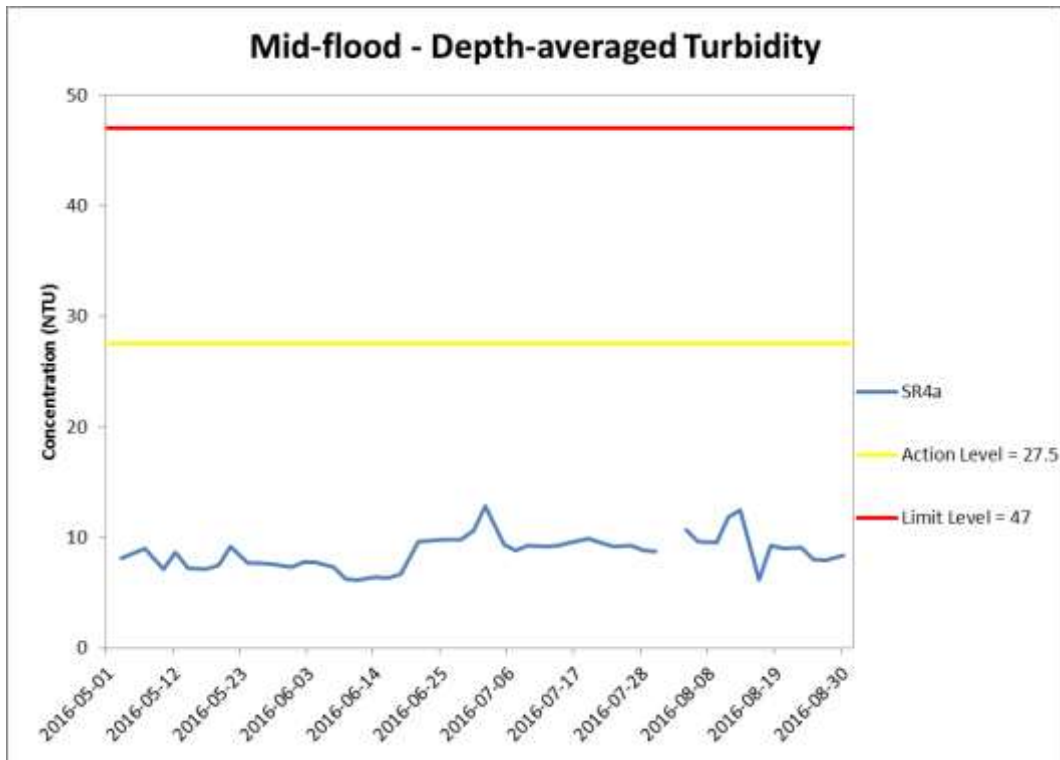
Figure H28 Impact Monitoring - Mean Level of depth-averaged Turbidity (NTU) during mid-flood tide between 1 May and 31 August 2016 at SR4a.

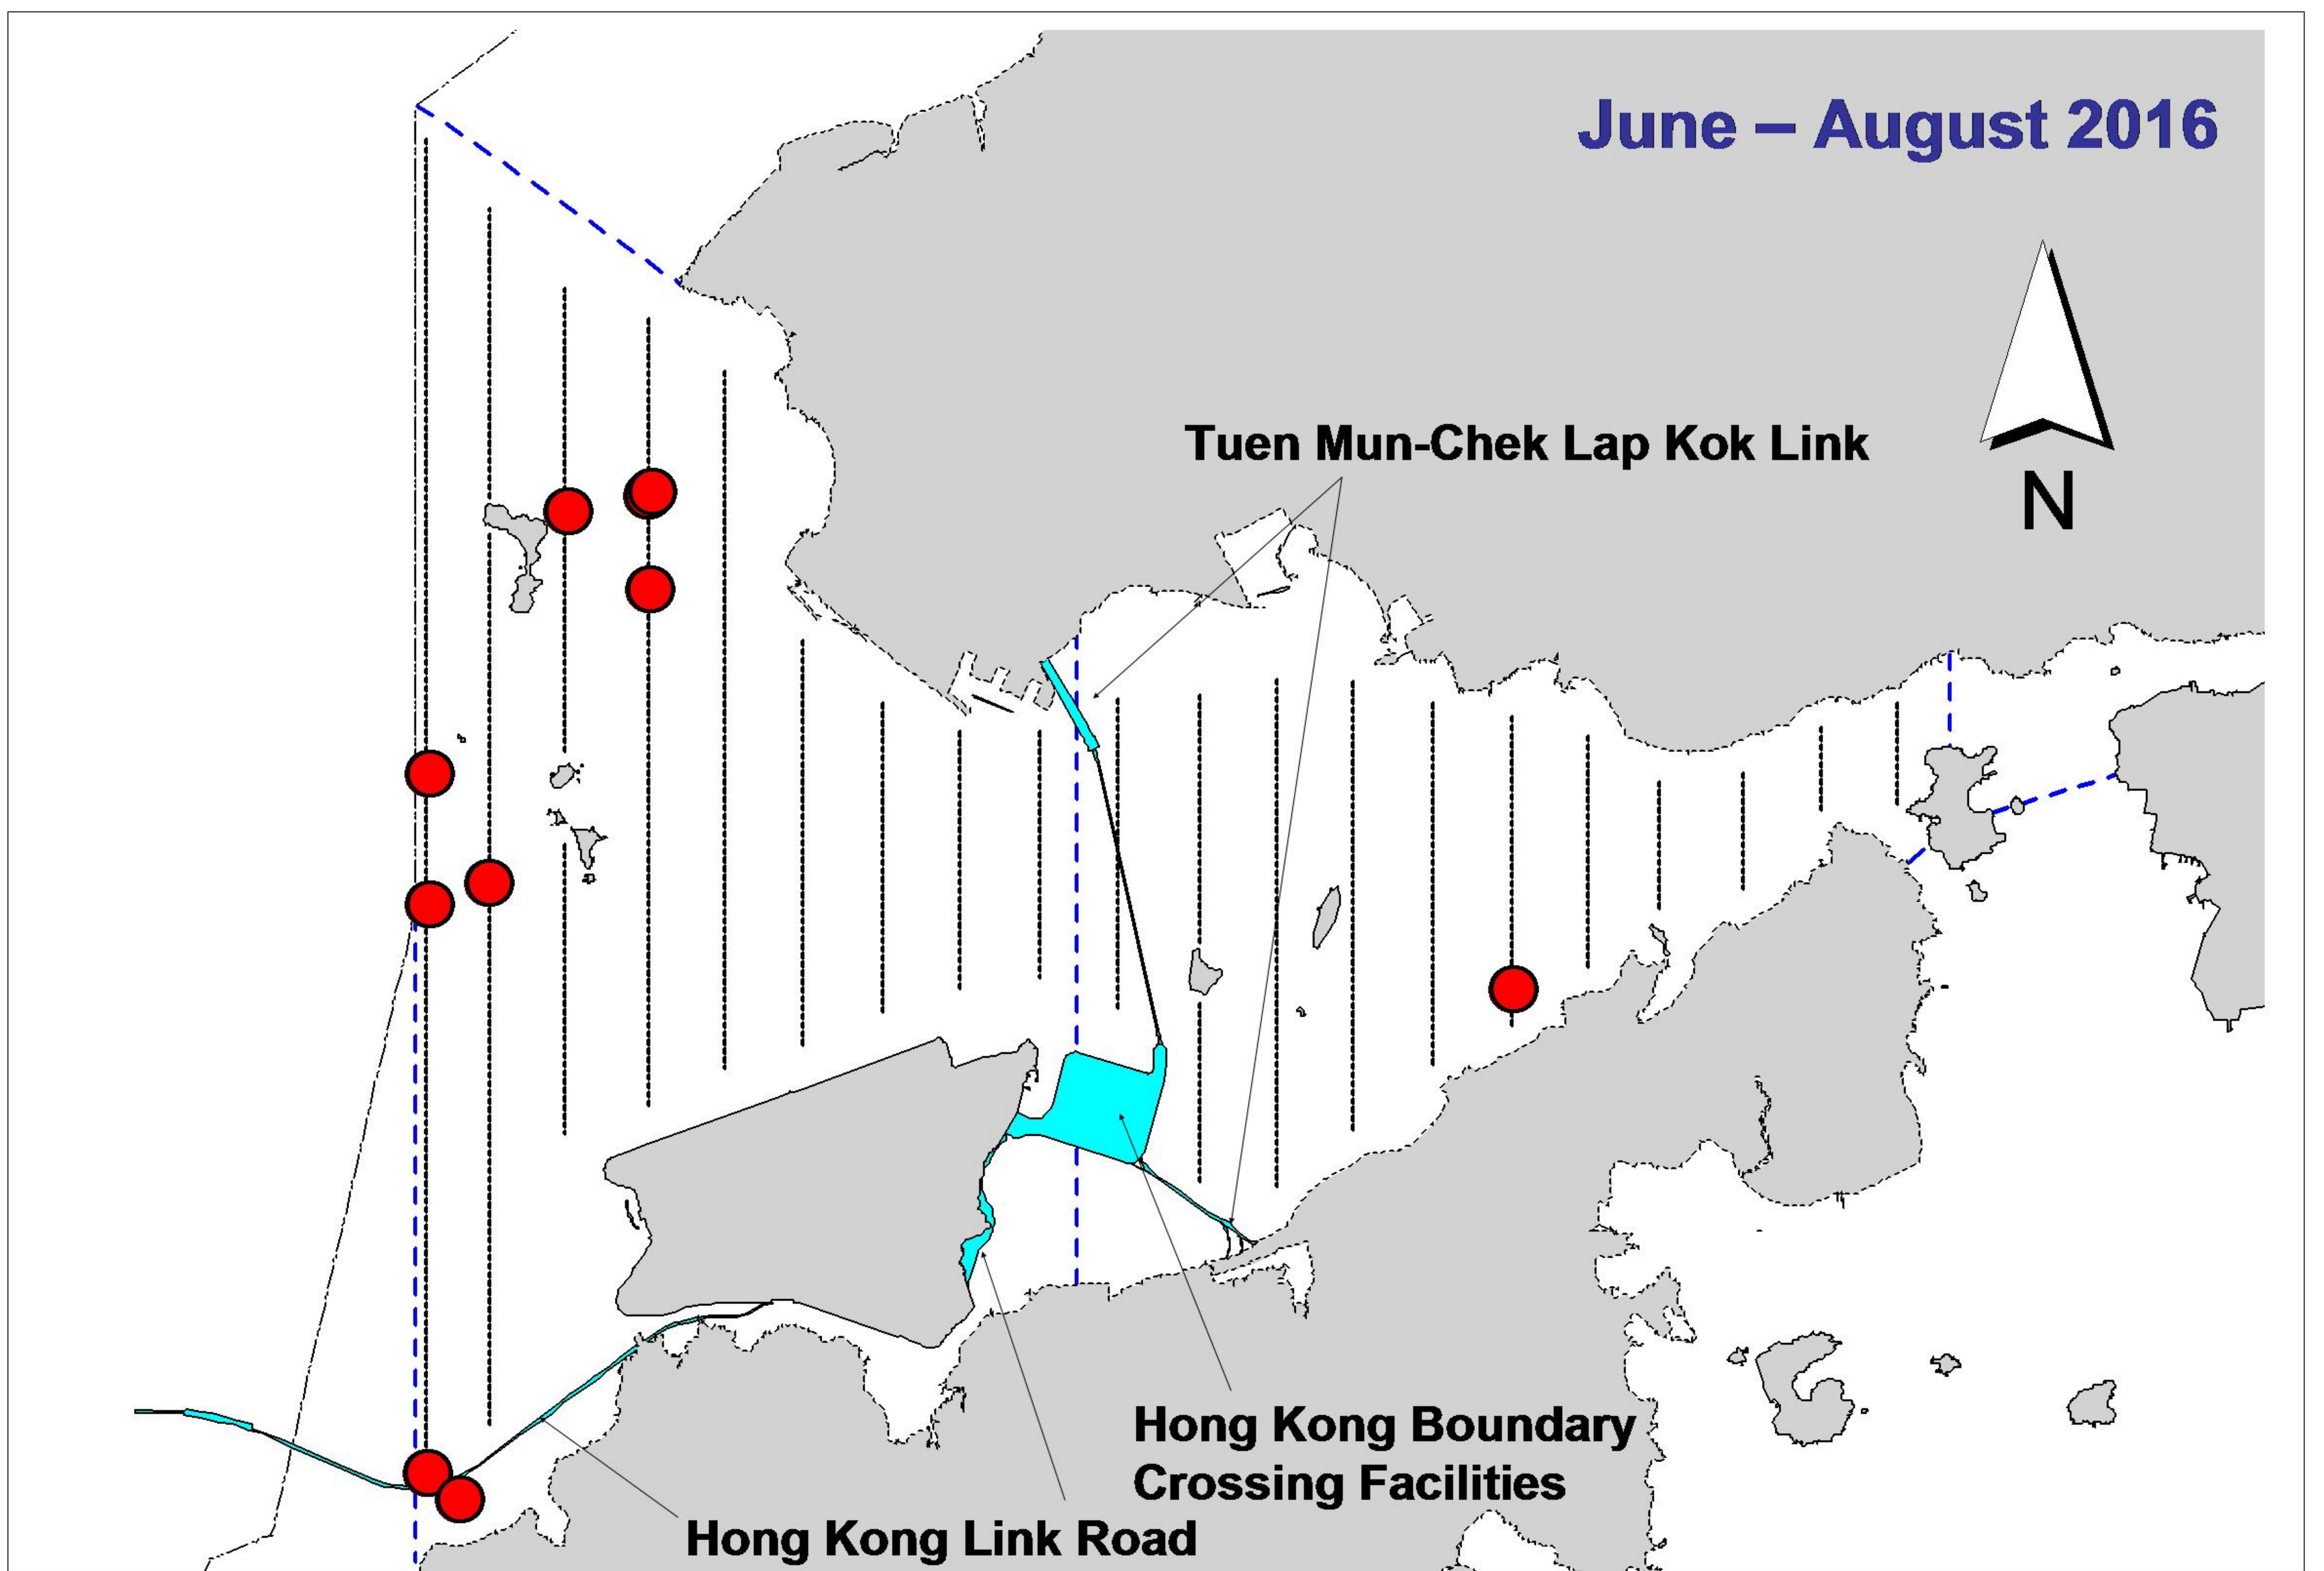
Figure 1. Distribution of Chinese white dolphin sighting in Northwest and Northeast Lantau during HKLR03 impact phase (top) and baseline monitoring surveys (bottom)
