**Contract No. HY/2012/08
Tuen Mun – Chek Lap Kok Link –
Northern Connection Sub-sea Tunnel
Section**

*Third Quarterly Environmental Monitoring &
Audit (EM&A) Report*

20 November 2014

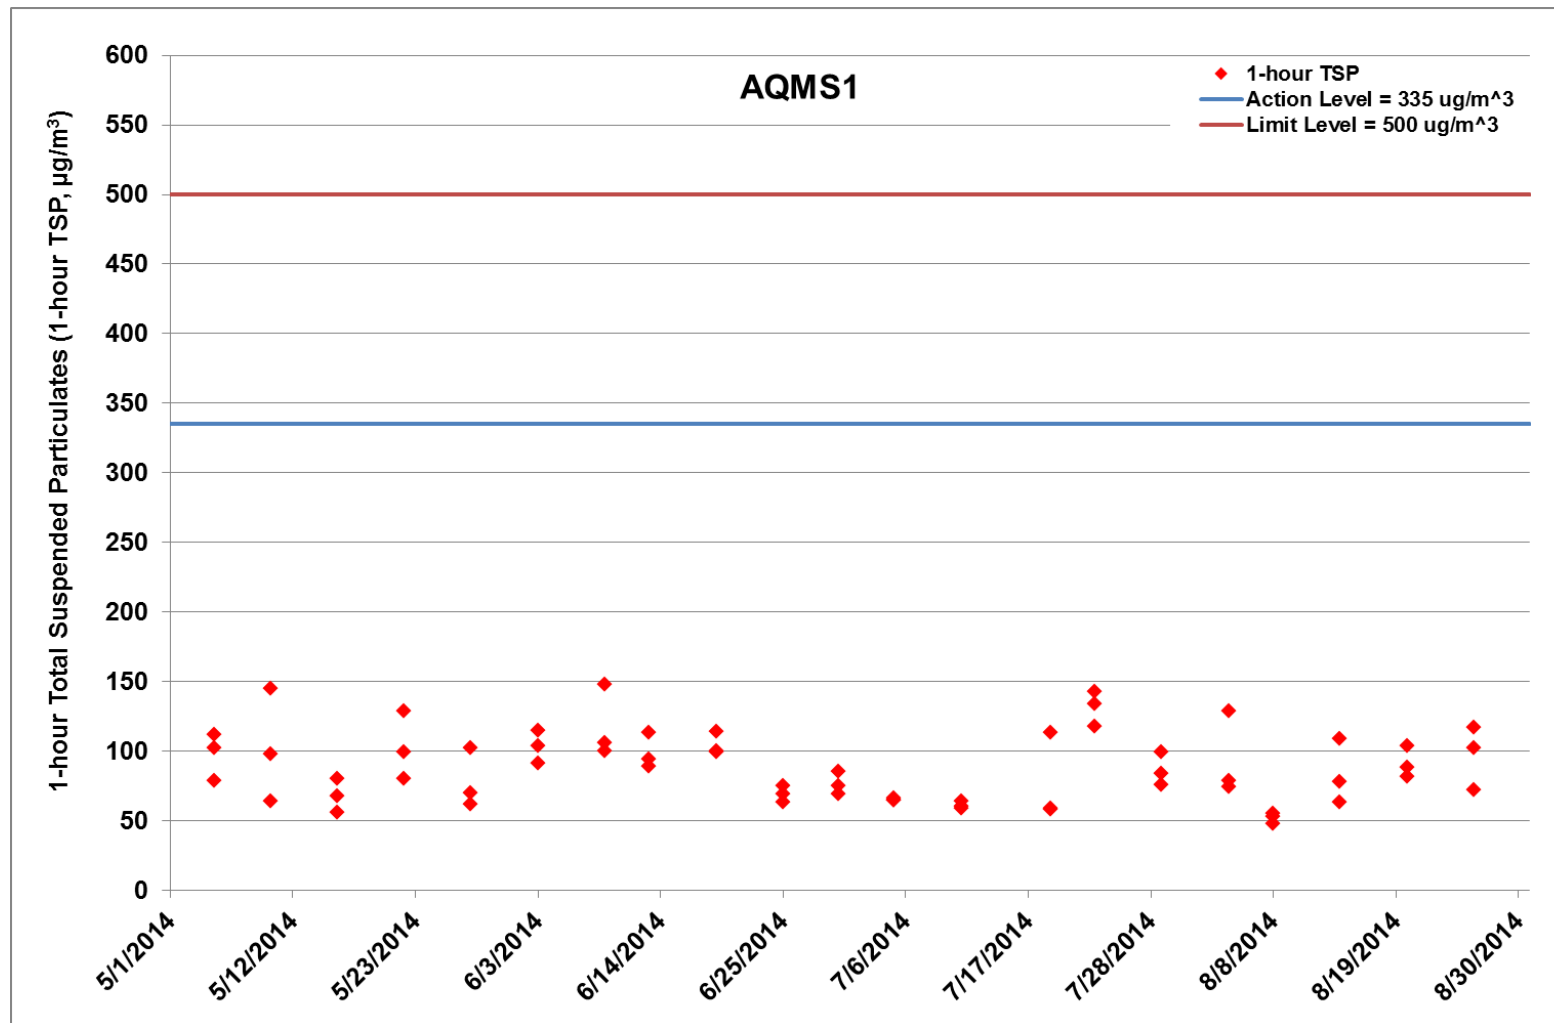
Figure F.1 Impact Monitoring - 1-hour Total Suspended Particulates ($\mu\text{g}/\text{m}^3$) at AQMS1 between 1 May 2014 and 31 August 2014 during impact monitoring period. The weather conditions during the monitoring period varied from sunny to cloudy. Major land-based construction activities included: Diaphragm Wall Construction at Reclamation Works Area - Portion N-A (14/5/2014 - 31/8/2014) & Construction of CLP Temporary Substation at N6 (1/5/2014 - 31/8/2014)

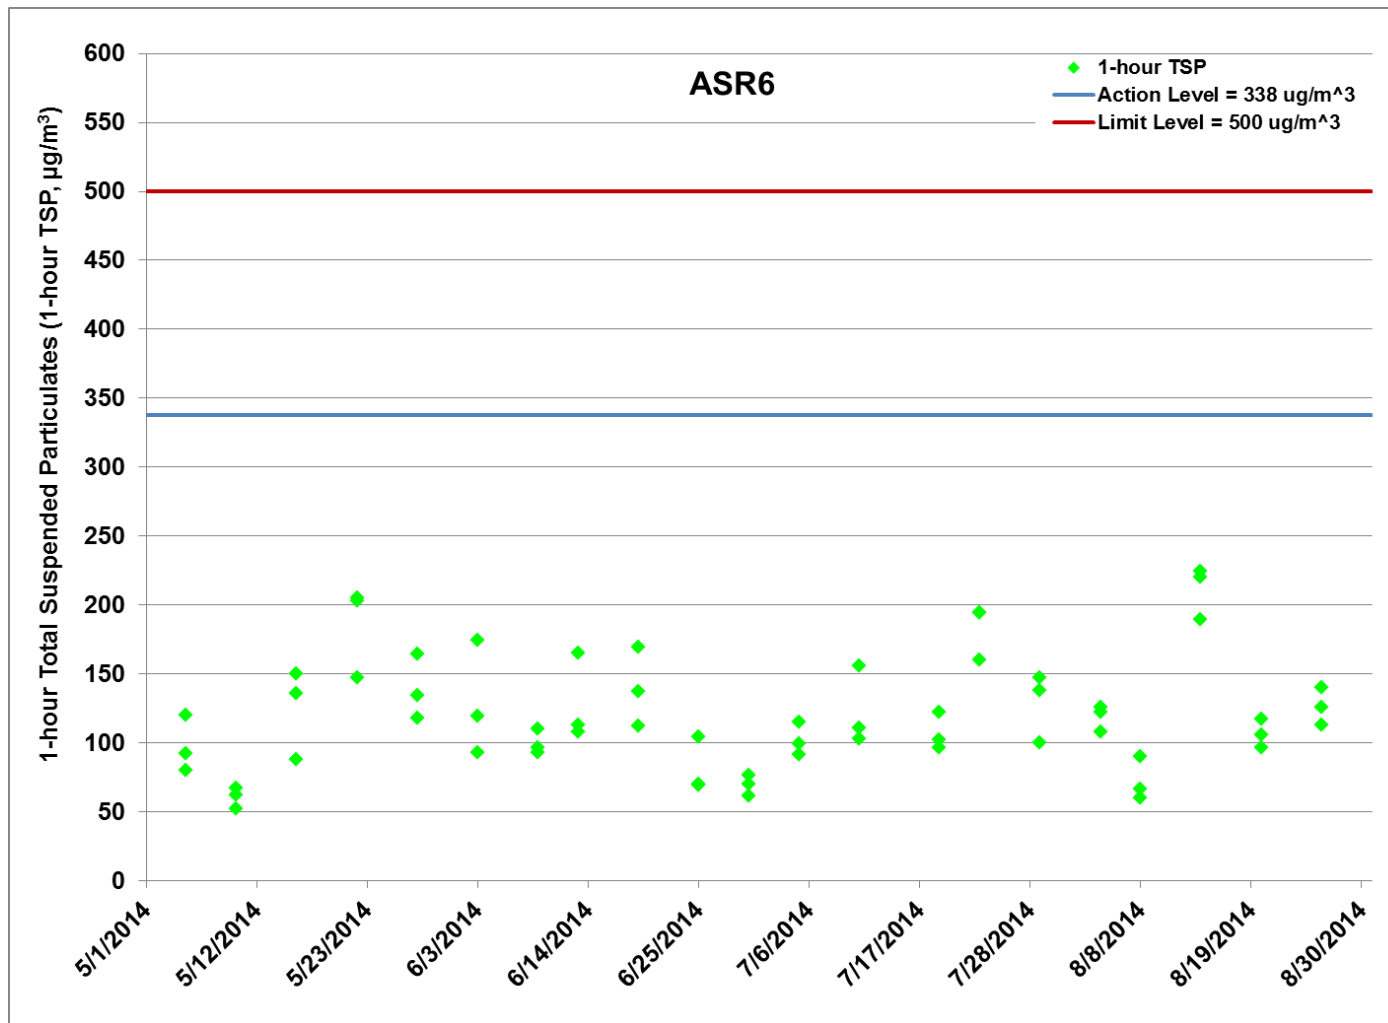
Figure F.2 Impact Monitoring - 1-hour Total Suspended Particulates ($\mu\text{g}/\text{m}^3$) at ASR6 between 1 May 2014 and 31 August 2014 during impact monitoring period. The weather conditions during the monitoring period varied from sunny to cloudy. Major land-based construction activities included: Diaphragm Wall Construction at Reclamation Works Area - Portion N-A (14/5/2014 - 31/8/2014) & Construction of CLP Temporary Substation at N6 (1/5/2014 - 31/8/2014)

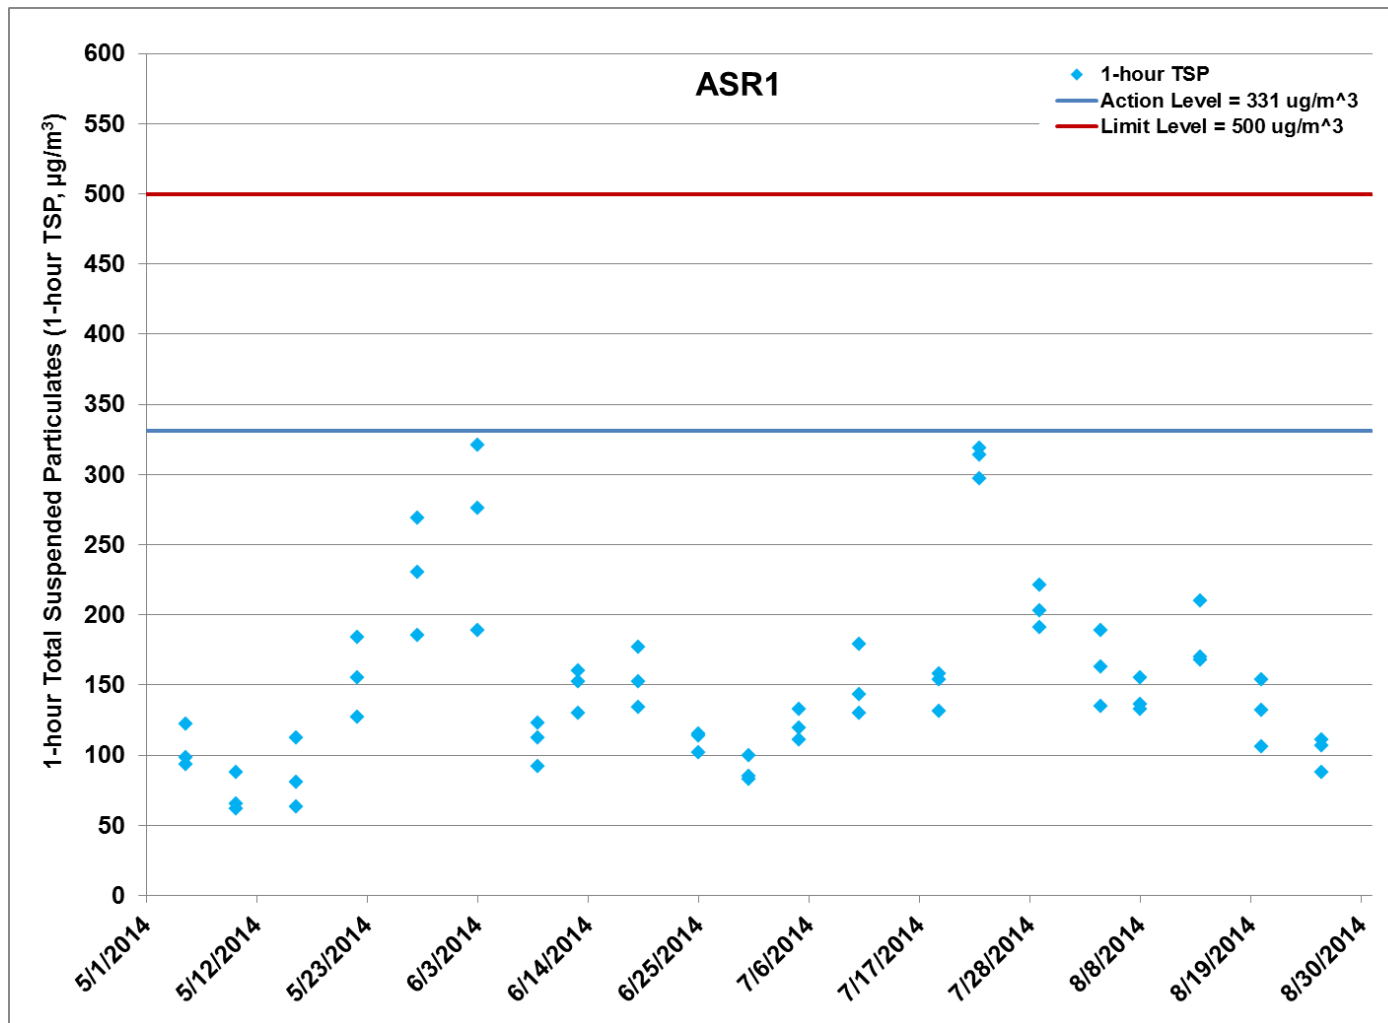
Figure F.3 Impact Monitoring - 1-hour Total Suspended Particulates ($\mu\text{g}/\text{m}^3$) at ASR1 between 1 May 2014 and 31 August 2014 during impact monitoring period. The weather conditions during the monitoring period varied from sunny to cloudy. Major land-based construction activities included: Diaphragm Wall Construction at Reclamation Works Area - Portion N-A (14/5/2014 - 31/8/2014) & Construction of CLP Temporary Substation at N6 (1/5/2014 - 31/8/2014)

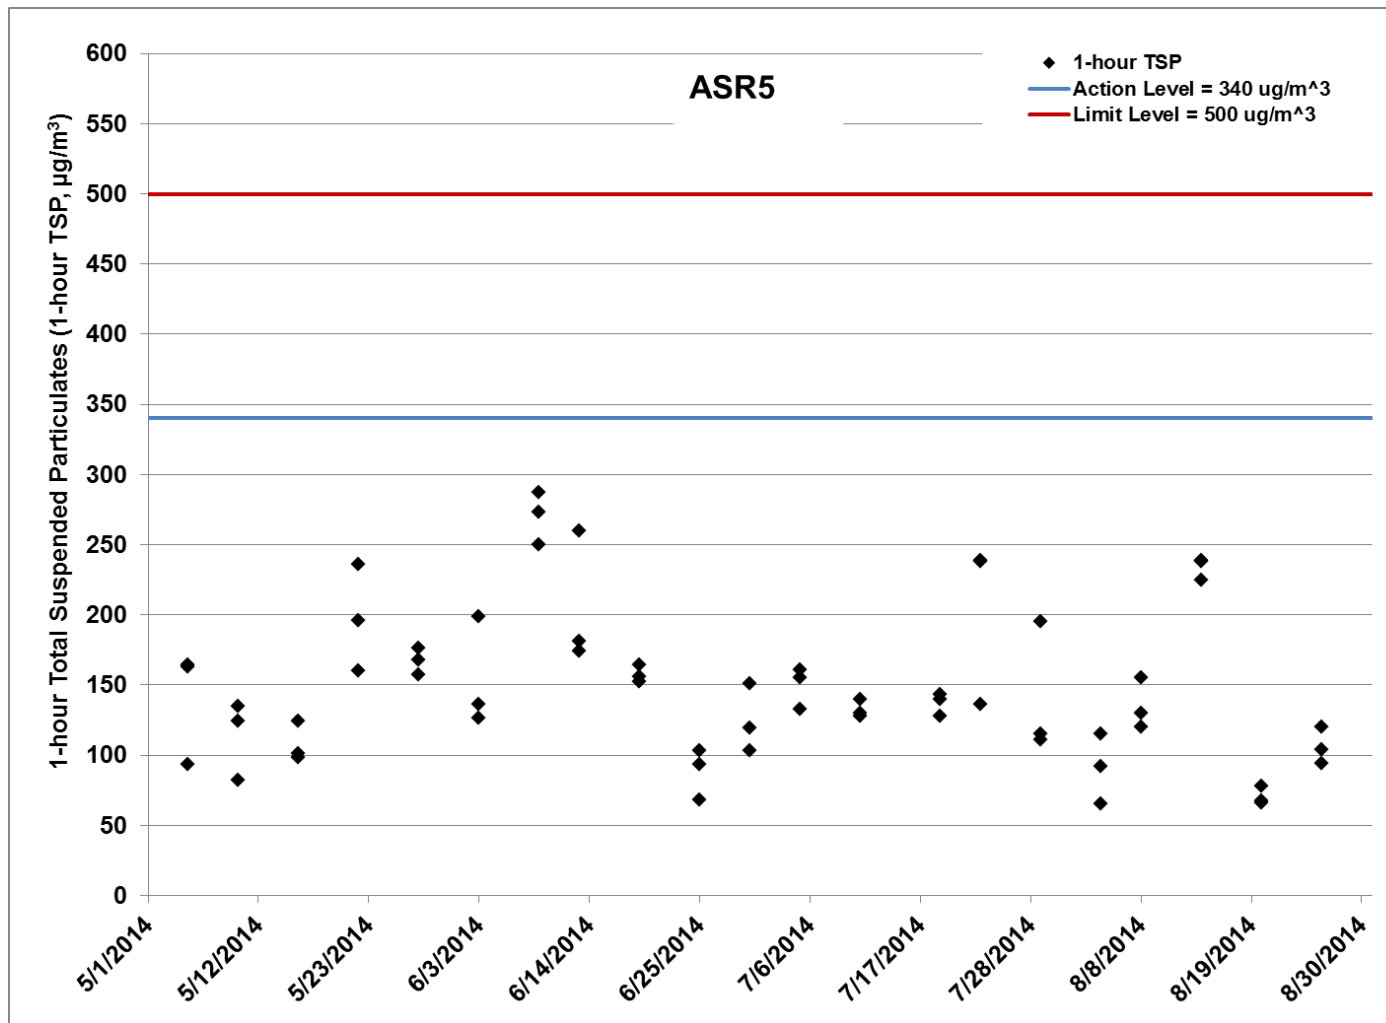
Figure F.4 Impact Monitoring - 1-hour Total Suspended Particulates ($\mu\text{g}/\text{m}^3$) at ASR5 between 1 May 2014 and 31 August 2014 during impact monitoring period. The weather conditions during the monitoring period varied from sunny to cloudy. Major land-based construction activities included: Diaphragm Wall Construction at Reclamation Works Area - Portion N-A (14/5/2014 - 31/8/2014) & Construction of CLP Temporary Substation at N6 (1/5/2014 - 31/8/2014)

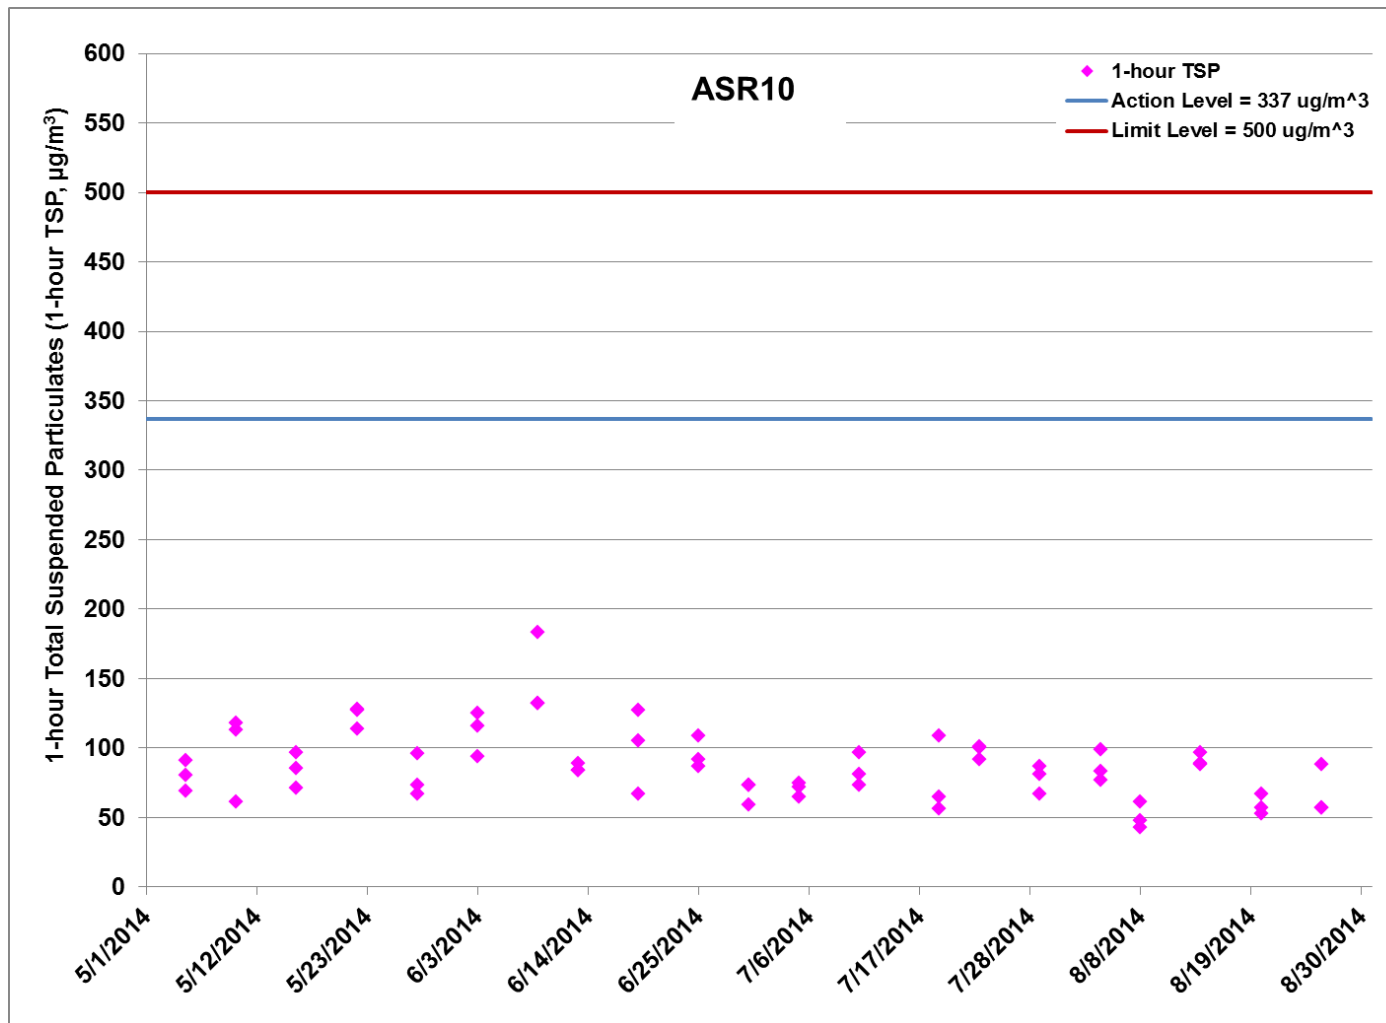
Figure F.5 Impact Monitoring - 1-hour Total Suspended Particulates ($\mu\text{g}/\text{m}^3$) at ASR10 between 1 May 2014 and 31 August 2014 during impact monitoring period. The weather conditions during the monitoring period varied from sunny to cloudy. Major land-based construction activities included: Diaphragm Wall Construction at Reclamation Works Area - Portion N-A (14/5/2014 - 31/8/2014) & Construction of CLP Temporary Substation at N6 (1/5/2014 - 31/8/2014)

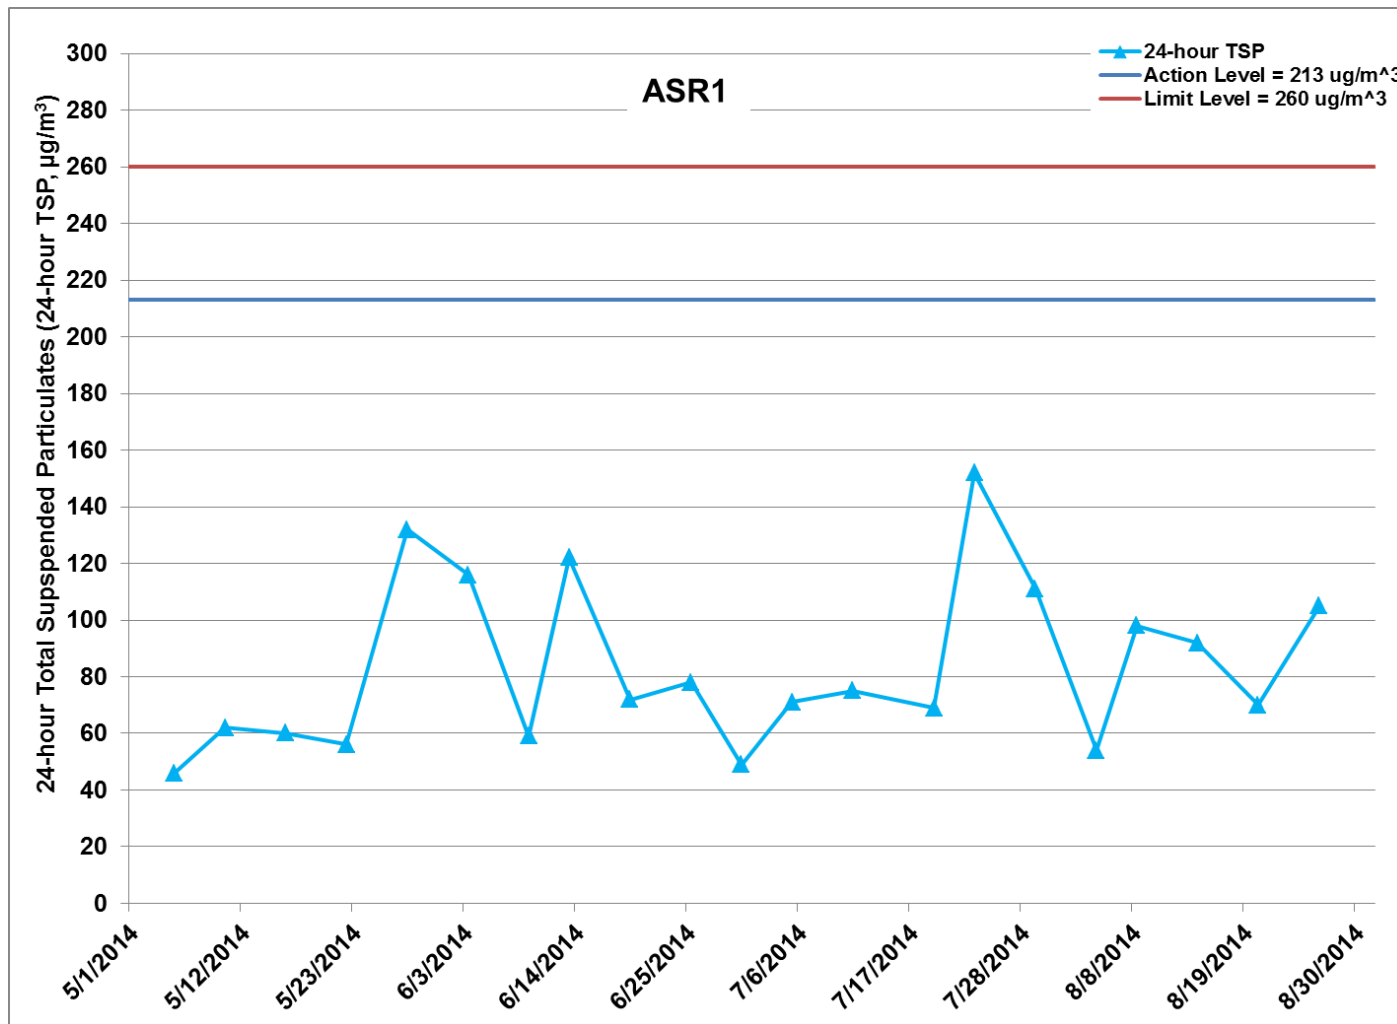
Figure F.6 Impact Monitoring - 24-hour Total Suspended Particulates ($\mu\text{g}/\text{m}^3$) at ASR1 between 1 May 2014 and 31 August 2014 during impact monitoring period. The weather conditions during the monitoring period varied from sunny to cloudy. Major land-based construction activities included: Diaphragm Wall Construction at Reclamation Works Area - Portion N-A (14/5/2014 - 31/8/2014) & Construction of CLP Temporary Substation at N6 (1/5/2014 - 31/8/2014)

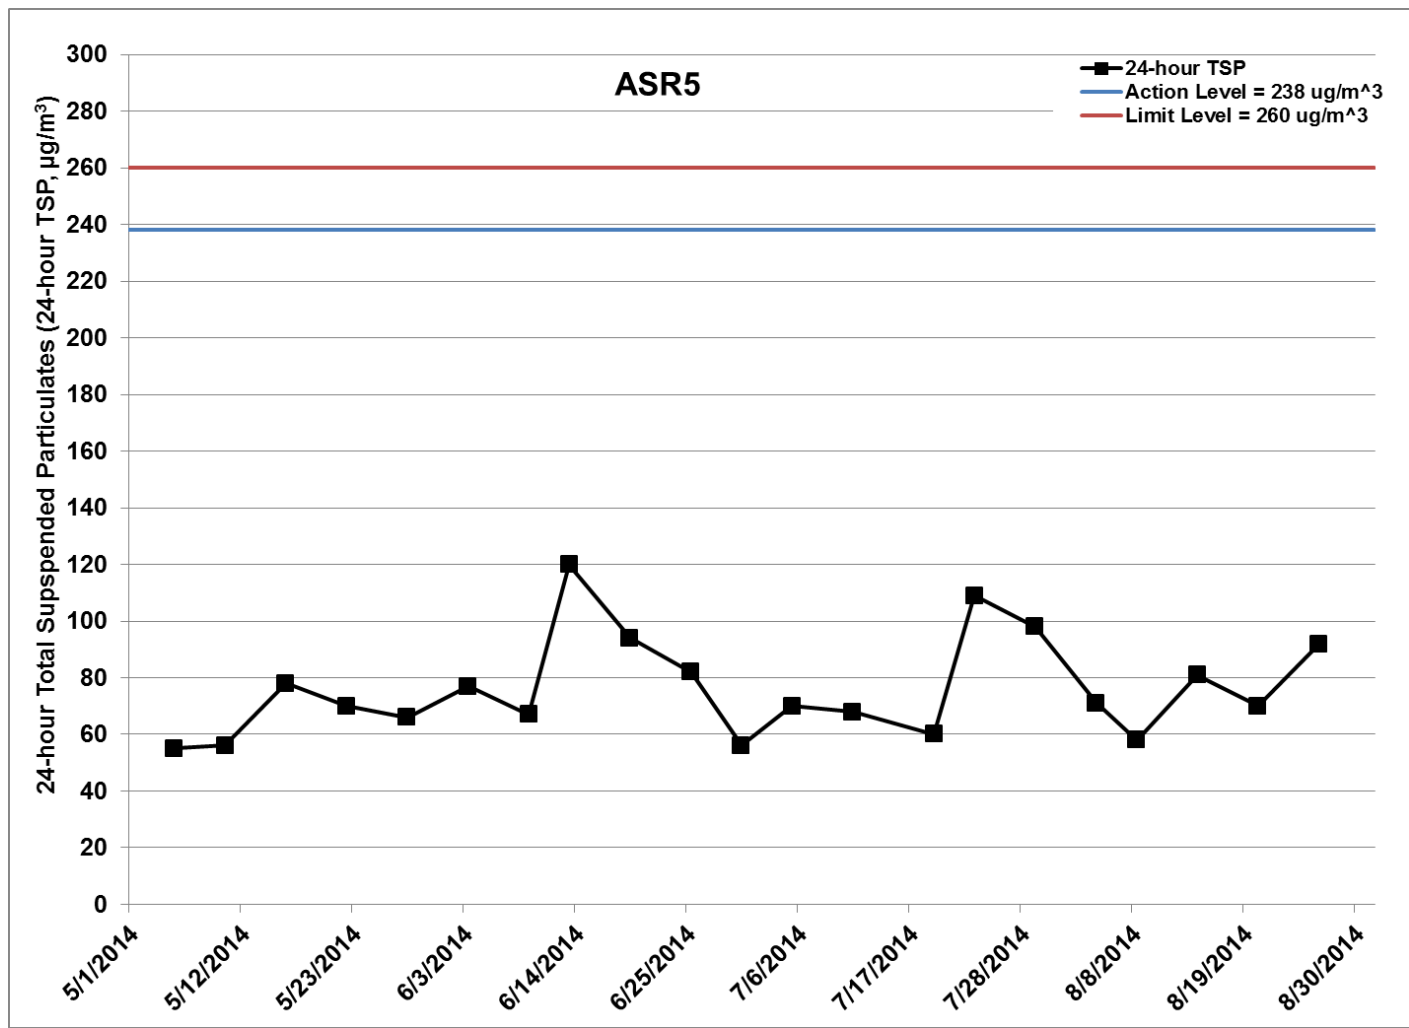
Figure F.7 Impact Monitoring - 24-hour Total Suspended Particulates ($\mu\text{g}/\text{m}^3$) at ASR5 between 1 May 2014 and 31 August 2014 during impact monitoring period. The weather conditions during the monitoring period varied from sunny to cloudy. Major land-based construction activities included: Diaphragm Wall Construction at Reclamation Works Area - Portion N-A (14/5/2014 - 31/8/2014) & Construction of CLP Temporary Substation at N6 (1/5/2014 - 31/8/2014)

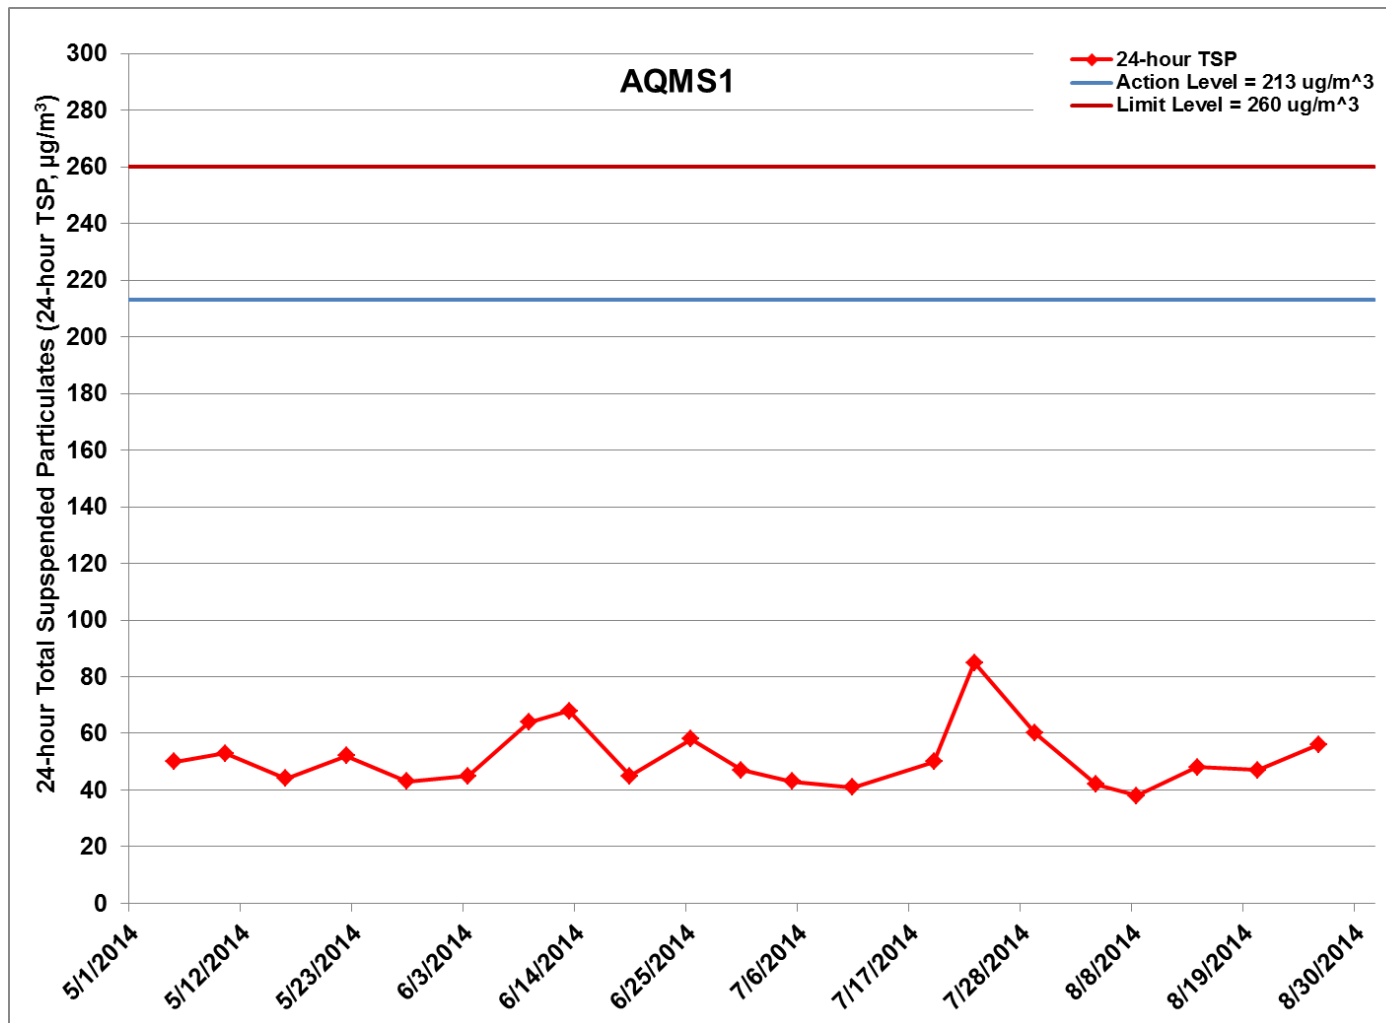
Figure F.8 Impact Monitoring - 24-hour Total Suspended Particulates ($\mu\text{g}/\text{m}^3$) at AQMS1 between 1 May 2014 and 31 August 2014 during impact monitoring period. The weather conditions during the monitoring period varied from sunny to cloudy. Major land-based construction activities included: Diaphragm Wall Construction at Reclamation Works Area - Portion N-A (14/5/2014 - 31/8/2014) & Construction of CLP Temporary Substation at N6 (1/5/2014 - 31/8/2014)

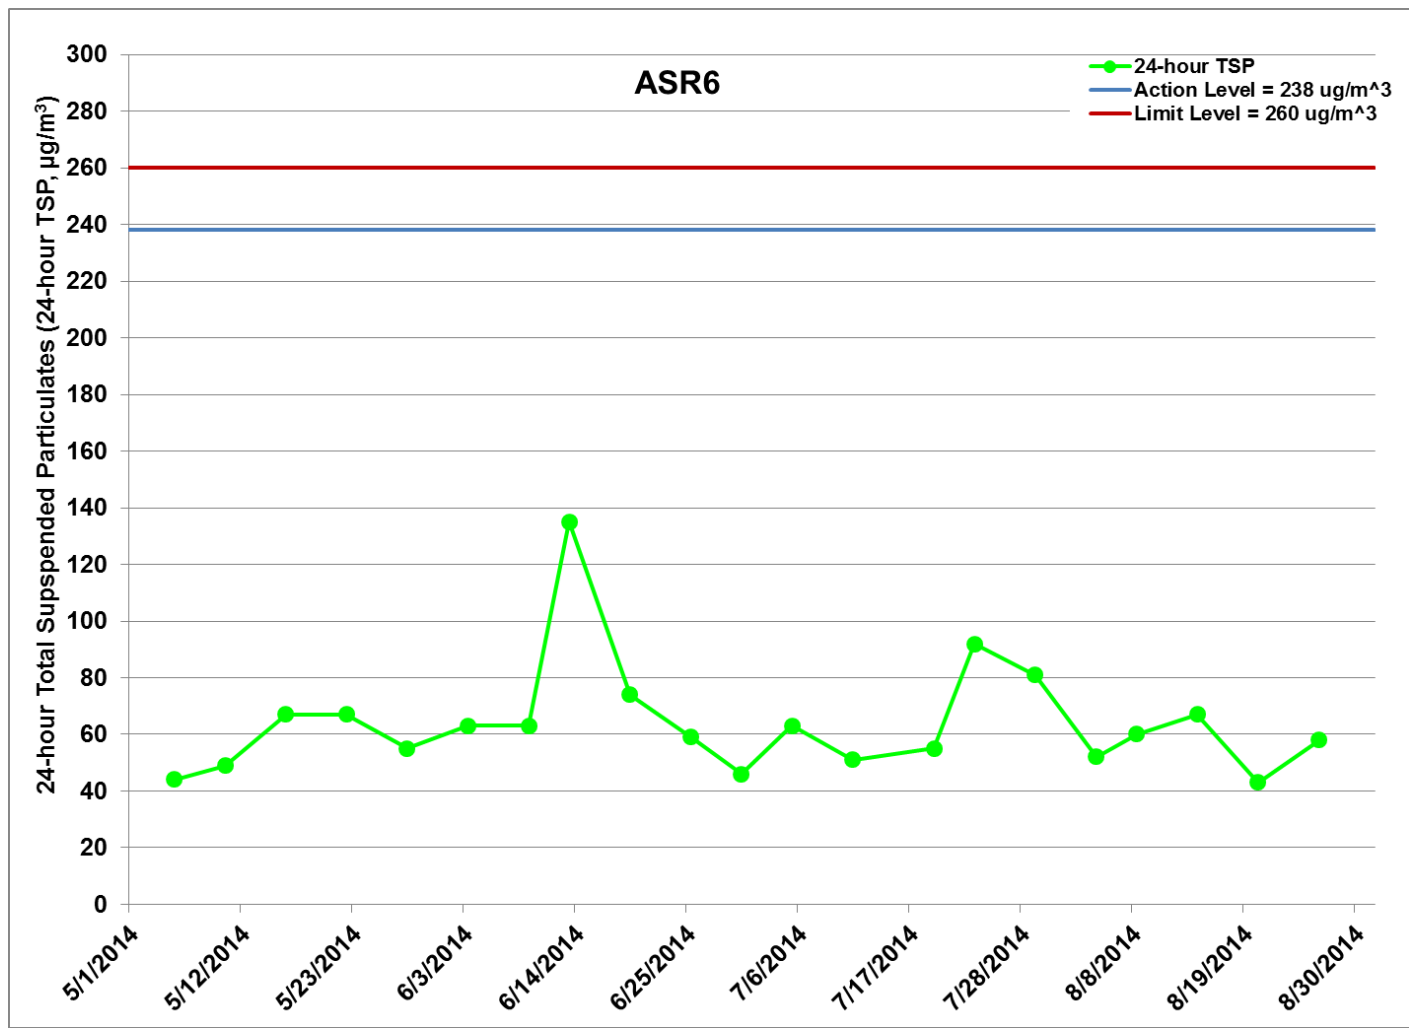
Figure F.9 Impact Monitoring - 24-hour Total Suspended Particulates ($\mu\text{g}/\text{m}^3$) at ASR6 between 1 May 2014 and 31 August 2014 during impact monitoring period. The weather conditions during the monitoring period varied from sunny to cloudy. Major land-based construction activities included: Diaphragm Wall Construction at Reclamation Works Area - Portion N-A (14/5/2014 - 31/8/2014) & Construction of CLP Temporary Substation at N6 (1/5/2014 - 31/8/2014)

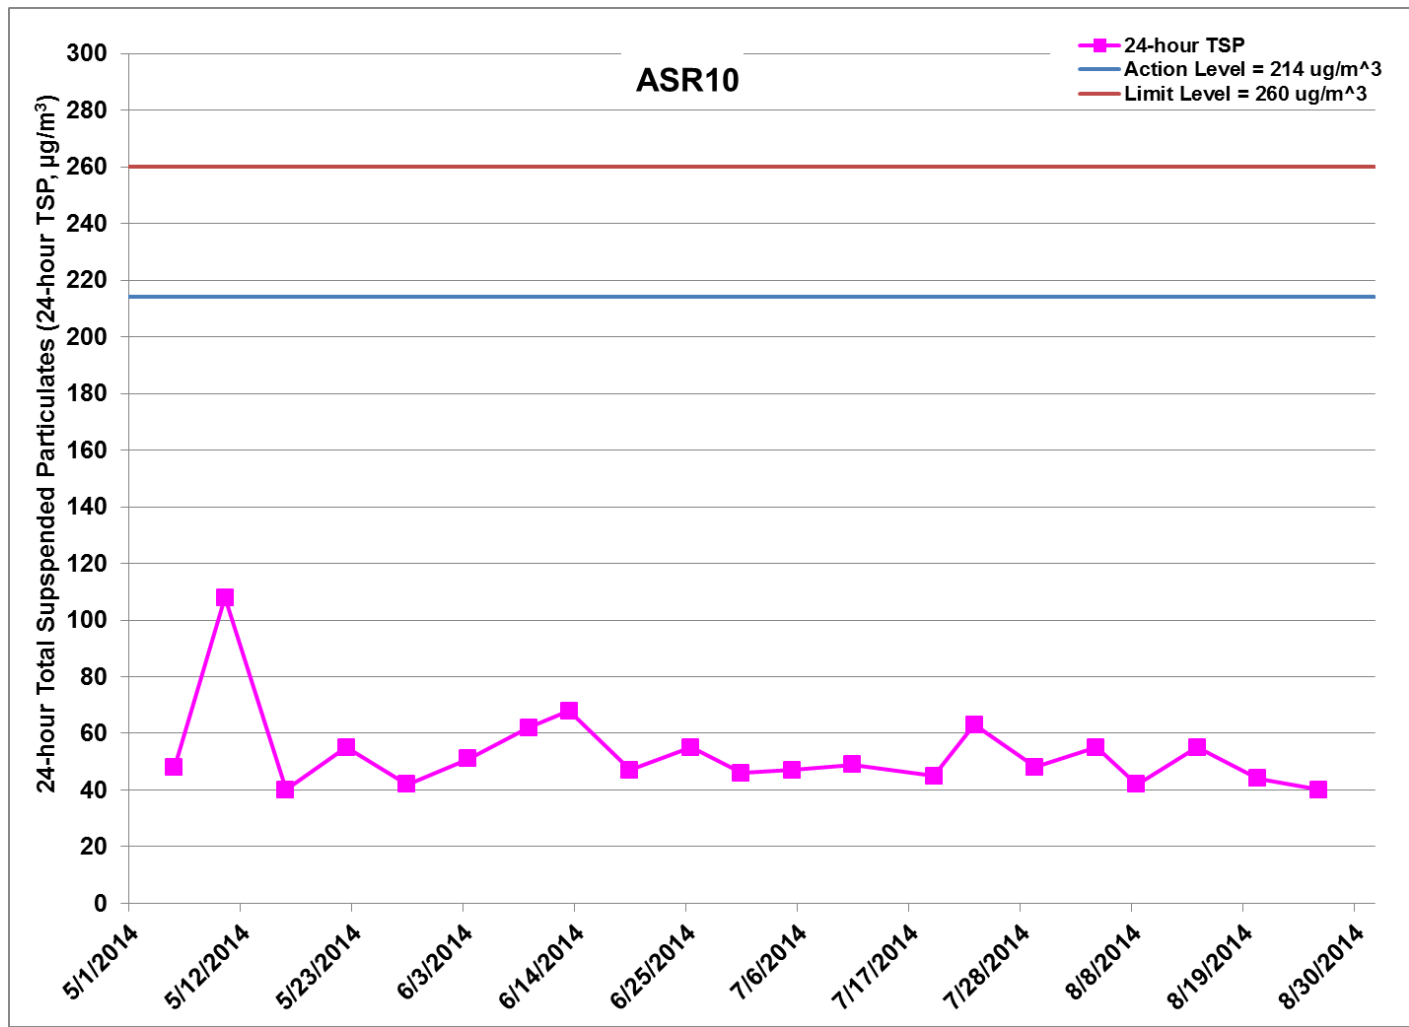
Figure F.10 Impact Monitoring - 24-hour Total Suspended Particulates ($\mu\text{g}/\text{m}^3$) at ASR10 between 1 May 2014 and 31 August 2014 during impact monitoring period. The weather conditions during the monitoring period varied from sunny to cloudy. Major land-based construction activities included: Diaphragm Wall Construction at Reclamation Works Area - Portion N-A (14/5/2014 - 31/8/2014) & Construction of CLP Temporary Substation at N6 (1/5/2014 - 31/8/2014)

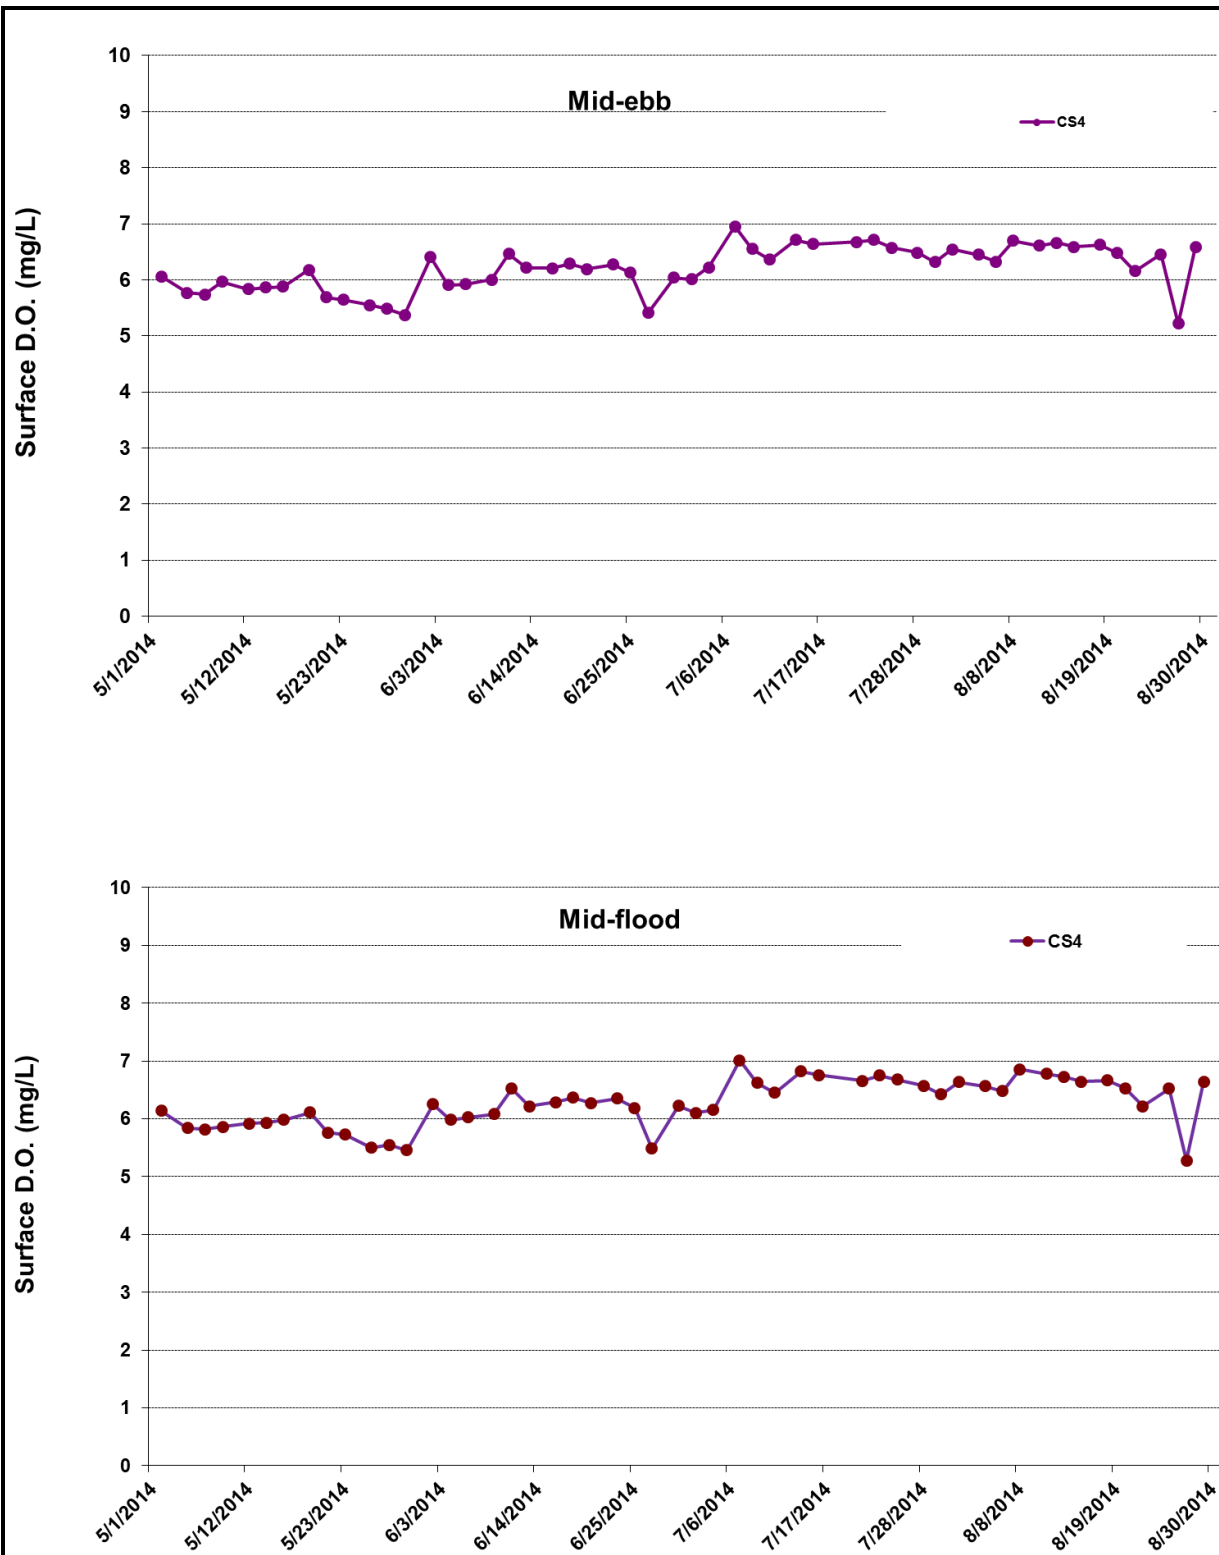
Figure G1 Impact Monitoring - Mean Level of Dissolved Oxygen (mg/L) in surface waters between 1 May 2014 and 31 August 2014 at CS4. The weather conditions during the monitoring period varied mostly from sunny to cloudy. Major marine construction activities included: Dredging (5/1/2014 - 8/6/2014); Construction of Temporary Seawalls (5/1/2013 - 8/31/2014); Sheet Piling (5/1/2014 - 8/31/2014); Filling (5/1/2014 - 8/31/2014). No monitoring was conducted on 18 July 2014 due to adverse weather condition. Ref: 0212330_Impact-WQM_August2014_graphs_Rev a.xls

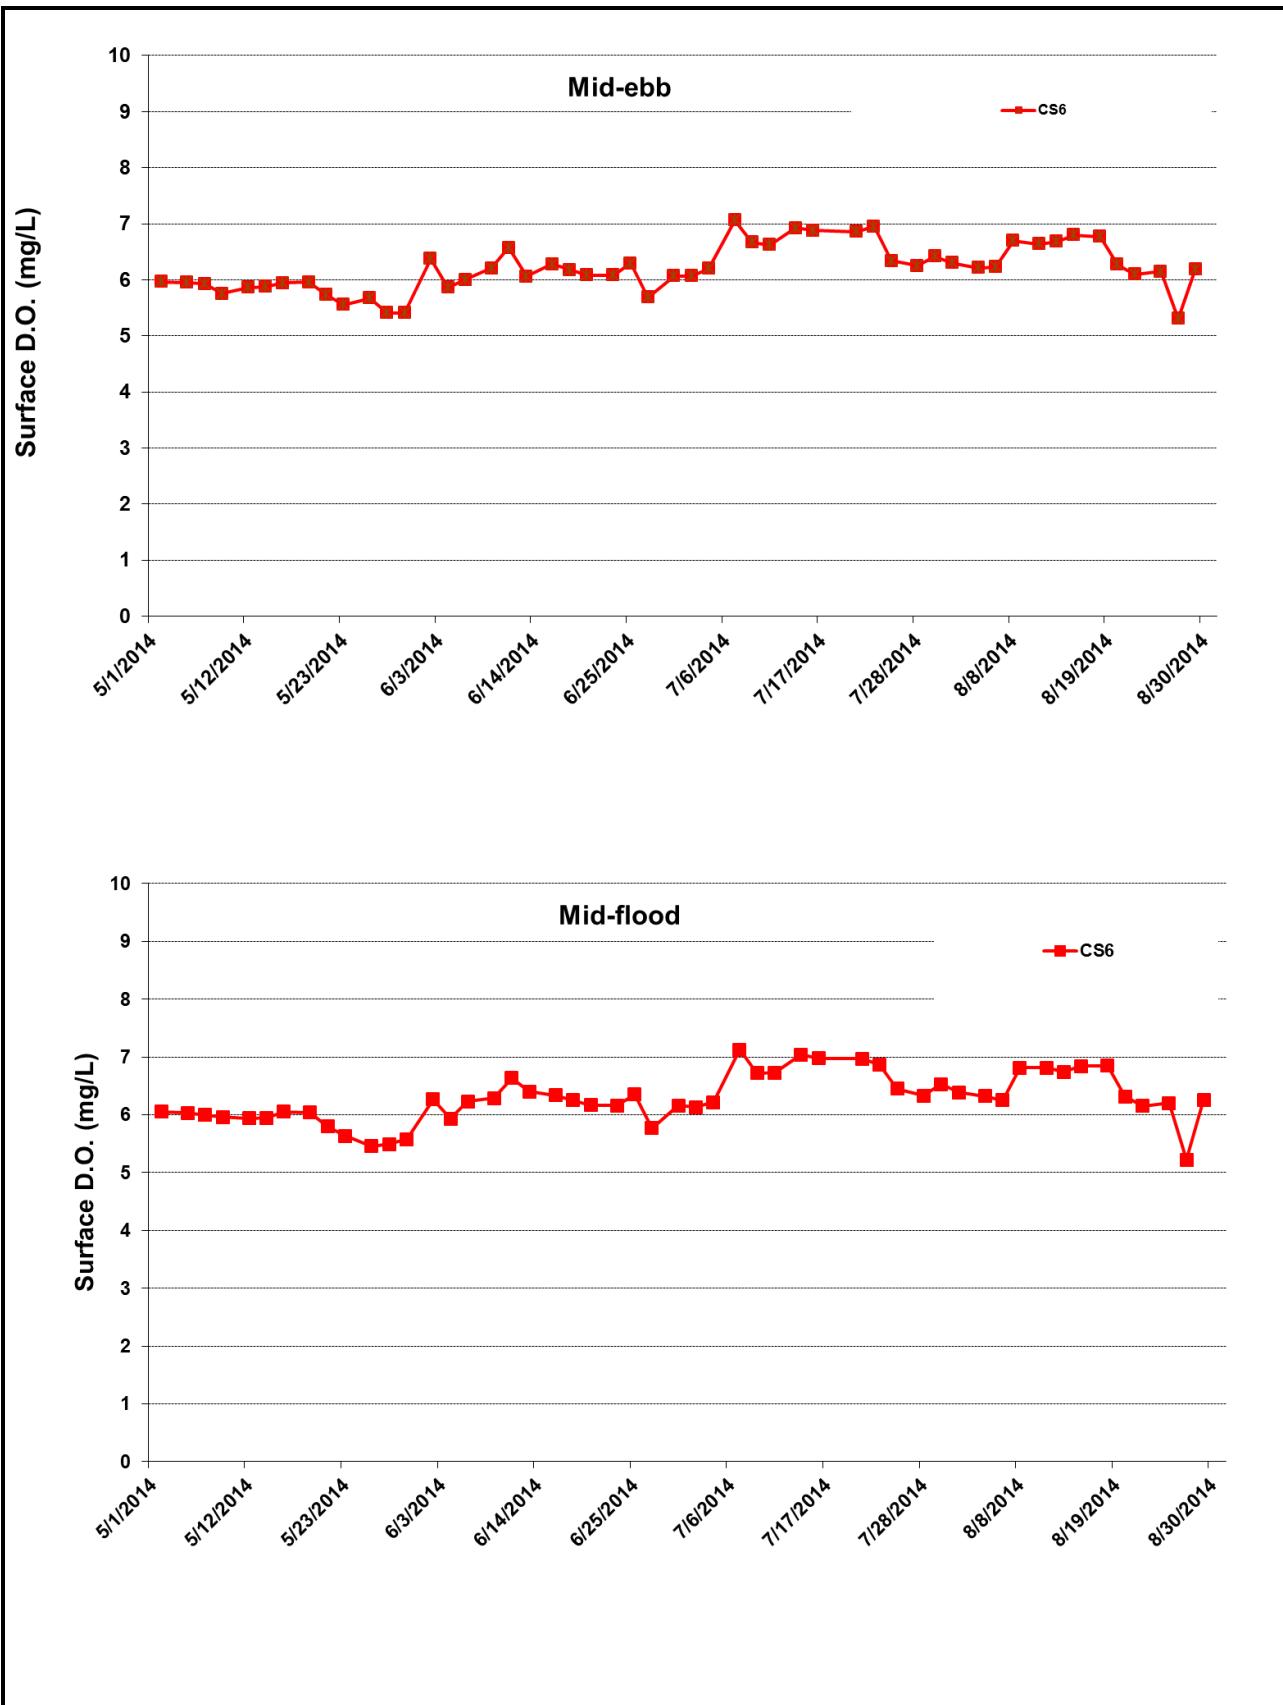
Figure G2 Impact Monitoring - Mean Level of Dissolved Oxygen (mg/L) in surface waters between 1 May 2014 and 31 August 2014 at CS6. The weather conditions during the monitoring period varied mostly from sunny to cloudy. Major marine construction activities included: Dredging (5/1/2014 - 8/6/2014); Construction of Temporary Seawalls (5/1/2013 - 8/31/2014); Sheet Piling (5/1/2014 - 8/31/2014); Filling (5/1/2014 - 8/31/2014). No monitoring was conducted on 18 July 2014 due to adverse weather condition. Ref: 0212330_Impact-WQM_August2014_graphs_Rev a.xls

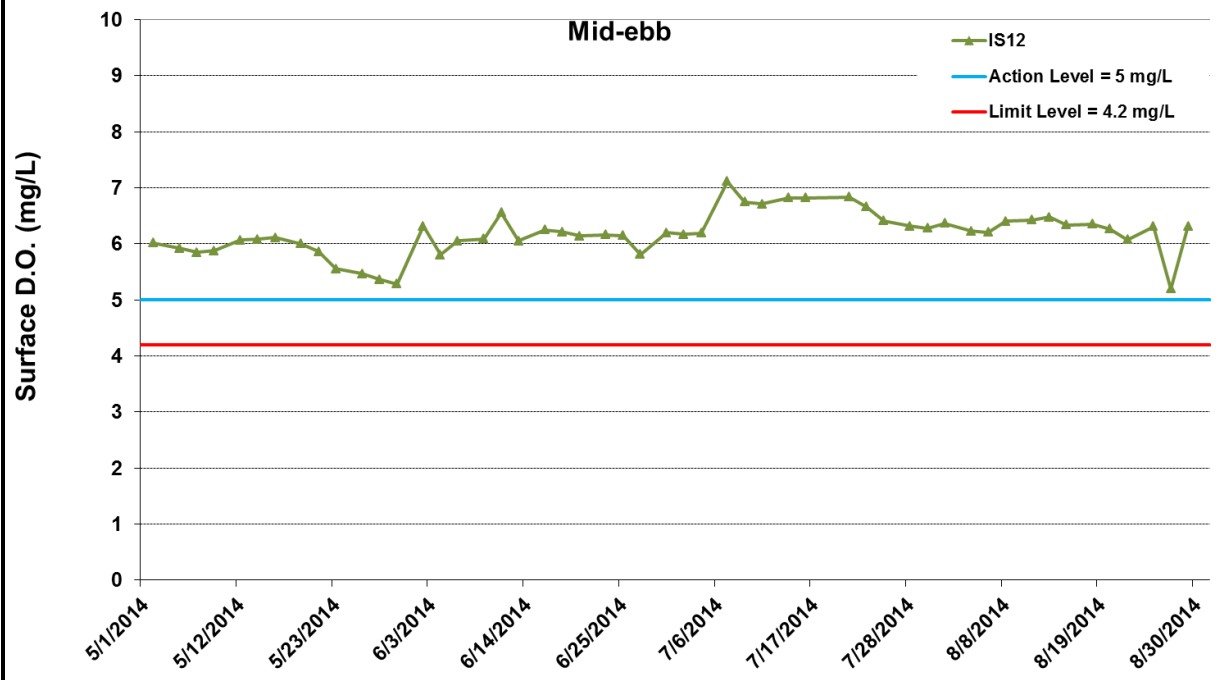
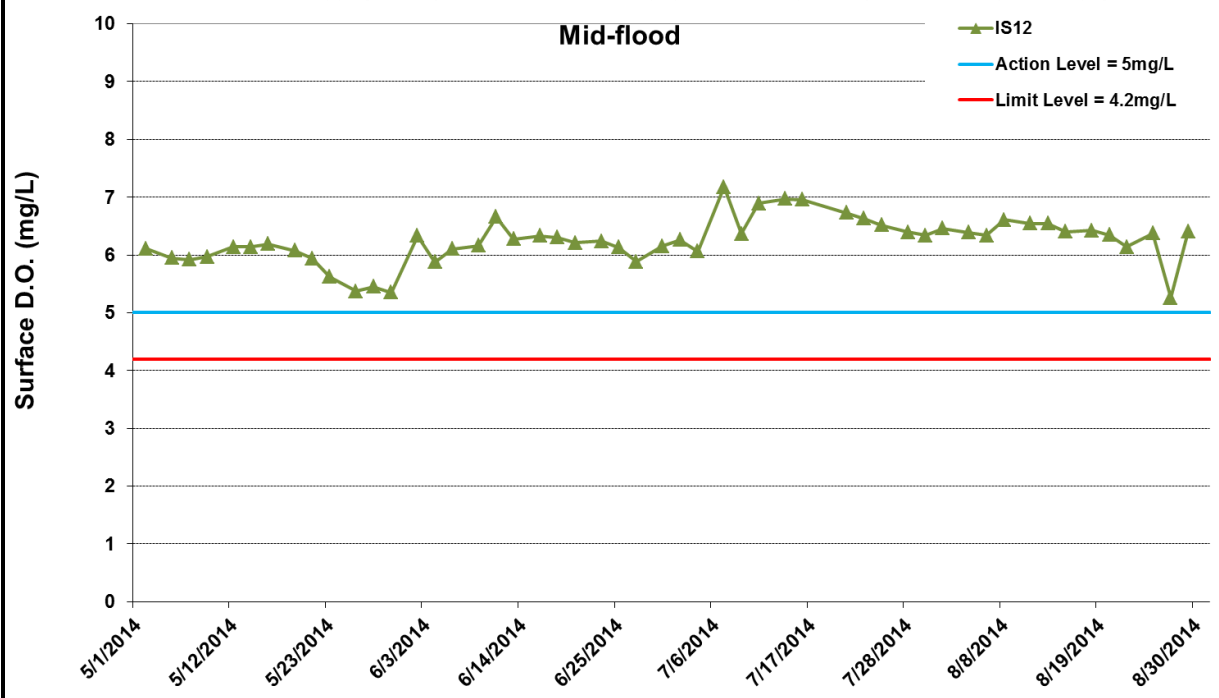
Figure G3 Impact Monitoring - Mean Level of Dissolved Oxygen (mg/L) in surface waters between 1 May 2014 and 31 August 2014 at IS12. The weather conditions during the monitoring period varied mostly from sunny to cloudy. Major marine construction activities included: Dredging (5/1/2014 - 8/6/2014); Construction of Temporary Seawalls (5/1/2013 - 8/31/2014); Sheet Piling (5/1/2014 - 8/31/2014); Filling (5/1/2014 - 8/31/2014). No monitoring was conducted on 18 July 2014 due to adverse weather condition. Ref: 0212330_Impact-WQM_August2014_graphs_Rev a.xls
