**Contract No. HY/2012/08
Tuen Mun – Chek Lap Kok Link –
Northern Connection Sub-sea Tunnel
Section**

*Third Quarterly Environmental Monitoring &
Audit (EM&A) Report*

20 November 2014

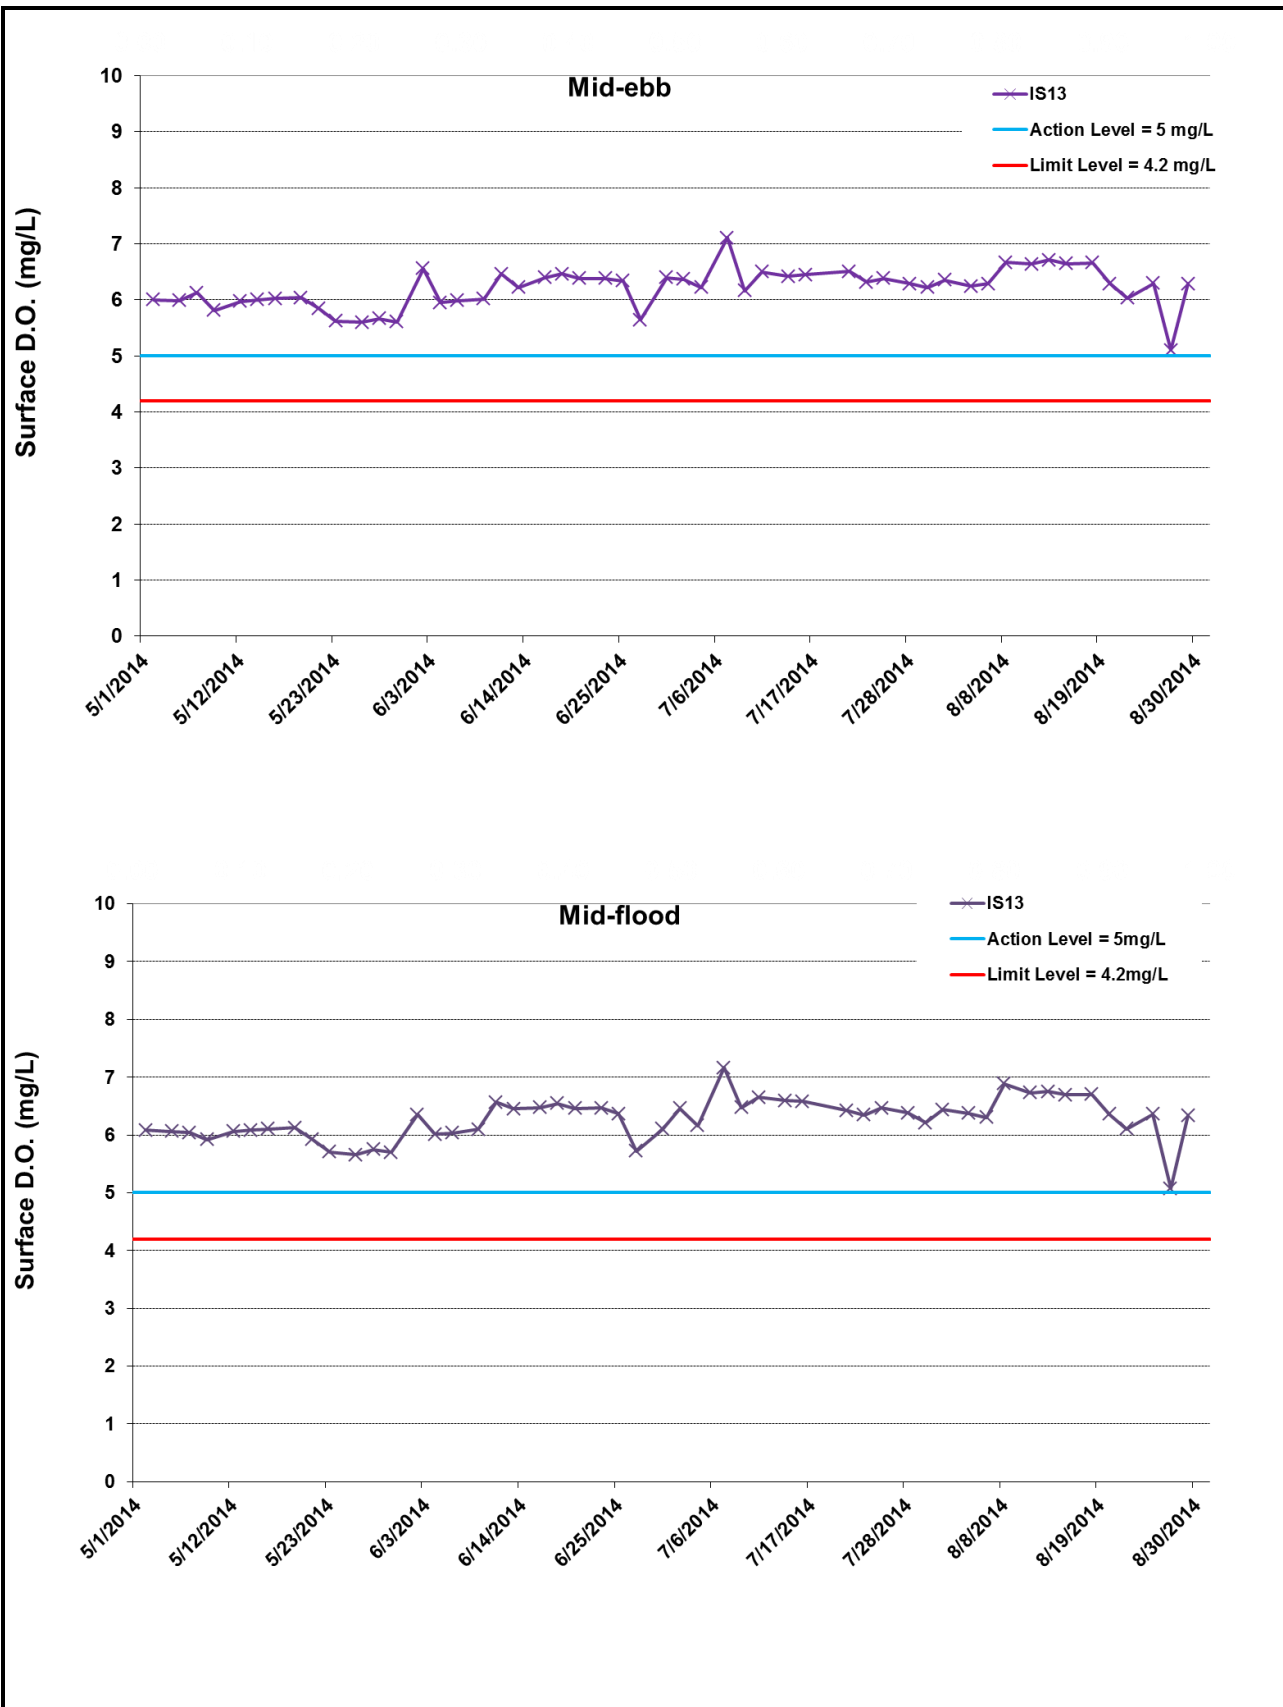
Figure G4 Impact Monitoring - Mean Level of Dissolved Oxygen (mg/L) in surface waters between 1 May 2014 and 31 August 2014 at IS13. The weather conditions during the monitoring period varied mostly from sunny to cloudy. Major marine construction activities included: Dredging (5/1/2014 - 8/6/2014); Construction of Temporary Seawalls (5/1/2013 - 8/31/2014); Sheet Piling (5/1/2014 - 8/31/2014); Filling (5/1/2014 - 8/31/2014). No monitoring was conducted on 18 July 2014 due to adverse weather condition. Ref: 0212330_Impact-WQM_August2014_graphs_Rev a.xls

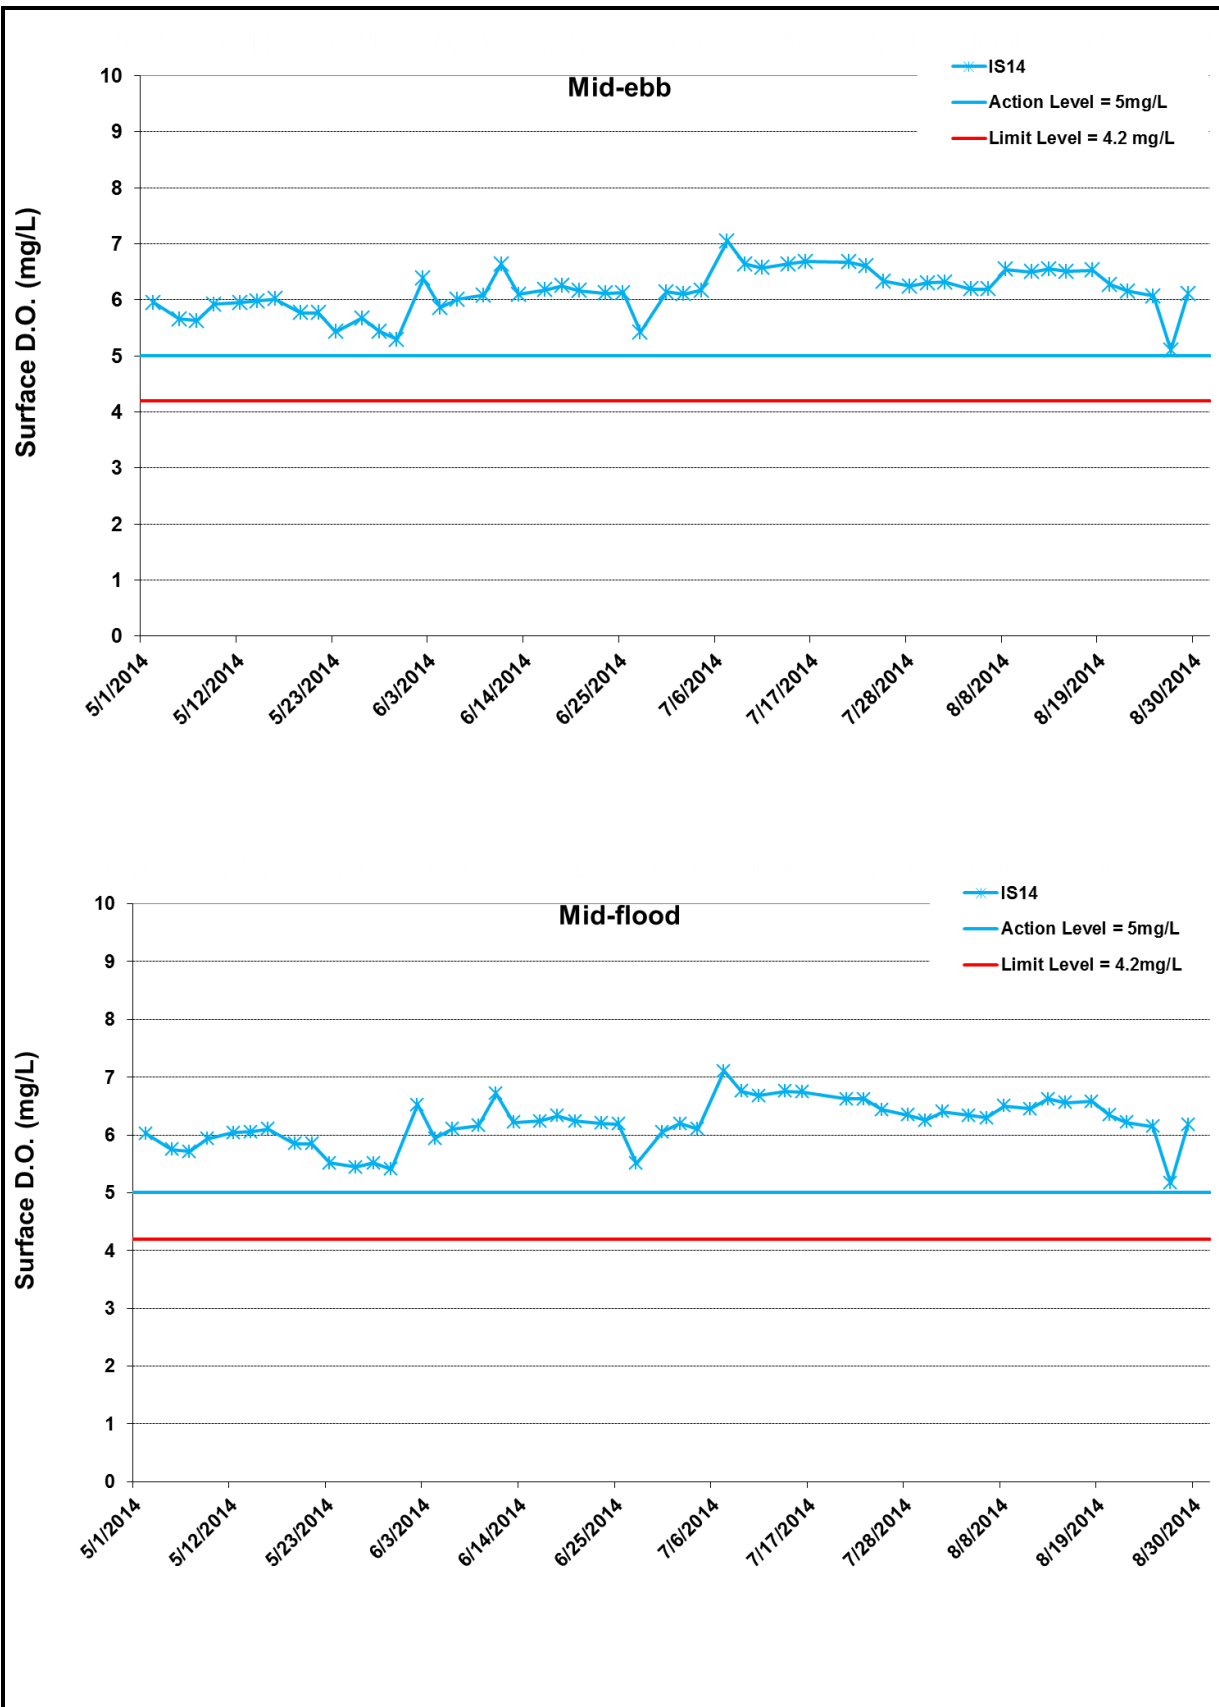
Figure G5 Impact Monitoring - Mean Level of Dissolved Oxygen (mg/L) in surface waters between 1 May 2014 and 31 August 2014 at IS14. The weather conditions during the monitoring period varied mostly from sunny to cloudy. Major marine construction activities included: Dredging (5/1/2014 - 8/6/2014); Construction of Temporary Seawalls (5/1/2013 - 8/31/2014); Sheet Piling (5/1/2014 - 8/31/2014); Filling (5/1/2014 - 8/31/2014). No monitoring was conducted on 18 July 2014 due to adverse weather condition. Ref: 0212330_Impact-WQM_August2014_graphs_Rev a.xls

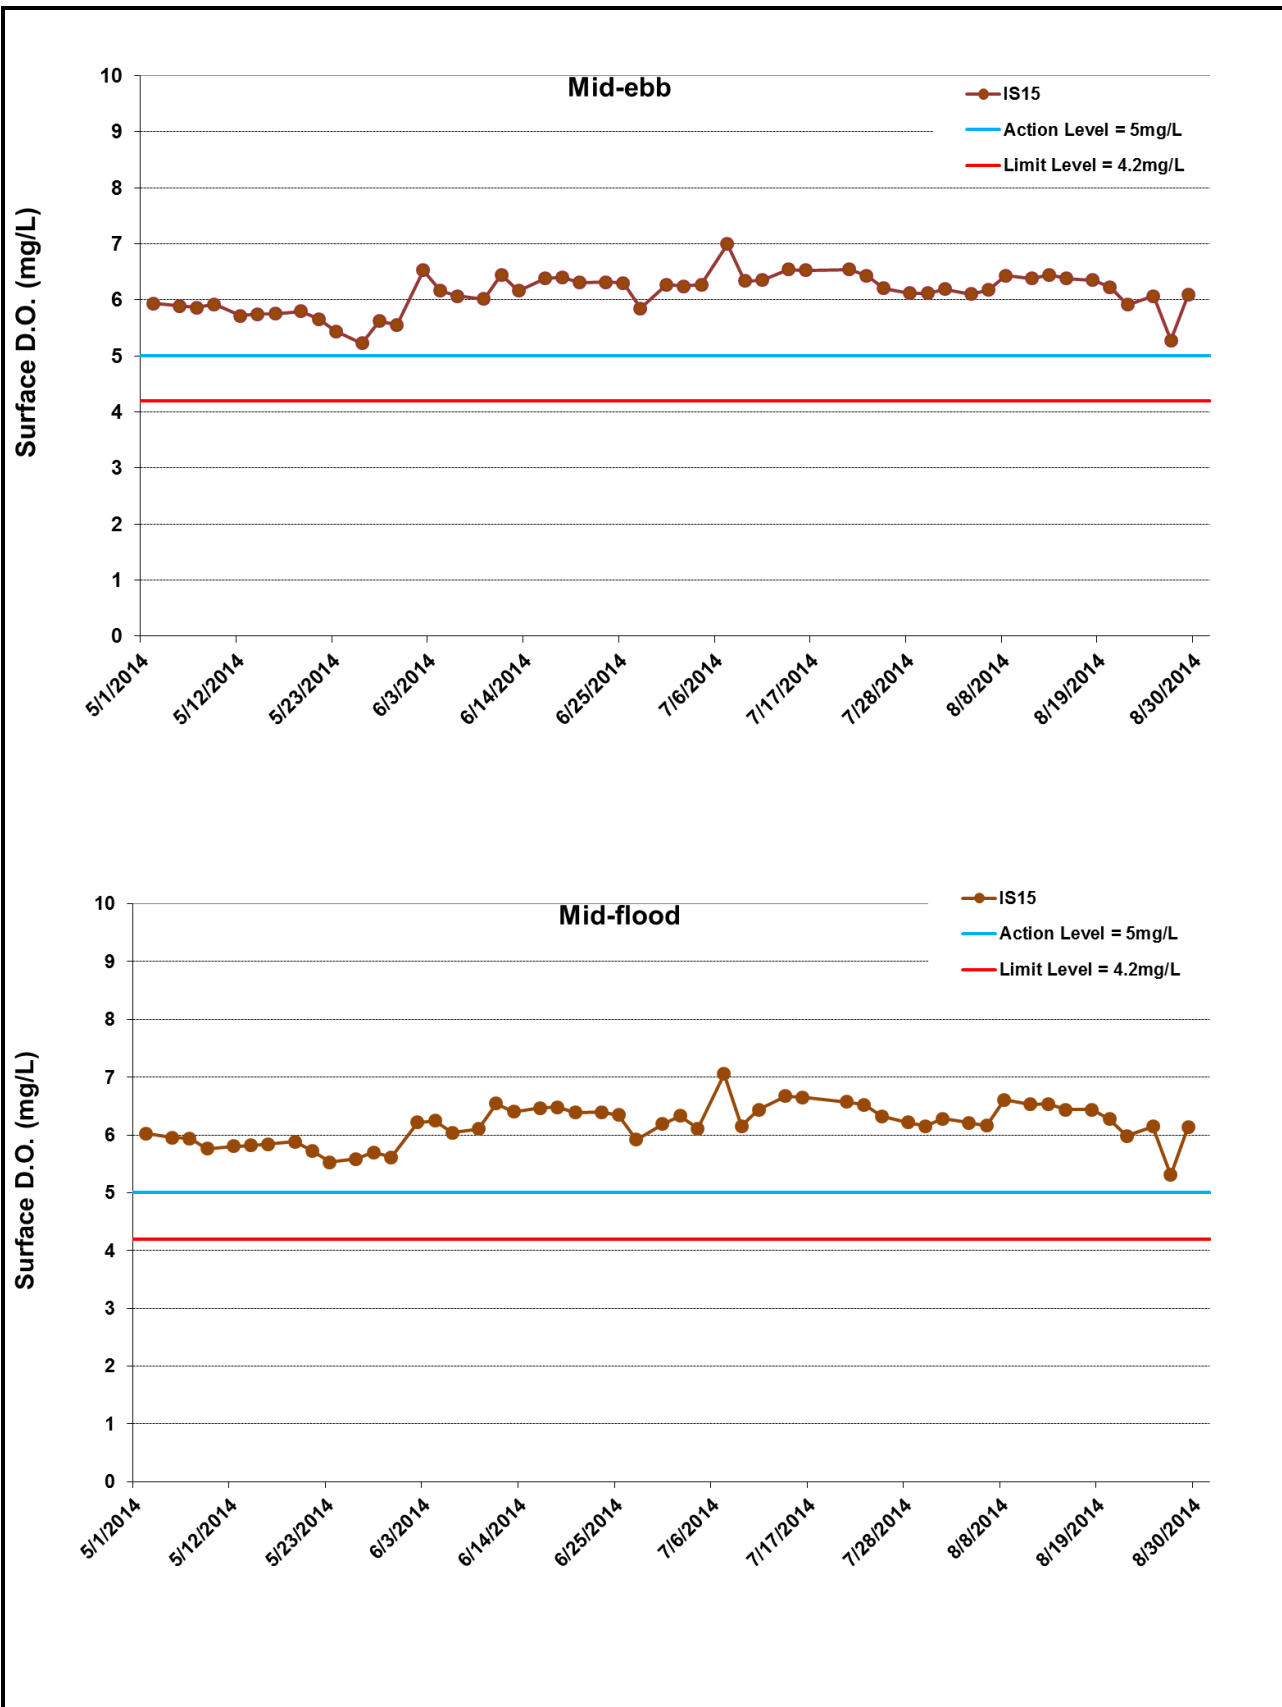
Figure G6 Impact Monitoring - Mean Level of Dissolved Oxygen (mg/L) in surface waters between 1 May 2014 and 31 August 2014 at IS15. The weather conditions during the monitoring period varied mostly from sunny to cloudy. Major marine construction activities included: Dredging (5/1/2014 - 8/6/2014); Construction of Temporary Seawalls (5/1/2013 - 8/31/2014); Sheet Piling (5/1/2014 - 8/31/2014); Filling (5/1/2014 - 8/31/2014). No monitoring was conducted on 18 July 2014 due to adverse weather condition. Ref: 0212330_Impact-WQM_August2014_graphs_Rev a.xls

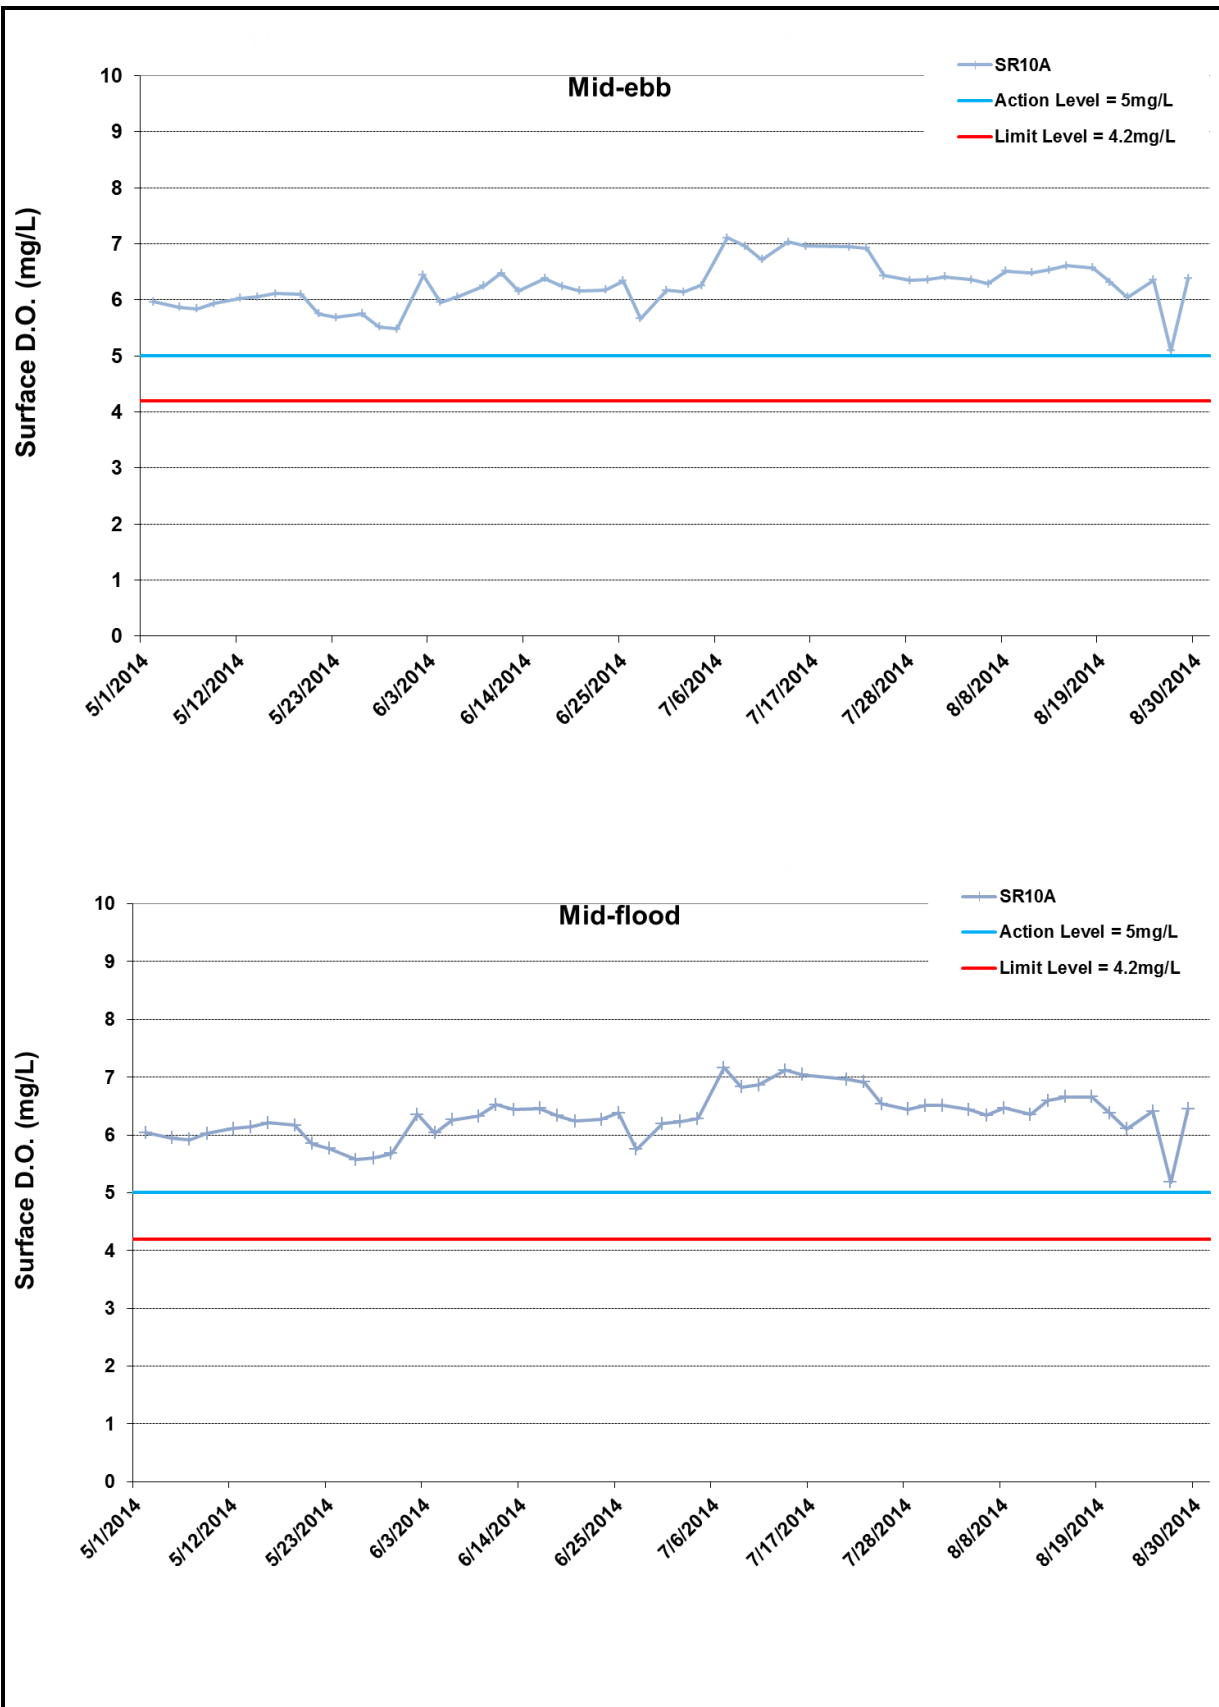
Figure G7 Impact Monitoring - Mean Level of Dissolved Oxygen (mg/L) in surface waters between 1 May 2014 and 31 August 2014 at SR10A. The weather conditions during the monitoring period varied mostly from sunny to cloudy. Major marine construction activities included: Dredging (5/1/2014 - 8/6/2014); Construction of Temporary Seawalls (5/1/2013 - 8/31/2014); Sheet Piling (5/1/2014 - 8/31/2014); Filling (5/1/2014 - 8/31/2014). No monitoring was conducted on 18 July 2014 due to adverse weather condition. Ref: 0212330_Impact-WQM_August2014_graphs_Rev a.xls

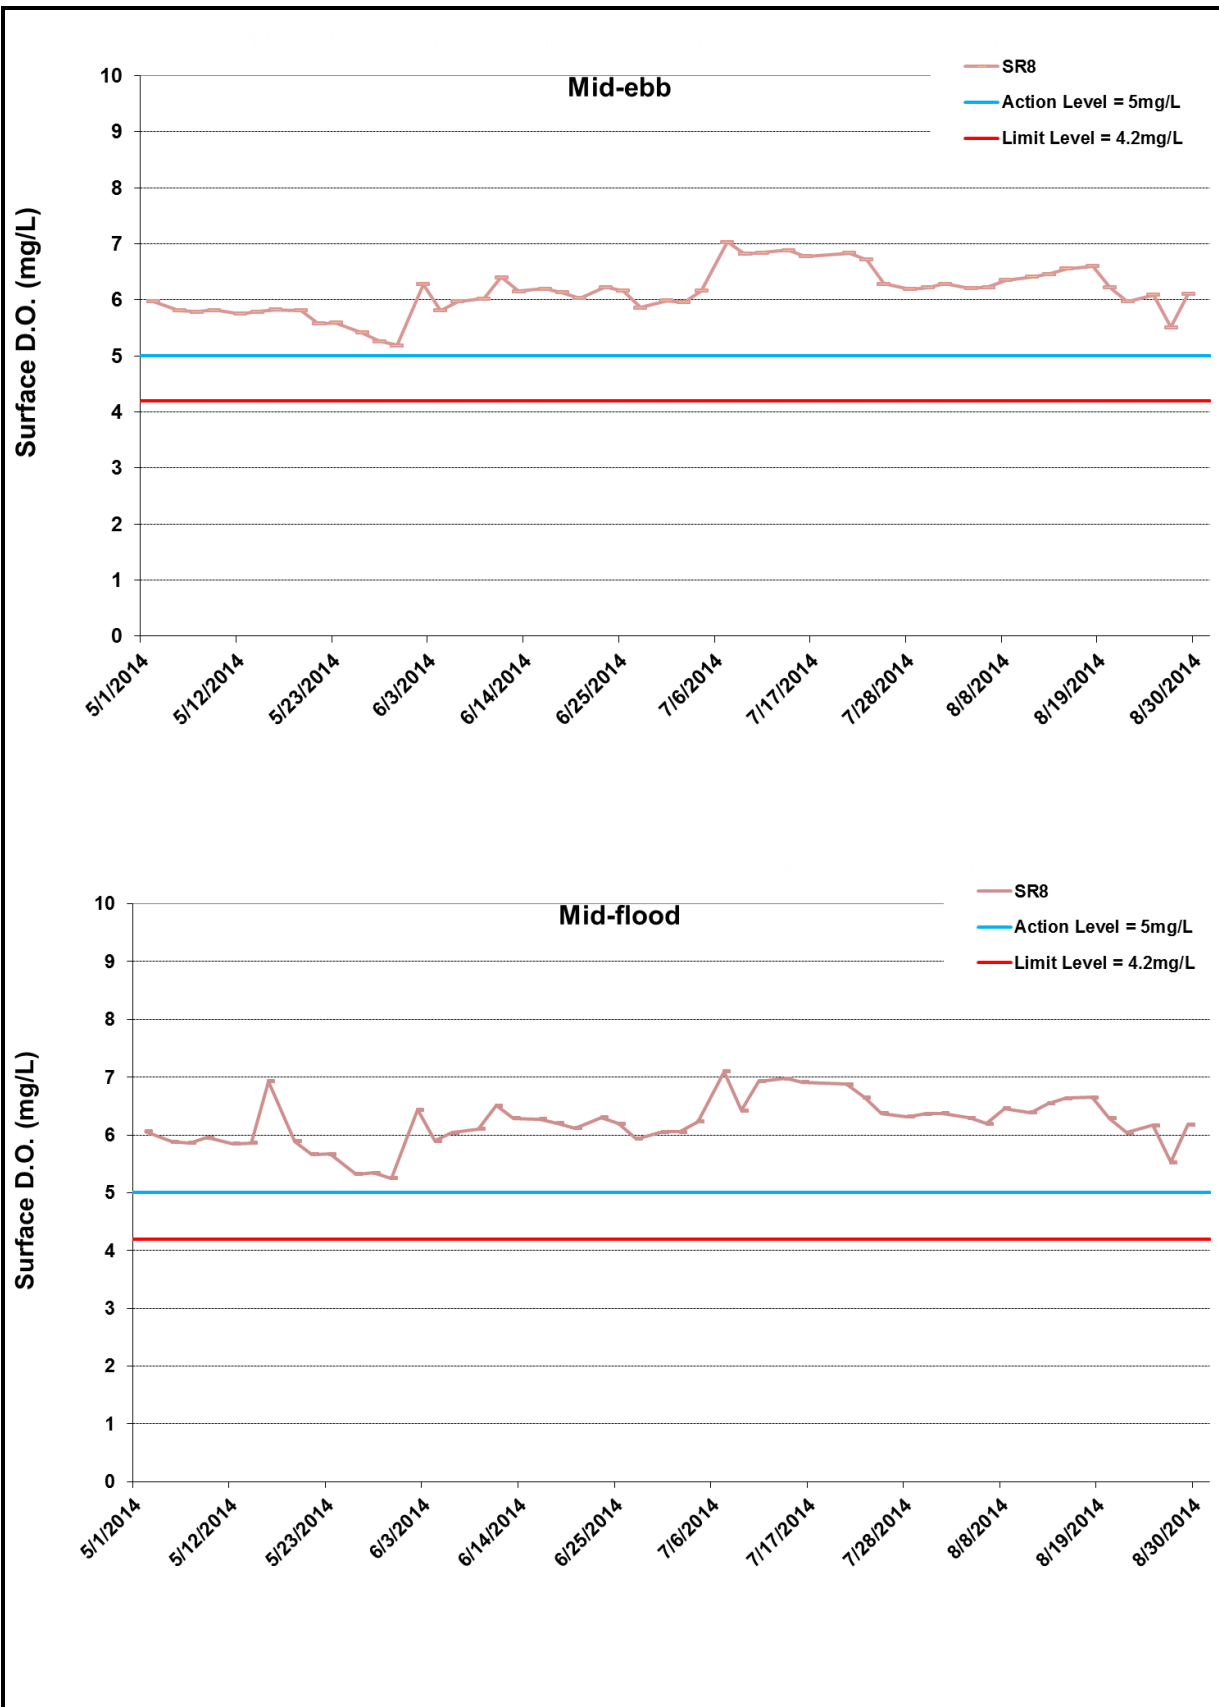
Figure G8 Impact Monitoring - Mean Level of Dissolved Oxygen (mg/L) in surface waters between 1 May 2014 and 31 August 2014 at SR8. The weather conditions during the monitoring period varied mostly from sunny to cloudy. Major marine construction activities included: Dredging (5/1/2014 - 8/6/2014); Construction of Temporary Seawalls (5/1/2013 - 8/31/2014); Sheet Piling (5/1/2014 - 8/31/2014); Filling (5/1/2014 - 8/31/2014). No monitoring was conducted on 18 July 2014 due to adverse weather condition. Ref: 0212330_Impact-WQM_August2014_graphs_Rev a.xls

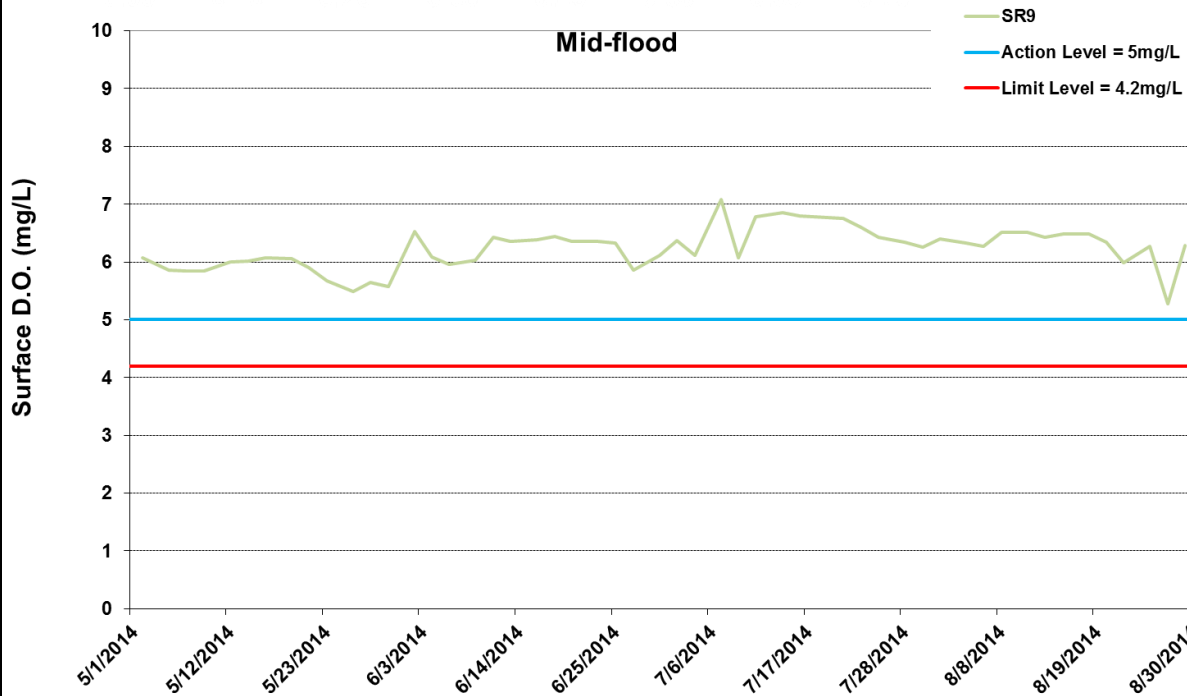
Figure G9 Impact Monitoring - Mean Level of Dissolved Oxygen (mg/L) in surface waters between 1 May 2014 and 31 August 2014 at SR9. The weather conditions during the monitoring period varied mostly from sunny to cloudy. Major marine construction activities included: Dredging (5/1/2014 - 8/6/2014); Construction of Temporary Seawalls (5/1/2013 - 8/31/2014); Sheet Piling (5/1/2014 - 8/31/2014); Filling (5/1/2014 - 8/31/2014). No monitoring was conducted on 18 July 2014 due to adverse weather condition. Ref: 0212330_Impact-WQM_August2014_graphs_Rev a.xls

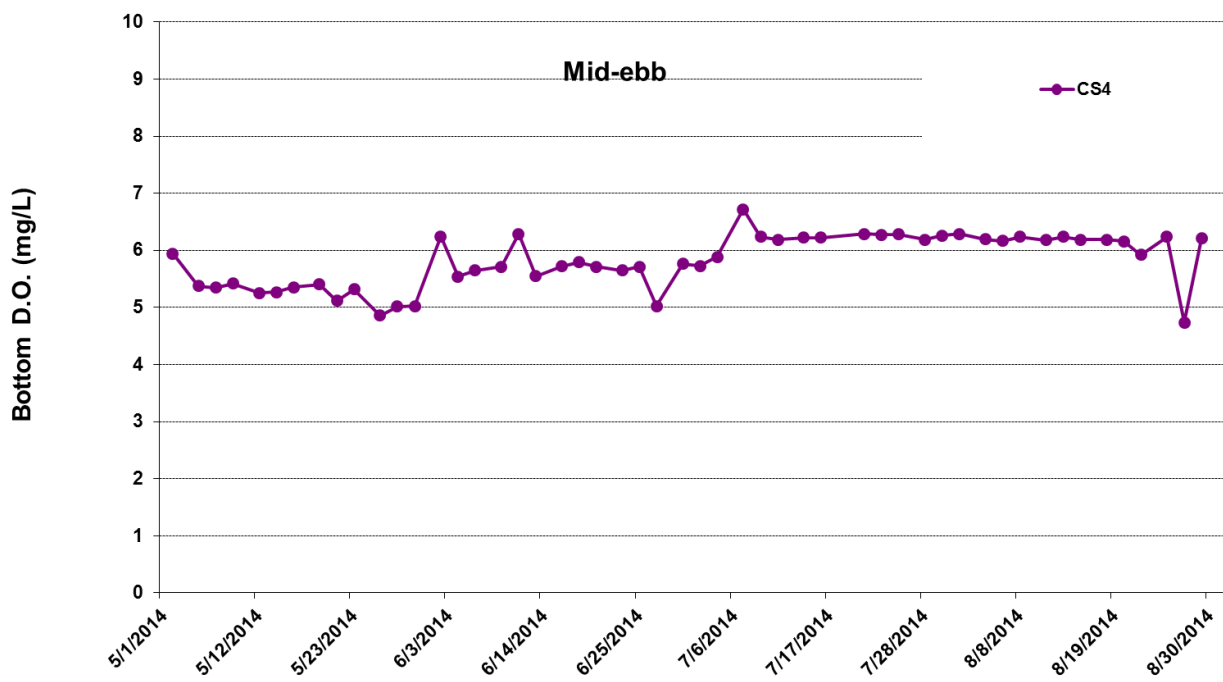
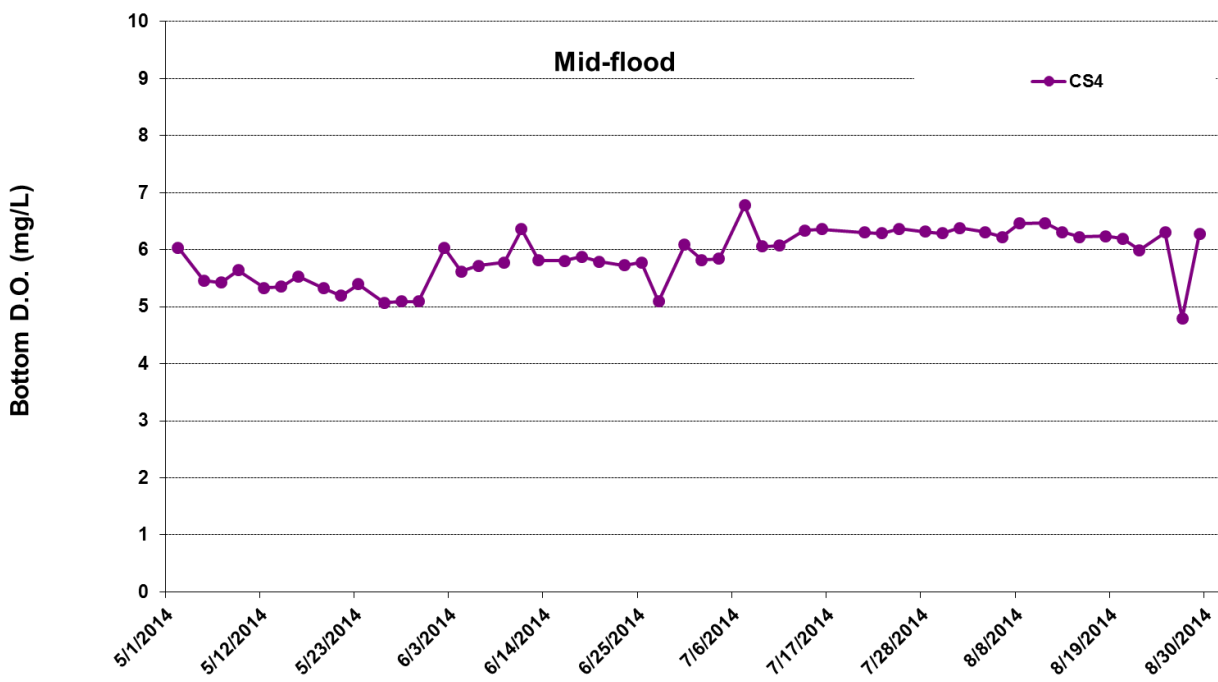
Figure G17 Impact Monitoring - Mean Level of Dissolved Oxygen (mg/L) in bottom water between 1 May 2014 and 31 August 2014 at CS4. The weather conditions during the monitoring period varied mostly from sunny to cloudy. Major marine construction activities included: Dredging (5/1/2014 - 8/6/2014); Construction of Temporary Seawalls (5/1/2013 - 8/31/2014); Sheet Piling (5/1/2014 - 8/31/2014); Filling (5/1/2014 - 8/31/2014). No monitoring was conducted on 18 July 2014 due to adverse weather condition.

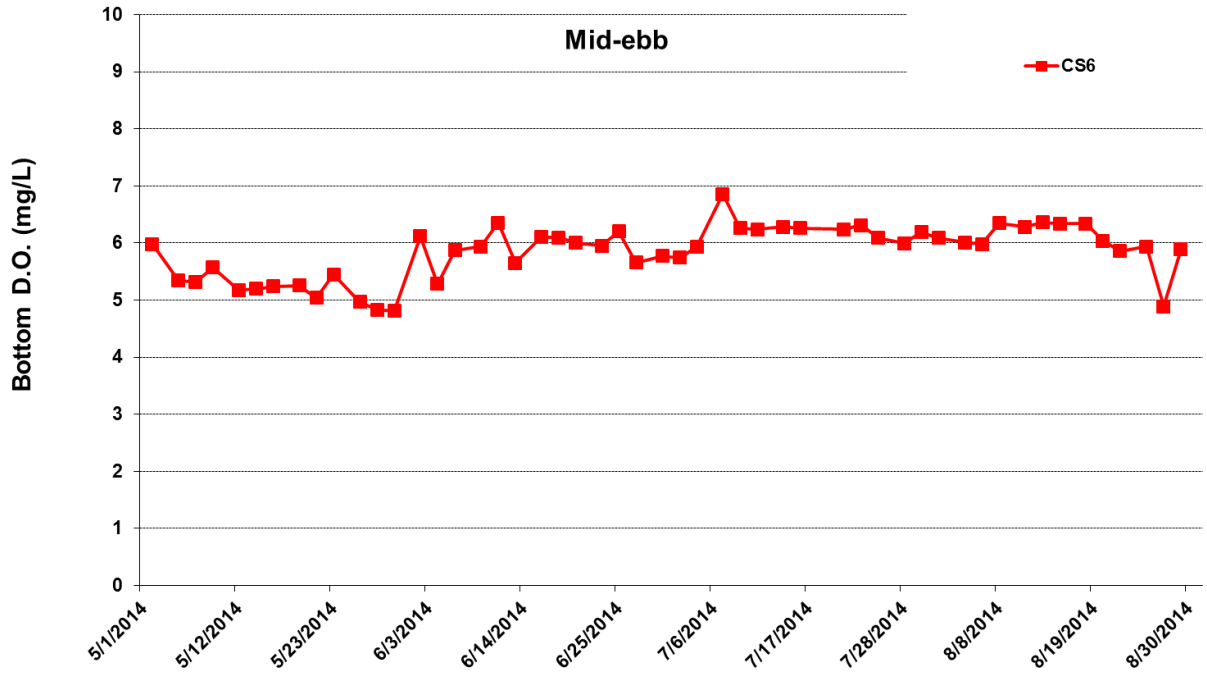
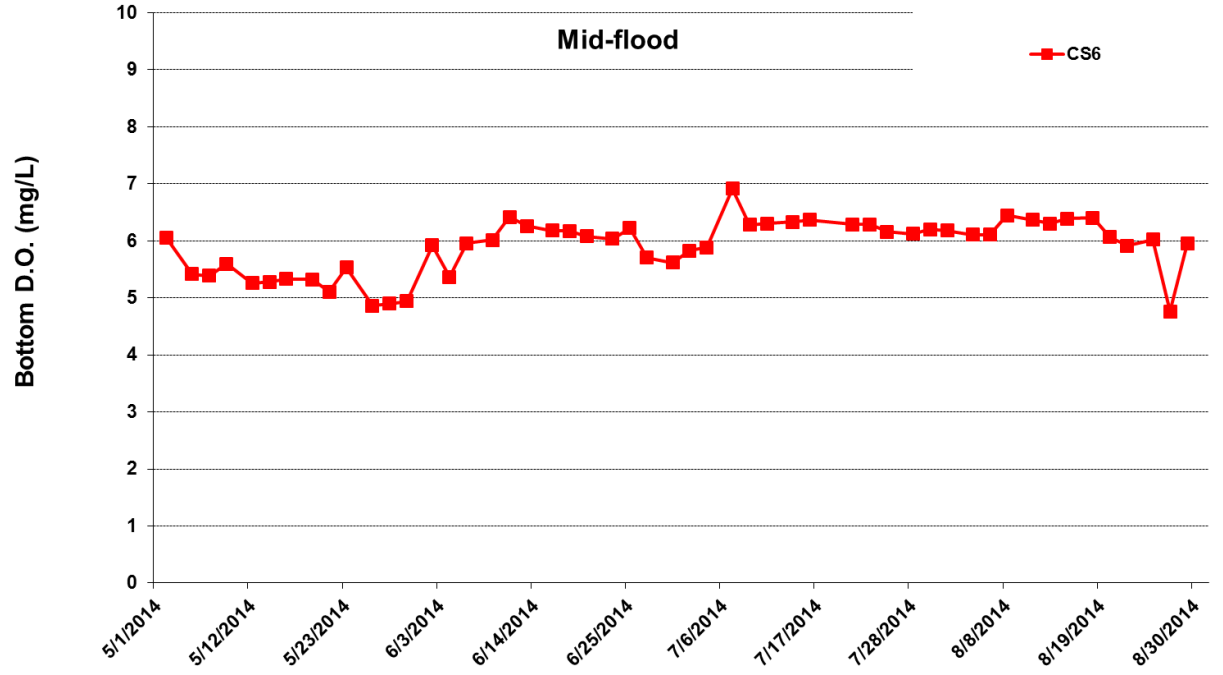
Figure G18 Impact Monitoring - Mean Level of Dissolved Oxygen (mg/L) in bottom water between 1 May 2014 and 31 August 2014 at CS6. The weather conditions during the monitoring period varied mostly from sunny to cloudy. Major marine construction activities included: Dredging (5/1/2014 - 8/6/2014); Construction of Temporary Seawalls (5/1/2013 - 8/31/2014); Sheet Piling (5/1/2014 - 8/31/2014); Filling (5/1/2014 - 8/31/2014). No monitoring was conducted on 18 July 2014 due to adverse weather condition.
 Ref: 0212330_Impact-WQM_August2014_graphs_Rev a.xls

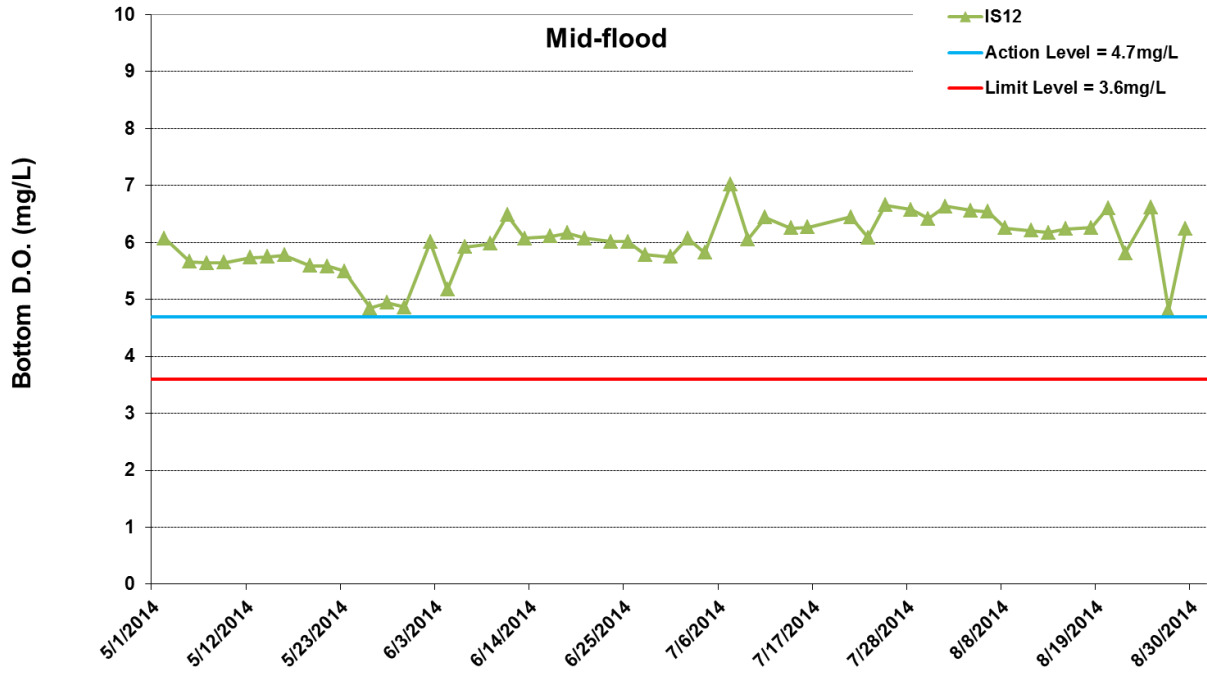
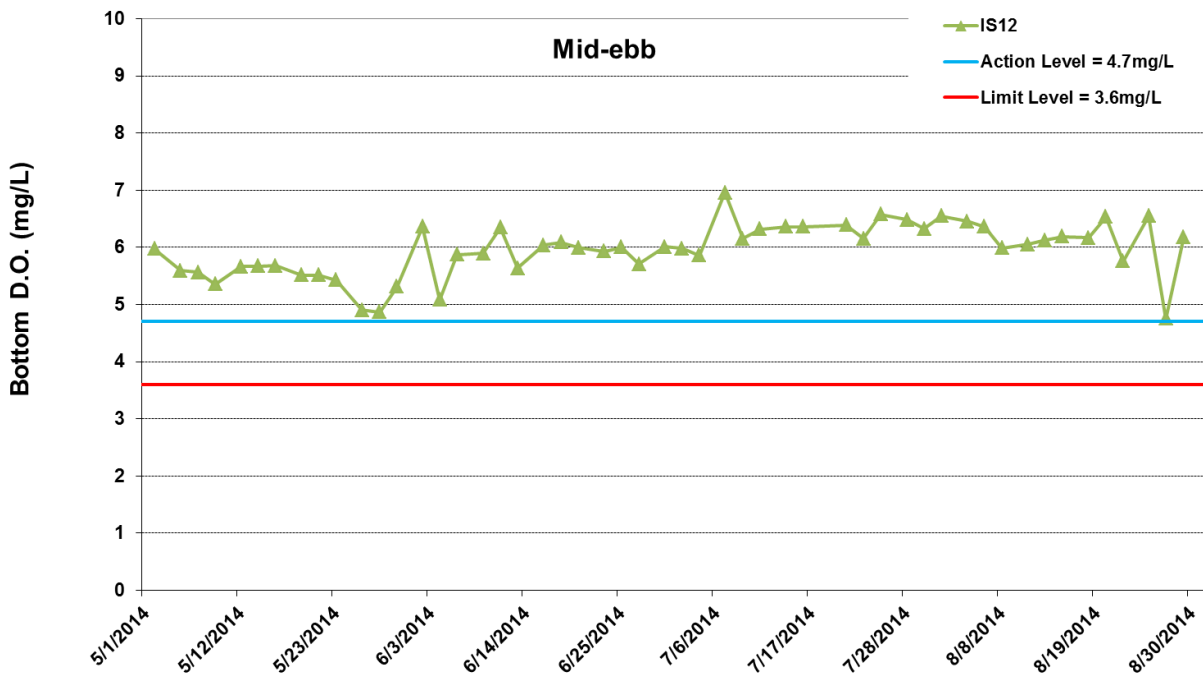
Figure G19 Impact Monitoring - Mean Level of Dissolved Oxygen (mg/L) in bottom water between 1 May 2014 and 31 August 2014 at IS12. The weather conditions during the monitoring period varied mostly from sunny to cloudy. Major marine construction activities included: Dredging (5/1/2014 - 8/6/2014); Construction of Temporary Seawalls (5/1/2013 - 8/31/2014); Sheet Piling (5/1/2014 - 8/31/2014); Filling (5/1/2014 - 8/31/2014). No monitoring was conducted on 18 July 2014 due to adverse weather condition.

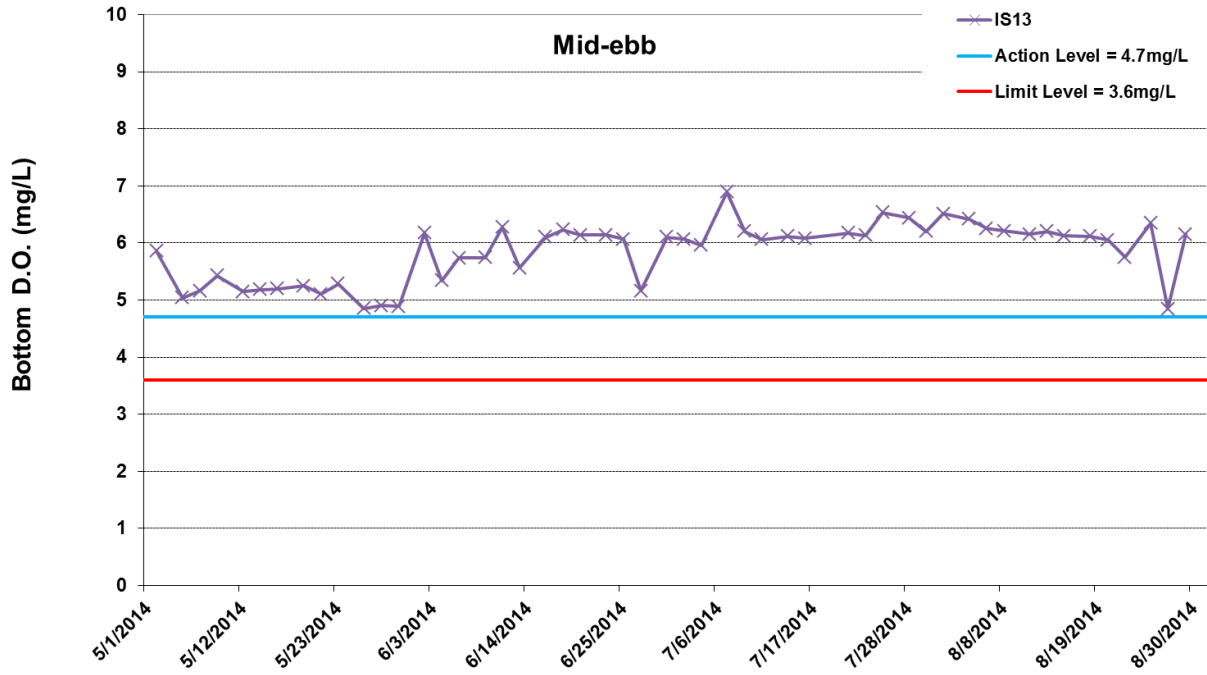
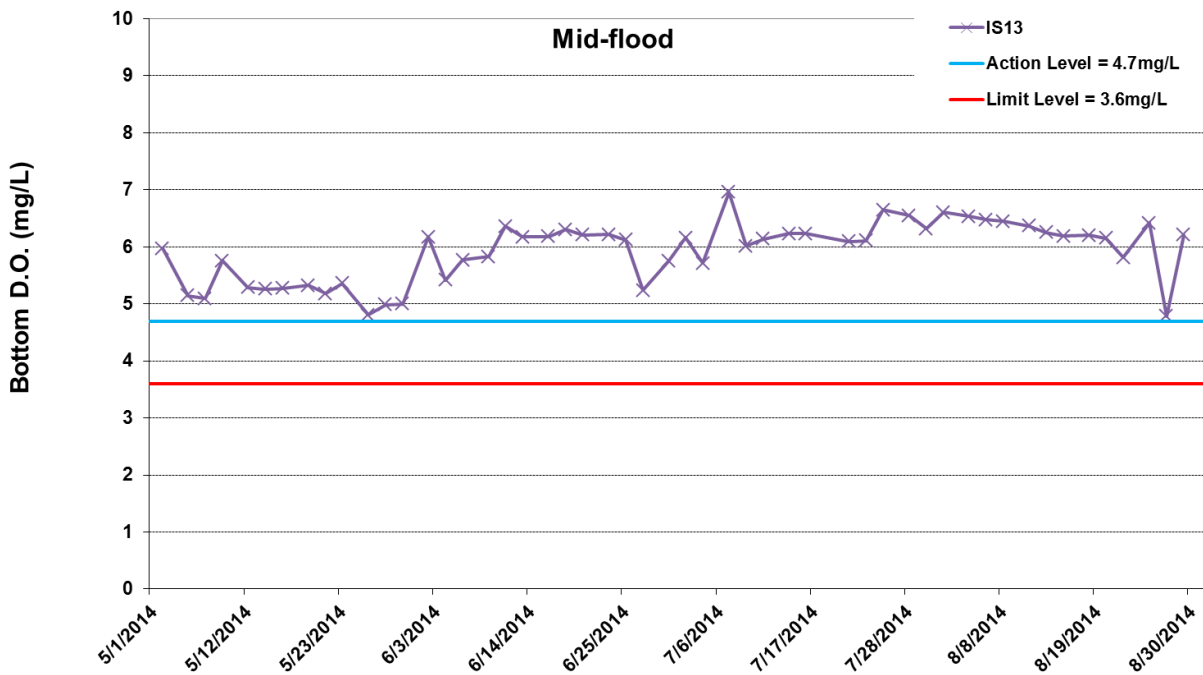
Figure G20 Impact Monitoring - Mean Level of Dissolved Oxygen (mg/L) in bottom water between 1 May 2014 and 31 August 2014 at IS13. The weather conditions during the monitoring period varied mostly from sunny to cloudy. Major marine construction activities included: Dredging (5/1/2014 - 8/6/2014); Construction of Temporary Seawalls (5/1/2013 - 8/31/2014); Sheet Piling (5/1/2014 - 8/31/2014); Filling (5/1/2014 - 8/31/2014). No monitoring was conducted on 18 July 2014 due to adverse weather condition.

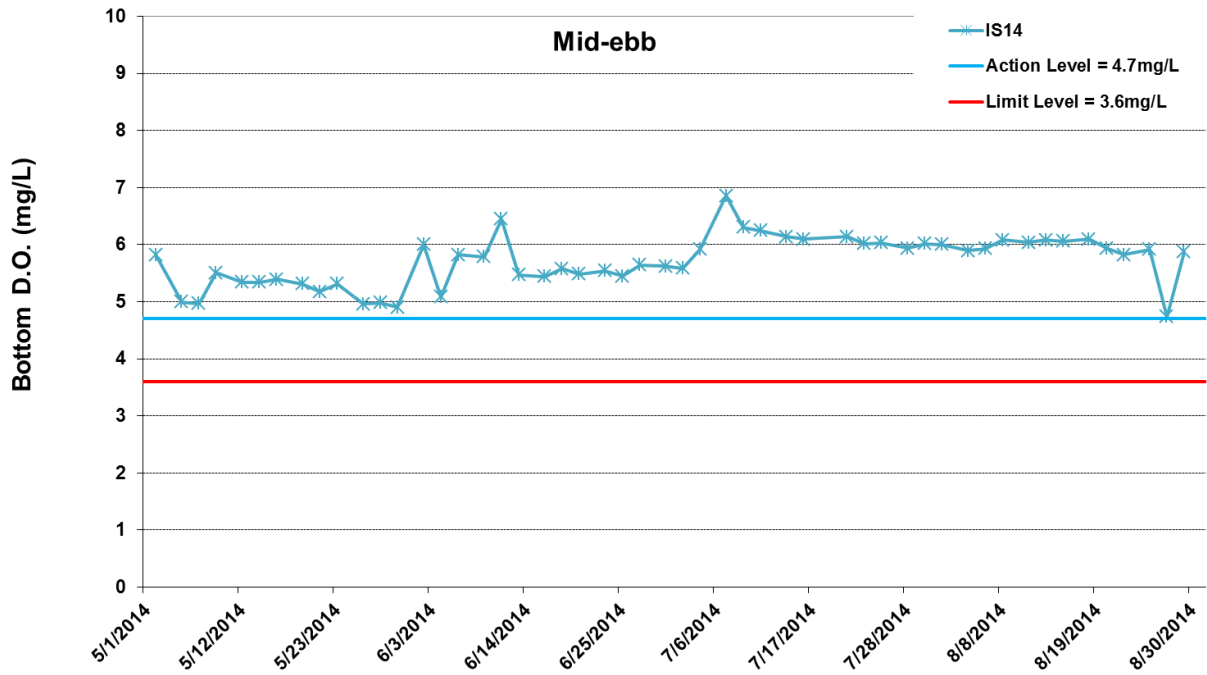
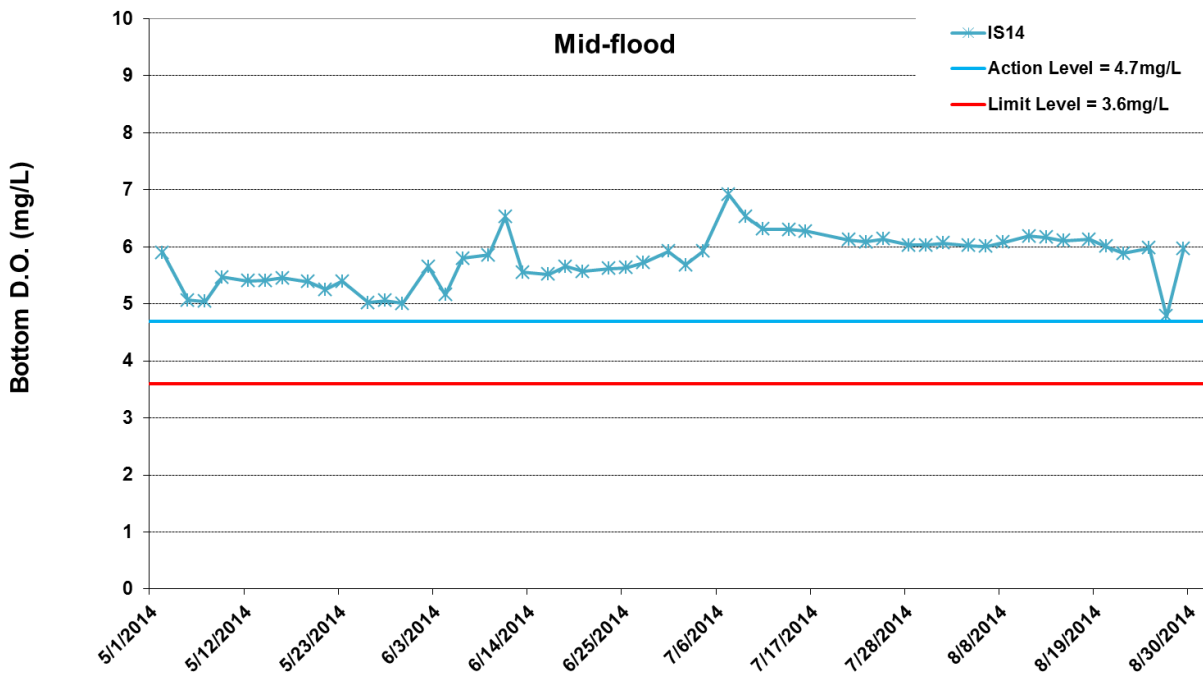
Figure G21 Impact Monitoring - Mean Level of Dissolved Oxygen (mg/L) in bottom water between 1 May 2014 and 31 August 2014 at IS14. The weather conditions during the monitoring period varied mostly from sunny to cloudy. Major marine construction activities included: Dredging (5/1/2014 - 8/6/2014); Construction of Temporary Seawalls (5/1/2013 - 8/31/2014); Sheet Piling (5/1/2014 - 8/31/2014); Filling (5/1/2014 - 8/31/2014). No monitoring was conducted on 18 July 2014 due to adverse weather condition.

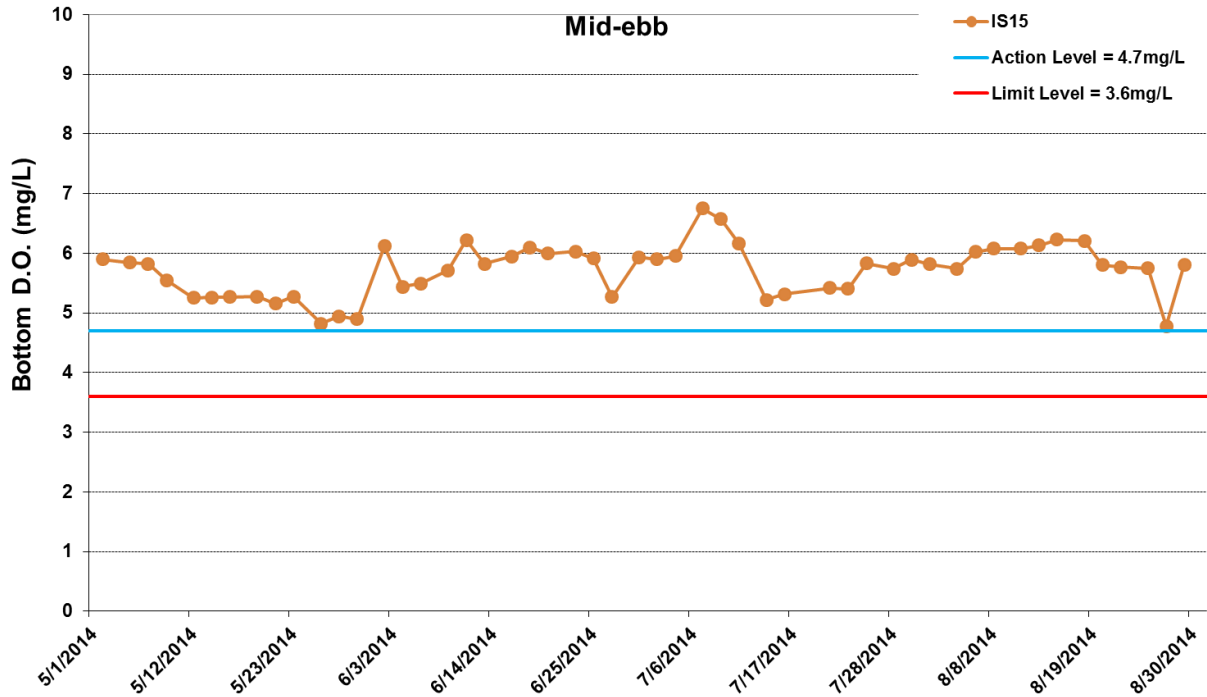
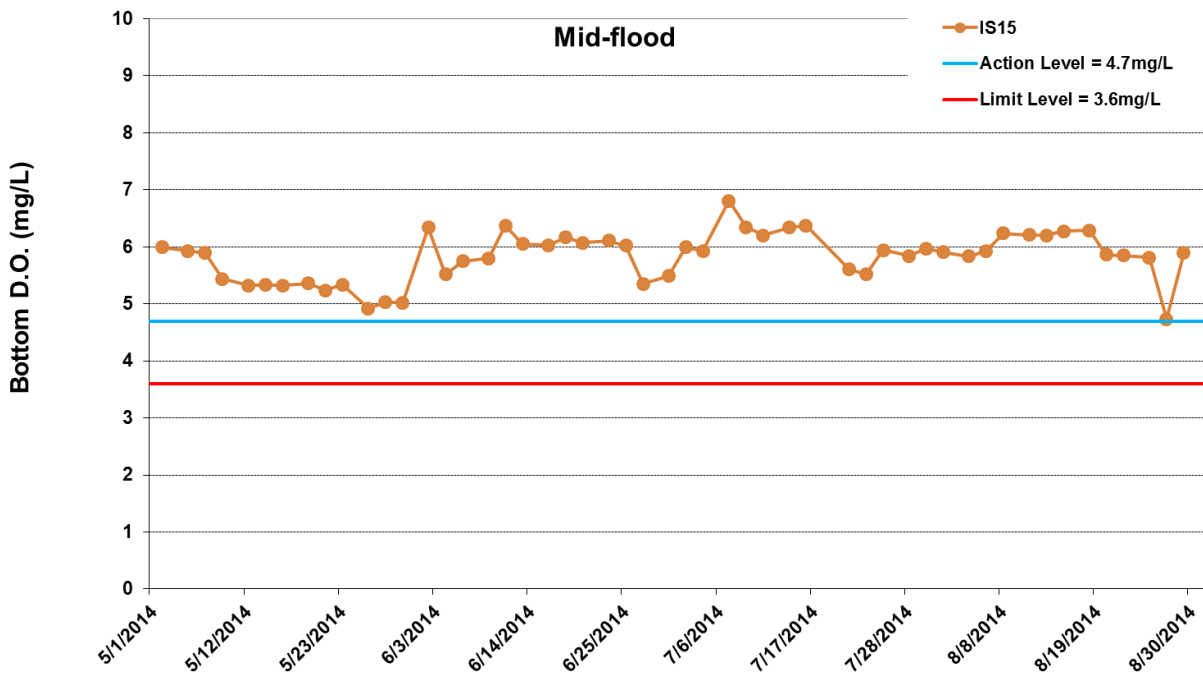
Figure G22 Impact Monitoring - Mean Level of Dissolved Oxygen (mg/L) in bottom water between 1 May 2014 and 31 August 2014 at IS15. The weather conditions during the monitoring period varied mostly from sunny to cloudy. Major marine construction activities included: Dredging (5/1/2014 - 8/6/2014); Construction of Temporary Seawalls (5/1/2013 - 8/31/2014); Sheet Piling (5/1/2014 - 8/31/2014); Filling (5/1/2014 - 8/31/2014). No monitoring was conducted on 18 July 2014 due to adverse weather condition.
