**Contract No. HY/2012/08
Tuen Mun – Chek Lap Kok Link –
Northern Connection Sub-sea Tunnel
Section**

*Third Quarterly Environmental Monitoring &
Audit (EM&A) Report*

20 November 2014

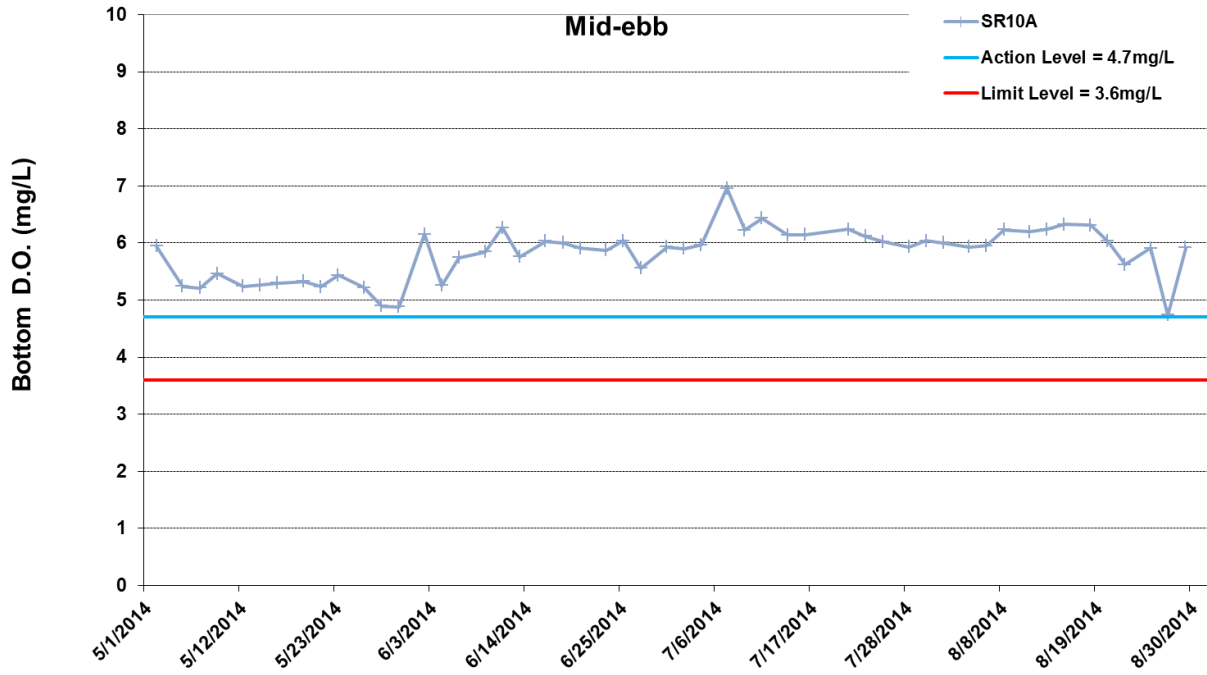
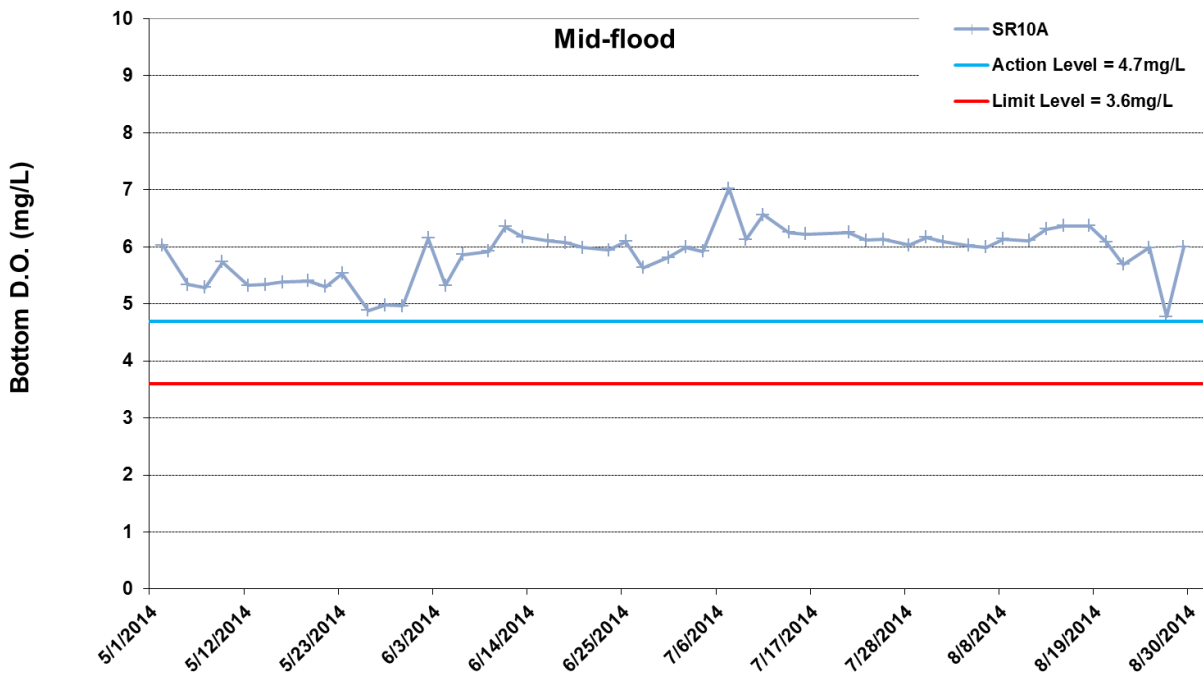
Figure G23 Impact Monitoring - Mean Level of Dissolved Oxygen (mg/L) in bottom water between 1 May 2014 and 31 August 2014 at SR10A. The weather conditions during the monitoring period varied mostly from sunny to cloudy. Major marine construction activities included: Dredging (5/1/2014 - 8/6/2014); Construction of Temporary Seawalls (5/1/2013 - 8/31/2014); Sheet Piling (5/1/2014 - 8/31/2014); Filling (5/1/2014 - 8/31/2014). No monitoring was conducted on 18 July 2014 due to adverse weather condition.

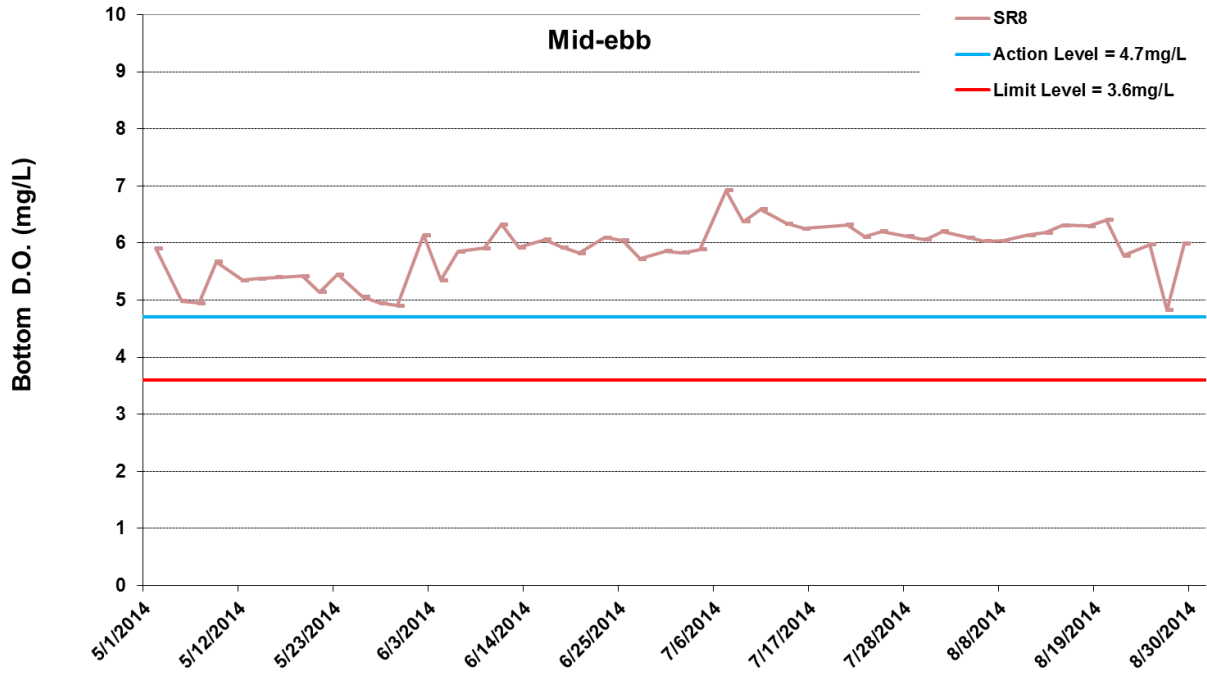
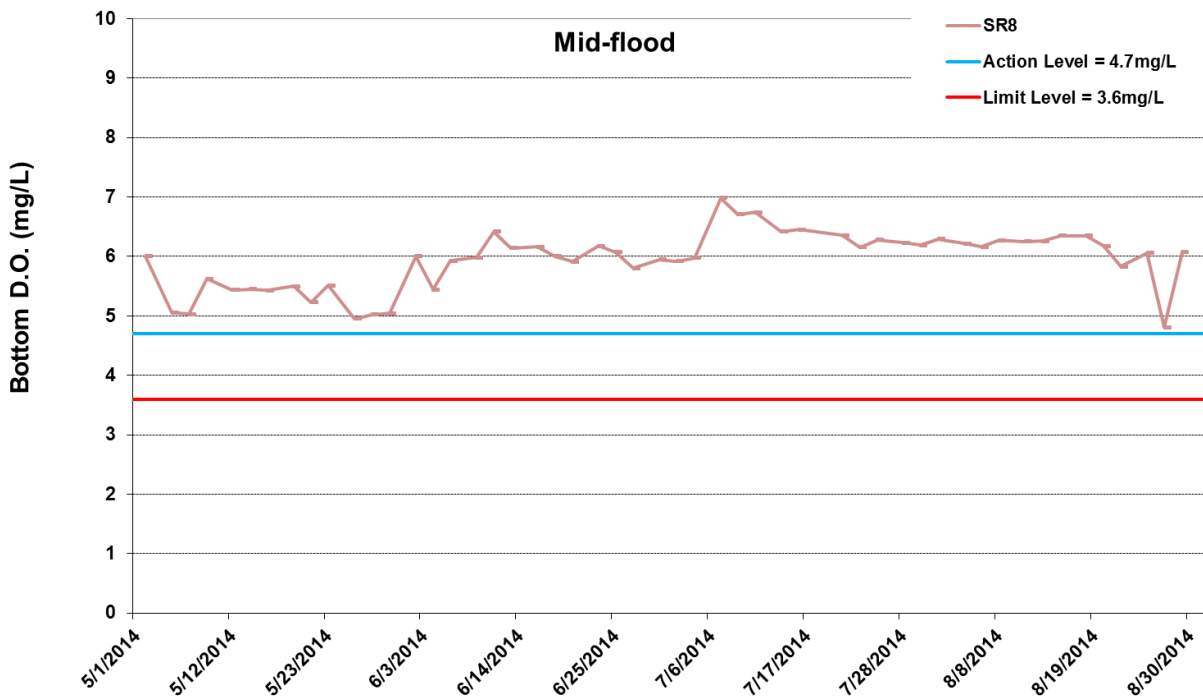
Figure G24 Impact Monitoring - Mean Level of Dissolved Oxygen (mg/L) in bottom water between 1 May 2014 and 31 August 2014 at SR8. The weather conditions during the monitoring period varied mostly from sunny to cloudy. Major marine construction activities included: Dredging (5/1/2014 - 8/6/2014); Construction of Temporary Seawalls (5/1/2013 - 8/31/2014); Sheet Piling (5/1/2014 - 8/31/2014); Filling (5/1/2014 - 8/31/2014). No monitoring was conducted on 18 July 2014 due to adverse weather condition.

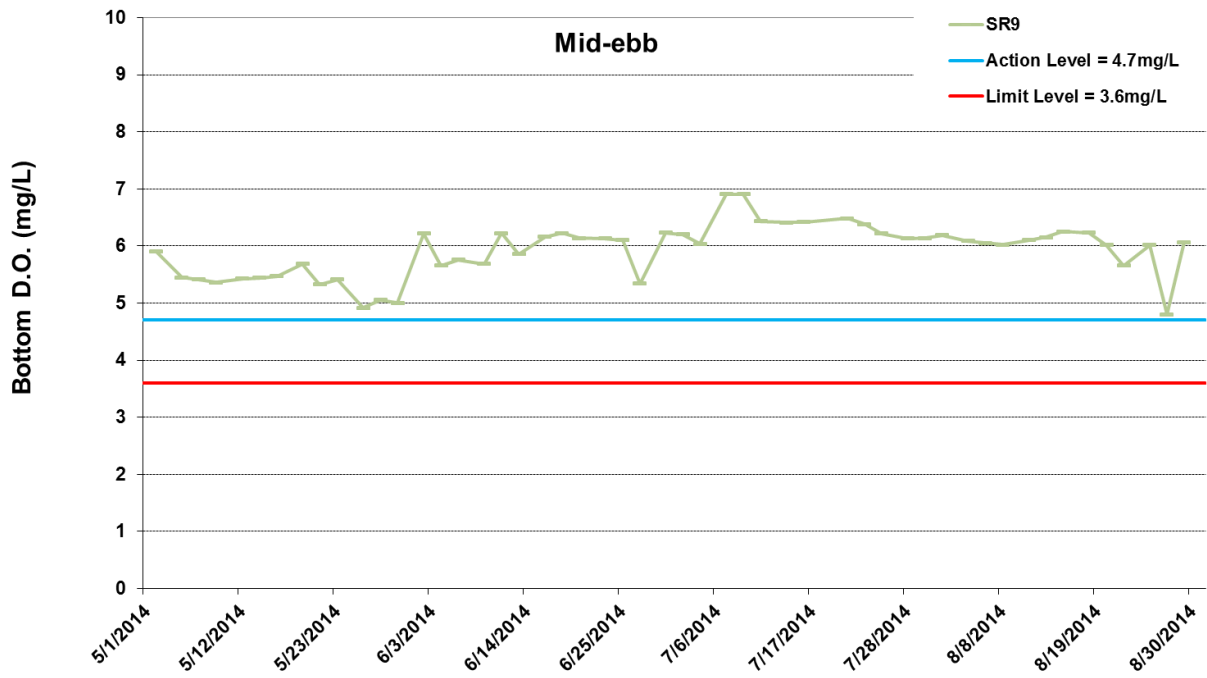
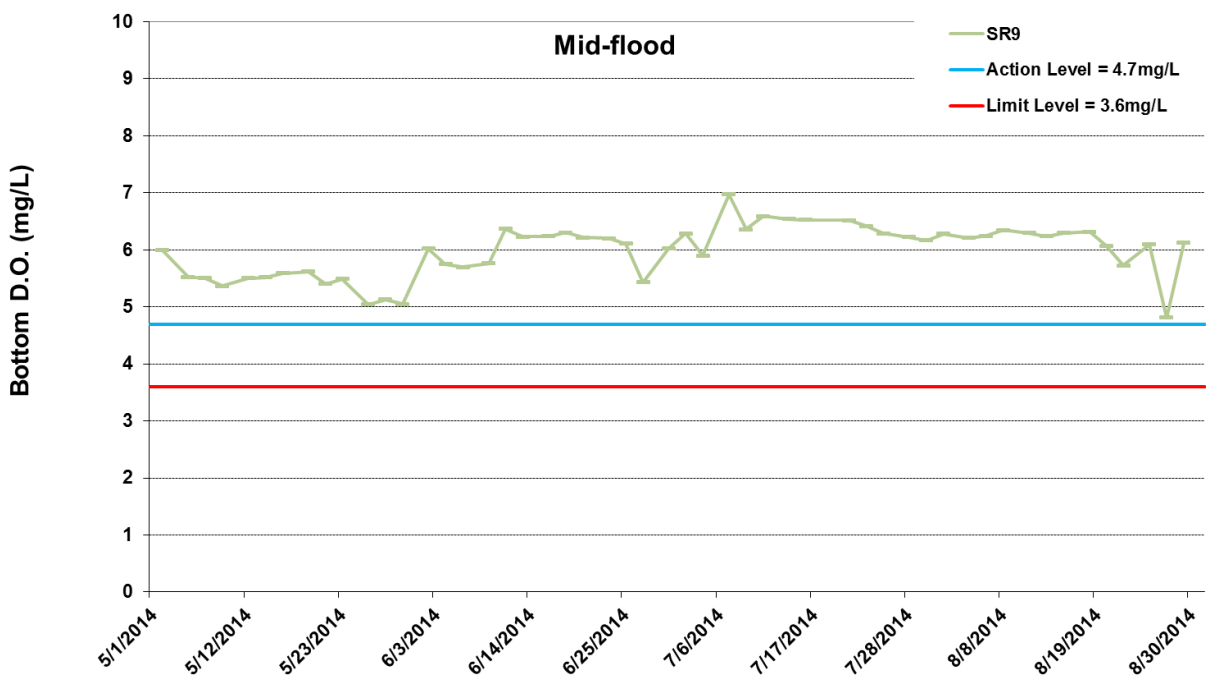
Figure G25 Impact Monitoring - Mean Level of Dissolved Oxygen (mg/L) in bottom water between 1 May 2014 and 31 August 2014 at SR9. The weather conditions during the monitoring period varied mostly from sunny to cloudy. Major marine construction activities included: Dredging (5/1/2014 - 8/6/2014); Construction of Temporary Seawalls (5/1/2013 - 8/31/2014); Sheet Piling (5/1/2014 - 8/31/2014); Filling (5/1/2014 - 8/31/2014). No monitoring was conducted on 18 July 2014 due to adverse weather condition.

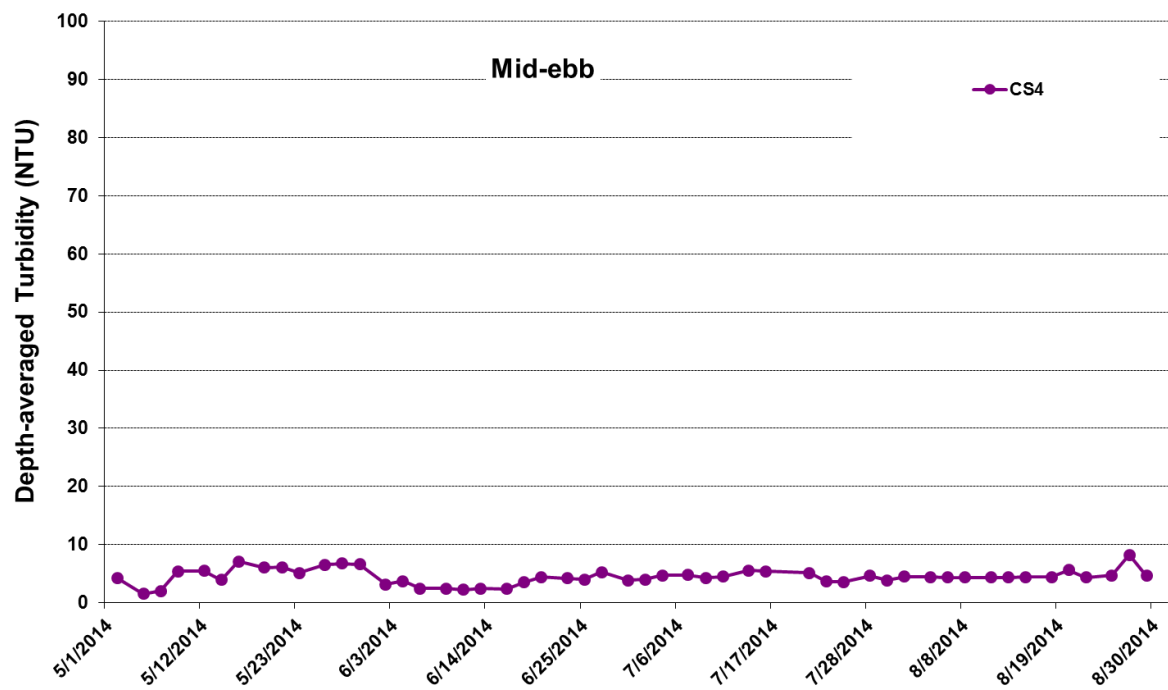
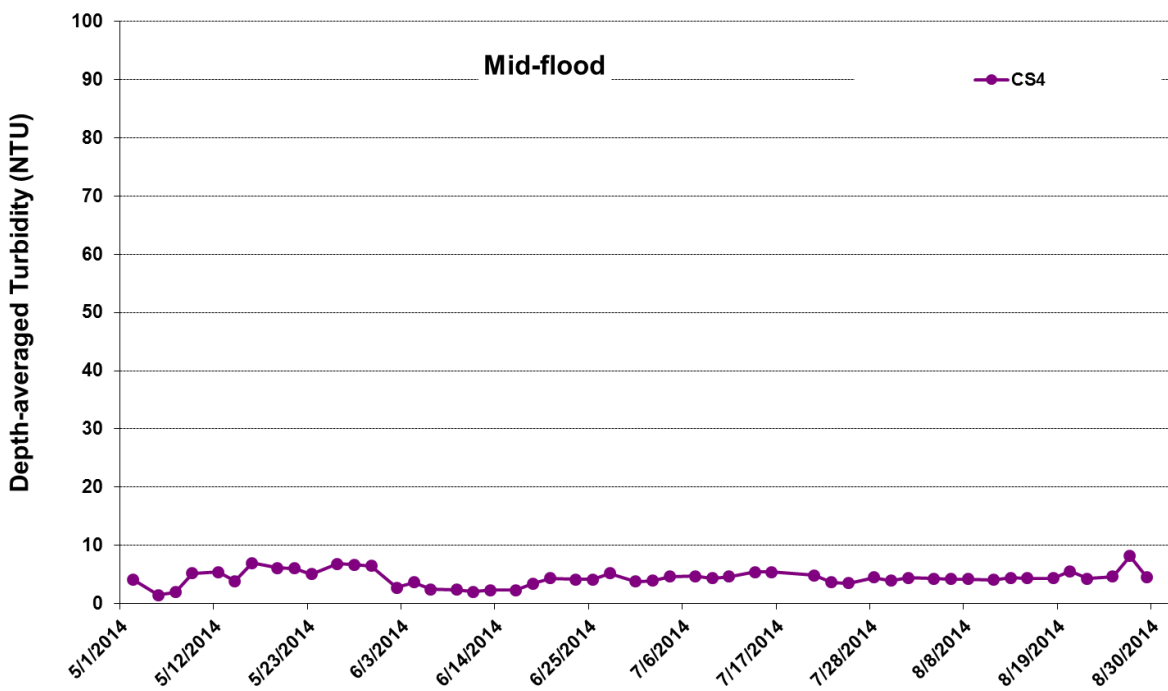
Figure G26 Impact Monitoring - Mean Depth-averaged Level of Turbidity (NTU) between 1 May 2014 and 31 August 2014 at CS4. The weather conditions during the monitoring period varied mostly from sunny to cloudy. Major marine construction activities included: Dredging (5/1/2014 - 8/6/2014); Construction of Temporary Seawalls (5/1/2013 - 8/31/2014); Sheet Piling (5/1/2014 - 8/31/2014); Filling (5/1/2014 - 8/31/2014). No monitoring was conducted on 18 July 2014 due to adverse weather condition.

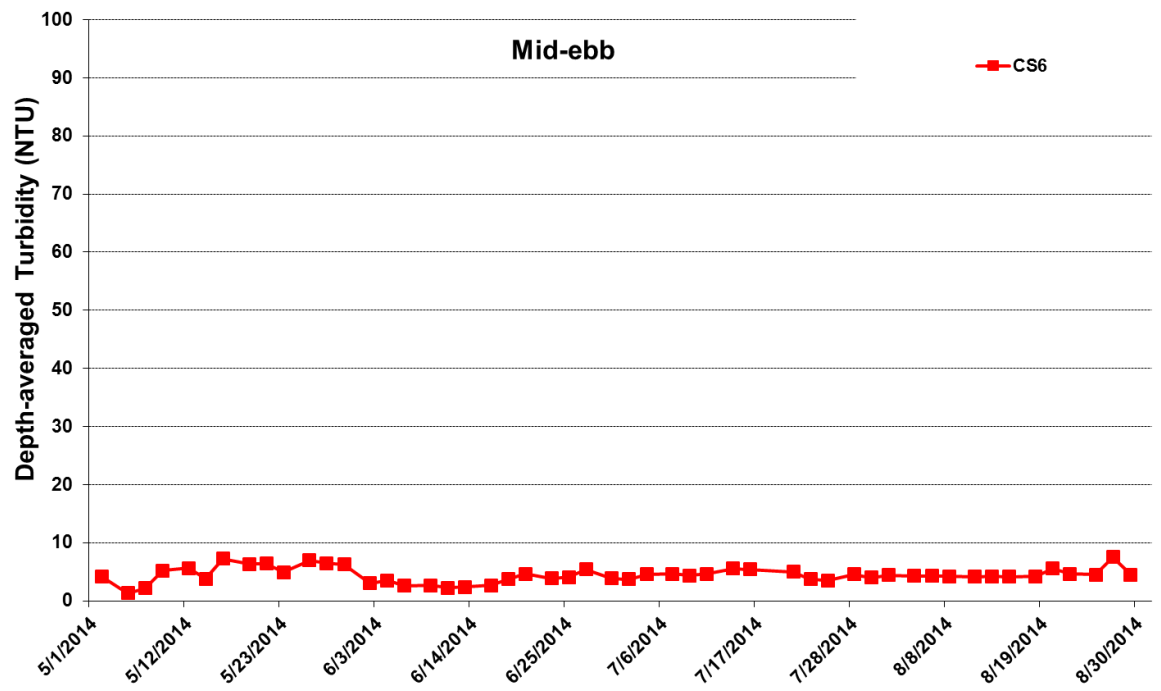
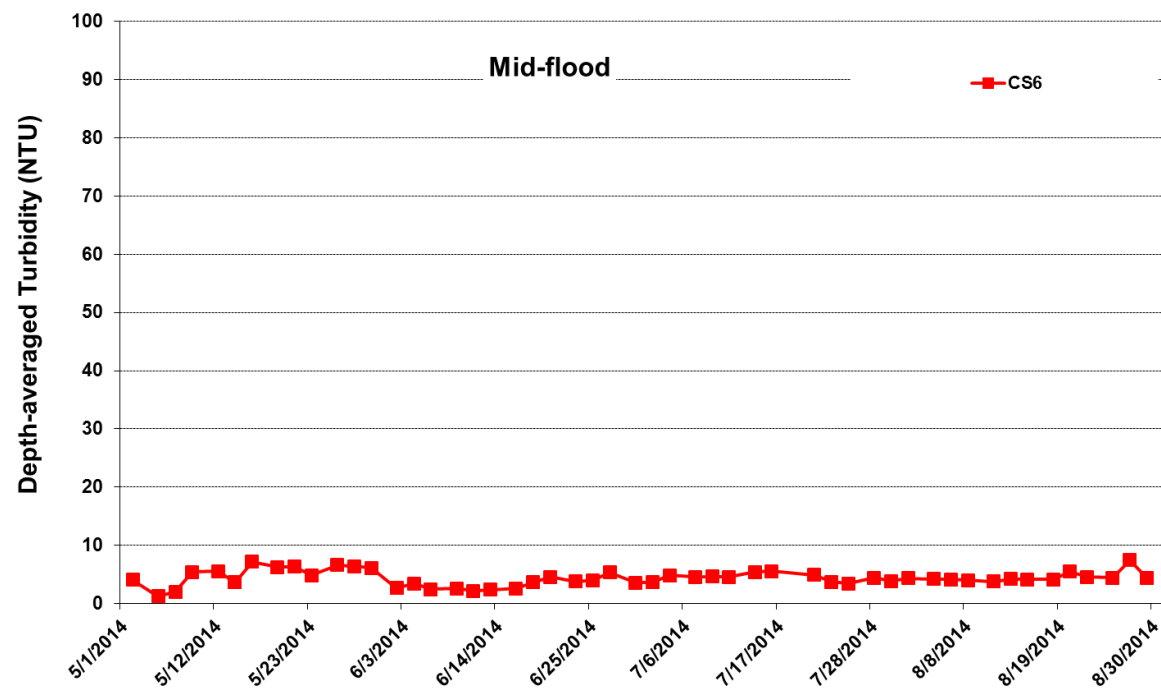
Figure G27 Impact Monitoring - Mean Depth-averaged Level of Turbidity (NTU) between 1 May 2014 and 31 August 2014 at CS6. The weather conditions during the monitoring period varied mostly from sunny to cloudy. Major marine construction activities included: Dredging (5/1/2014 - 8/6/2014); Construction of Temporary Seawalls (5/1/2013 - 8/31/2014); Sheet Piling (5/1/2014 - 8/31/2014); Filling (5/1/2014 - 8/31/2014). No monitoring was conducted on 18 July 2014 due to adverse weather condition.

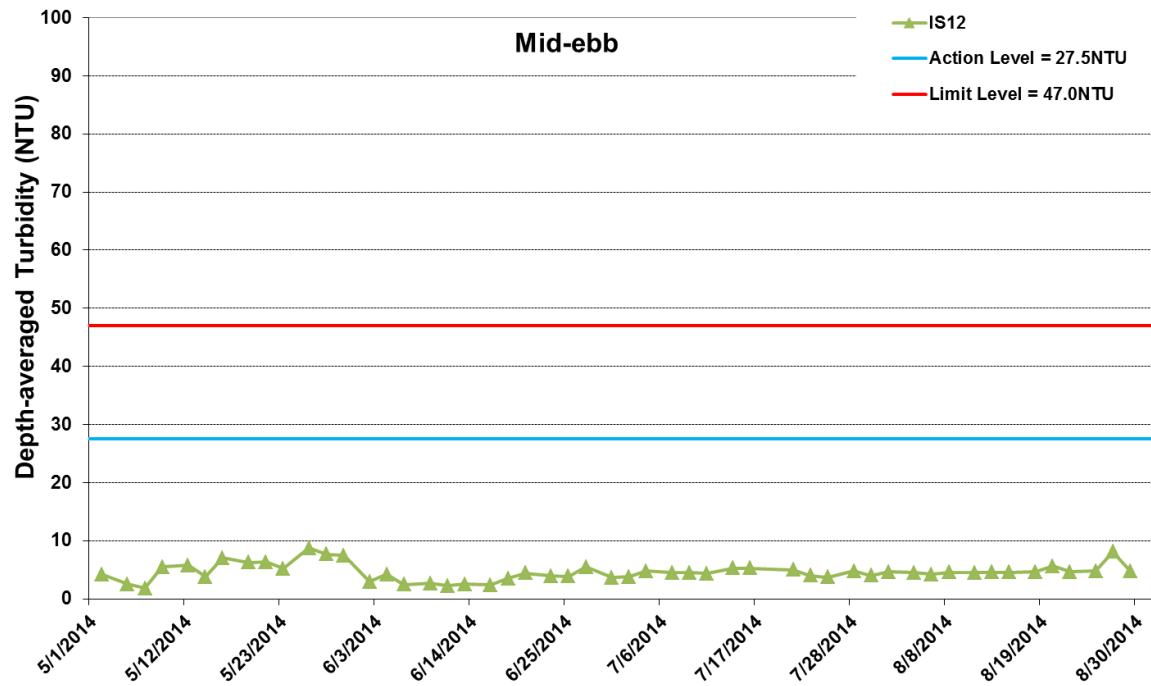
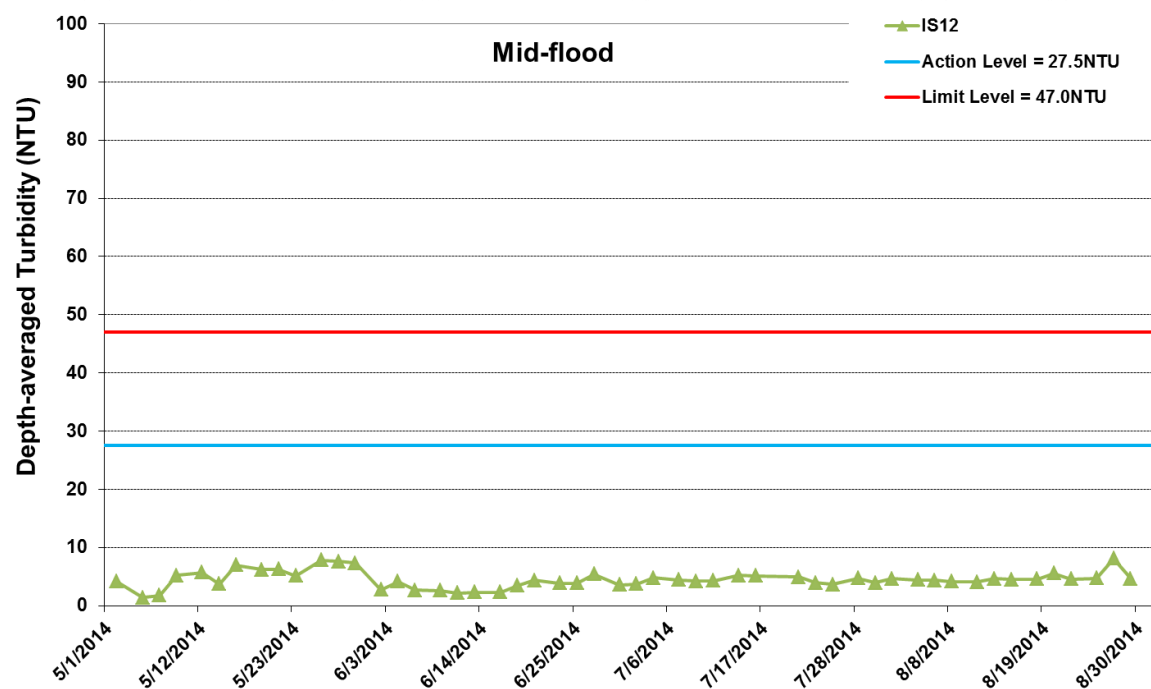
Figure G28 Impact Monitoring - Mean Depth-averaged Level of Turbidity (NTU) between 1 May 2014 and 31 August 2014 at IS12. The weather conditions during the monitoring period varied mostly from sunny to cloudy. Major marine construction activities included: Dredging (5/1/2014 - 8/6/2014); Construction of Temporary Seawalls (5/1/2013 - 8/31/2014); Sheet Piling (5/1/2014 - 8/31/2014); Filling (5/1/2014 - 8/31/2014). No monitoring was conducted on 18 July 2014 due to adverse weather condition.

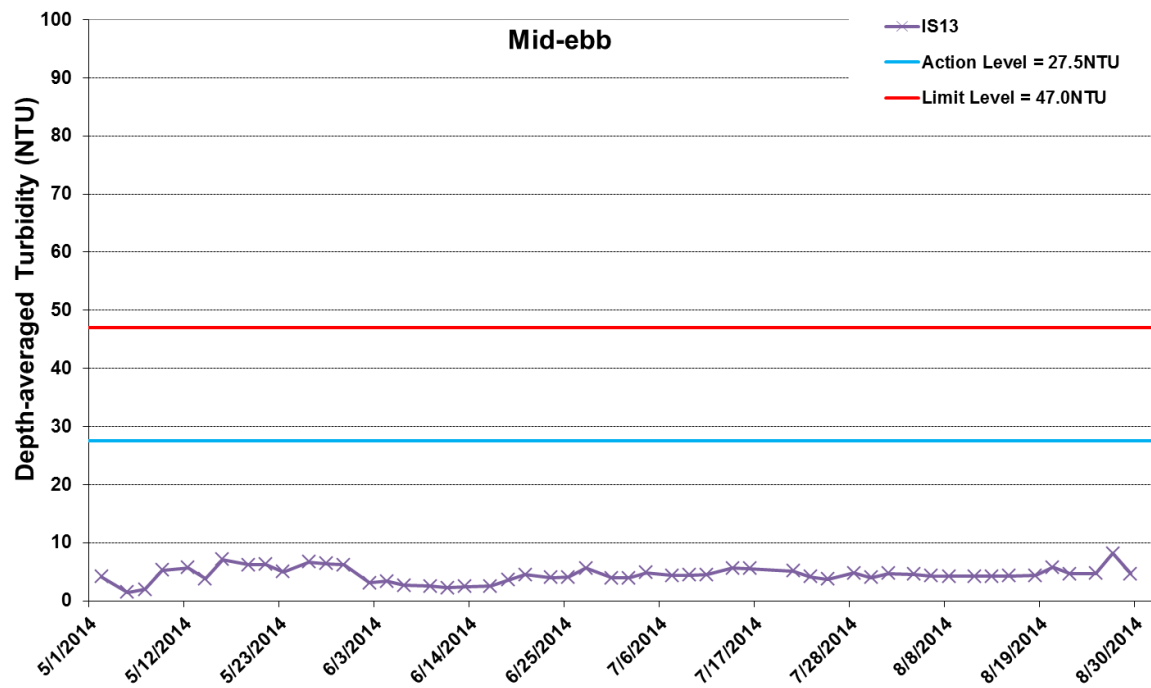
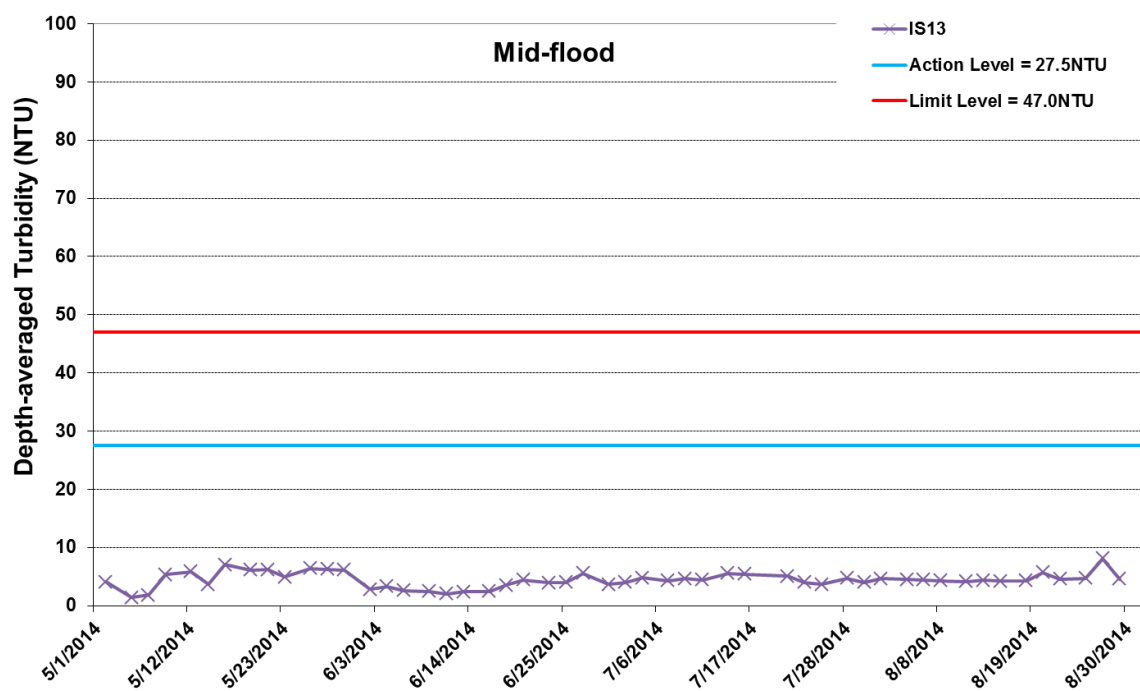
Figure G29 Impact Monitoring - Mean Depth-averaged Level of Turbidity (NTU) between 1 May 2014 and 31 August 2014 at IS13. The weather conditions during the monitoring period varied mostly from sunny to cloudy. Major marine construction activities included: Dredging (5/1/2014 - 8/6/2014); Construction of Temporary Seawalls (5/1/2013 - 8/31/2014); Sheet Piling (5/1/2014 - 8/31/2014); Filling (5/1/2014 - 8/31/2014). No monitoring was conducted on 18 July 2014 due to adverse weather condition.

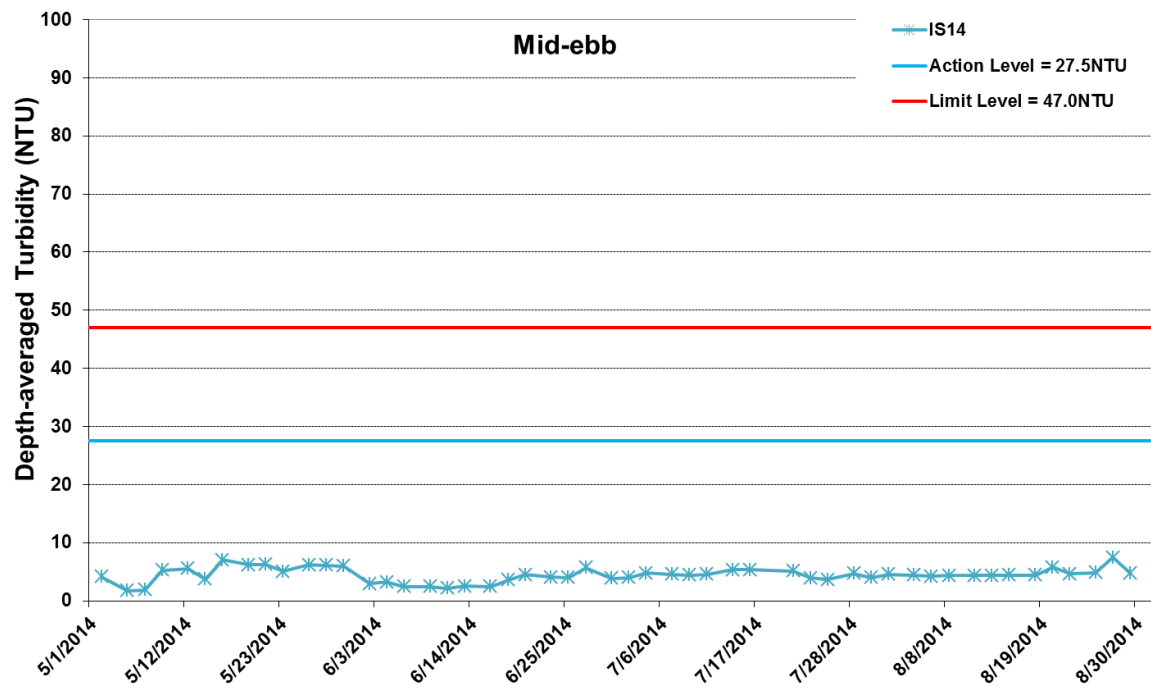
Figure G30 Impact Monitoring - Mean Depth-averaged Level of Turbidity (NTU) between 1 May 2014 and 31 August 2014 at IS14. The weather conditions during the monitoring period varied mostly from sunny to cloudy. Major marine construction activities included: Dredging (5/1/2014 - 8/6/2014); Construction of Temporary Seawalls (5/1/2013 - 8/31/2014); Sheet Piling (5/1/2014 - 8/31/2014); Filling (5/1/2014 - 8/31/2014). No monitoring was conducted on 18 July 2014 due to adverse weather condition.

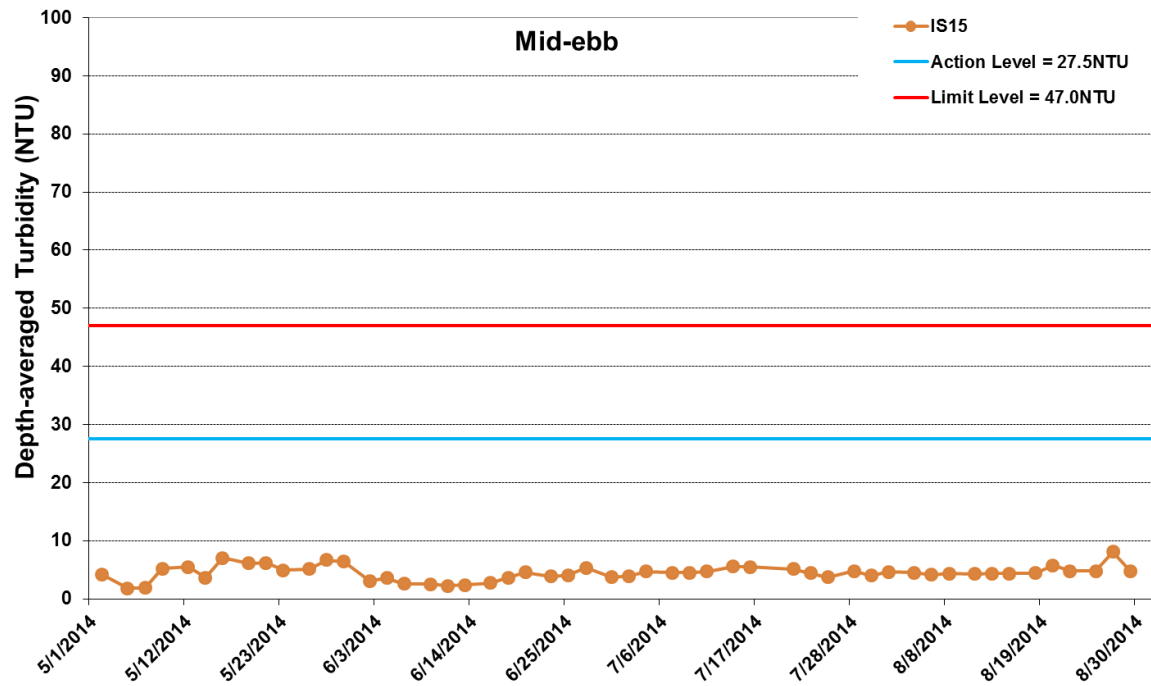
Figure G31 Impact Monitoring - Mean Depth-averaged Level of Turbidity (NTU) between 1 May 2014 and 31 August 2014 at IS15. The weather conditions during the monitoring period varied mostly from sunny to cloudy. Major marine construction activities included: Dredging (5/1/2014 - 8/6/2014); Construction of Temporary Seawalls (5/1/2013 - 8/31/2014); Sheet Piling (5/1/2014 - 8/31/2014); Filling (5/1/2014 - 8/31/2014). No monitoring was conducted on 18 July 2014 due to adverse weather condition.

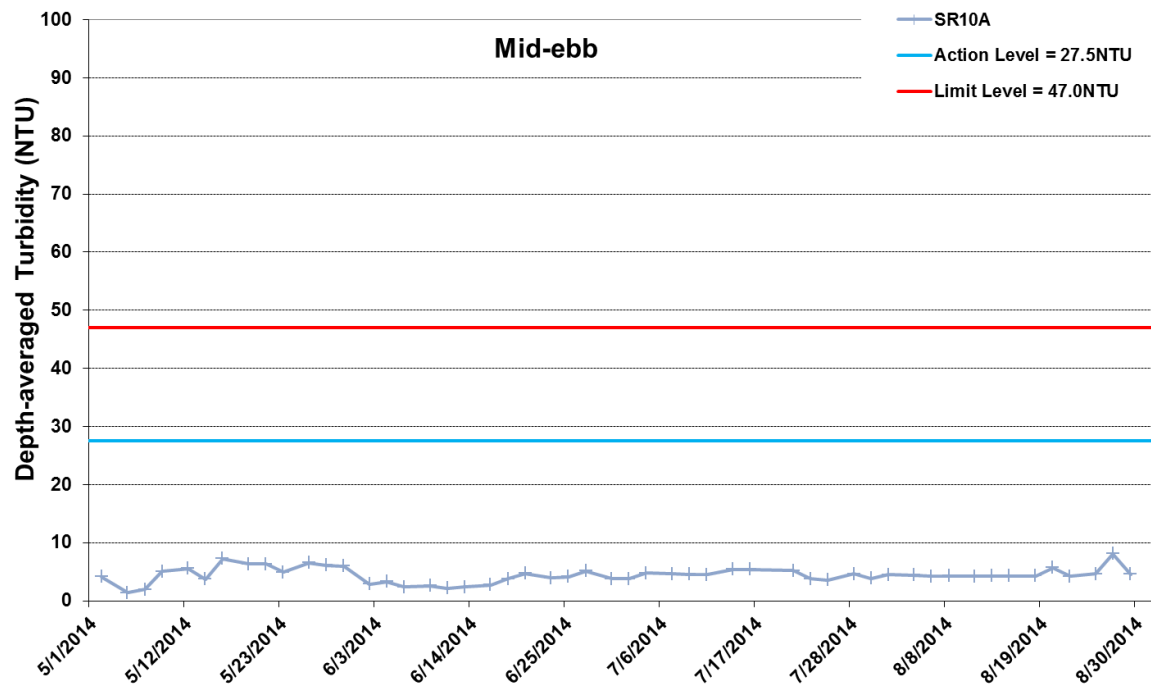
Figure G32 Impact Monitoring - Mean Depth-averaged Level of Turbidity (NTU) between 1 May 2014 and 31 August 2014 at SR10A. The weather conditions during the monitoring period varied mostly from sunny to cloudy. Major marine construction activities included: Dredging (5/1/2014 - 8/6/2014); Construction of Temporary Seawalls (5/1/2013 - 8/31/2014); Sheet Piling (5/1/2014 - 8/31/2014); Filling (5/1/2014 - 8/31/2014). No monitoring was conducted on 18 July 2014 due to adverse weather condition.

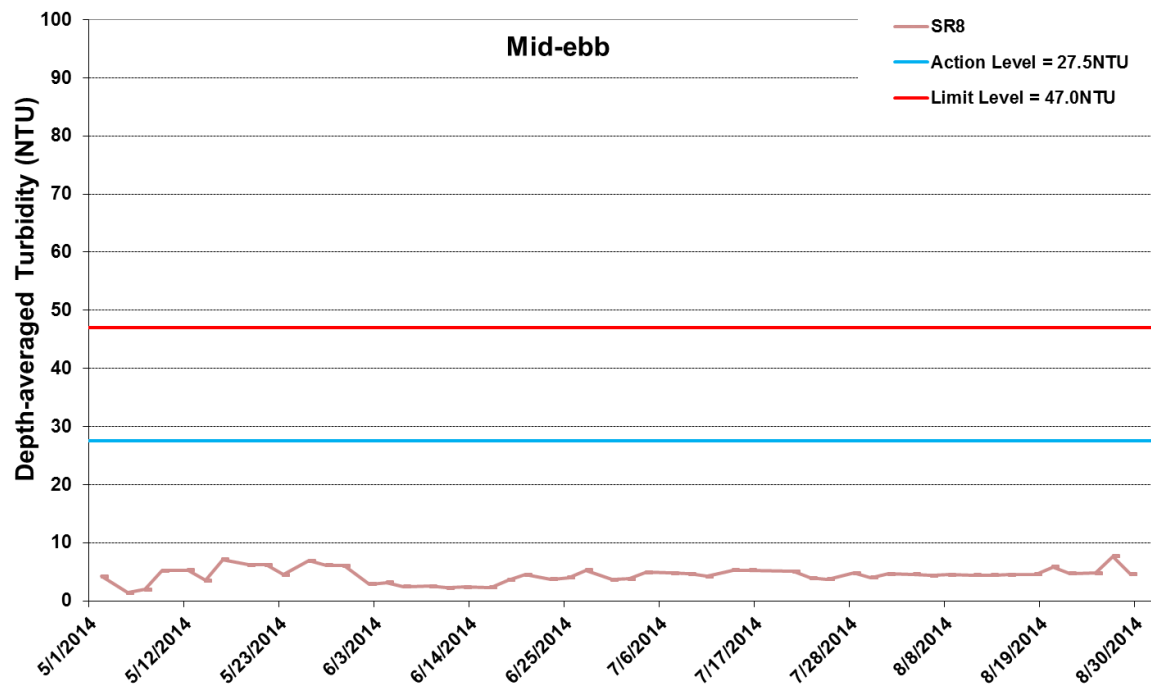
Figure G33 Impact Monitoring - Mean Depth-averaged Level of Turbidity (NTU) between 1 May 2014 and 31 August 2014 at SR8. The weather conditions during the monitoring period varied mostly from sunny to cloudy. Major marine construction activities included: Dredging (5/1/2014 - 8/6/2014); Construction of Temporary Seawalls (5/1/2013 - 8/31/2014); Sheet Piling (5/1/2014 - 8/31/2014); Filling (5/1/2014 - 8/31/2014). No monitoring was conducted on 18 July 2014 due to adverse weather condition.

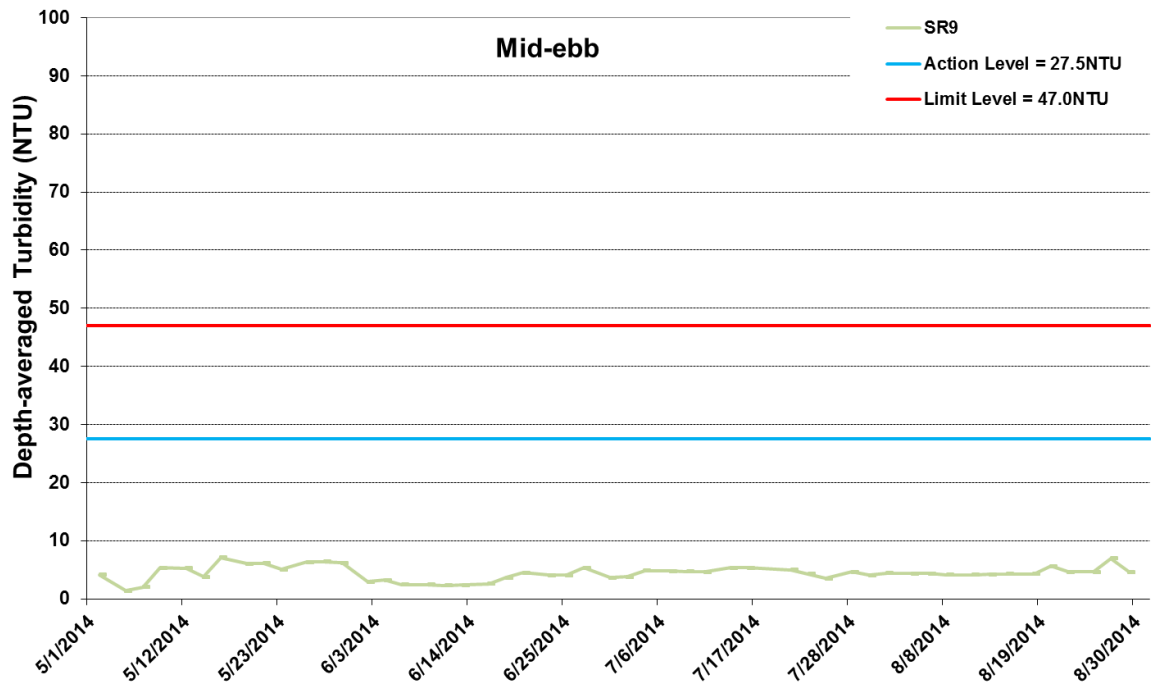
Figure G34 Impact Monitoring - Mean Depth-averaged Level of Turbidity (NTU) between 1 May 2014 and 31 August 2014 at SR9. The weather conditions during the monitoring period varied mostly from sunny to cloudy. Major marine construction activities included: Dredging (5/1/2014 - 8/6/2014); Construction of Temporary Seawalls (5/1/2013 - 8/31/2014); Sheet Piling (5/1/2014 - 8/31/2014); Filling (5/1/2014 - 8/31/2014). No monitoring was conducted on 18 July 2014 due to adverse weather condition.

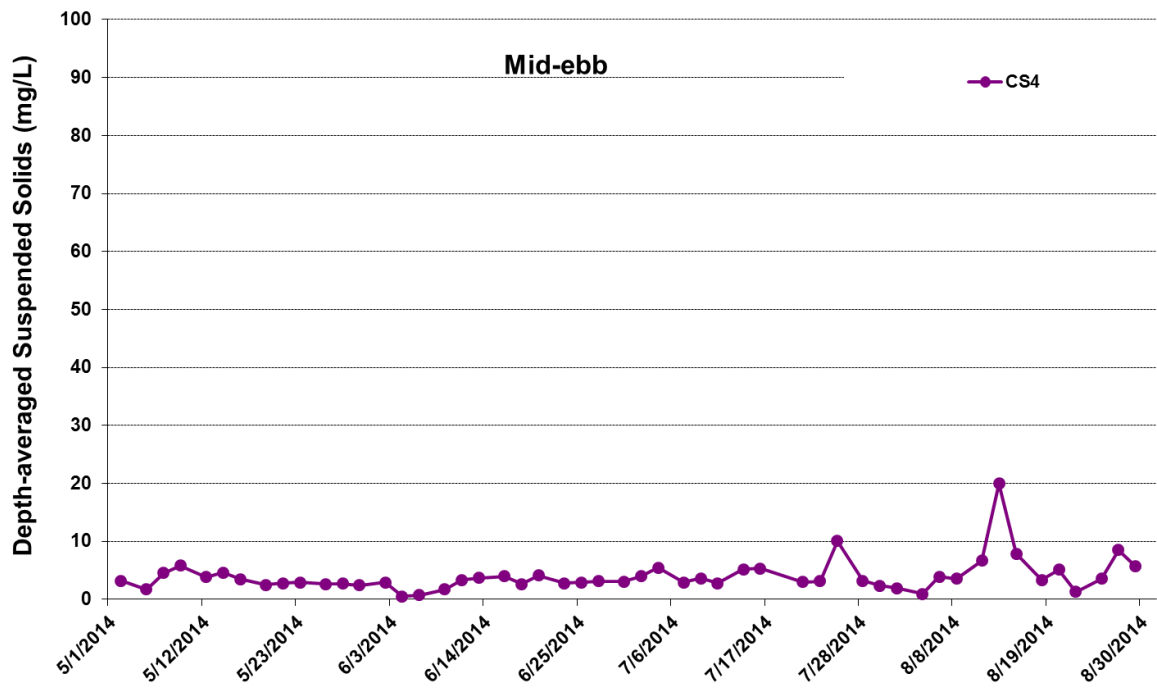
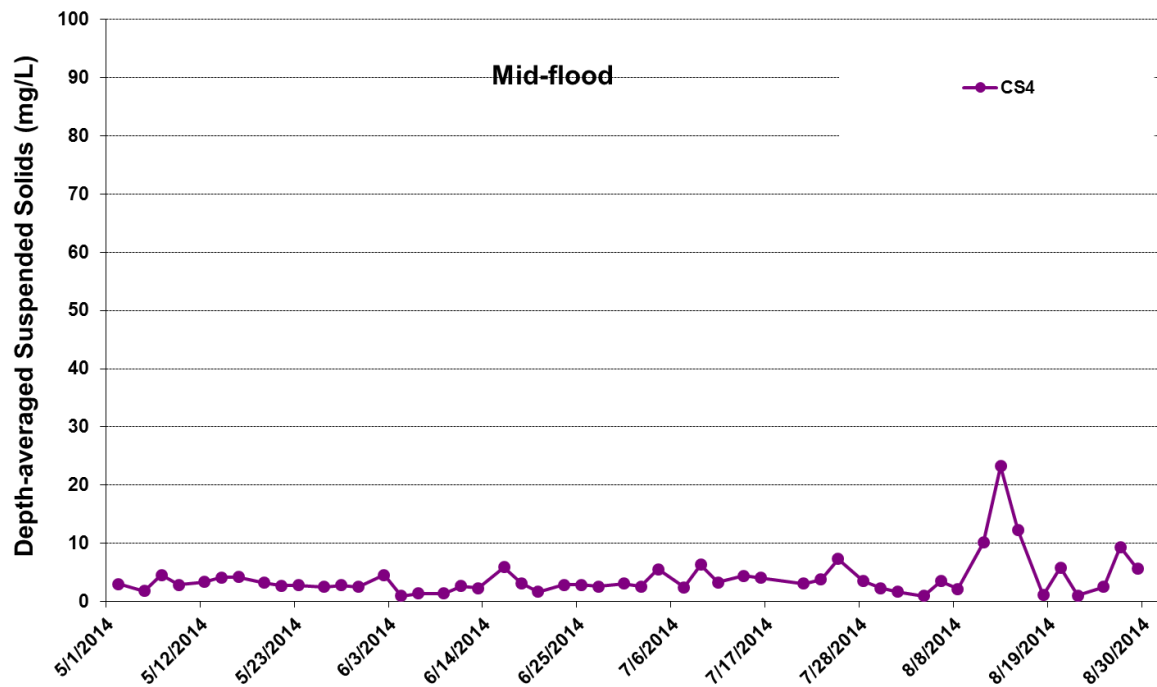
Figure G35 Impact Monitoring – Mean Depth-averaged Level of Suspended Solids (mg/L) between 1 May 2014 and 31 August 2014 at CS4. The weather conditions during the monitoring period varied mostly from sunny to cloudy. Major marine construction activities included: Dredging (5/1/2014 – 8/6/2014); Construction of Temporary Seawalls (5/1/2013 – 8/31/2014); Sheet Piling (5/1/2014 – 8/31/2014); Filling (5/1/2014 – 8/31/2014). No monitoring was conducted on 18 July 2014 due to adverse weather condition.

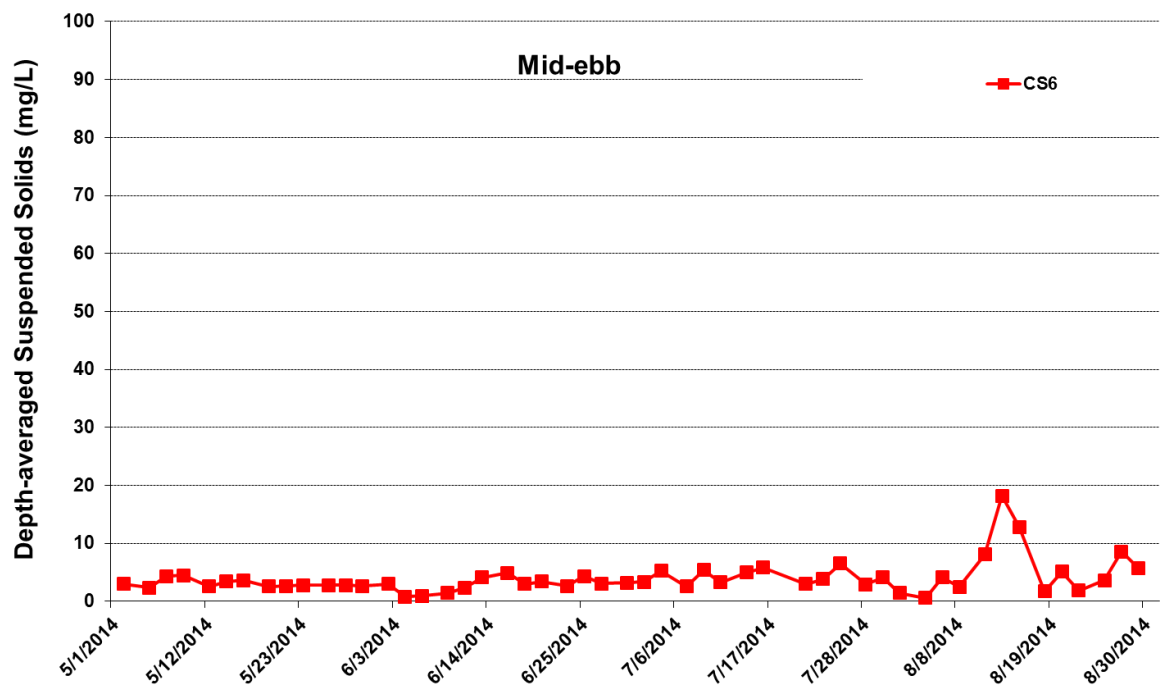
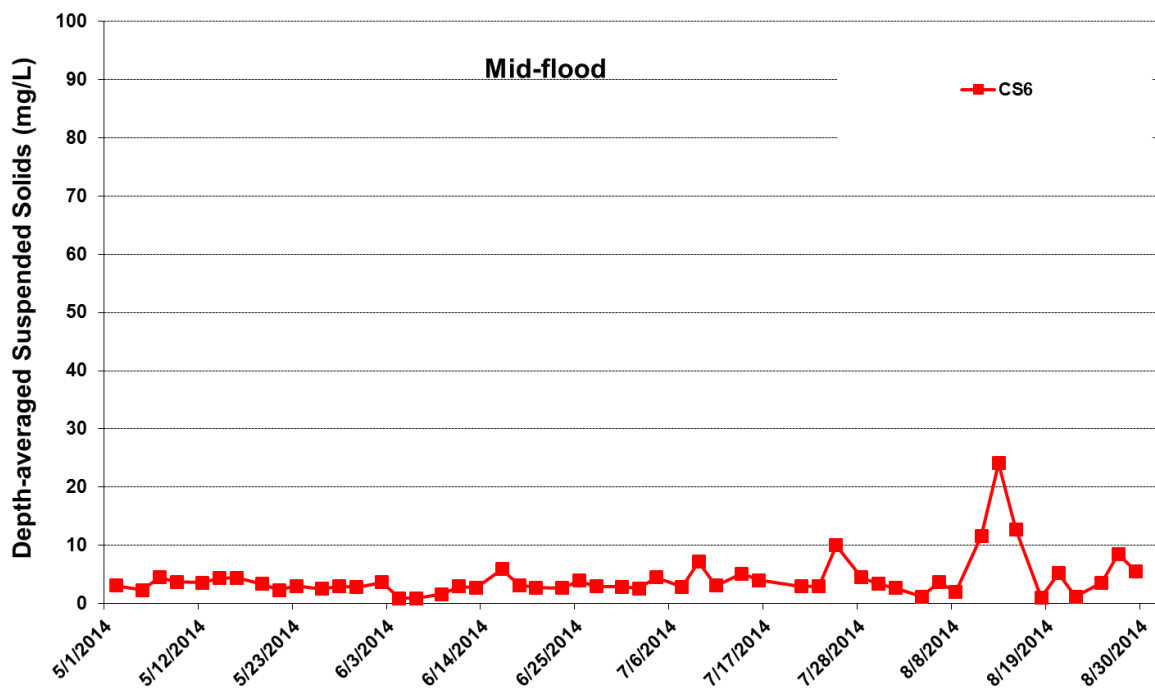
Figure G36 Impact Monitoring – Mean Depth-averaged Level of Suspended Solids (mg/L) between 1 May 2014 and 31 August 2014 at CS6. The weather conditions during the monitoring period varied mostly from sunny to cloudy. Major marine construction activities included: Dredging (5/1/2014 – 8/6/2014); Construction of Temporary Seawalls (5/1/2013 – 8/31/2014); Sheet Piling (5/1/2014 – 8/31/2014); Filling (5/1/2014 – 8/31/2014). No monitoring was conducted on 18 July 2014 due to adverse weather condition.

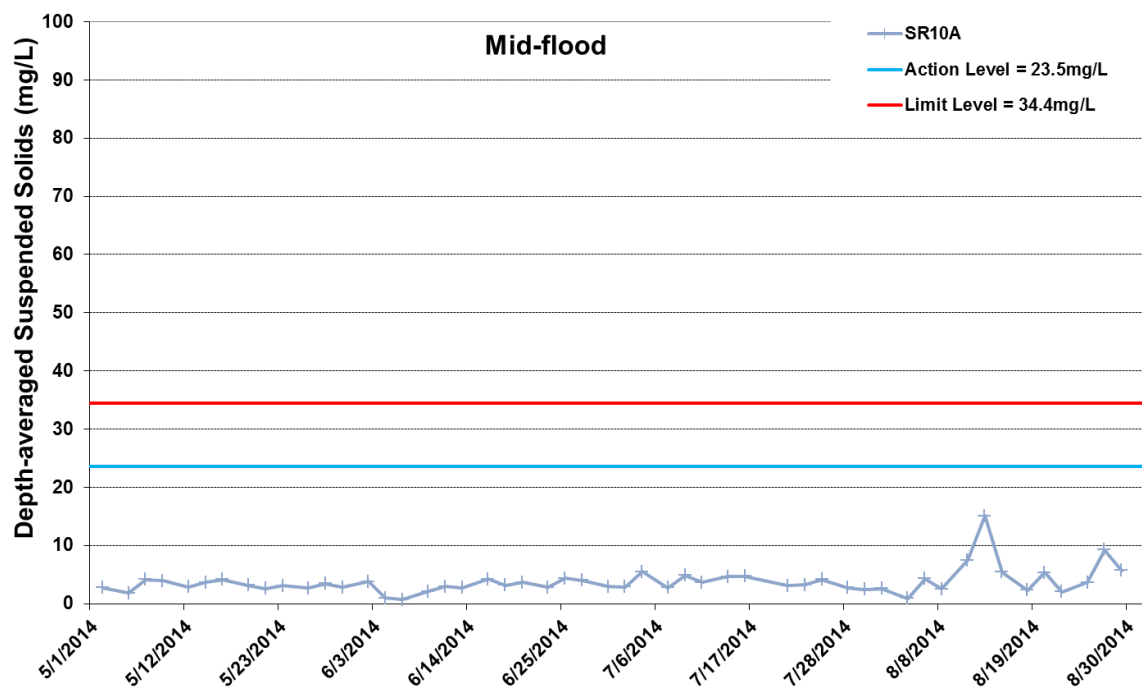
Figure G41 Impact Monitoring – Mean Depth-averaged Level of Suspended Solids (mg/L) between 1 May 2014 and 31 August 2014 at SR10A. The weather conditions during the monitoring period varied mostly from sunny to cloudy. Major marine construction activities included: Dredging (5/1/2014 – 8/6/2014); Construction of Temporary Seawalls (5/1/2013 – 8/31/2014); Sheet Piling (5/1/2014 – 8/31/2014); Filling (5/1/2014 – 8/31/2014). No monitoring was conducted on 18 July 2014 due to adverse weather condition.

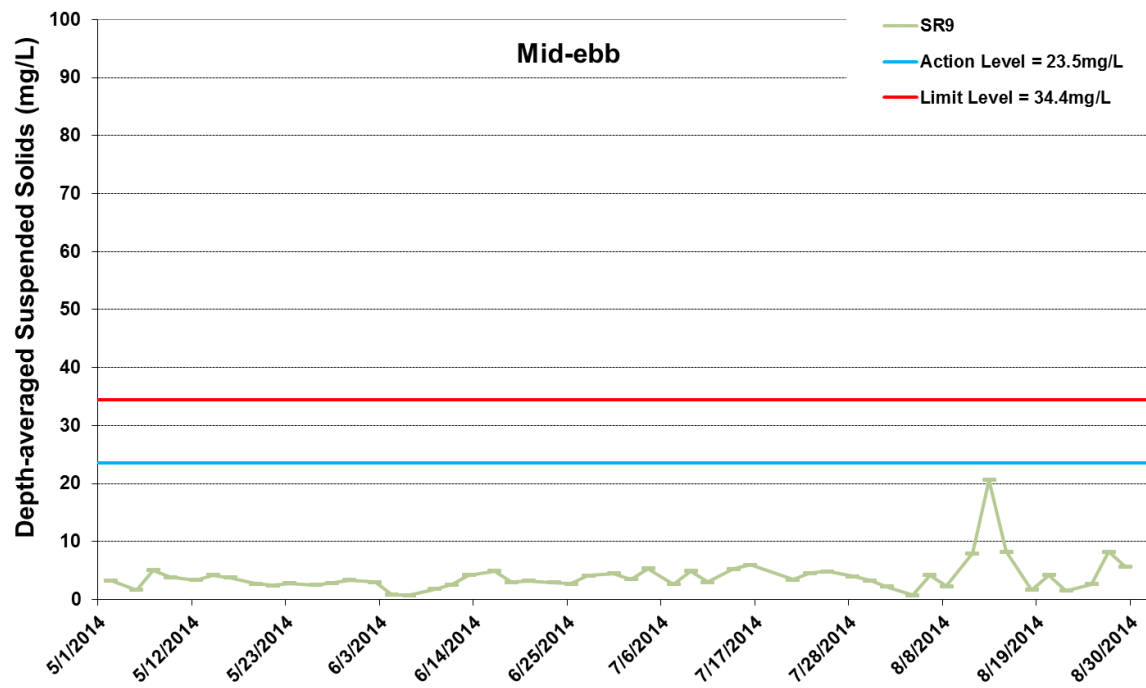
Figure G43 Impact Monitoring - Mean Depth-averaged Level of Suspended Solids (mg/L) between 1 May 2014 and 31 August 2014 at SR9. The weather conditions during the monitoring period varied mostly from sunny to cloudy. Major marine construction activities included: Dredging (5/1/2014 - 8/6/2014); Construction of Temporary Seawalls (5/1/2013 - 8/31/2014); Sheet Piling (5/1/2014 - 8/31/2014); Filling (5/1/2014 - 8/31/2014). No monitoring was conducted on 18 July 2014 due to adverse weather condition.
