**Contract No. HY/2012/08
Tuen Mun – Chek Lap Kok Link –
Northern Connection Sub-sea Tunnel
Section**

*Third Quarterly Environmental Monitoring &
Audit (EM&A) Report*

20 November 2014

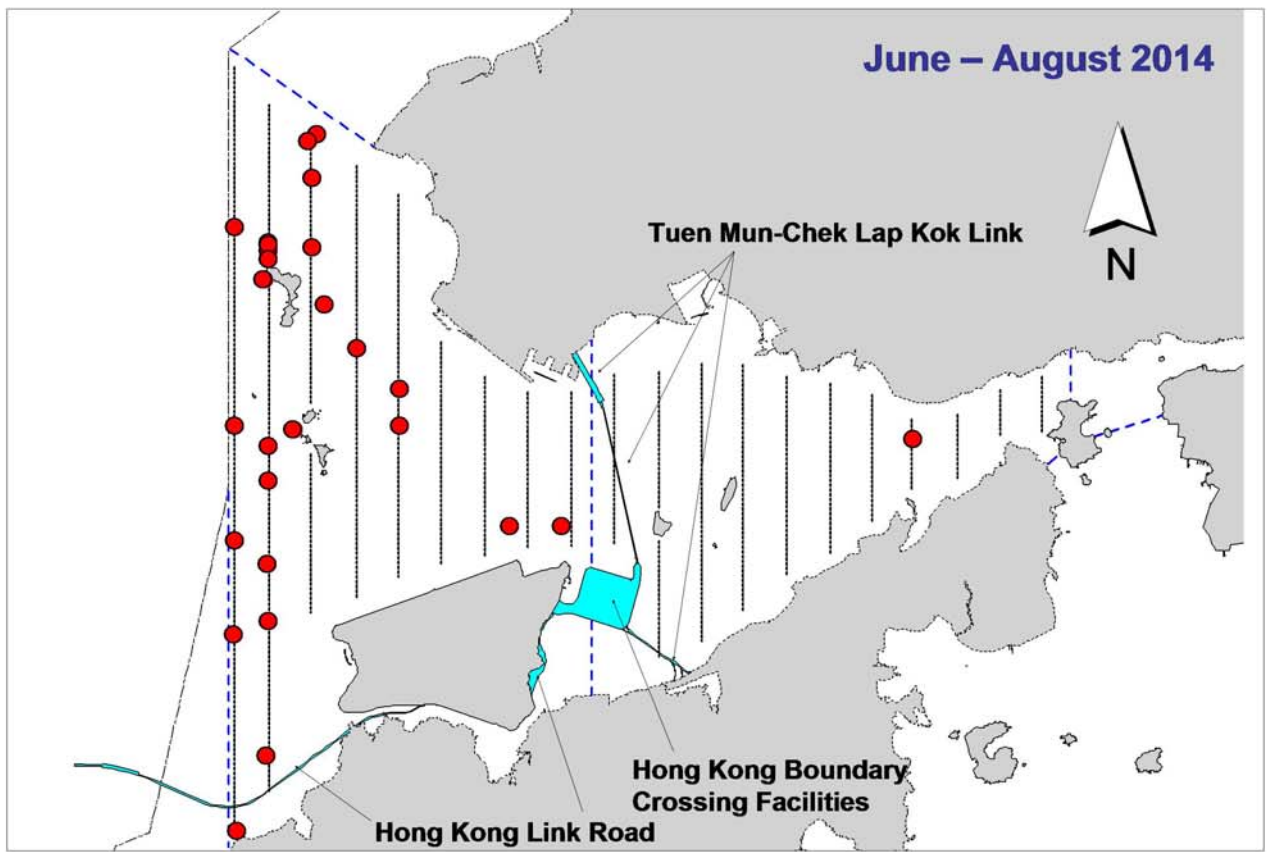
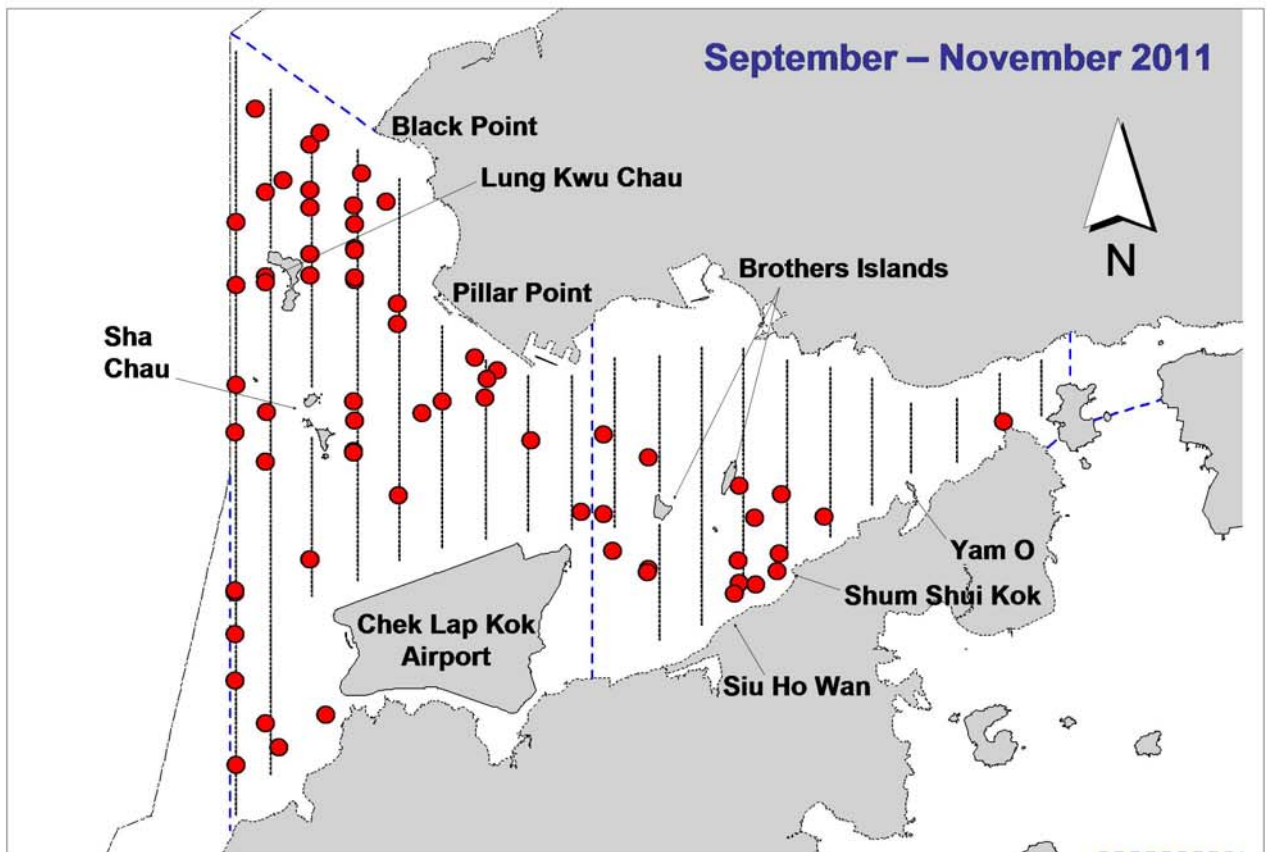
Figure 1. Distribution of Chinese white dolphin sighting in Northwest and Northeast Lantau during HKLR03 impact phase (top) and baseline monitoring surveys (bottom)
