China Harbour – China State Joint Venture

CONTRACT NO. CV/2009/02

TSEUNG KWAN O AREA 137 FILL BANK

MONTHLY EM&A REPORT NO.28

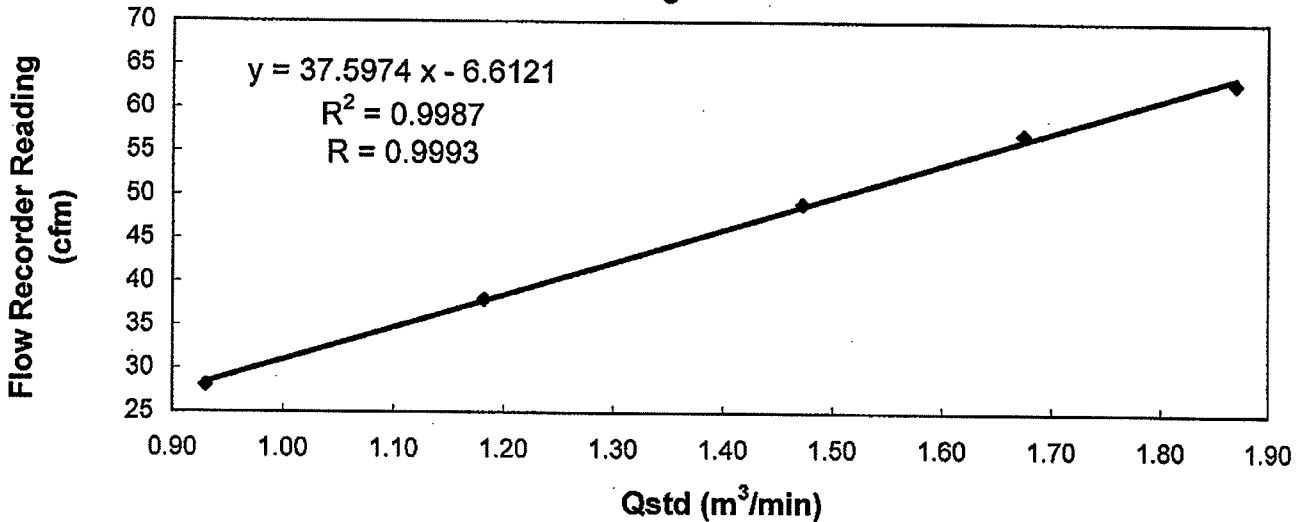
Sampler 10581 Calibration Curve
Site: Tseung Kwan O A-1

Results	Flow recorder reading (cfm)	63	57	49	38	28
	Qstd (Actual flow rate, m ³ /min)	1.87	1.68	1.47	1.18	0.93
	Pressure :	768.06	mm Hg	Temp. :	283	K

Acceptance Criteria : Correlation coefficient (r) of the calibration curve greater than 0.990 after a 5-point calibration.

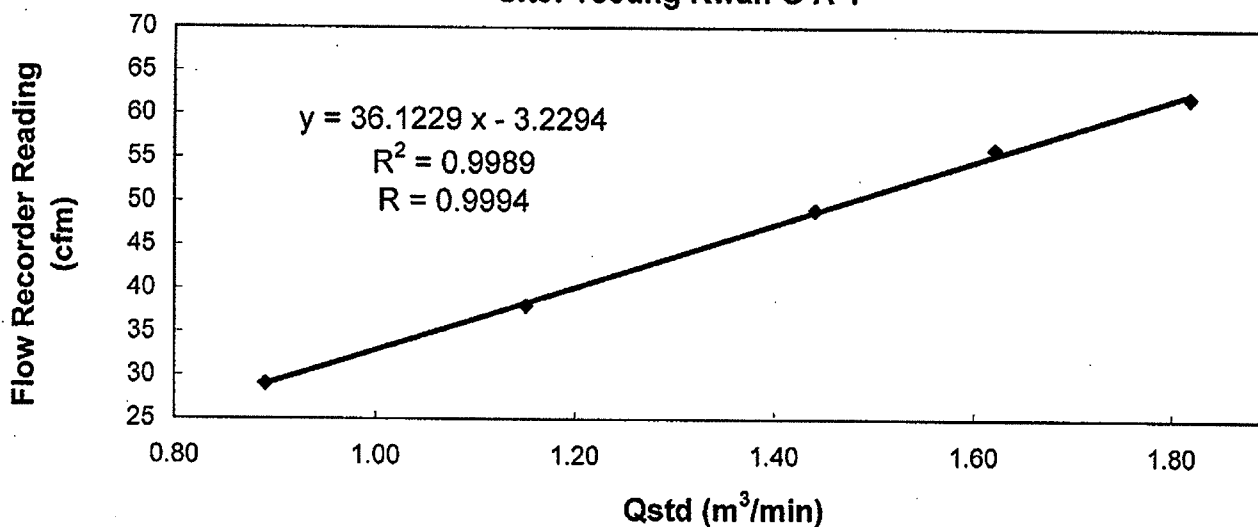
Sampler 10581 Calibration Curve
Site: Tseung Kwan O A-1

Flow recorder reading (cfm)	62	56	49	38	29
Qstd (Actual flow rate, m ³ /min)	1.82	1.62	1.44	1.15	0.89
Pressure :	768.06	mm Hg	Temp. :	299	K

Acceptance Criteria : Correlation coefficient (r) of the calibration curve greater than 0.990 after a 5-point calibration.

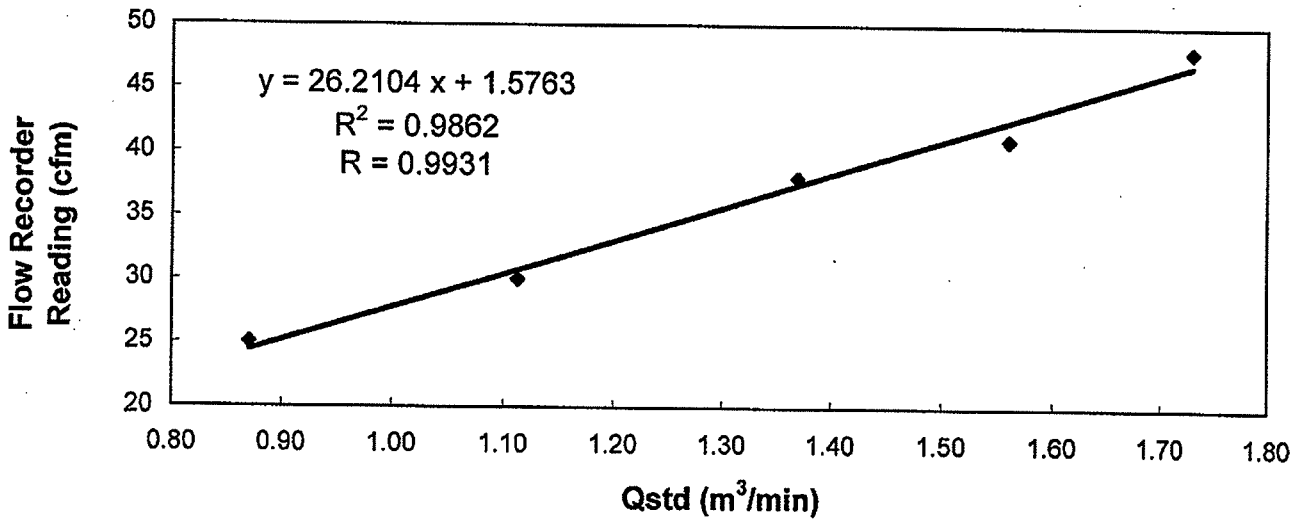
Sampler 1172 Calibration Curve
Site: Tseung Kwan O A-2

Flow recorder reading (cfm)	48	41	38	30	25
Qstd (Actual flow rate, m ³ /min)	1.73	1.56	1.37	1.11	0.87
Pressure :	768.06	mm Hg	Temp. :	283	K

Acceptance Criteria : Correlation coefficient (r) of the calibration curve greater than 0.990 after a 5-point calibration.

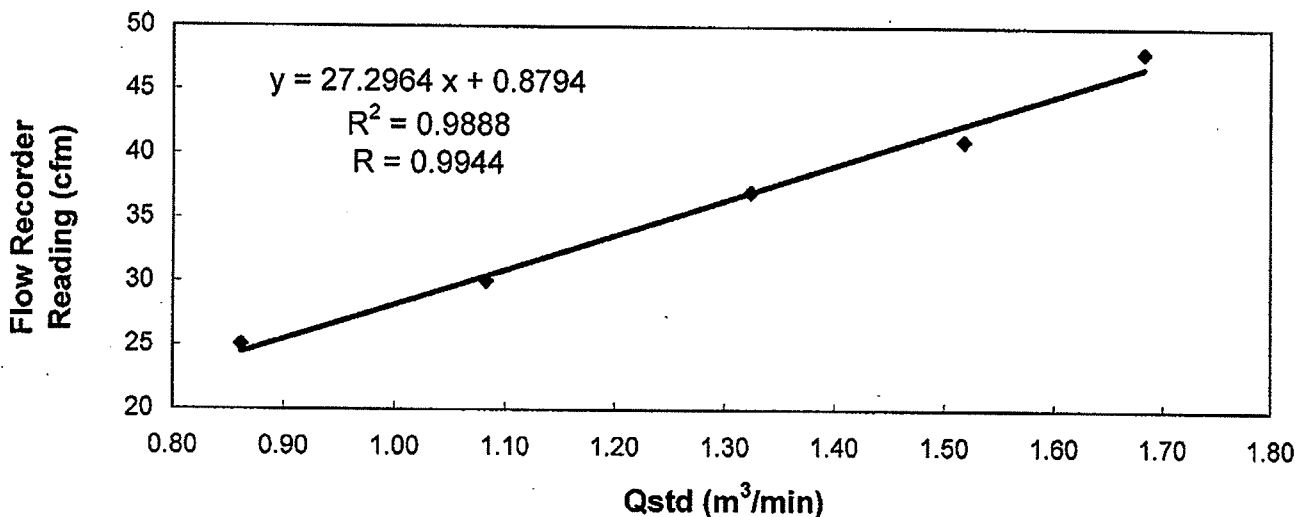
**Sampler 1172 Calibration Curve
Site: Tseung Kwan O A-2**

Results	Flow recorder reading (cfm)	48	41	37	30	25
	Qstd (Actual flow rate, m ³ /min)	1.68	1.52	1.32	1.08	0.86
	Pressure : 768.06 mm Hg	Temp. : 299 K

Acceptance Criteria : Correlation coefficient (r) of the calibration curve greater than 0.990 after a 5-point calibration.

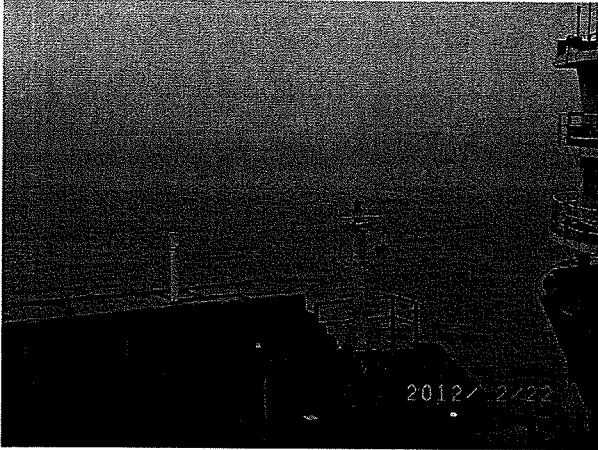
Photo 1

No silt curtain was provided near Tipping Hall No.1.

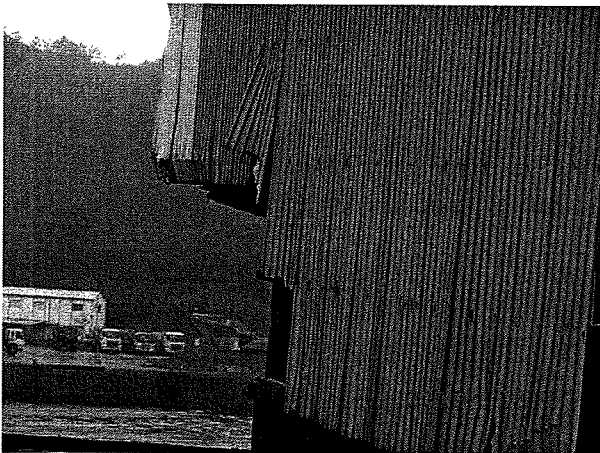
Photo 3

Enclosure of Tipping Hall was damaged.
The Contractor was reminded to repair the damaged part of tipping hall.

- Follow up action to the outstanding finding in the previous month, the enclosure of tipping hall No.1 was still found damaged during several weekly sit inspections in this reporting month. The Contractor was reminded to repair the damaged part of tipping hall properly. Since the finding was observed at the last weekly site inspection in this reporting month, it will be verified in the coming month;

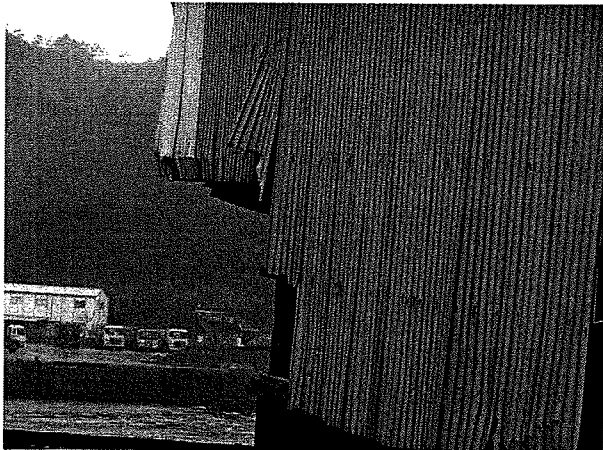
Photo 1

Enclosure of Tipping Hall was damaged.
The Contractor was reminded to repair the damaged part of tipping hall.

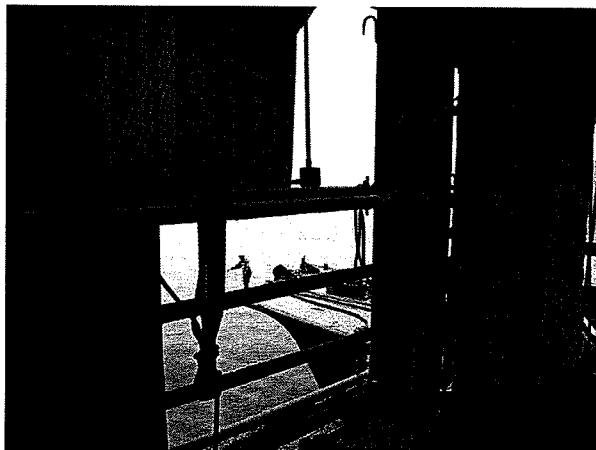
Photo 2

Tipping Hall was still damaged. **(Follow up)**

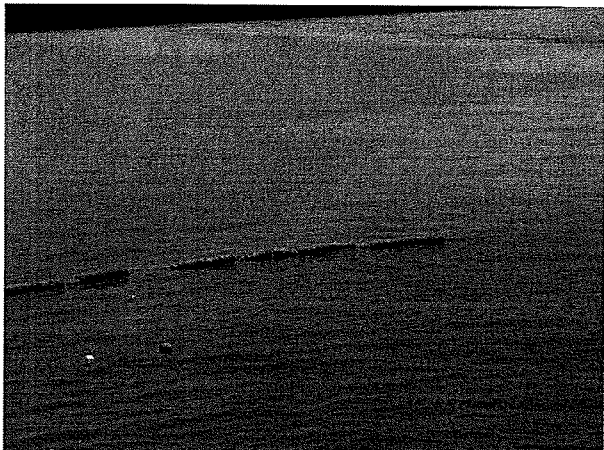
Photo 3

Floating buoys of silt curtain were broken.
The Contractor should conduct regular maintenance for silt curtain and ensure its properly functioning.

- Follow up action to the outstanding finding in the previous month, silt curtain near the tipping hall No.1 was found damaged during the several weekly site inspections in this reporting month. The Contractor was reminded to repair and maintain the silt curtain properly. Since the finding was still observed in the last weekly site inspection, it will be verified in the coming month;
