CONTRACT NO. CV/2009/02

HANDLING OF SURPLUS PUBLIC FILL

TSEUNG KWAN O AREA 137 FILL BANK

MONTHLY EM&A REPORT NO.29

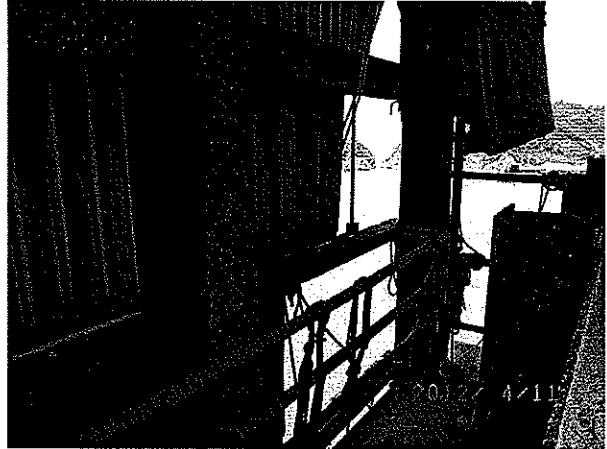
Photo 2

Tipping Hall No.1

Tipping Hall was still damaged. **(Follow up)**

- Follow up action to the outstanding finding in the previous month, the enclosure of tipping hall No.1 was repaired during several weekly sit inspection on 18 April 2012;

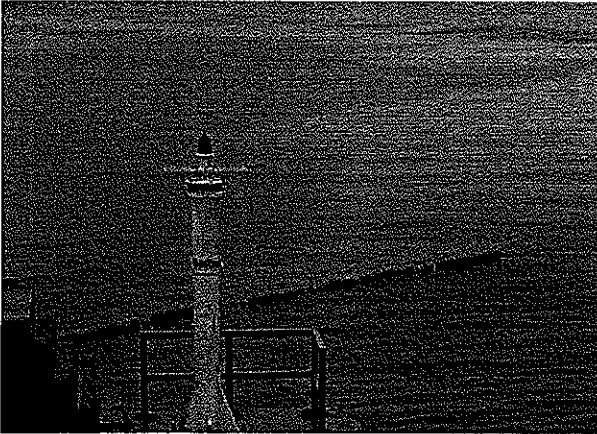
Photo 3

Silt Curtain

Floating buoys of silt curtain were broken.
The Contractor should conduct regular maintenance for silt curtain and ensure its properly functioning.

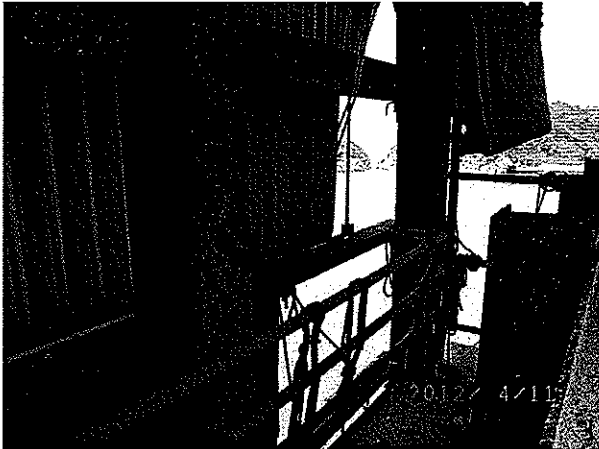
Photo 1

Tipping Hall No.1

Enclosure of Tipping Hall was damaged.
The Contractor was reminded to repair the damaged part of tipping hall.

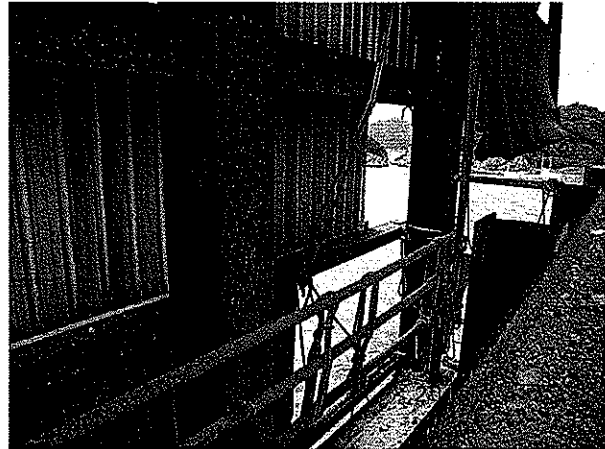
Photo 2

Tipping Hall No.1

Tipping Hall was still damaged. **(Follow up)**

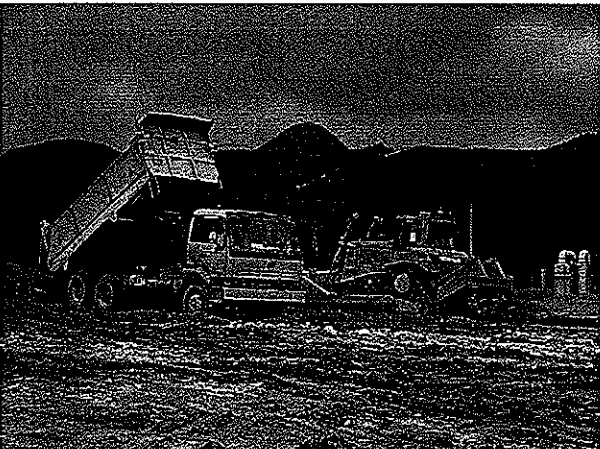
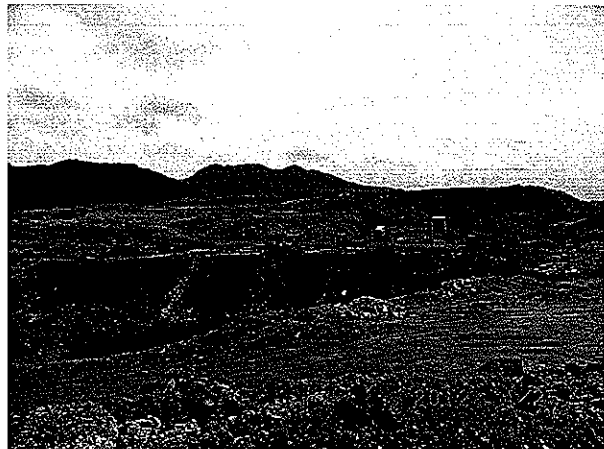
Photo 9 and 10 – No new environmental deficiency was recorded.
