TEST REPORT

CONTRACT NO. CV/2009/02

HANDLING OF SURPLUS PUBLIC FILL

MONTHLY EM&A REPORT NO.30

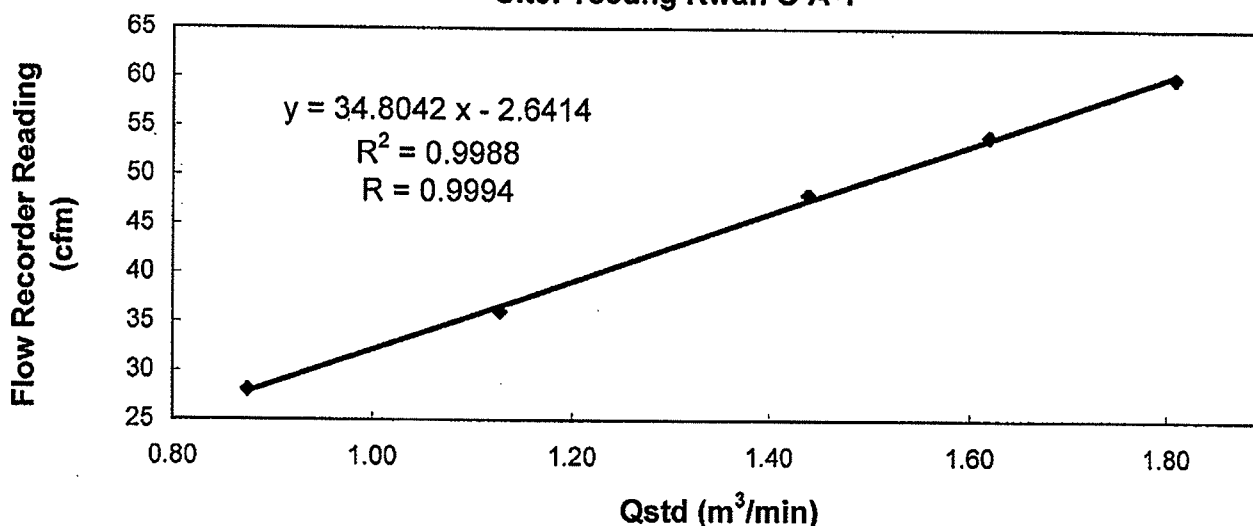
**Sampler 10581 Calibration Curve
Site: Tseung Kwan O A-1**

Flow recorder reading (cfm)	60	54	48	36	28
Qstd (Actual flow rate, m ³ /min)	1.81	1.62	1.44	1.13	0.88
Pressure :	763.56	mm Hg	Temp. :	298	K

Acceptance Criteria : Correlation coefficient (r) of the calibration curve greater than 0.990 after a 5-point calibration.

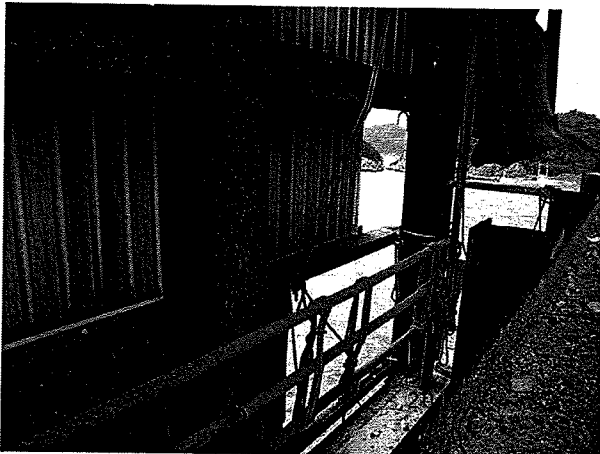
Photo 1

- The enclosure of tipping hall No.1 was found broken during the weekly site inspection on 09 May 2012. The Contractor was reminded to repair and maintain the tripping hall properly. As reported by the Contractor on 10 May 2012, the damaged part of tipping hall was repaired;

Tipping Hall No.1

Enclosure of Tipping Hall was damaged. The Contractor was reminded to repair the damaged part of tipping hall.

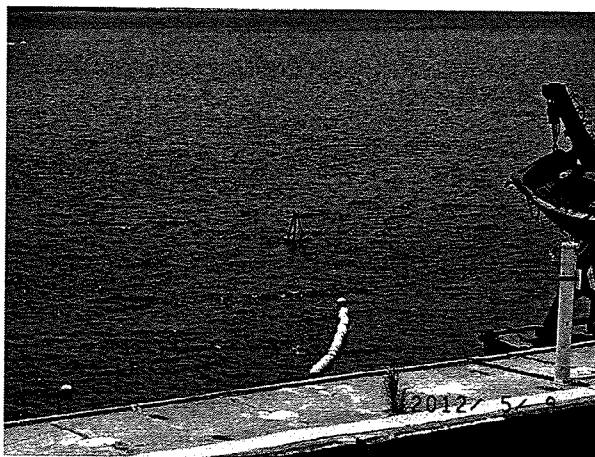
Photo 4

Silt Curtain

Silt curtain were still broken. **(Follow up)**

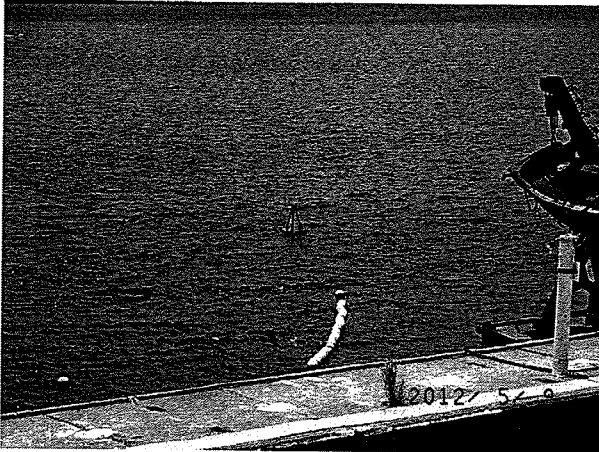
Photo 1

Silt Curtain

The Contractor should conduct regular maintenance for silt curtain and ensure its properly functioning.

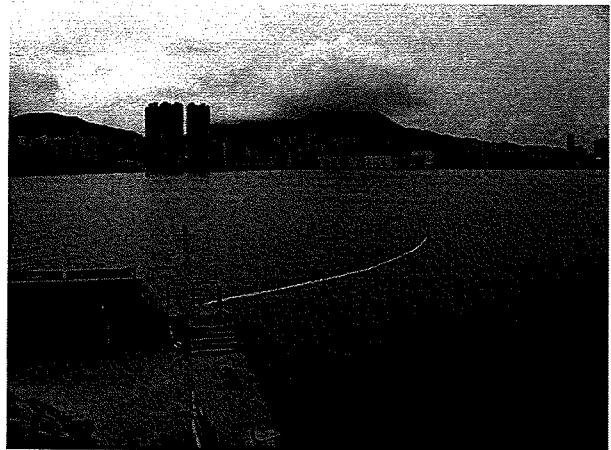
Photo 2

Silt Curtain

Replacement of silt curtain had been carried out. **(Closed)**

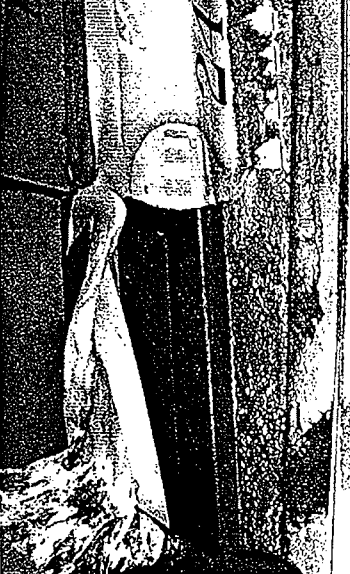
<p>16/5/2012 10:37 Photo 120516_002 (Drip tray for generator near the Contractor's site office)</p>
