CONTRACT NO. CV/2009/02

HANDLING OF SURPLUS PUBLIC FILL

TSEUNG KWAN O AREA 137 FILL BANK

MONTHLY EM&A REPORT NO.31

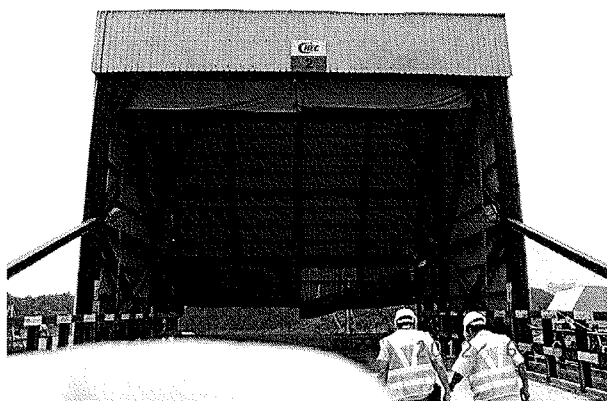
Photo 1 and 2

Tipping Hall No.2

The Contractor should replace the damaged cladding for tipping hall.

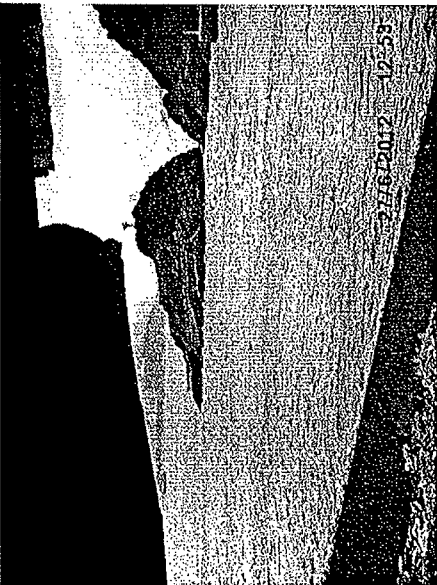
<p>27/6/2012 12:53</p> <p>Photo 120627_005 (Silt curtain near the Contractor site office)</p>

- Floating booms of silt curtain near the Contractor's site office was found damaged during the weekly site inspection on 27 June 2012. The Contractor was reminded to repair the silt curtain as soon as possible. Since the finding was observed at the last weekly site inspection, it will be verified in the coming month.

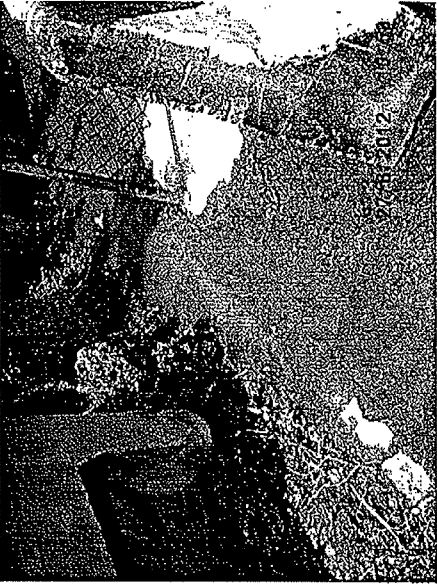
<p>27/6/2012</p> <p>Photo 120627_006 (Footpath near Temporary Construction Waste Sorting Facilities)</p>

- Stagnant water was noted at the footpath near Temporary Construction Waste Sorting Facilities during the weekly site inspection on 27 June 2012. The Contractor was reminded to clear the stagnant water or apply pesticide to avoid mosquito breeding. Since the finding was observed at the last weekly site inspection, it will be verified in the coming month; and
