TEST REPORT

CONTRACT NO. CV/2009/02

HANDLING OF SURPLUS PUBLIC FILL

MONTHLY EM&A REPORT NO.34

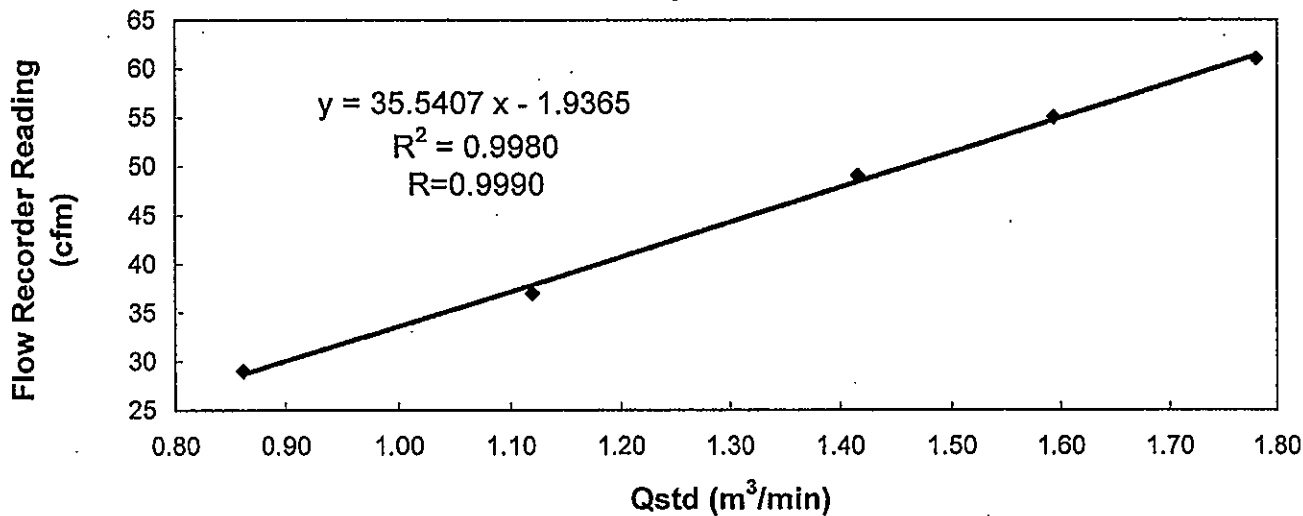
Sampler 10581 Calibration Curve
Site: Tseung Kwan O A-1

Results :	Flow recorder reading (cfm)	61	55	49	37	29
	Qstd (Actual flow rate, m ³ /min)	1.78	1.59	1.42	1.12	0.86
	Pressure : 756.06 mm Hg	Temp. :		305	K

Acceptance Criteria : Correlation coefficient (r) of the calibration curve greater than 0.990 after a 5-point calibration.

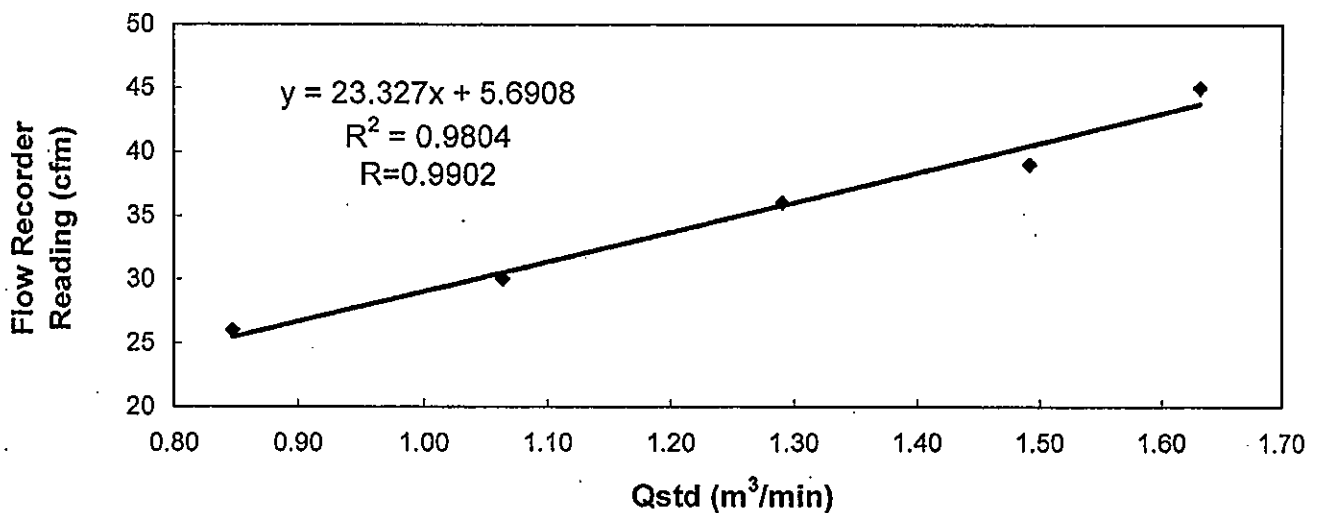
Sampler 1172 Calibration Curve
Site: Tseung Kwan O A-2

Flow recorder reading (cfm)	45	39	36	30	26
Qstd (Actual flow rate, m ³ /min)	1.63	1.49	1.29	1.06	0.85
Pressure :	756.06	mm Hg	Temp. :	305	K

Acceptance Criteria : Correlation coefficient (r) of the calibration curve greater than 0.990 after a 5-point calibration.

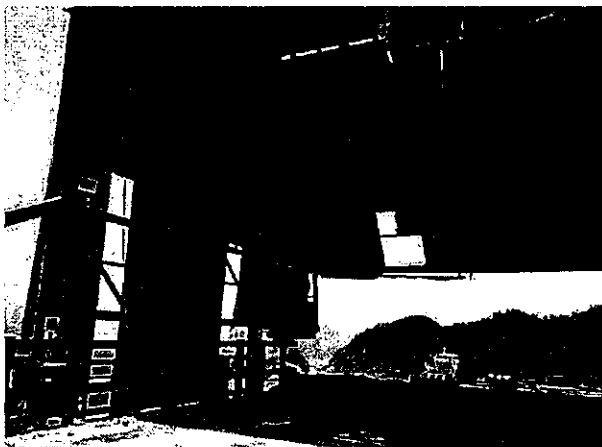
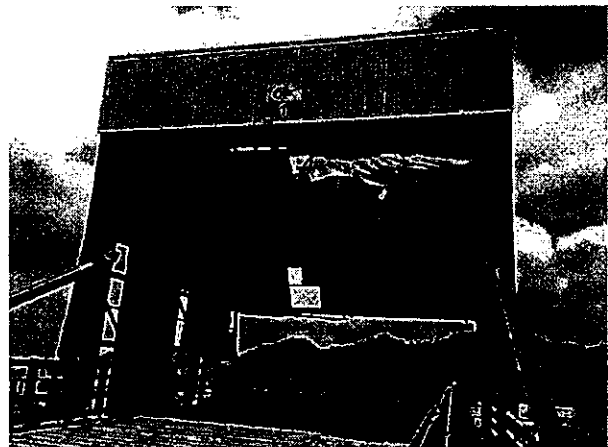
Tipping Hall No.1 to No.3 were damaged.
The Contractor should repair the damaged parts of tipping hall.

- Follow up action to the outstanding finding in the previous month, the enclosure of tipping hall No.2 and No.3 was still found broken during the several weekly site inspections in this reporting month. The Contractor was reminded to repair and maintain the tripping hall properly as soon as possible. Since the finding was still observed at the last weekly site inspection on 25 September 2012, it will be verified in the following month;

- Follow up action to the outstanding finding in the previous month, the enclosure of tipping hall No.1 was noted repaired during the weekly site inspection on 25 September 2012;

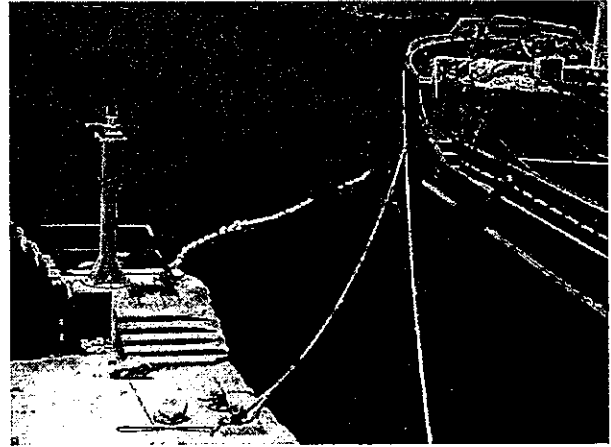
Photo 8

The Contractor was reminded to provide silt curtain properly at TKOFB. (Follow up)

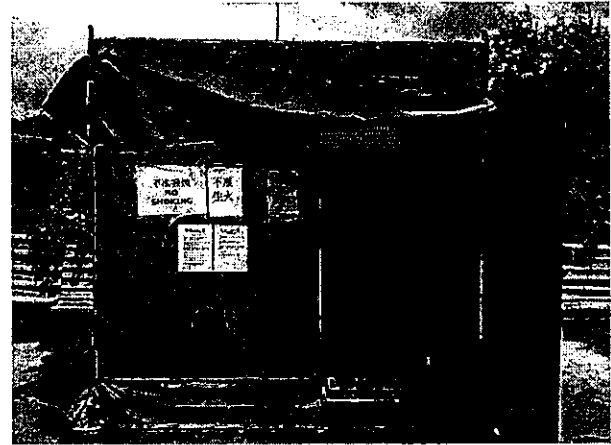
Photo 10

Chemical wastes including waste oil and oil containers had been collected by the licensed chemical waste collector. (Closed)

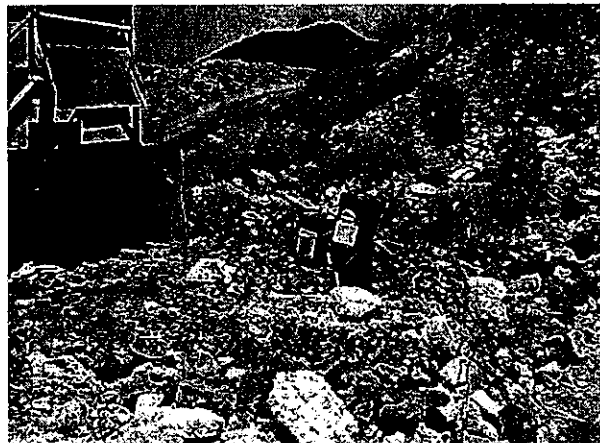
Photo 11

Emptied oil containers were discarded at Area A4.

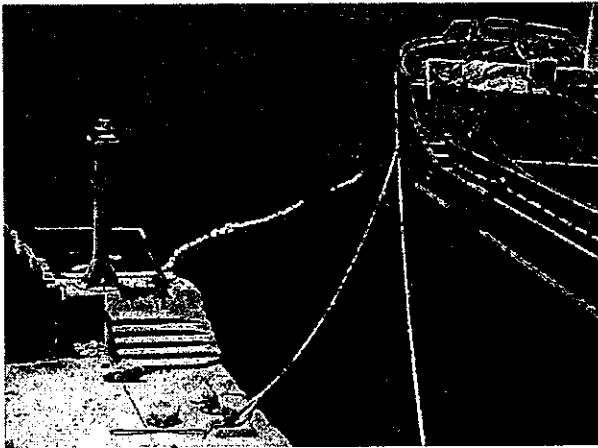
Photo 7

Silt curtain near Pier No.1 was not properly fixed.

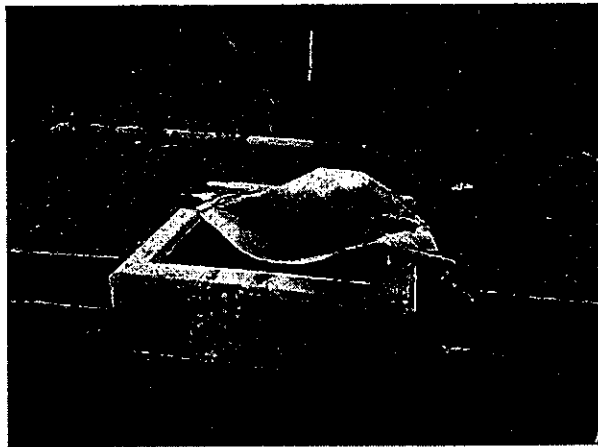
Photo 9

The desilting cloth provided at Catchpit No.5 was broken.

The Contractor was reminded to provide the desilting facilities at the drainage system as soon as possible.

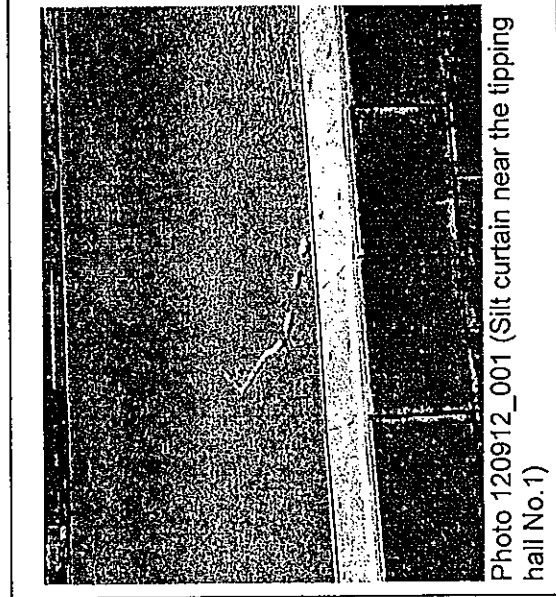
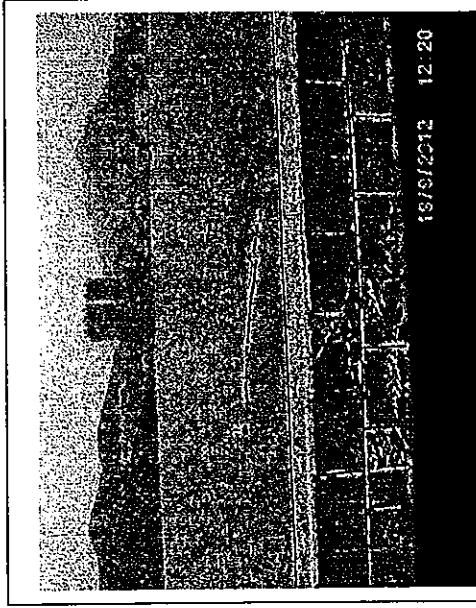
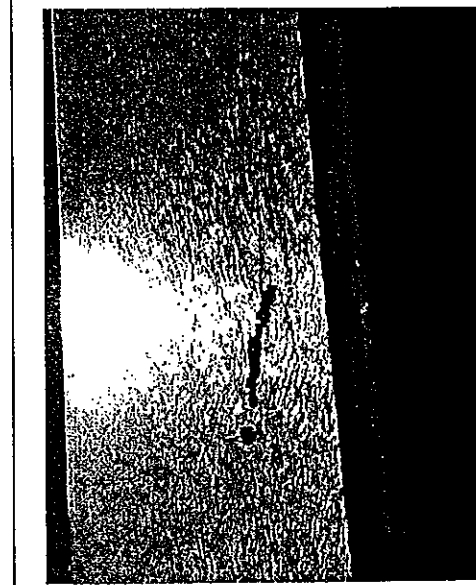
- Follow up action to the outstanding finding in the previous month, floating booms of silt curtain near tipping hall No.1 were still found damaged during the several weekly site inspections in this reporting month. The contractor was reminded to repair the damaged parts of silt curtain as soon as possible. Since the finding was still observed at the last weekly site inspection on 25 September 2012, it will be verified in the following month;

Photo 120905_001 (Silt curtain near the tipping hall No.1)

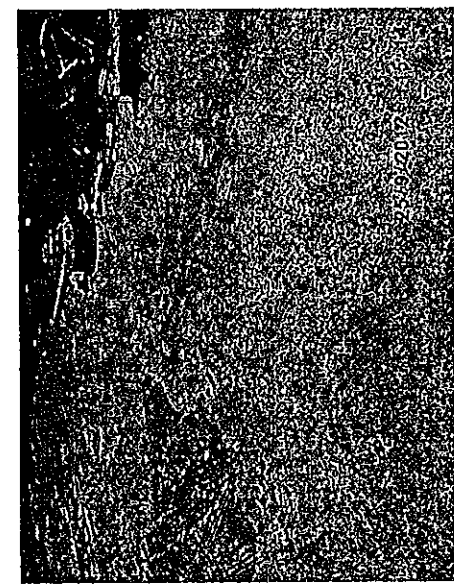
- C&D waste (e.g. cardboard and metal) was noted discarded on the ground near tire repair workshop at Section A6 during the weekly site inspection on 19 September 2012. The Contractor was reminded to collect the C&D waste and treat them properly. During the subsequent weekly site inspection on 25 September 2012, the C&D waste was cleared; and
- Sufficient rubbish skips had been provided at site by the Contractor in this reporting month.

Photo 120919_006 (Near tire repair workshop)

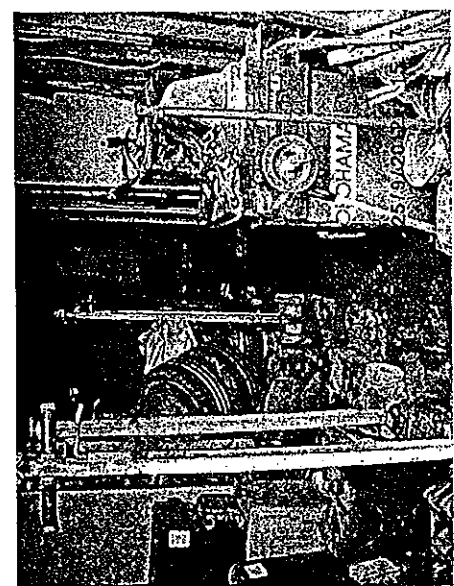
- The door of CWSA was found locked properly during weekly site inspections in this month;
- Waste oil was found inside a cargo near tire repair workshop at Section A6 during the weekly site inspection on 25 September 2012. The Contractor was reminded to remove and store / dispose of the waste oil properly. Since the finding was observed at the last weekly site inspection on, it will be verified in the following month; and

Photo 120925_006 (Cargo near tire repair workshop)
